Publication No. FHWA-RD-88-071
July 1989

Rehabilitation of Concrete Pavements

Volume I: Repair Rehabilitation Techniques

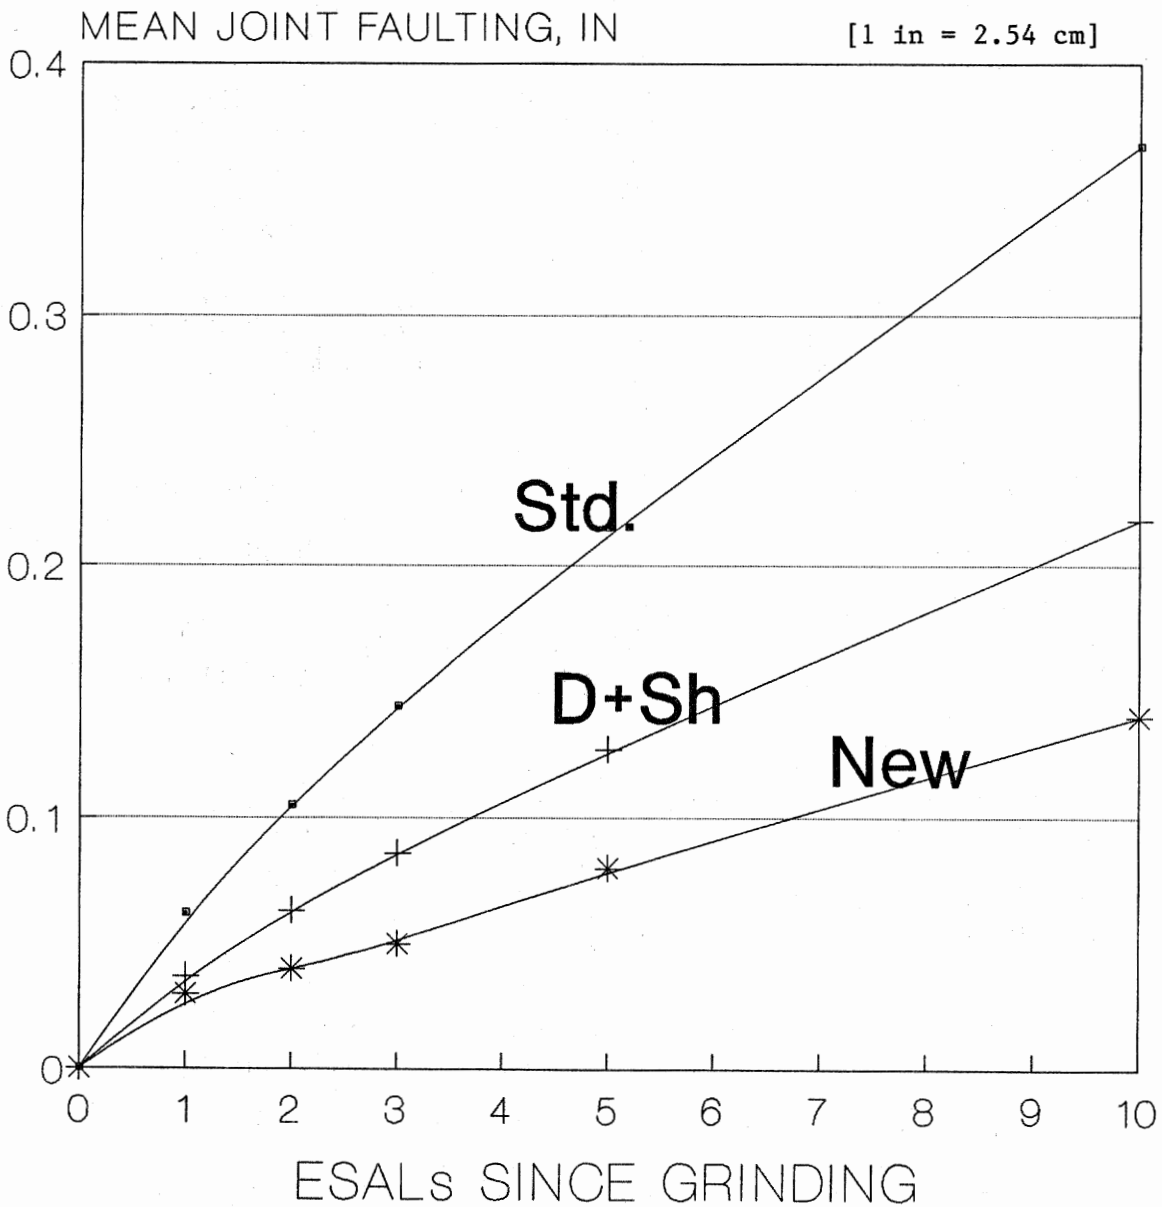
Figure 9. Faulting projections for standard JRCP and standard plus drains and PCC shoulders (Estimated faulting for new section also shown for comparison).

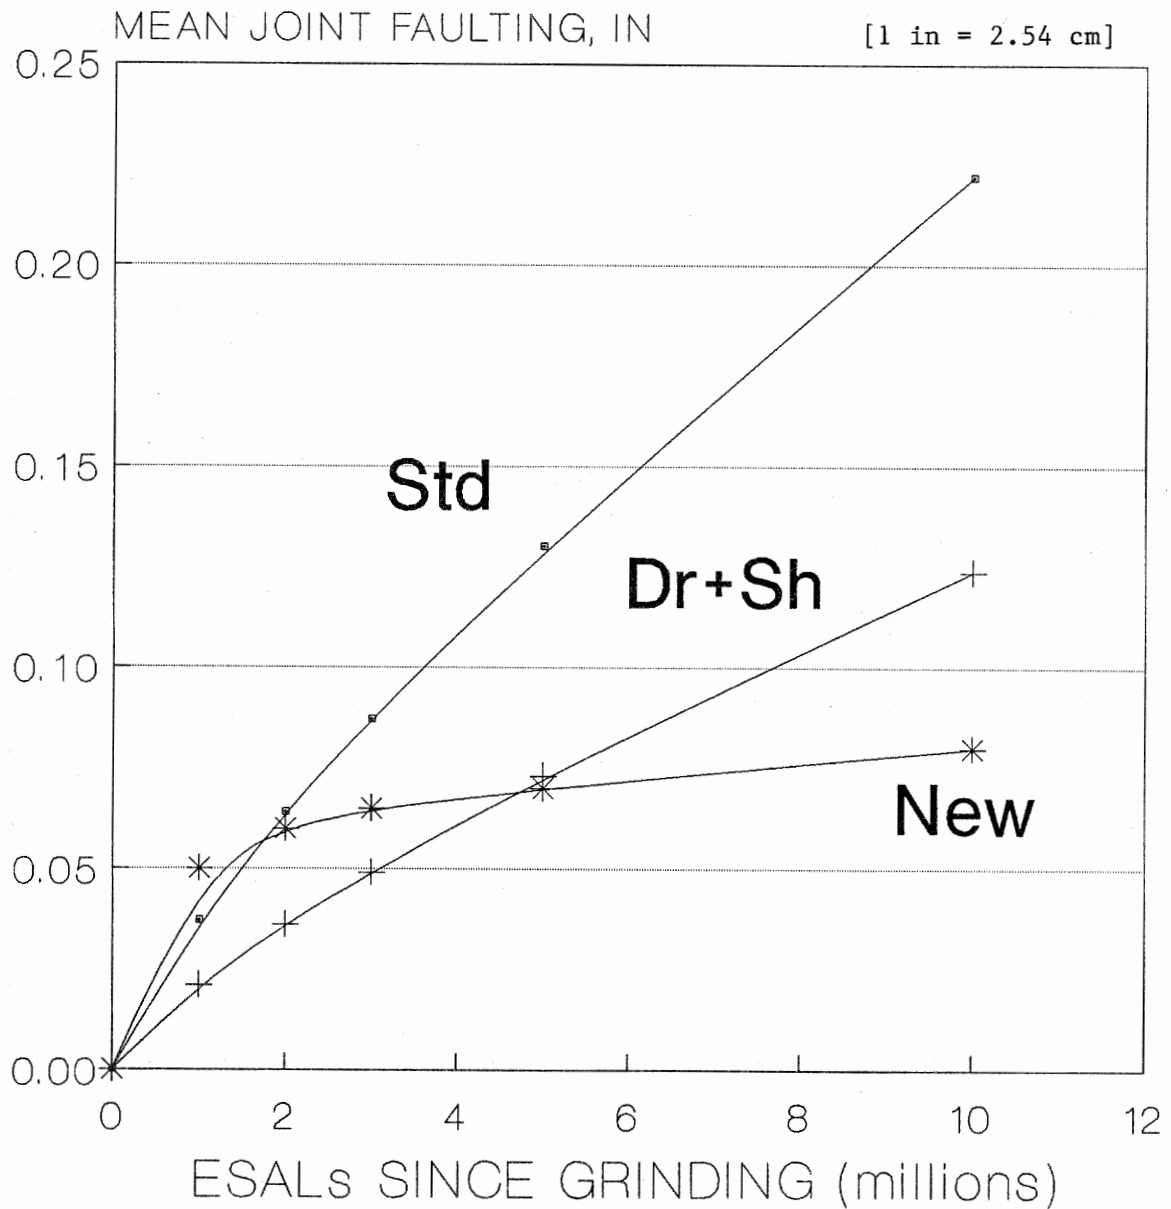
Figure 10. Faulting projections for standard JPCP and standard plus drains and PCC shoulders (Estimated faulting for new section also shown for comparison).

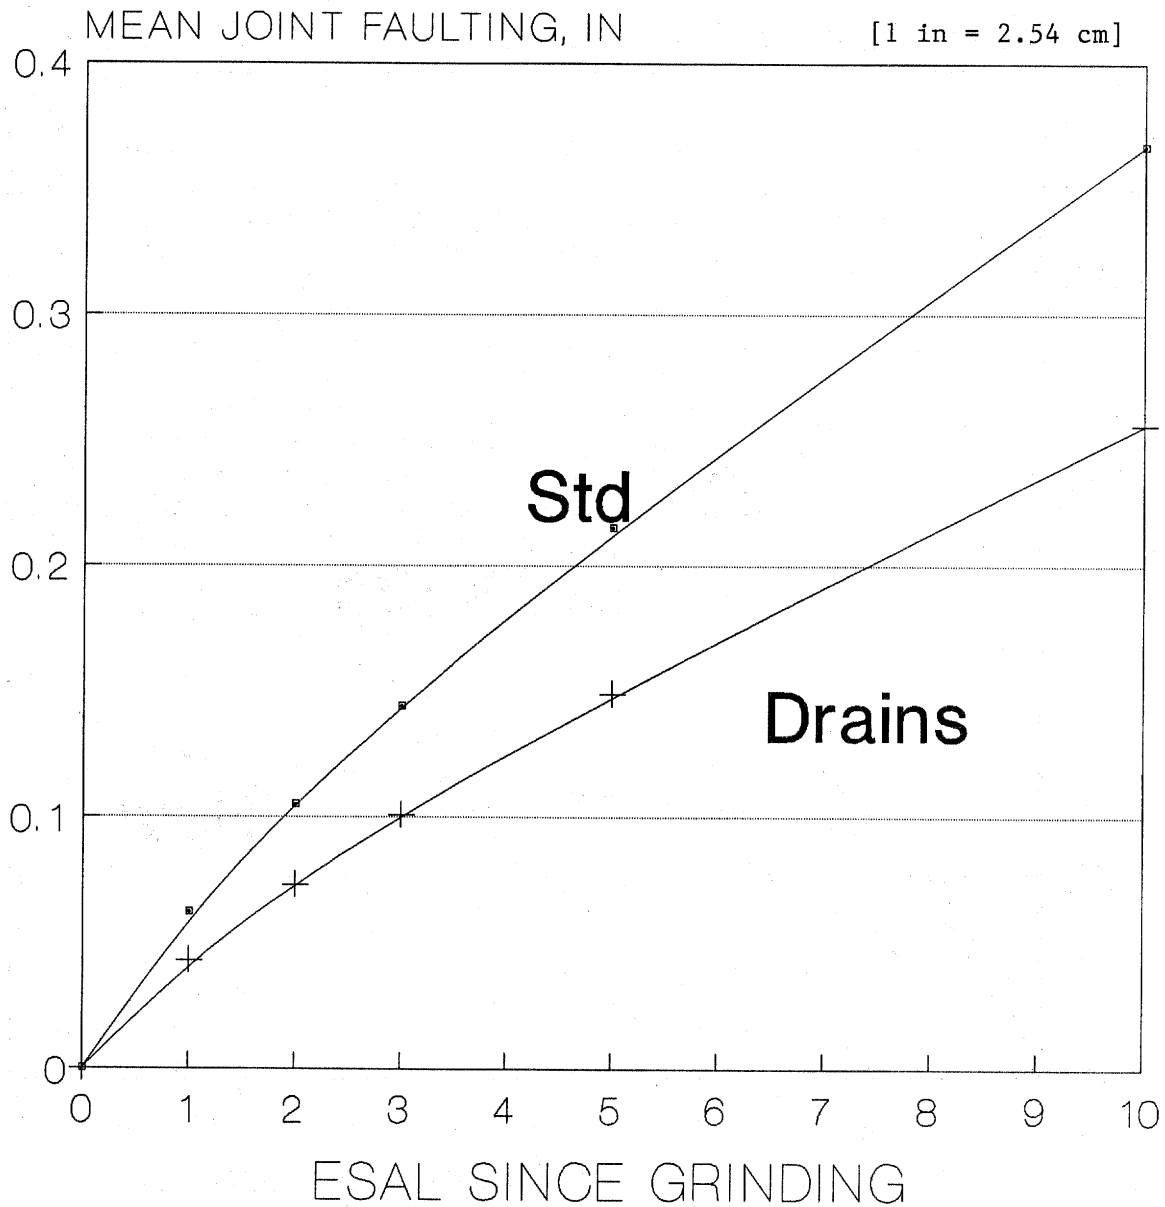
Figure 11. Faulting projections for standard JRCP and standard plus drains and PCC shoulders.

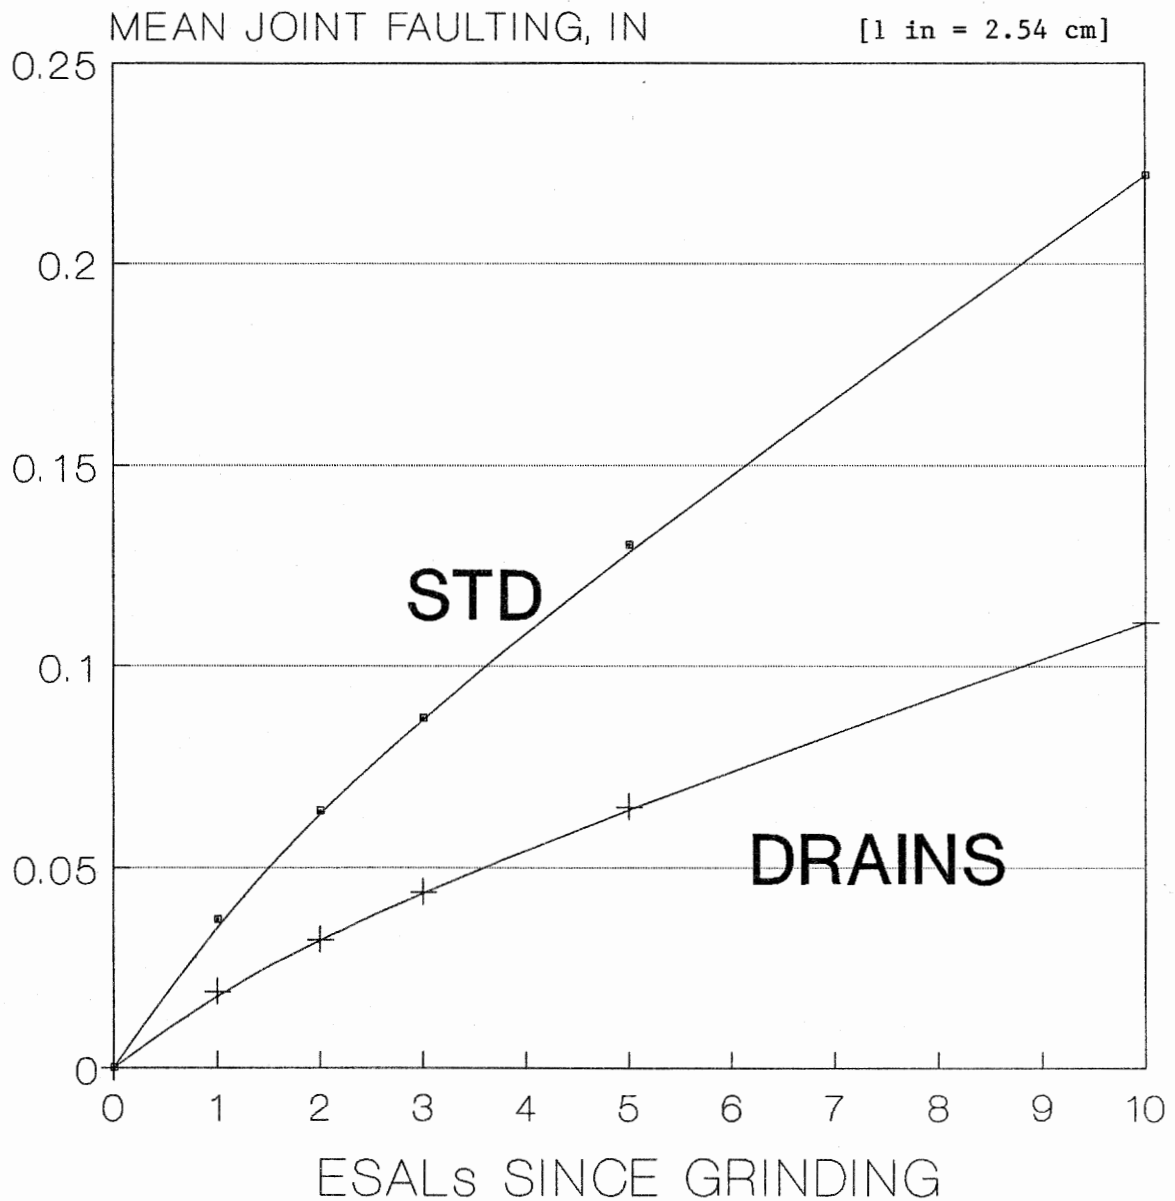
Figure 12. Faulting projections for standard JPCP and standard plus drains and PCC shoulders.

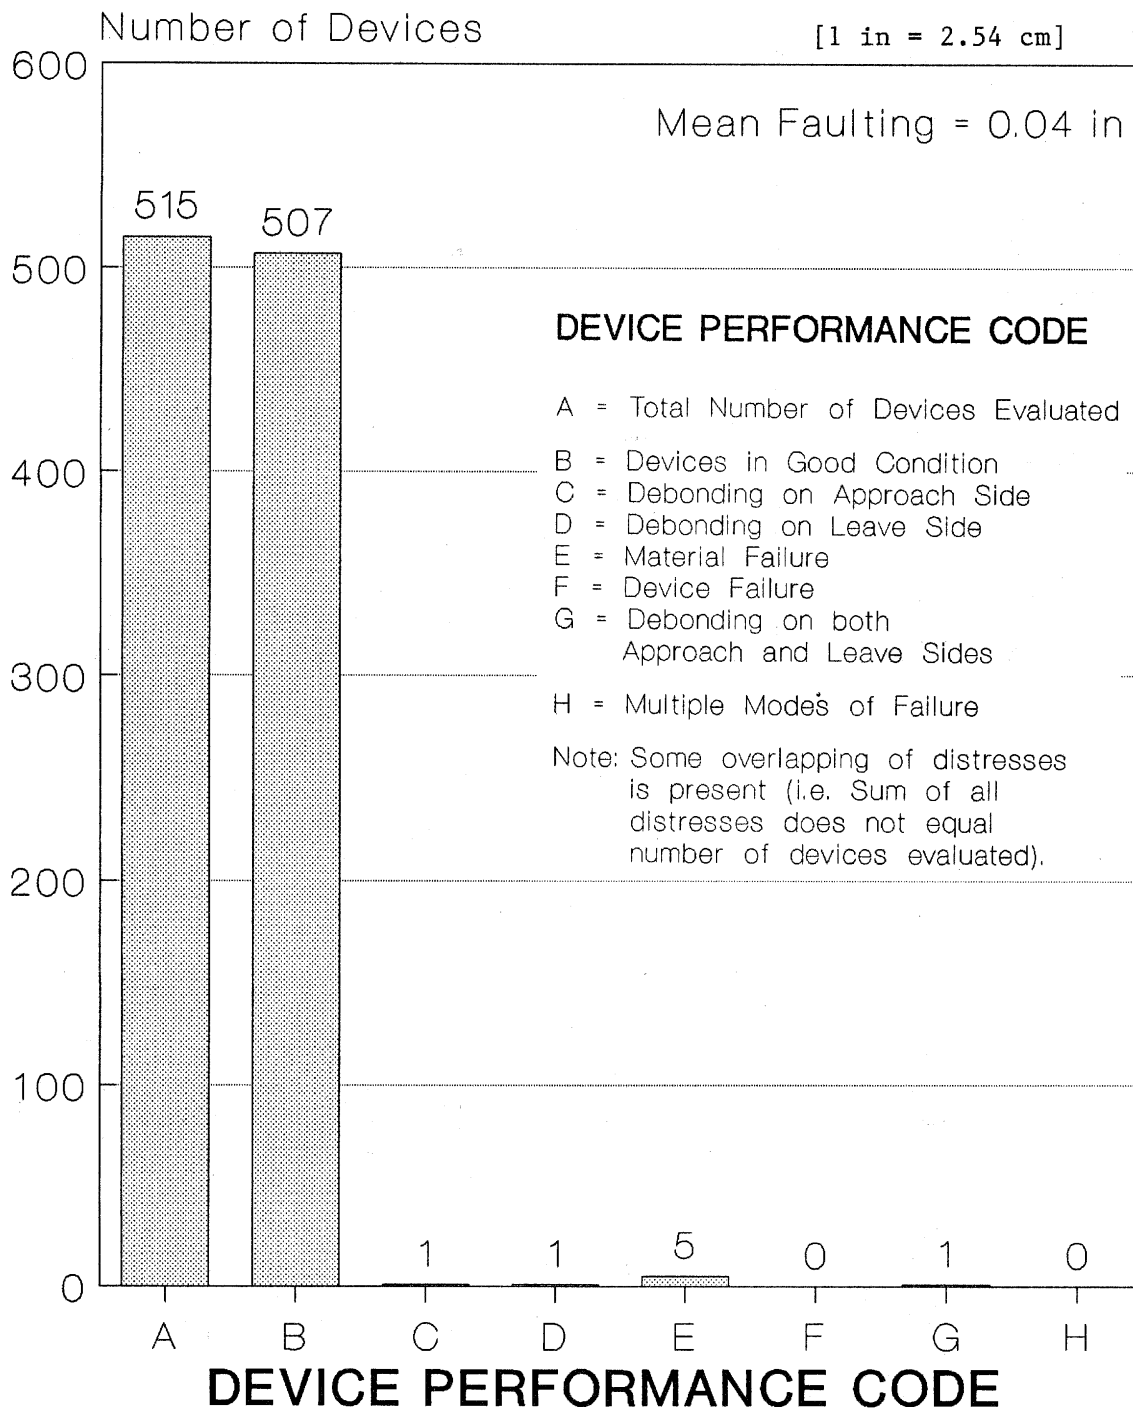
Figure 18. Distribution of retrofit dowel performance.

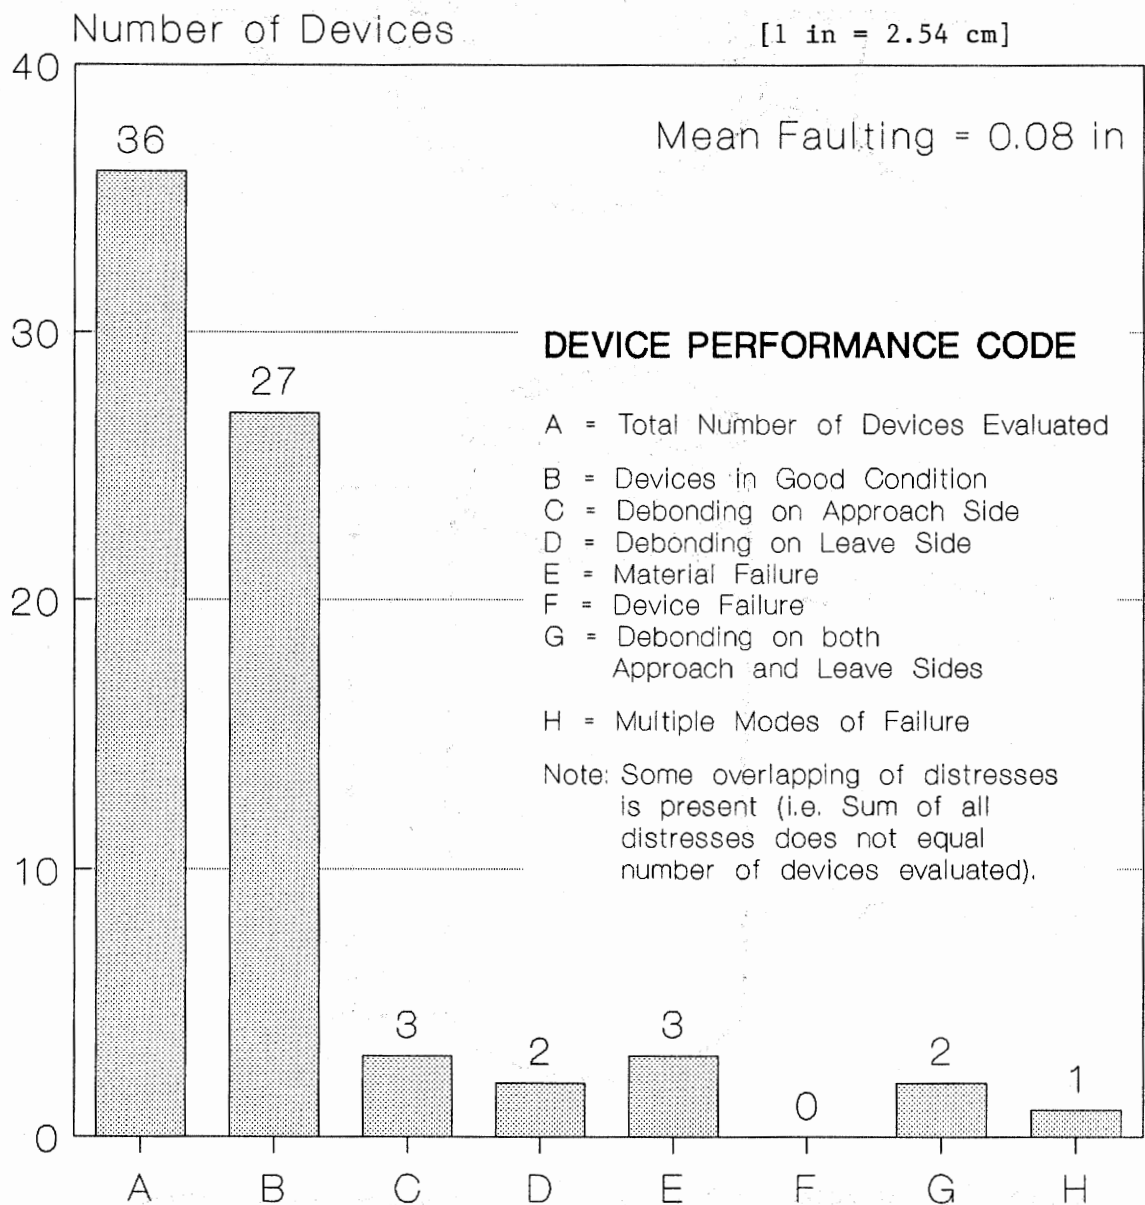
Figure 23. Distribution of figure-eight device performance.

Of the 36 Figure-eight load transfer devices inspected, 27, or 75 percent, of the devices were in good condition (see figure 23). The most prominent failure modes identified were debonding on the device approach side and material failure. Both of
