## **4.2. Insulation**

### **4.2.1. Fiberglass**

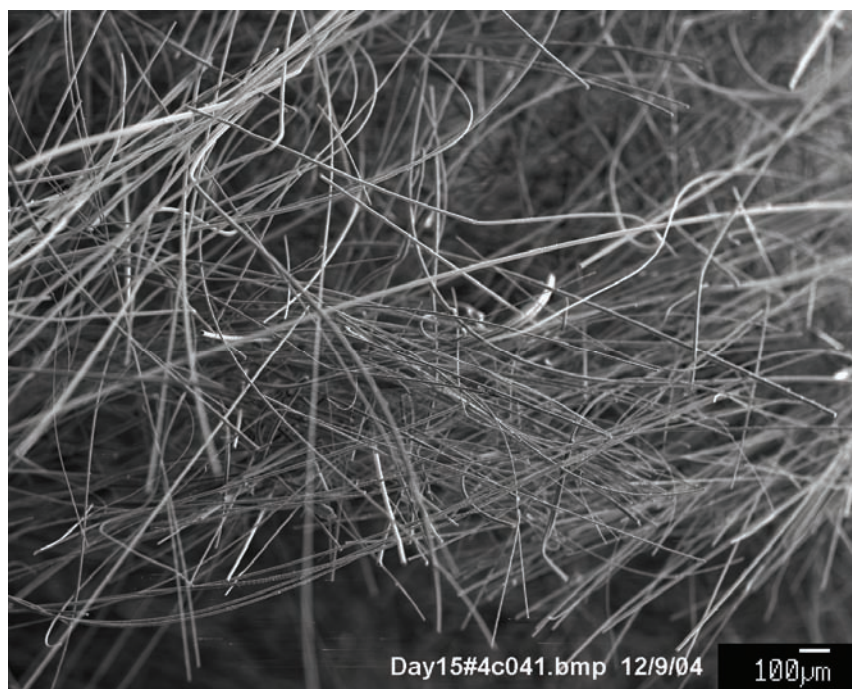
**Figure 4-17. Clean fiberglass before exposure to test chemicals.**

An SEM image of clean fiberglass, before exposure to the test solution, is shown in Figure 4-17. This SEM image provides a visual baseline as a comparison for images from samples taken after the tests began. As can be seen, there are no deposits on the clean fiberglass. Over the course of each test, deposits were observed throughout the fiberglass samples. These deposits could be of chemical origin (i.e., solids that formed at the surface of the fiberglass because of chemical reactions between soluble chemical species and the fiberglass or because of precipitation of soluble species at that location) or physically retained or attached (i.e., deposits that existed as solid particles in the test solution and were captured by the fiberglass). Because there was not significant water flow through the fiber, particle migration into the fiberglass interior was not likely; however, physical retention and attachment of particles at the exterior of fiberglass were possible. Therefore, deposits found in the interior of the fiberglass samples were likely of chemical origin, whereas the deposits on the exterior could have been of either origin.

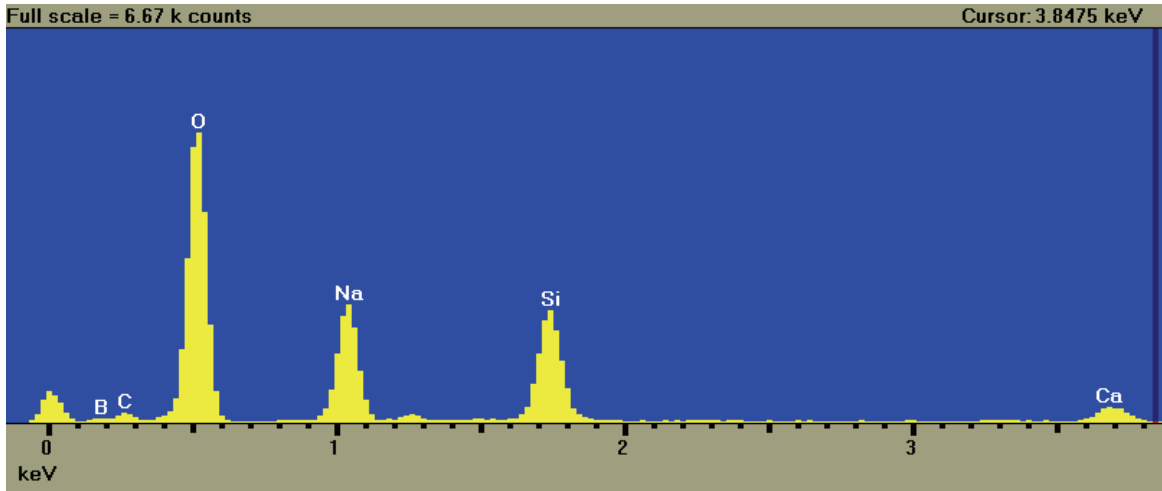
Figure 4-29. EDS counting spectrum for the film on fiberglass, as shown in Figure 4-28. (rfgbn05.tif, 8/5/05)

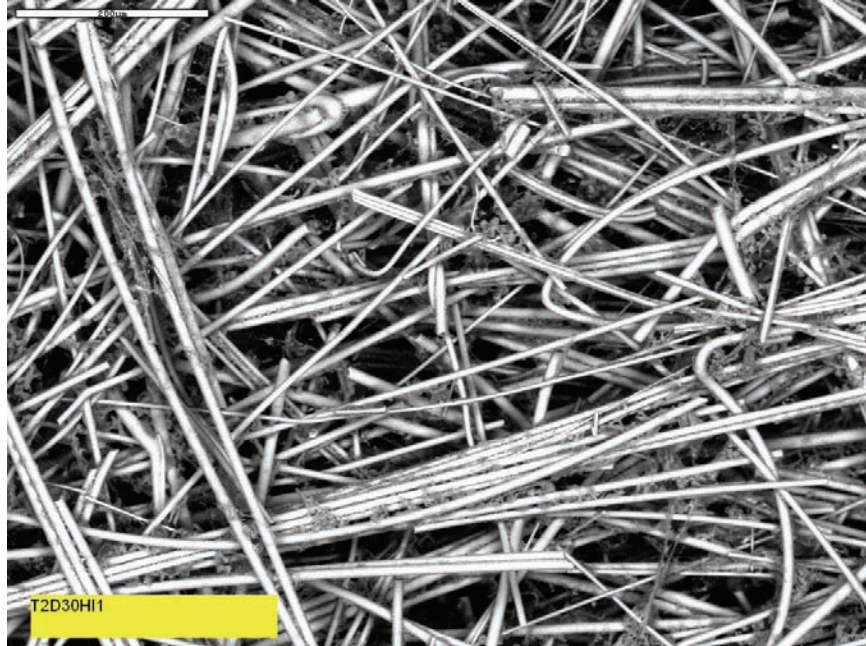
Figure 4-32. ESEM image for a Test #2, Day 30, high-flow interior fiberglass sample.

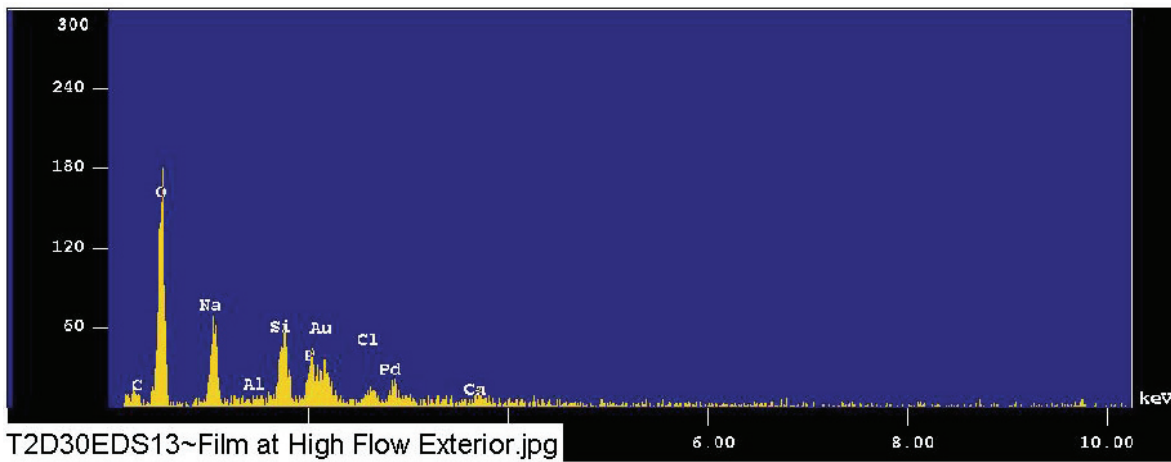
Figure 4-35. EDS counting spectrum for the deposits on a high-flow exterior fiberglass sample.

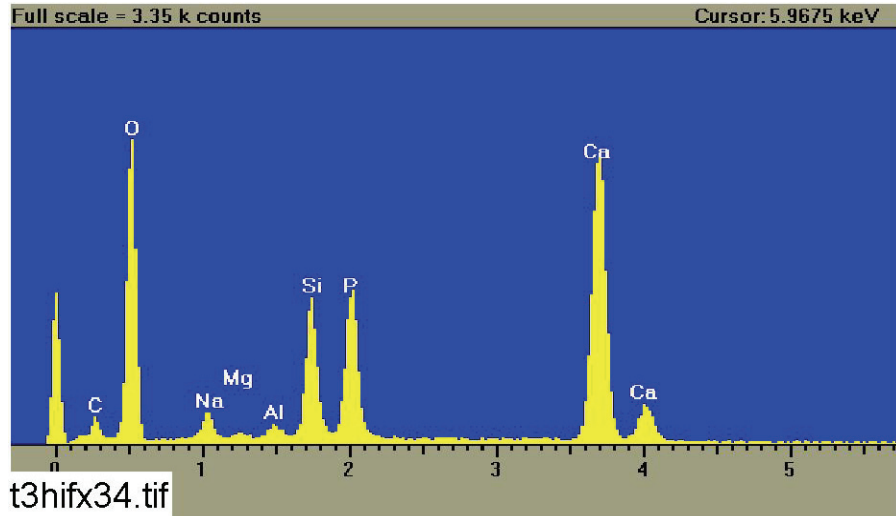
Figure 4-37. EDS counting spectrum for the large masses of particulate deposits shown in Figure 4-36. (t3hifx34, 5/11/05)

Tests #3 and Test #4 each had much greater amounts of deposits than Tests #1, #2, and #5. In addition, the amount of deposits increased as the test proceeded. The greatest amount of deposits was found on the exteriors of the Day-30 samples, as shown in Figure 4-36. The corresponding EDS is shown in Figure 4-37. Based on EDS analysis, the particulate deposits on the fiberglass exterior may be divided into two categories according to phosphorus and silicon content, as shown in Figures 4-38 and 4-39. Particulate deposits of lower phosphorus and higher silicon content were likely cal-sil particles. The particulate deposits with lower silicon and high phosphorus, calcium, and oxygen content were likely composed of calcium phosphate precipitates, and it is compositionally similar to the white gel found on the tank bottom at the end of the test. It is likely that calcium and phosphate precipitated when dissolved calcium from the cal-sil reacted with phosphate from the TSP. After precipitation, the calcium phosphate precipitates were transported to the fiberglass exterior by sedimentation and/or water flow depending on the location of the fiberglass sample within the tank. Both kinds of deposits (cal-sil and calcium phosphate precipitates) may be physically transported and/or deposited onto the fiberglass sample exterior in this manner.

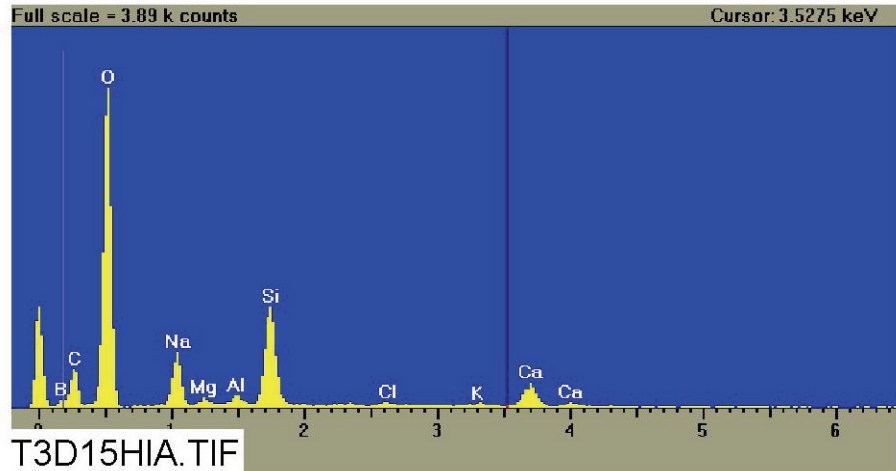
Figure 4-43. EDS counting spectrum for the flocculent deposits between the fibers on the ESEM image shown in Figure 4-42. (T3D15HIA, 4/22/05)

In contrast to the exterior regions of the fiberglass, the interior fiberglass samples were relatively pristine, as shown in Figures 4-40 and 4-41. These results suggest that almost all of the particulate deposits were physically retained at the fiberglass exterior. Any deposits observed in the fiberglass interior likely were chemical byproducts in the test or formed by chemical precipitation during the sample-drying process for ESEM/SEM analysis (see Figure 4-42). EDS analysis indicates that the deposits in Figure 4-42 contained insignificant amounts of phosphorus (see Figure 4-43), meaning that the deposits were distinct from the white gel found in this test.
