### 4.3. Sediment

#### **4.3.1. Test #1 Sediment**

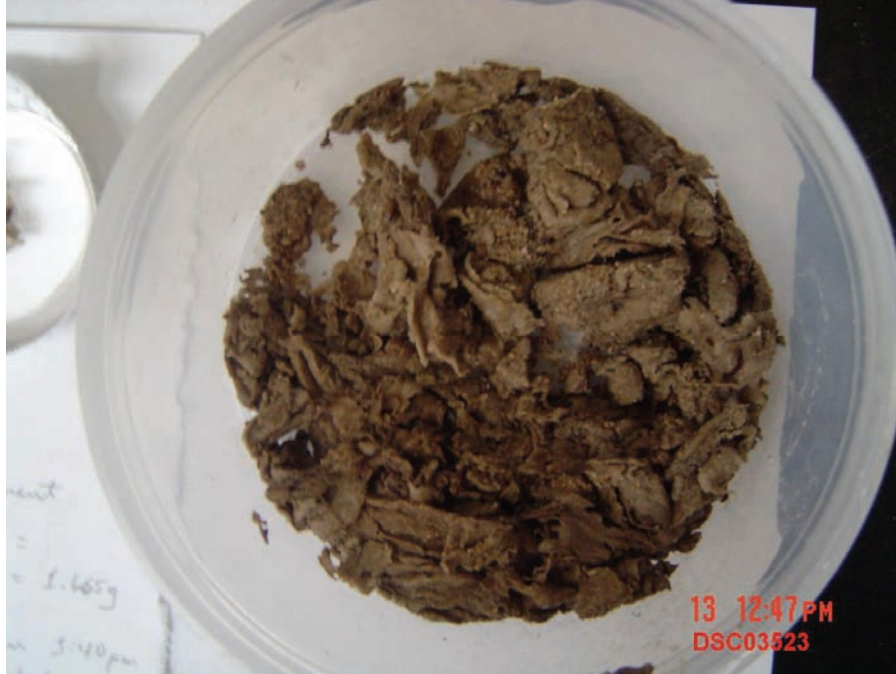
**Figure 4-74. Sediment from south quadrant of tank after Test #1.**

Figure 4-74 is a photograph of the sediment sample from the bottom of the tank after completion of Test #1. The photograph shows that a large portion of the sediment is fiberglass debris, which is consistent with SEM images in Figures 4-75, 4-76, and 4-77. Besides fiberglass debris, the particulate materials in the sediment mixture likely are from corrosion products, dirt, and chemical precipitates. A total of 292 g of wet sediment were recovered from the tank following the test.

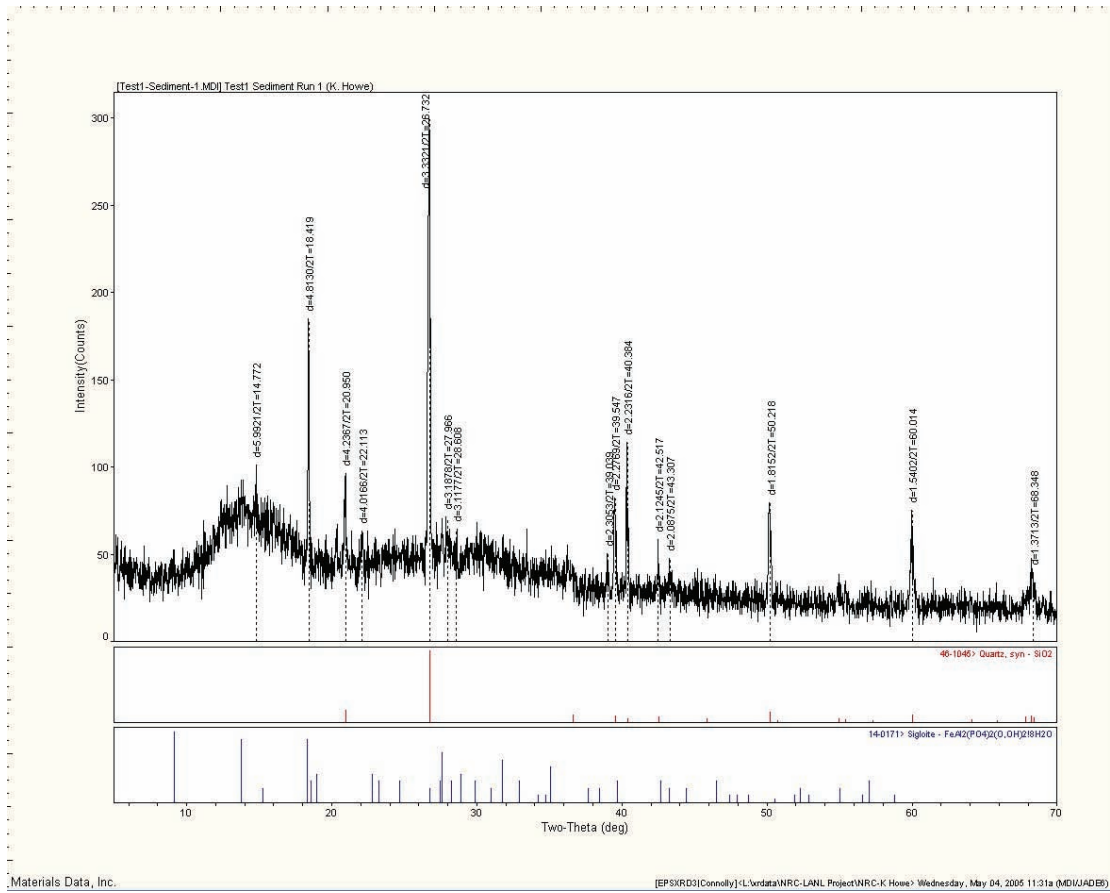
**Figure 4-78. XRD result on a Test #1, Day 30, mixed-sediment sample.**

In addition to the photograph and SEM images, XRD was used to determine the composition and the structure of some solid polycrystalline substances. As shown in Figure 4-78, the XRD spectrum indicates the presence of quartz in the sediment, which is consistent with the photograph and SEM images showing fiberglass debris in the sediment. Another possible crystal, sigloite, is not likely present in the sediment because the sigloite XRD peaks do not totally match the sample spectrum.

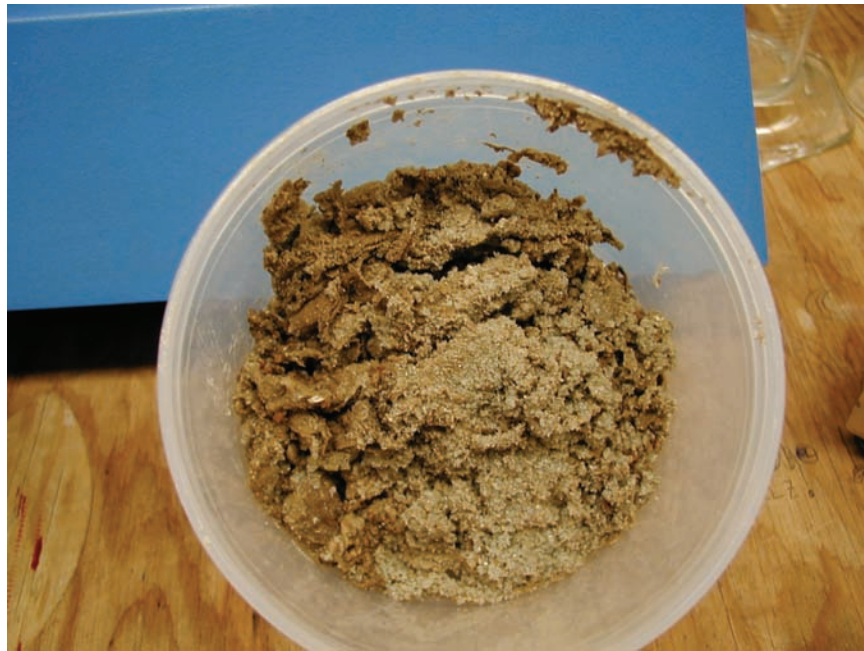
**Figure 4-79.** Picture of a Test #2, Day 30, sediment sample.

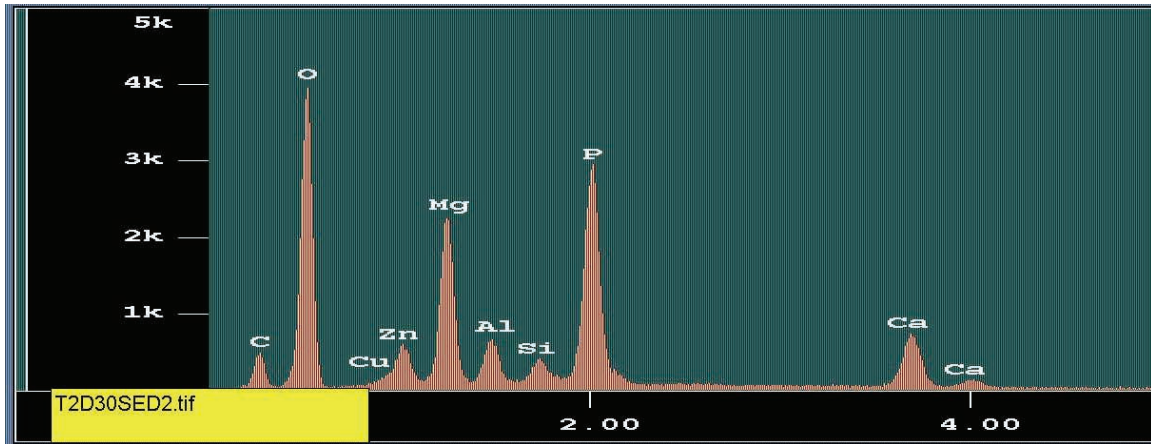
Figure 4-82. EDS counting spectrum for the porously structured material shown in Figure 4-81.

Figures 4-81 and 4-82 provide a higher magnification and an EDS spectrum of the same Test #2 sediment shown in Figure 4-80. Underlying fibers are visible in this image, and the dominant elemental constituents of the particulate deposits are oxygen, magnesium, phosphorus, calcium, aluminum, silicon, carbon, and zinc. The XRD result of Test #2 sediment is shown in Figure 4-83. Again, the presence of quartz is consistent with the fiberglass debris in the sediment.

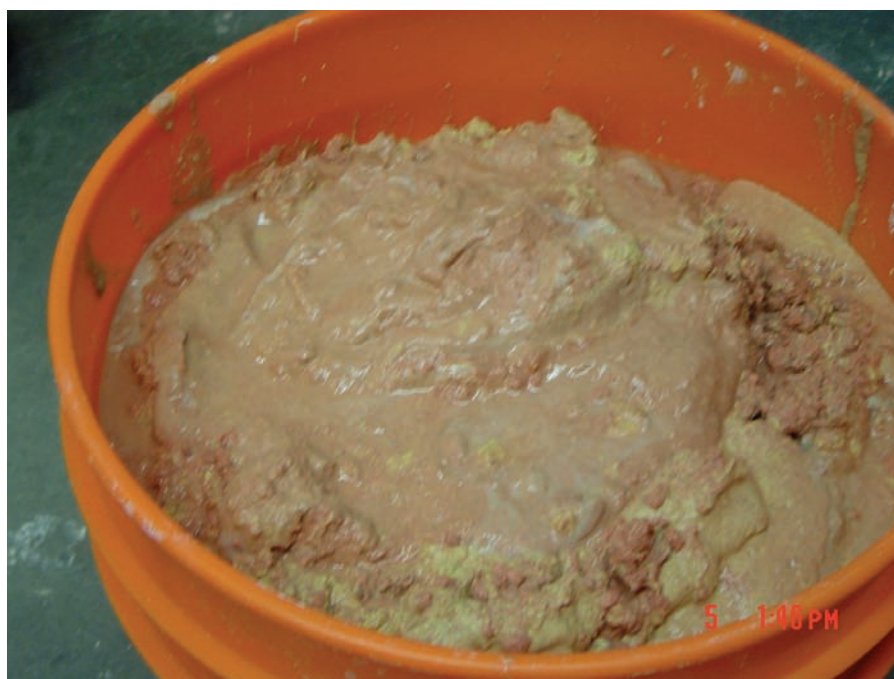
**Figure 4-84. Sediment removed from the tank after Test #3.**

Eighty percent of the fiberglass was replaced by cal-sil in Test #3. As a result, the cal-sil debris contributed significantly to the sediment, as shown in Figure 4-84, which is a photograph of the Test #3 sediment extracted from the bottom of the tank. The pink and yellow particles seen in the sediment correspond to baked and unbaked cal-sil. Over 78 kg of wet sediment were recovered

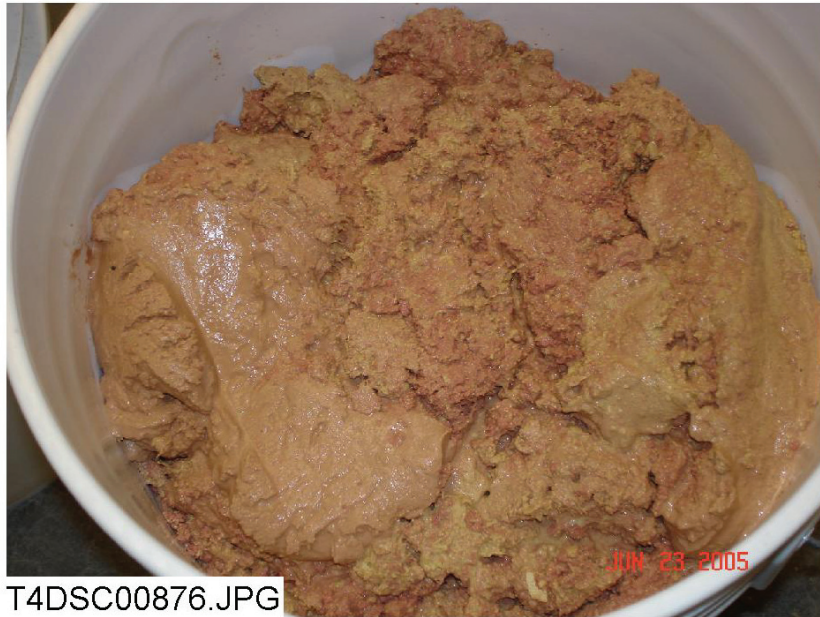
Figure 4-90. Sediment removed from the tank after Test #4.

As in Test #3, 80% of the fiberglass was replaced by cal-sil in Test #4. Over 86 kg of wet sediment were recovered from the tank following the test (approximately 20 kg of dry cal-sil dust was initially added to the tank). Figure 4-90 shows a photograph of the sediment, which appears to be composed mainly of cal-sil debris. The SEM/EDS and XRD analysis provided information on the morphology and composition of Test #4 sediments, as shown in Figures 4-91, 4-92, 4-93, and 4-94. EDS results show that more than 84% of the sediment was composed of silicon, calcium, and oxygen. Similarly, the XRF results in Table 4-6 show that Si and Ca are the major elements in the composition of the sediment (oxygen is not detectable by XRF), plus small amounts of Na, Al, Fe, and Mg.
