### **3.2.3. Optical/TEM Images from Filtered and Unfiltered Samples**

## **3.3. Insulation**

### **3.3.1. Deposits in Fiberglass Samples**

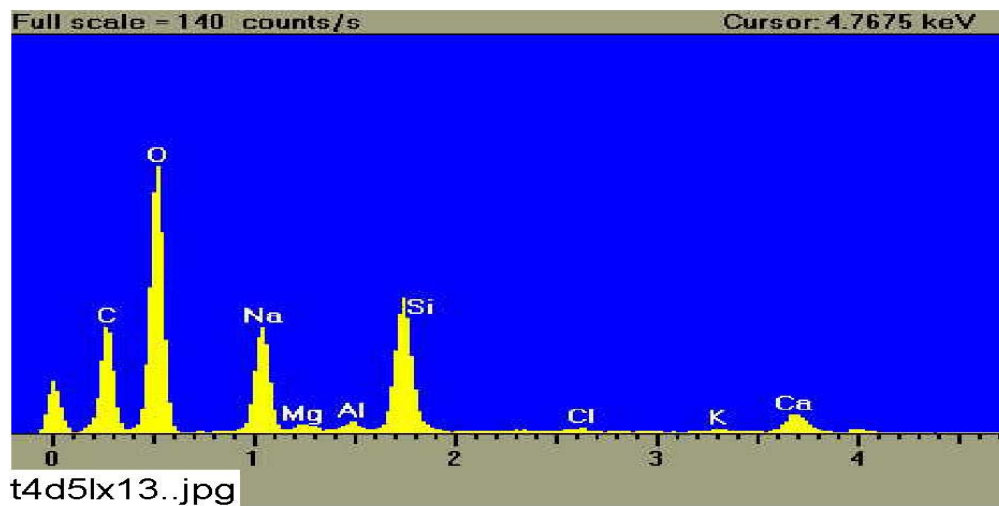
Figure 3-20. EDS counting spectrum for the film between the fibers shown in Figure 3-19. (t4d5lx13.jpg)

Since there was no significant water flowing through the fiberglass samples during the test, the migration of particulate deposits from the solution into the fiberglass interior is insignificant. Based on the ESEM results, some deposits were found after 5 days of the test on both the exterior and the interior of the low-flow fiberglass samples. In these deposits, a few particulates were found on the fiberglass exterior only (see Figure 3-17). However, most of the deposits were formed continuously like a film among glass fibers and coatings on the fibers. Therefore, these deposits are likely of chemical origin instead of being physically attached/retained. EDS results indicated that the film was composed of C, O, Na, Ca, Mg, Al, and possibly Si. Comparing the amount of the film on the

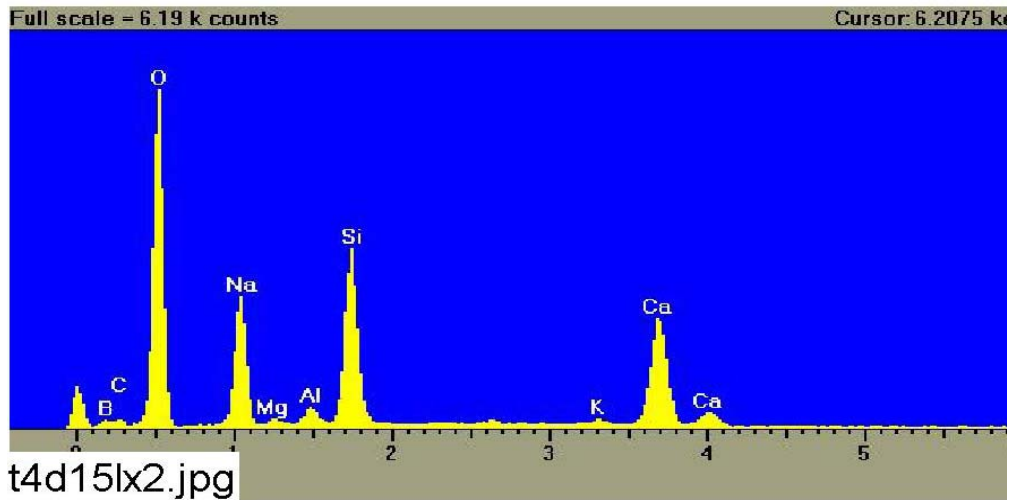
Figure 3-27. EDS counting spectrum for the particulate deposit on fiberglass shown in Figure 3-26. (t4d15lx2.jpg)

Similar to the Day-5 samples, a few particulate deposits were found on the fiberglass exterior. EDS analysis shows that the particulate deposits were mainly composed of O, Na, Ca, Al, Mg, B, C, K, and possibly Si. However, the film deposits were prevalent on both the exterior and the interior fiberglass samples. There was no significant increase in the amount of deposits on Day-15 samples compared to Day-5 samples. Comparing the amount of the film deposits on the exterior and the interior Day-15 low-flow fiberglass samples, the difference was insignificant. Figures 3-25 through 3-30 show the Day-15 low-flow fiberglass results.
