Changes in Streamflow Patterns Related to Hydrologic Restoration of a Sedge Fen Wetland in Seney National Wildlife Refuge, Michigan, 1998-2004

Scientific Investigations Report 2005-5137

By B.P. Neff, T.L. Weaver, and D.G. Wydra

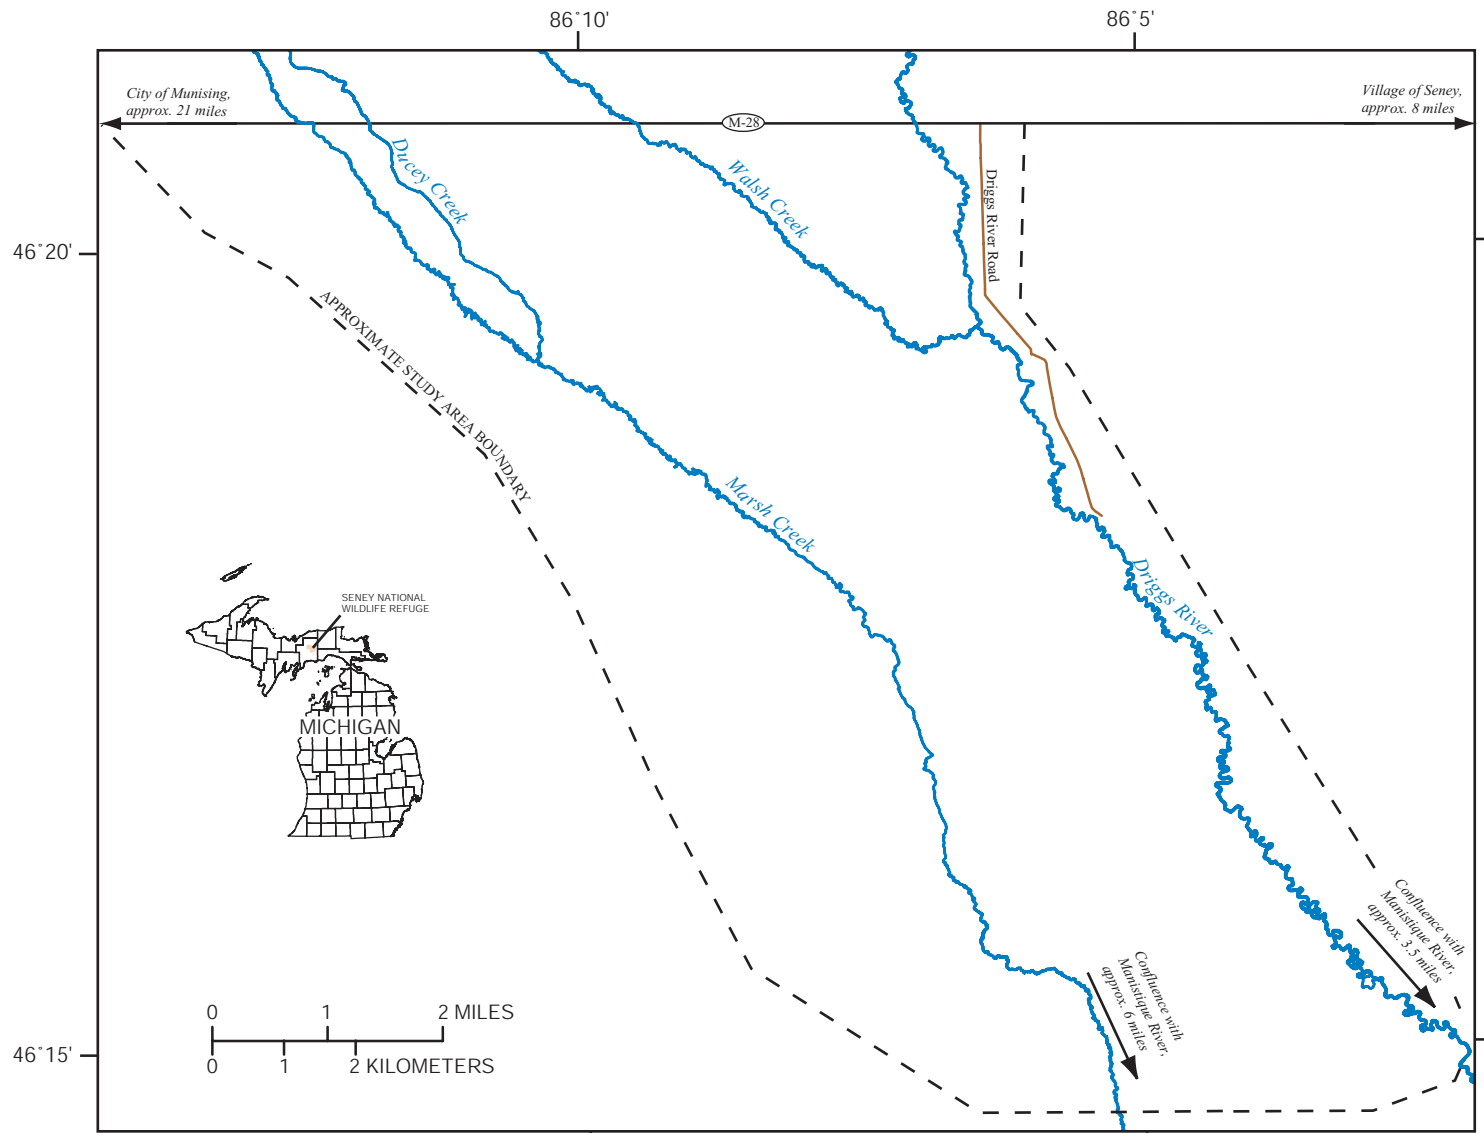
City and river names and locations from U.S. Geological Survey digital raster graphics. Hydrologic features interpreted from 1998 U.S. Geological Survey digital orthophoto quadrangle data. Figure projection is Universal Transverse Mercator, units in meters, NAD83 datum, and zone 16N.

Figure 1. Seney National Wildlife Refuge study area, Michigan, pre-disturbance.

Historically, much of the land in and near what is now Seney National Wildlife Refuge (NWR) in Michigan's Upper Peninsula was an expansive ground-water-supported sedge fen (fig. 1). In the 1900s, this land was ditched and diked for agricultural development and, later, for waterfowl management. Major changes included the construction of Walsh Ditch and C-3 Pool (fig. 2). These activities severely disrupted the hydrology, and subsequently the ecology, of the surrounding area. Notably, these actions led to significant erosion, particularly in the portion of Walsh Ditch known as "The Spreads" (fig. 2), which has resulted in deposition of sand into Manistique River and degradation of salmonid

The study area is in the central Upper Peninsula of Michigan (figs. 1, 2). Terrain slopes southeast at approximately 8 ft/mi, as inferred from USGS 7.5-minute topographic quadrangle maps (Driggs Lake Southeast and Walsh quadrangles, 1972). Surficial sediments are primarily of glacial origin and overlie sandstone, limestone, and dolomite (Sweat, 2001). Much of the refuge contains peat deposits ranging in thickness from a few inches to more than 6 ft, a characteristic of bogs and fens (Smith, 1992; Niering, 1994; Sweat, 2001). Sweat (2001) and Wilcox and others (in press) describe the area north of C-3 Pool as largely forested, with a mixture of sedge fen and shrub-dominated areas. Outcrops of sand provide adequate habitat for islands of upland vegetation. Thirty-year average precipitation and temperature for the study area are 31.65 in. and approximately 5.1 °C (National Climatic Data Center, 2002).

Historically, surface water flowed through the study area in Marsh Creek, Ducey Creek, Walsh Creek, and the Driggs River (figs. 1, 3). Sheet flow (overland flow) was substantial. The water table was near the land surface and supported a vast sedge fen. Ground water discharged into the peat and streams and flowed under streambeds as hyporheic flow.

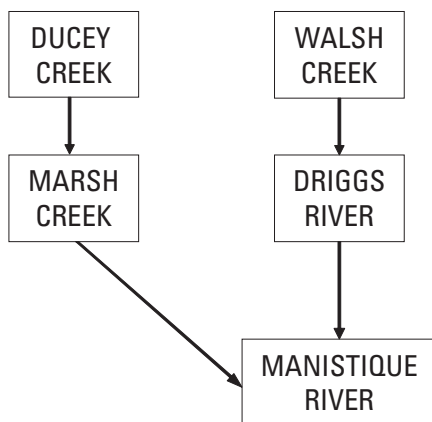
Figure 3. Pre-disturbance hydrology in Seney National Wildlife Refuge study area, Michigan.

After agricultural development failed, the area was incorporated into Seney National Wildlife Refuge in 1935. C-3 Pool was created in the early 1940s as waterfowl habitat. The pool was constructed by building a dike roughly perpendicular to the flow of water in the study area. Water was diverted to C-3 Pool primarily from Walsh Ditch. Although this construction successfully created waterfowl habitat, it also diverted water away from Driggs River, curtailed sheet flow across the wetland downstream from C-3 Pool, and raised the water table in the area. Comparison of figures 3 and 4 illustrates the hydrologic complexity of the current wetland.

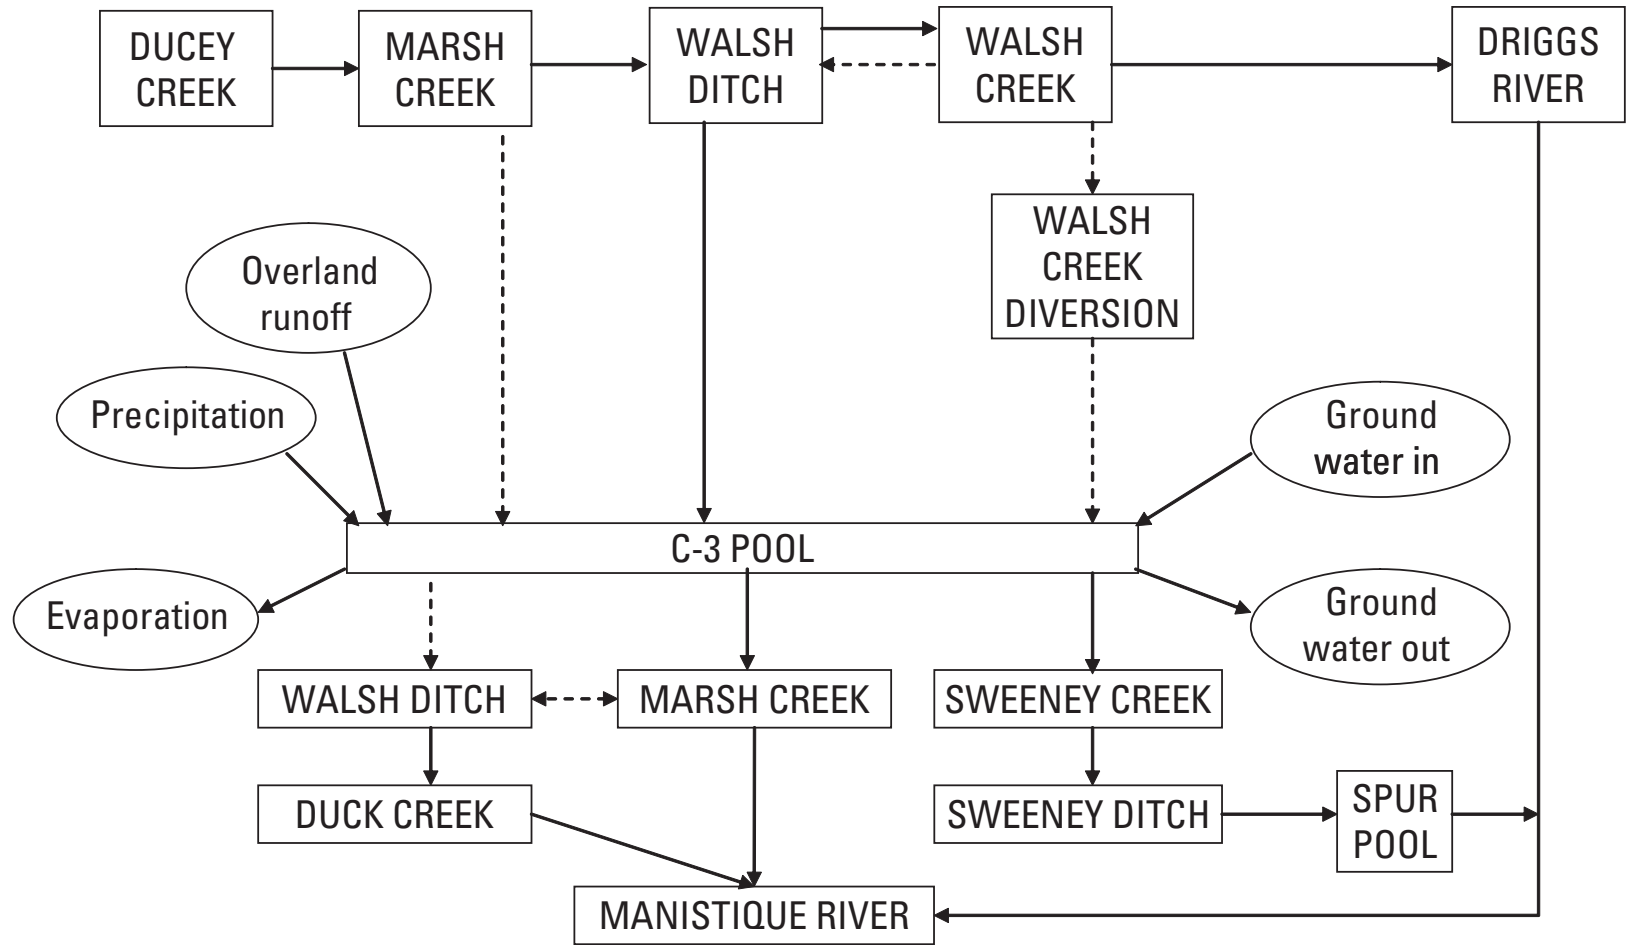
Figure 4. Present (2005) hydrology of Seney Wildlife Refuge study area, Michigan. [Solid lines indicate predominant flows, dashed lines indicate unknown, intermittent, or secondary flows.]

In support of agricultural development, the largest wetland drainage project in Michigan's history was begun at and around the study site in 1912 (Wilcox and others, in press). Walsh Ditch was constructed to redirect Walsh and Marsh Creeks and to lower the water table (figs. 2, 4). Despite this effort, agriculture proved unsustainable and was soon abandoned.

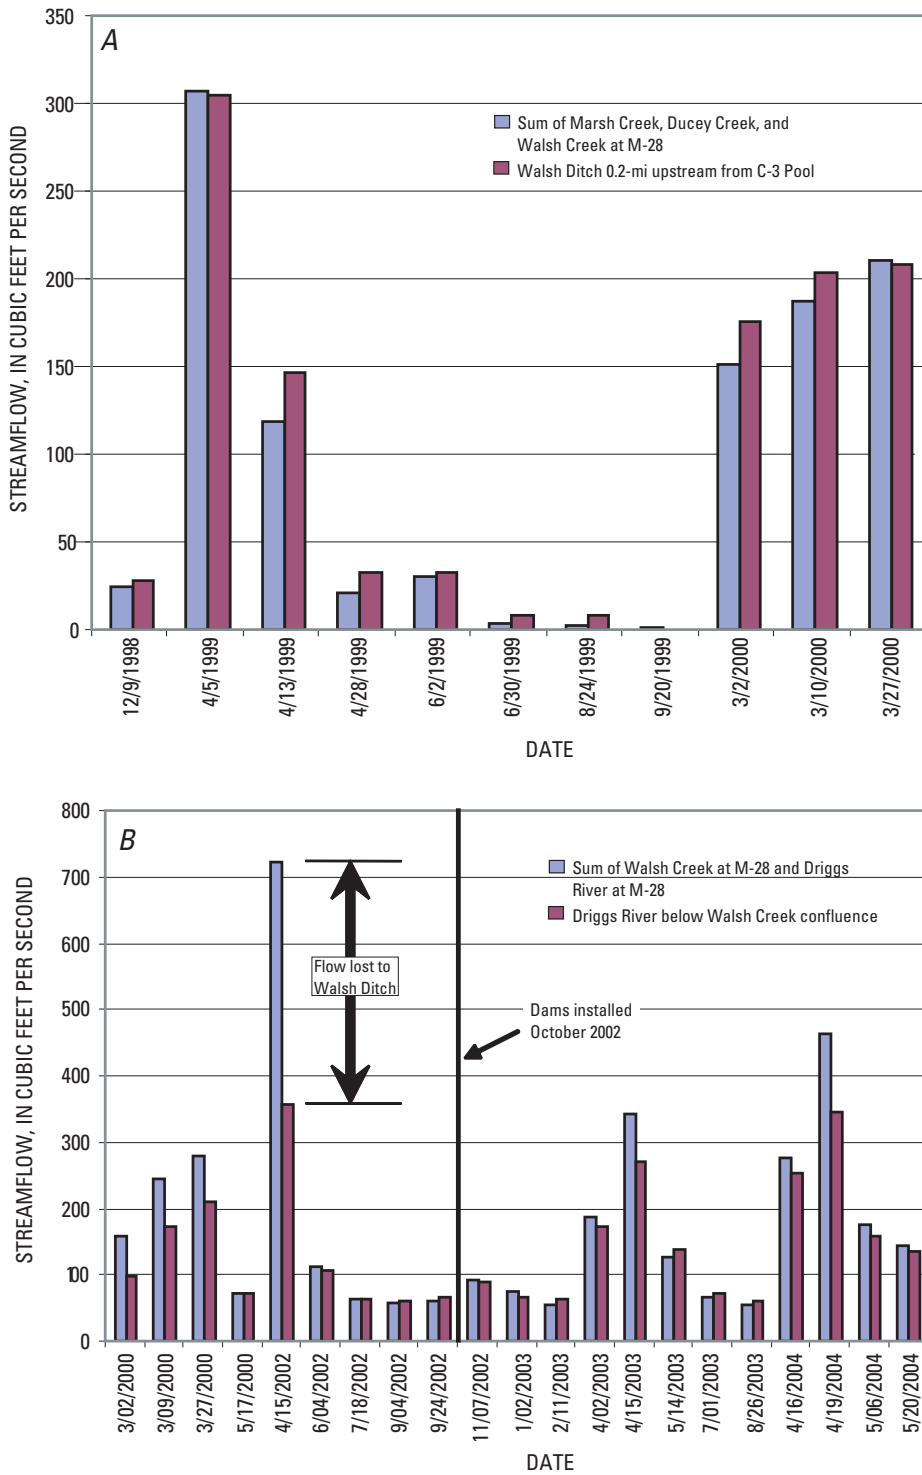
Figure 6. Flows in Seney National Wildlife Refuge study area, Michigan. [A, Walsh Ditch and tributaries, and B, Driggs River and tributaries.]

Results show that streamflow at Walsh Ditch 0.2 mi. upstream of from C-3 Pool was similar to the sum of the streamflow through Marsh Creek, Ducey Creek, and Walsh Creek, each measured where they intersect highway M-28 (fig. 6, table 1). This similarity suggests that most, or all, of Walsh Creek was being diverted into Walsh Ditch at both high and low streamflow on these dates. This observation is consistent with the fact that Walsh Ditch was not dammed until late October 2002.
