The Special Conditions

Accordingly, pursuant to the authority delegated to me by the Administrator, the following special conditions are issued as part of the supplemental type certification basis for the Raytheon Model HS.125 Series 700A and 700B airplanes modified by Raytheon Aircraft Services, Inc.

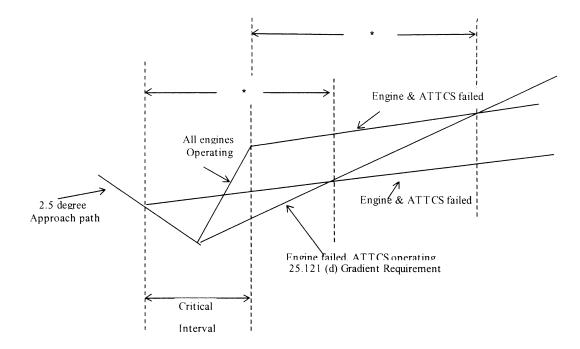
- (1) The critical time interval begins at a point on a 2.5 degree approach glide path from which, assuming a simultaneous engine and ATTCS failure, the resulting approach climb flight path intersects a flight path originating at a later point on the same approach path corresponding to the part

- 25 one-engine-inoperative approach climb gradient. The period of time from the point of simultaneous engine and ATTCS failure to the intersection of these flight paths must be no shorter than the time interval used in evaluating the critical time interval for takeoff beginning from the point of simultaneous engine and ATTCS failure and ending upon reaching a height of 400 feet.

- (2) The critical time interval ends at the point on a minimum performance, all-engines-operating go-around flight path from which, assuming a simultaneous engine and ATTCS failure, the resulting minimum approach climb flight path intersects a flight path corresponding to the part 25 minimum one-engine-inoperative approach climb gradient. The all-engines-operating go-around flight path

- and the part 25 one-engine-inoperative approach climb gradient flight path originate from a common point on a 2.5 degree approach path. The period of time from the point of simultaneous engine and ATTCS failure to the intersection of these flight paths must be no shorter than the time interval used in evaluating the critical time interval for the takeoff beginning from the point of simultaneous engine and ATTCS failure and ending upon reaching a height of 400 feet.

- c. The critical time interval is illustrated in the following figure:

* The engine and ATTCS failed time interval must be no shorter than the time interval from the point of simultaneous engine and ATTCS failure to a height of 400 feet used to comply with 125.2(b) for ATTCS use during takeoff.

- b. The critical time interval must be determined at the altitude resulting in the longest critical time interval for which one-engine-inoperative approach climb performance data are presented in the Airplane Flight Manual (AFM).
