# Design Guide

for Improving Hospital Safety  
in Earthquakes, Floods, and High Winds

*FEMA 577 / June 2007*

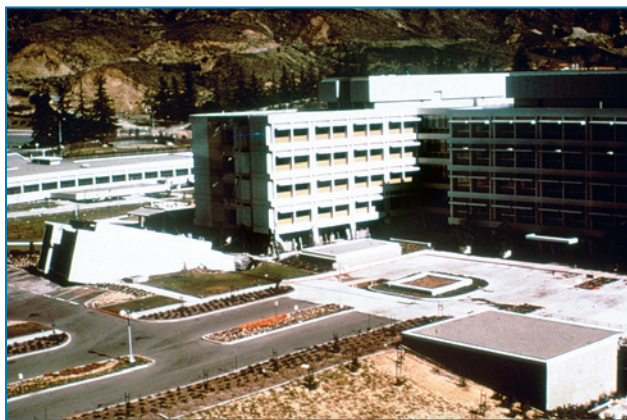
**Olive View Hospital After the 1971 Magnitude 6.7 San Fernando Earthquake**

The new Olive View hospital building shown on the cover performed well during the 1994 Northridge earthquake. This quake, of the same magnitude as the 1971 San Fernando Earthquake that nearly collapsed the original building, caused no serious damage. Built in 1970, the Medical Treatment and Care Building of the Olive View Hospital complex was designed to meet the earthquake provisions of building codes in place at that time. The hospital incurred heavy damage (at left) during the 1971 earthquake and was subsequently rebuilt to stricter design and construction standards.

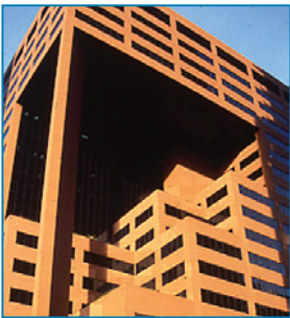
x	0	x	x	May create indirect load paths, stress concentrations, and torsional forces in earthquakes. May contribute to localized high wind pressures, and aggravate evacuation during fire emergencies.
	2A-4 Large roof overhangs

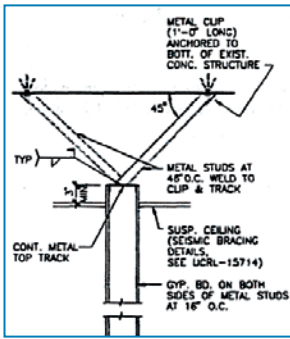
✓	✗	0	✓	Gypsum partitions properly braced to structure beneficial in seismic zones. Susceptible to flood damage, but good for fire if proper resistance is specified. Not significant for wind.
2D	OTHER ELEMENTS						
	2D-1 Tile roofs

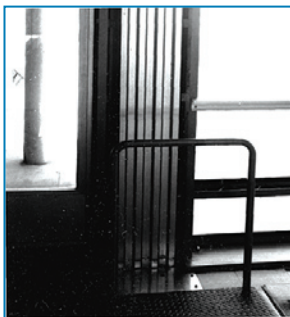
✓	0	x	x	Improves seismic response, but creates possible path for toxic gases during fire. (Cause of deaths in Las Vegas MGM Grand fire.) Needs careful protection against wind-driven rain.

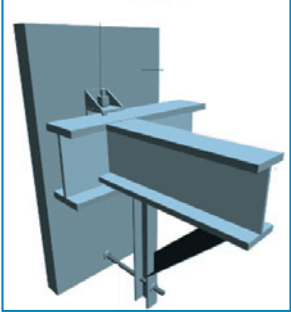
✘	0	✔	0	<p>Requires special detailing with ductile connections to structure in high seismic zones.</p> <p>Good for winds if well attached and joints are protected against wind-driven rain.</p>

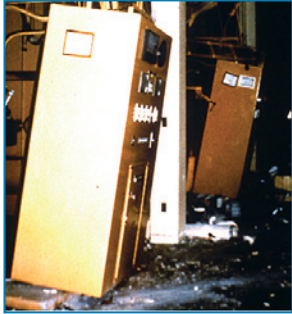
<p>Unbraced electrical cabinets</p>	✓	0	✓	✓	Essential for earthquake and wind (for exterior-mounted systems), beneficial for fire.
	8-2 Emergency power supply adequate for essential services and equipment securely braced

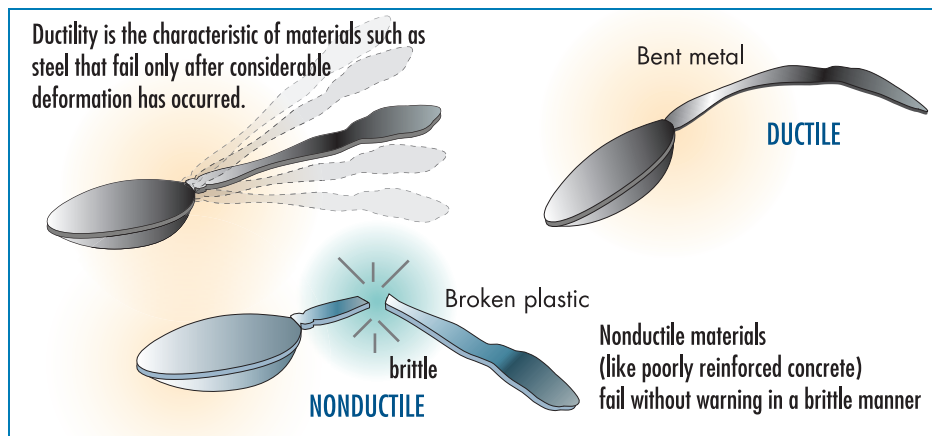
Figure 2-7:  
Ductility

Ductility is the characteristic of certain materials—steel in particular—that fail only after considerable distortion or deformation has occurred. This is why it is more difficult to break a metal spoon by bending it than one made of plastic. The metal object will remain whole, though distorted, while the plastic spoon will break suddenly without warning (Figure 2-7). This property of materials is used to ensure that a building may adequately resist more than its design ground motion.

The deformation of metal, even in the spoon, absorbs energy and defers absolute failure of the structure. Brittle materials, such as unreinforced masonry or ceramic tile, fail suddenly with a minimum of distortion. Ductility is an important characteristic of the structural system. Thus, buildings with appropriate seismic designs are either designed so that the materials and connections will distort but not break, in case they are subjected to forces higher than those required by the code, or they are designed for very large forces. Some structural materials, like masonry and concrete, are brittle on their own, but when properly combined with steel reinforcing bars, can exhibit high ductility. This characteristic of the structural system is also considered in the ELF methodology.

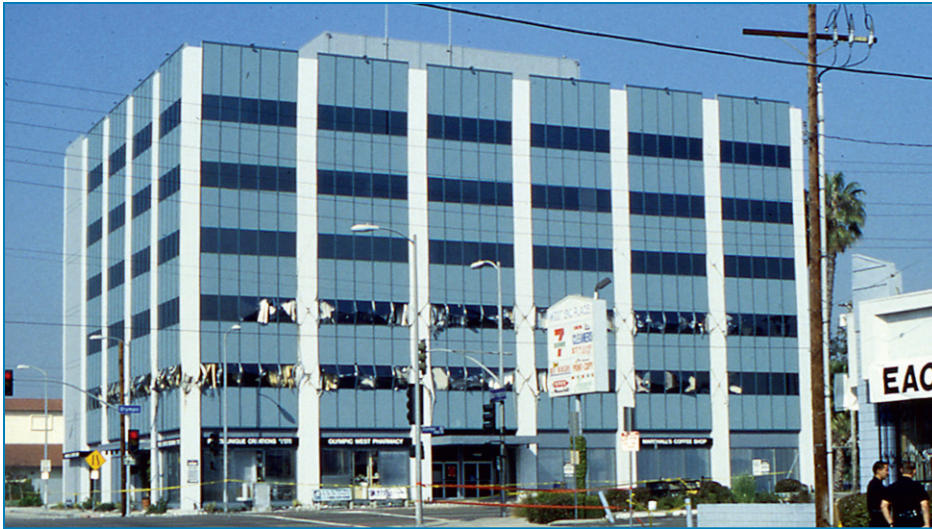
**Figure 2-16:**  
This concrete building suffered severe damage to the columns at the second floor level. It was deemed unsafe by the local jurisdiction and later demolished.

When the ground shakes in an earthquake, the shaking is transferred to the building, potentially causing structural damage. The damage can consist of cracks in structural walls, bent or broken braces, or damage to columns and beams. Damage can range from minor (a few cracks), to major (parts of the structure rendered ineffective and potentially unsafe), to complete collapse. See Figures 2-16, 2-17, 2-18, and 2-19 for examples of structural damage.

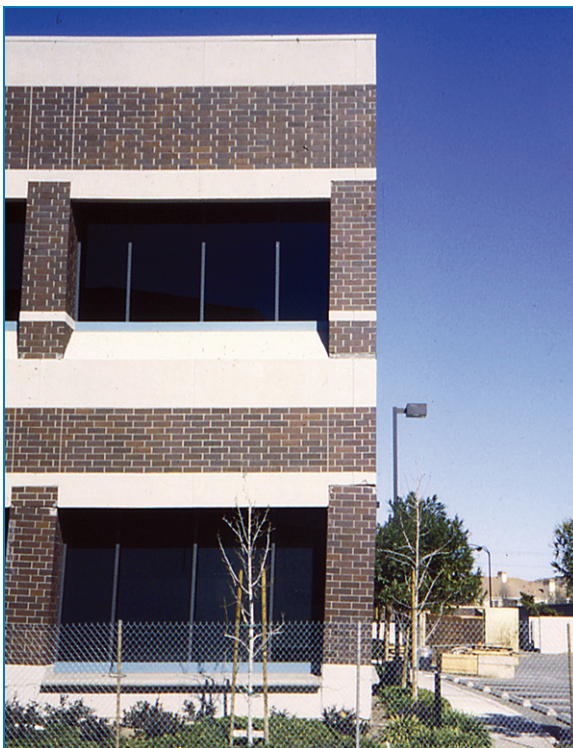
**Figure 2-17:**  
A steel frame building with a post-earthquake "lean" to the right, seen particularly at the first floor. Severe damage was found in its beam-column joints and it was later demolished.

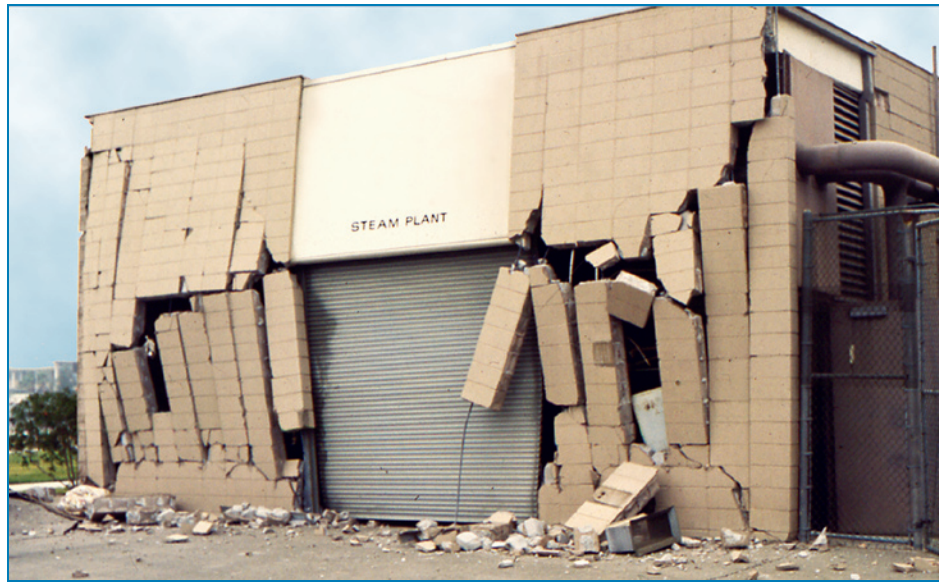
**Figure 2-19:**  
Damage to an exterior concrete wall. This hospital building was evacuated.

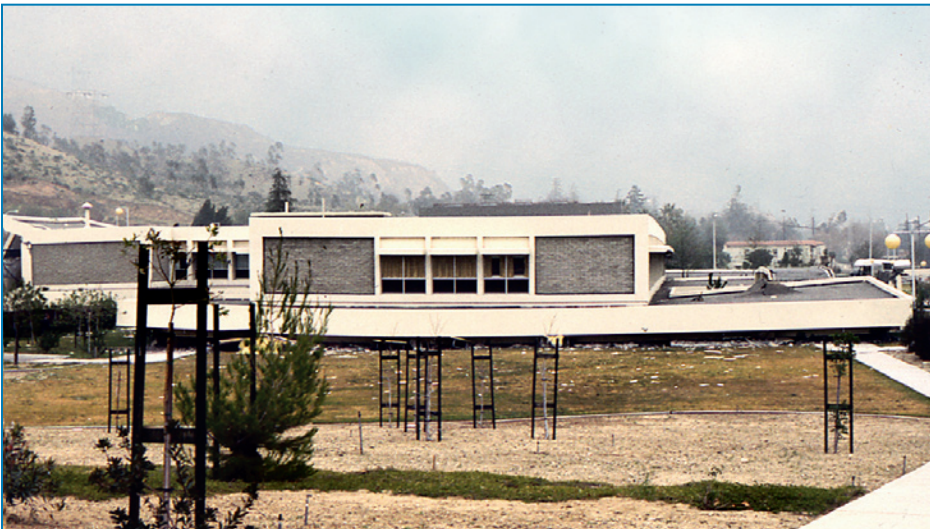
**Figure 2-22:**  
Completely collapsed  
first level (not visible)  
of Psychiatric Unit

Almost immediately after the event, the patients in the Psychiatric Unit began assembling in a parking lot adjacent to their facility. The need to evacuate was obvious, and the second floor wards were only feet from the ground after the first floor collapse (see Figure 2-22). Controlling and tracking these patients was nearly impossible, particularly in the first few hours. Within 5 hours, evacuation was underway in the main building using interior stairwells. The building had no power and therefore no elevators or lights. The nurses evacuated their own units, ambulatory patients first, and, when sufficient assistance was available, non-ambulatory patients. By that time, a network of ambulances and helicopters had been set up for transfer to other facilities (Arnold, 1983; Lew, 1971; NOAA, 1973).

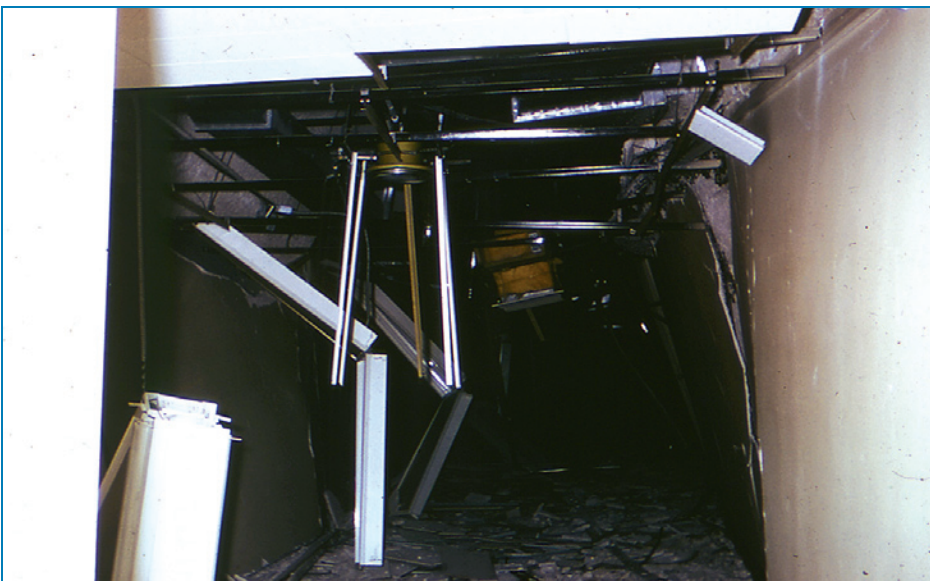
**Figure 2-23:**  
A damaged exit  
corridor—dark and  
barely passable

Damage to architectural systems consists of broken windows and cracked exterior walls and interior partitions. In extreme cases, exterior walls and partitions topple completely. Ceilings are also vulnerable to damage and can break into small pieces or fall to the floor (see Figure 2-23).

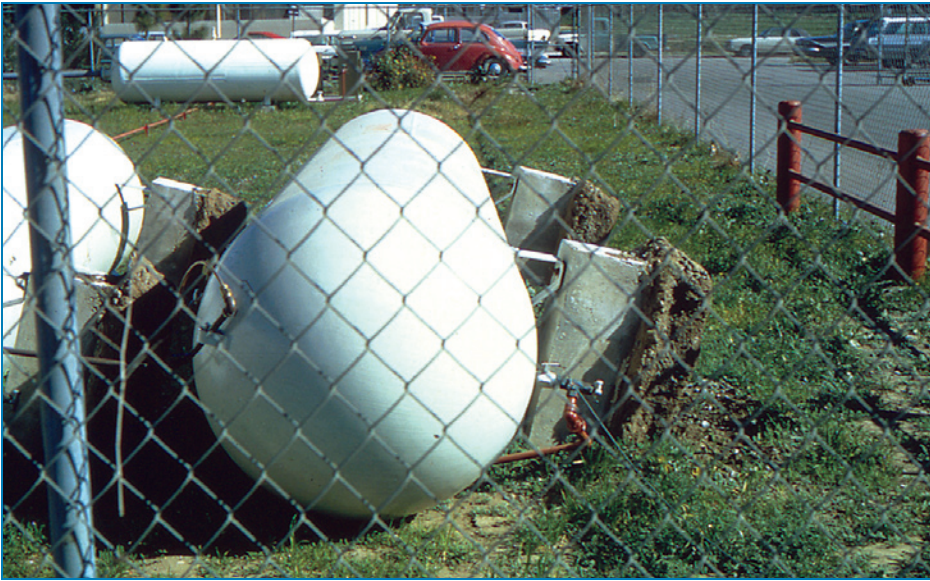
**Figure 2-30:**  
Overturned tank  
similar to medical gas  
storage

not well anchored to the structure (see Figure 2-27). Offices and storage rooms, such as the areas used to store critical supplies, medicine, medical records, chemicals, and fuel, can also be severely damaged by shaking (see Figures 2-28, 2-29, and 2-30).

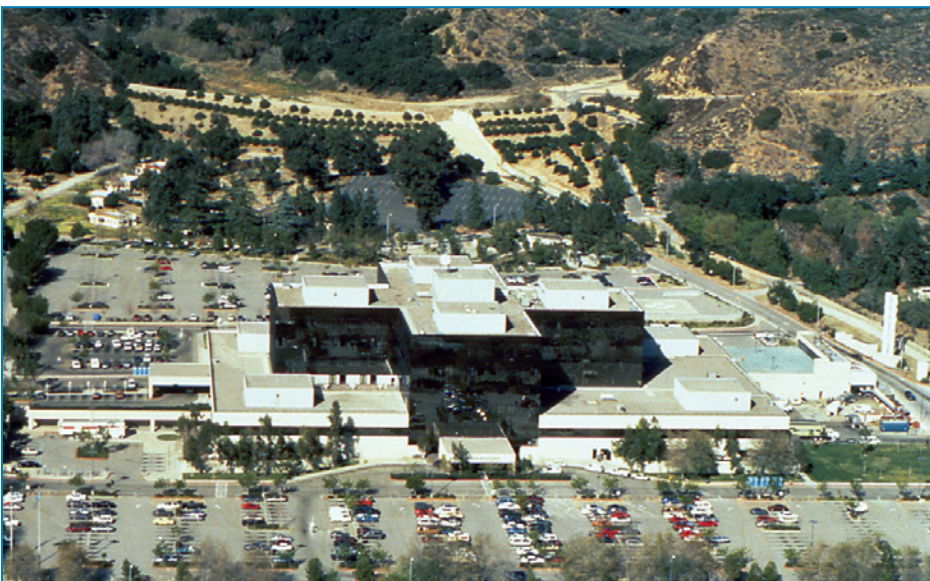
**Figure 2-31:**  
Aerial view of “new”  
Olive View Hospital  
(1986)

Nearly 15 years after the 1971 earthquake event that destroyed the Olive View Medical Center (see Section 2.3.1.1), a new hospital was opened on the same site in 1986 (see Figure 2-31). Built even stronger than required under the HSSA of 1972, the building has no basement and features a seismic system of concrete shear walls and steel plate shear panels. The building was also equipped with instruments to record its response in future earthquakes.

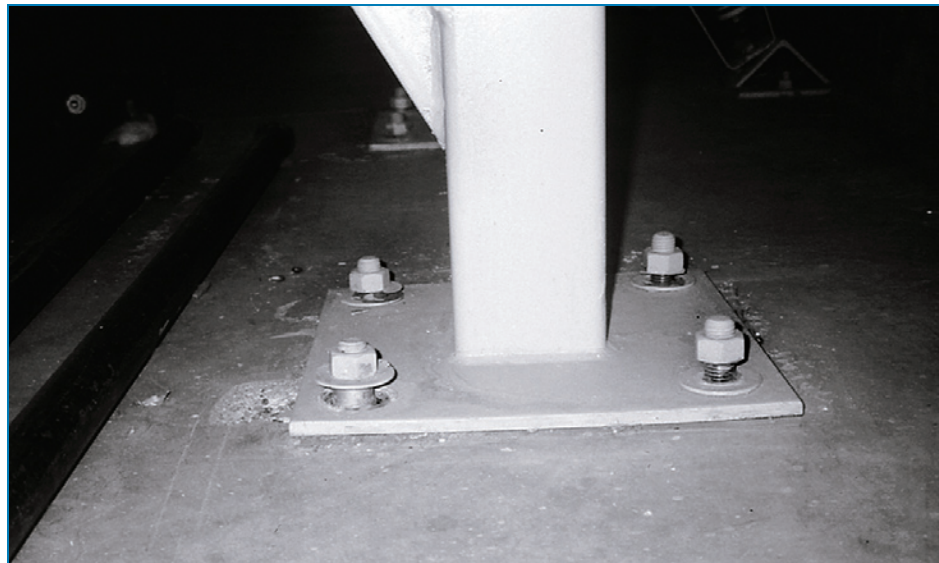
**Figure 2-32:**  
Anchor bolts  
stretched by large  
seismic accelerations  
at roof level

- Shifting, and in some cases, failure, of anchorages of equipment at the roof level, where accelerations were the highest. This movement broke one or more chiller water lines, causing flooding in the top floors (see Figure 2-32).

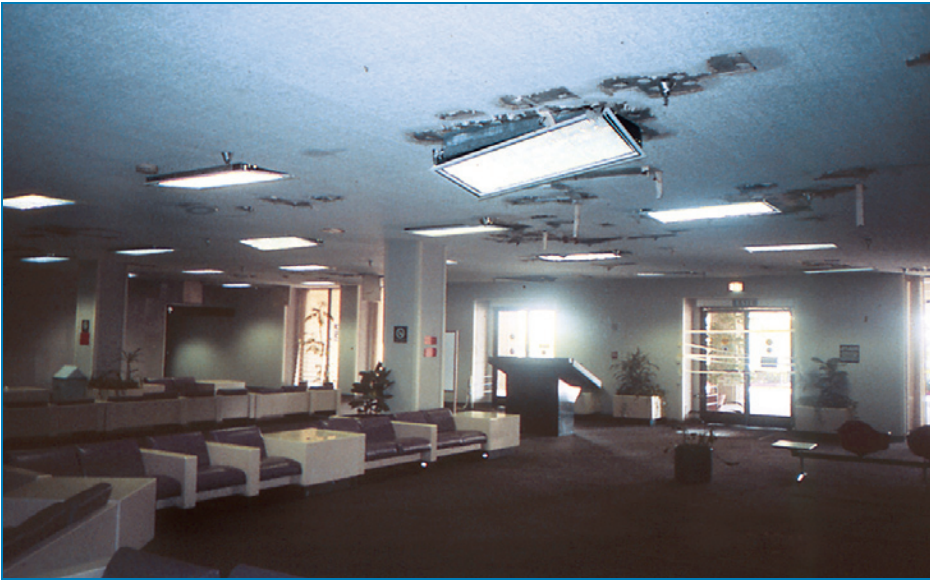
**Figure 2-33:**  
Damage to ceiling and fixtures from sprinkler breaks

- Excessive movement and failure of wall-mounted television brackets, causing some television units to fall.
- Extensive damage to suspended panelized ceilings, some exacerbated by leaks from water pipes from above.
- Excessive movement and interaction between gypsum board and other fire-rated ceilings and sprinkler lines, causing additional leaks.
- Movement at the copper tube reheat coils in the ceiling spaces, almost universally at the third through the sixth floor, causing leaks (see Figures 2-33 and 2-34).

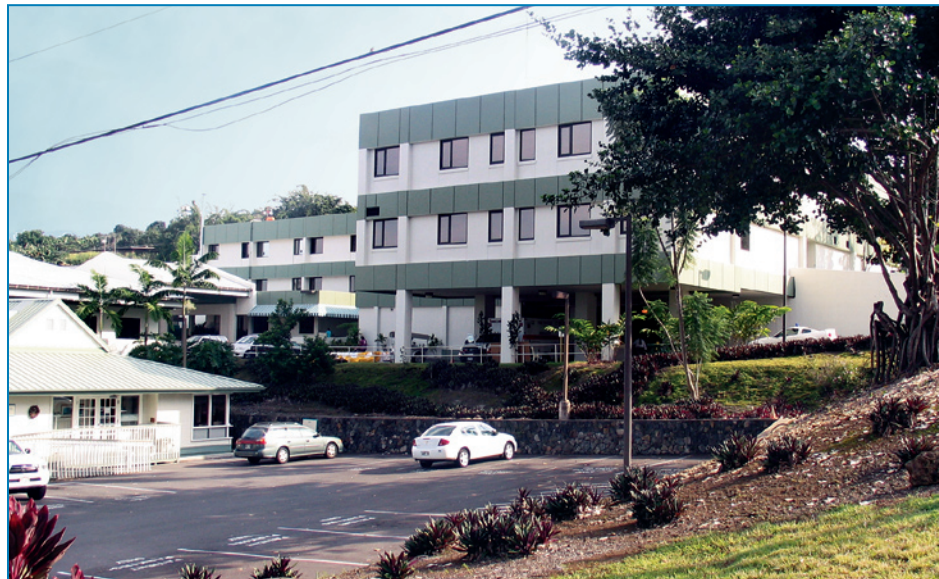
**Figure 2-35:**  
Kona Community Hospital. Addition (1989) supported on isolated columns in the foreground. The original building (1972) is in the left background.

The Special Services Building at KCH (seen in Figure 2-35 behind the small single-story building on the left) contained such an instrument. The response spectrum for one component of motion is shown in Figure 2-36 in blue. Note the rapid decline of spectral acceleration values for very short periods, much less than 0.5 seconds. The orange curve shows a spectral shape that might be expected in association with such high ground accelerations, and is included in building codes. High values of spectral acceleration between the periods of 0.5 seconds and 2.0 seconds, as shown in this standard curve, are usually associated with much greater building damage.

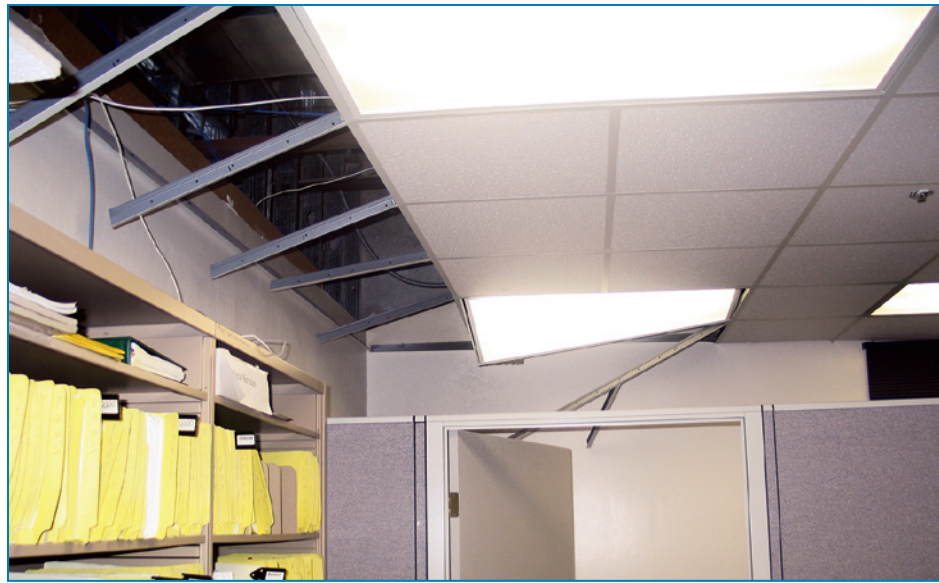
**Figure 2-38:**

Typical damage at the perimeter of a room from loss of support from the partition-mounted perimeter angles to the ceiling system tees or from contact with the ceiling system and the partitions.

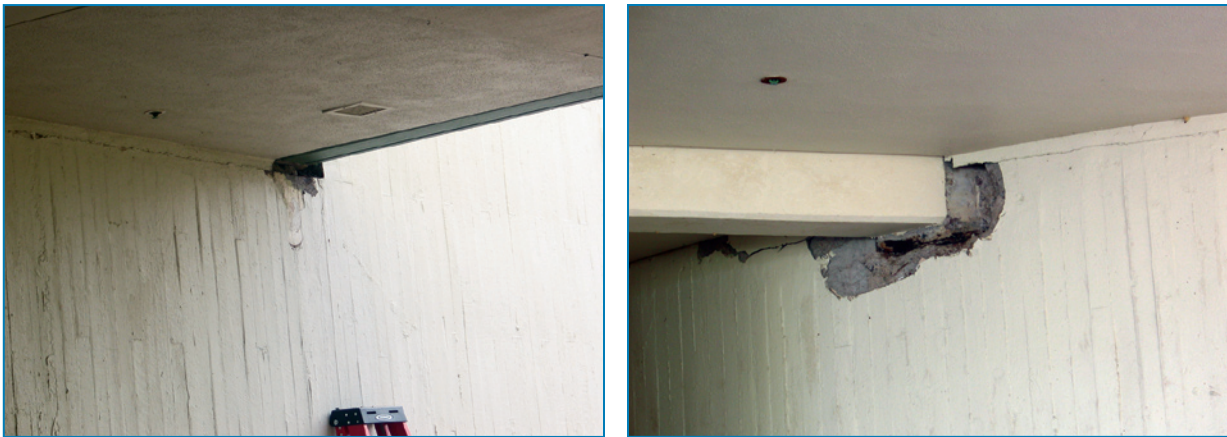
Figure 2-40: Spalling at beam connections

The potential torsional response of the building addition, identified in the 1993 evaluation, proved prophetic, as the column-supported west end attempted to rotate around the stiffly supported east end. As shown in Figure 2-40, the two beam connections tending to restrain the motion spalled. Similarly, in the partially enclosed penthouse, the embedded connection of a steel beam spanning between two exterior concrete walls pulled out due to a stiffness incompatibility. This damage was not considered serious enough for the structure and did not affect the occupancy status.

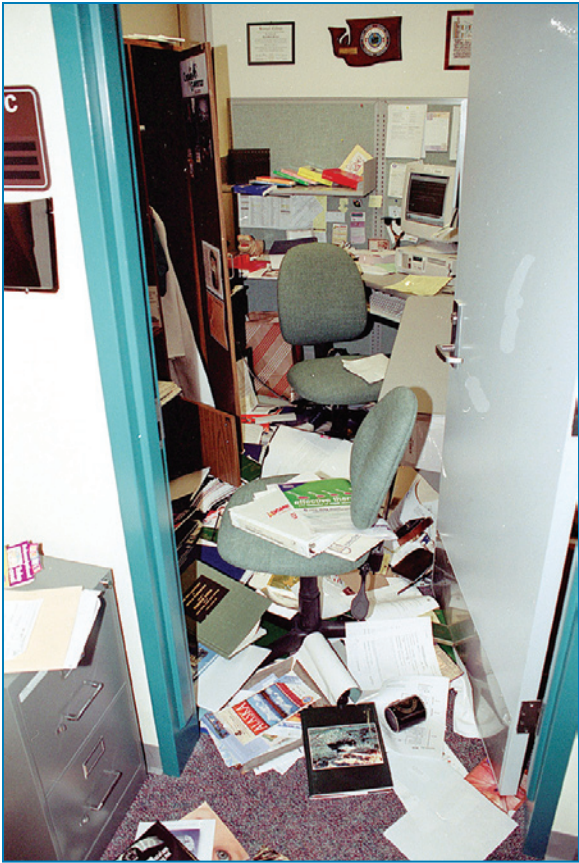
**Figure 2-51:**  
Disruption in the upper floors at Naval Hospital  
Bremerton from the Nisqually earthquake

In February 2001, while the Navy and the design team were considering their options, the Magnitude 6.8 Nisqually earthquake struck the area. The earthquake occurred deep below the surface and approximately 30 miles from the site. The ground motions at the site were below the design shaking for the site, but nevertheless caused significant nonstructural damage—particularly in the upper floors (see Figure 2-51). Such nonstructural damage always causes concern about the integrity of the structure—and often requires destructive exploration to verify. Based on preliminary structural inspections, aided by recordings of the response from instruments in the building, the Navy decided to stay in the building while more extensive exploration and analysis were performed. It took several months before nonstructural repairs were completed and the building returned to full use. Subsequent structural review indicated no structural damage.

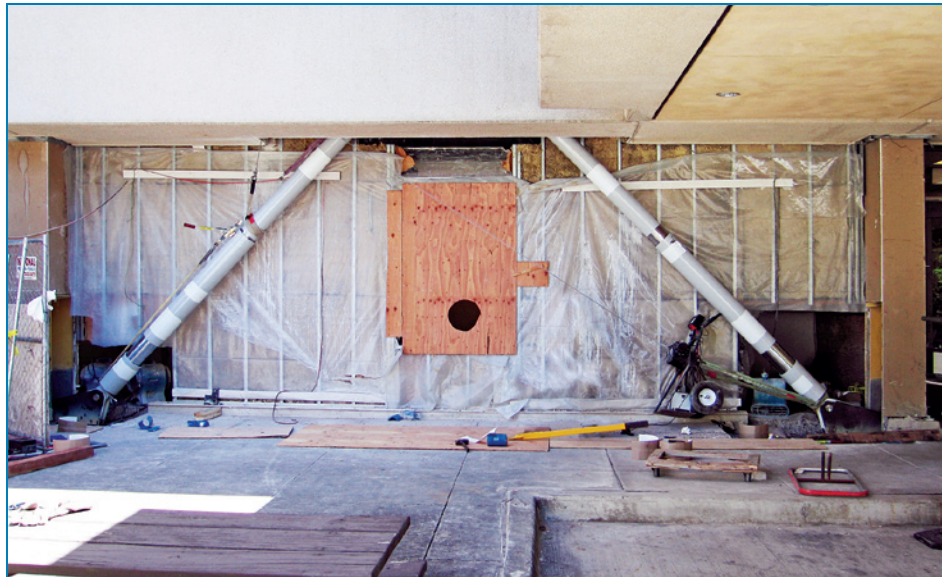
**Figure 2-52:**  
Installation of dampers  
at Naval Hospital  
Bremerton. The  
configuration is similar  
to steel braced frames.

Several styles of dampers are available for use in buildings, including those employing controlled yielding of steel elements, those based on friction (similar to a brake shoe), and more sophisticated hydraulic dampers (similar to a shock absorber). Dampers are normally placed in a building in a configuration similar to diagonal braces, and work against the movement between floors (see Figure 2-52). This action reduces inter-story drift and, to a lesser extent, reduces floor accelerations that cause sliding and overturning of equipment and contents. Although dampers should be evenly distributed throughout the building, they allow greater flex-

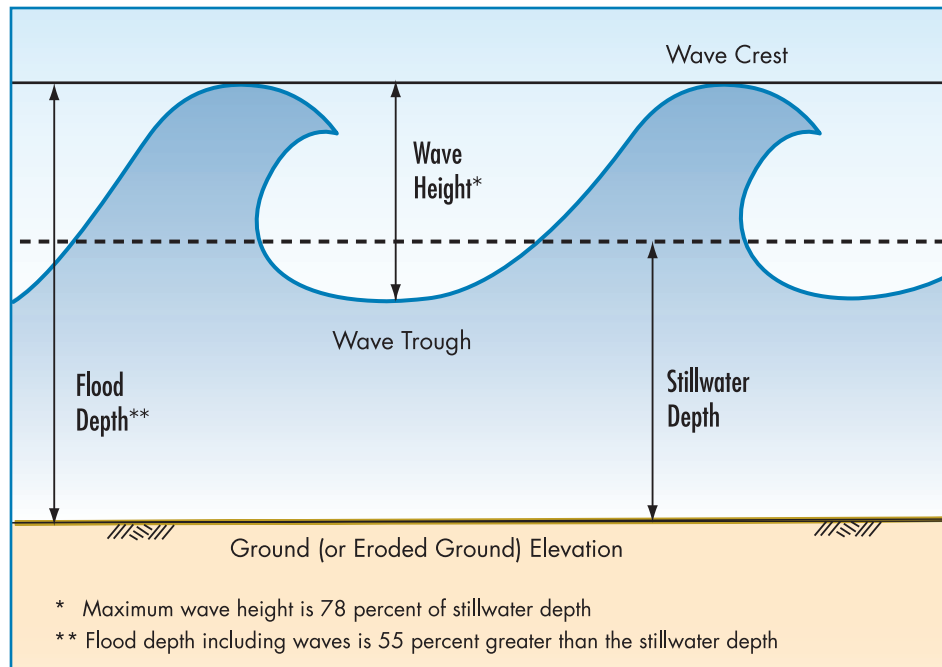
**Figure 3-6:**  
Definition sketch  
– coastal wave height  
and stillwater depth

In coastal areas, the flood elevations shown on FEMA flood maps account for stillwater flooding plus local wave effects, including wave heights, wave runup, or wave overtopping over vertical walls. As shown in Figure 3-6, subtracting the ground elevation from the FEMA flood map elevation will provide a flood depth comprised of the stillwater component and the predicted wave contribution.

Figure 3-6 illustrates the two main principles that are used to estimate wave heights at a particular site. Equations for wave height are based on the concept that waves are depth-limited, that is, waves propagating into shallow water will break when the wave height reaches a certain proportion of the underlying stillwater depth. For modeling wave heights during the base flood, FEMA utilizes the proportion determined by the National Academy of Sciences (1977): the total wave height will reach a maximum of 78 percent of stillwater depth before breaking. At any given site, this proportion may be reduced because of obstructions between open water and the site, such as dense stands of vegetation or unelevated buildings. In V Zones, 3-foot waves can be supported in only 4 feet of stillwater and the smaller “Coastal A Zone” waves of 1.5 feet can be supported in only 2 feet of stillwater. The second principle is that the wave

height extends from the trough, which is below the stillwater elevation to the crest, which is above the stillwater elevation, and is equal to 55 percent of this stillwater depth.

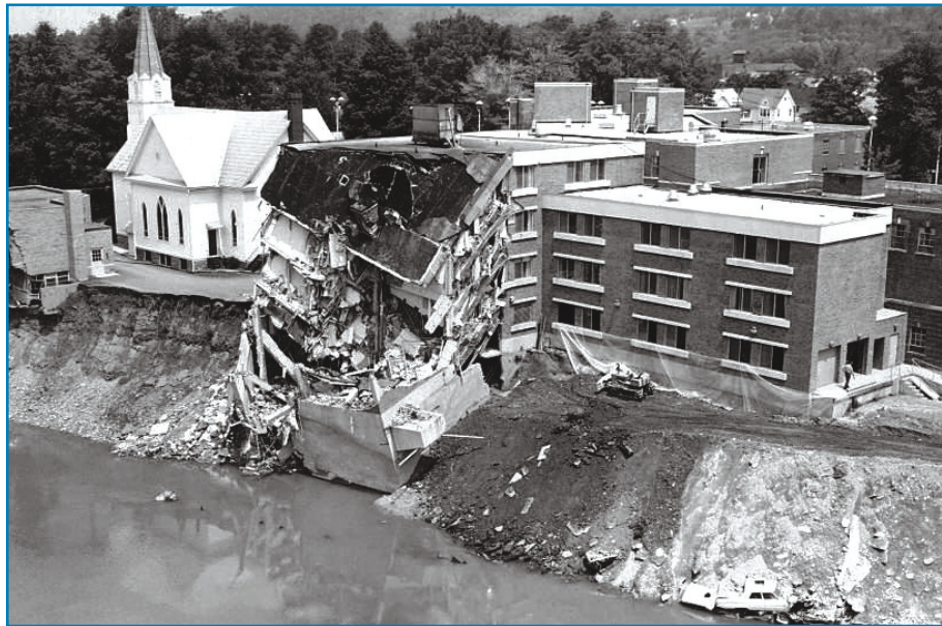
**Figure 3-12:** Riverbank erosion of the Genesee River during Hurricane Agnes flooding in 1972 eventually led to collapse of this wing of the Jones Memorial Hospital, Wellsville, NY.

**Erosion and scour:** All parts of a site that are subject to flooding by fast-moving water could experience erosion, and local scour could occur around any permanent obstructions to flow. Graded areas, filled areas, and cut or fill slopes are especially susceptible. Stream and channel bank erosion, and erosion of coastal shorelines, are natural phenomena that may, over time, threaten site improvements and buildings (see Figure 3-12).

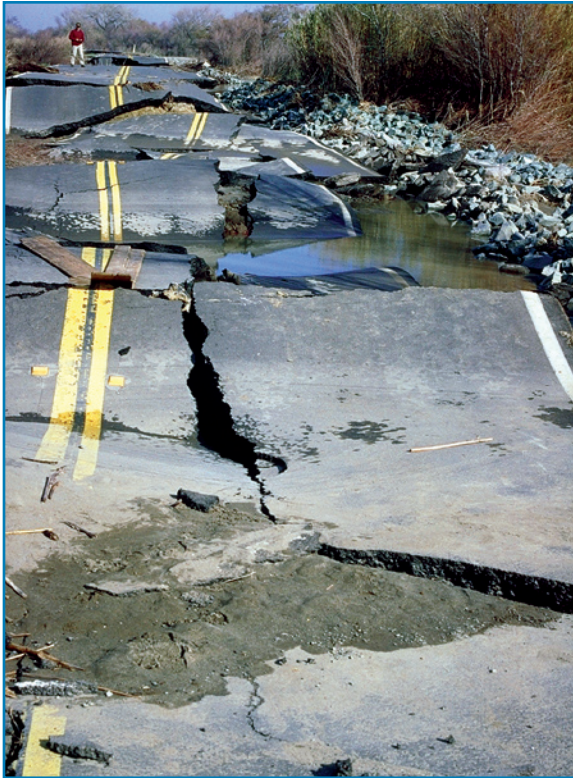
**Figure 3-13:**  
Flooding caused the failure of this road bed.

**Access roads:** Access roads that extend across flood-prone areas may be damaged by erosion, washout of drainage culverts, failure of fill and bedding materials, and loss of road surface (see Figure 3-13). Road damage could prevent uninterrupted access to a facility and thus impair its functionality.

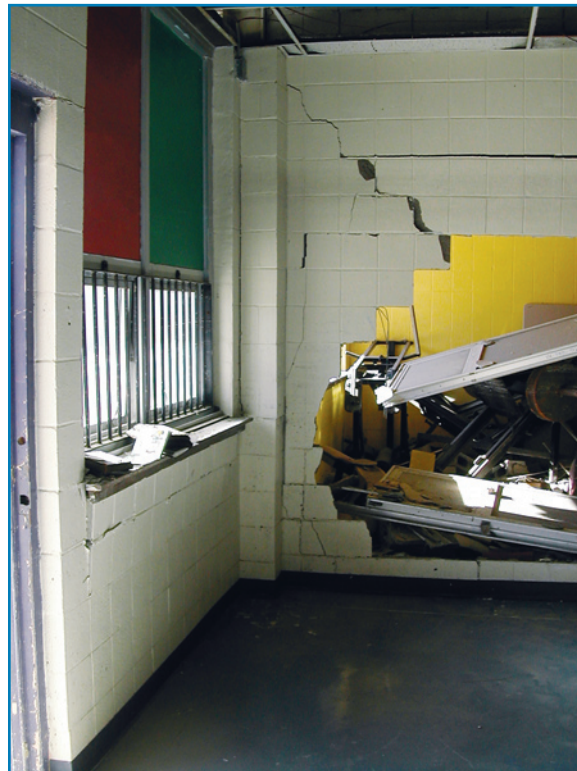
**Figure 3-14:** Interior unreinforced masonry walls of the Port Sulphur High School in Louisiana were damaged by hydrostatic loads associated with Hurricane Katrina's storm surge (2005).

**Depth:** The hydrostatic load against a wall or foundation is directly related to the depth of water. Standard stud and siding, or unreinforced brick veneer walls, may collapse under hydrostatic loads associated with relatively shallow water. Reinforced masonry walls perform better than unreinforced masonry walls (see Figure 3-14), although an engineering analysis is required to determine performance. Walls and floors of below-grade areas (basements) are particularly susceptible to damage by buoyancy force. When soils are saturated, pressures against below-grade walls are a function of the total depth of water, including the depth below-grade and the weight of the saturated soils.

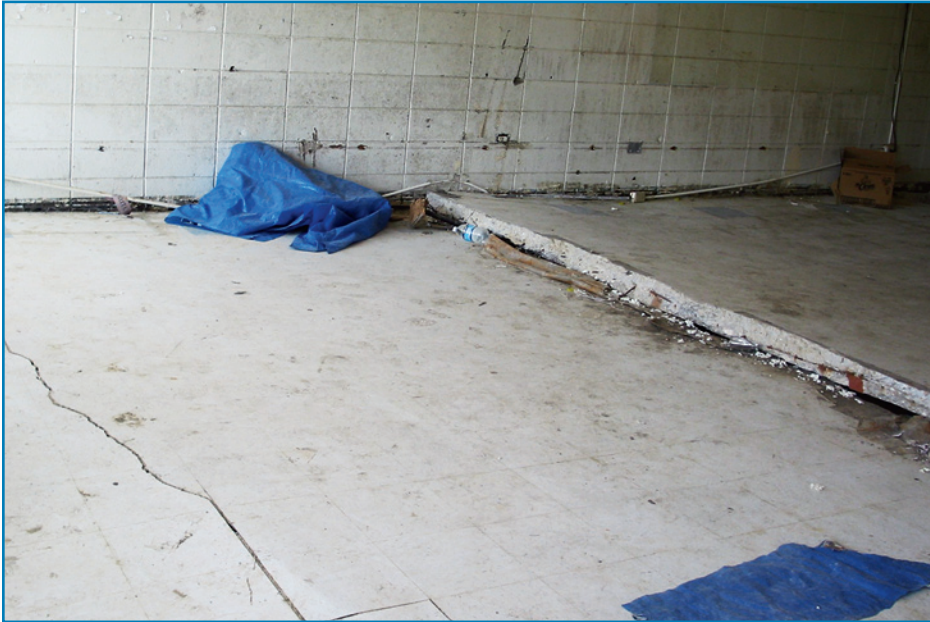
**Figure 3-15:** Concrete slab ruptured by hydrostatic pressure (buoyancy) induced by the floodwaters of Hurricane Katrina (2005).

**Buoyancy and uplift:** If below-grade areas are essentially watertight, buoyancy or uplift forces can float a building out of the ground or rupture concrete slabs-on-grade (see Figure 3-15). Buildings that are not adequately anchored can be floated or pushed off foundations. Although rare for large and heavy buildings, this is a concern for smaller structures. Buoyancy is a significant concern for underground and aboveground tanks, especially those used for emergency generator fuel and bulk oxygen.

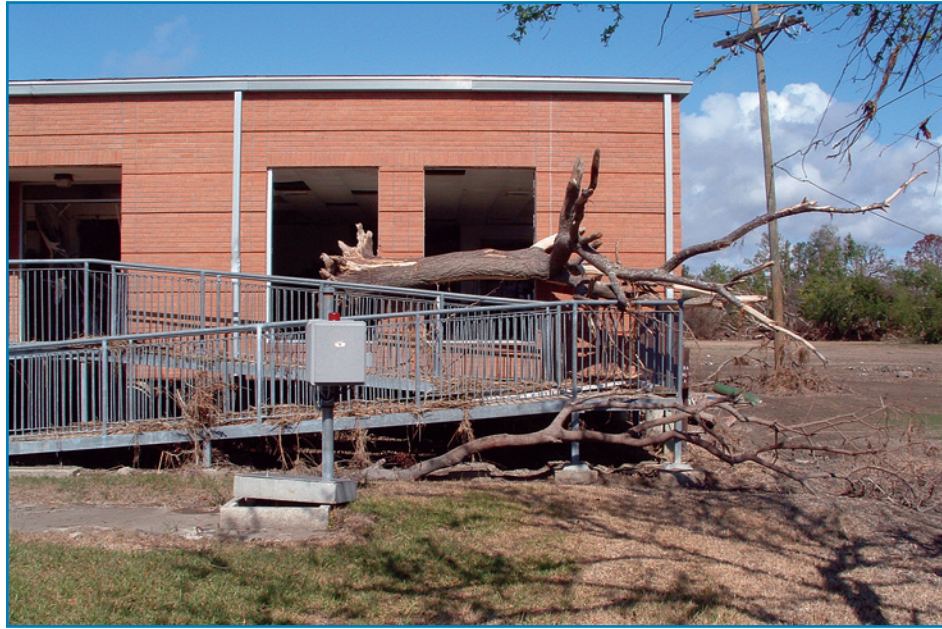
**Figure 3-16:**  
The South Cameron Memorial Hospital, Cameron, LA, was damaged by debris carried by Hurricane Rita's storm surge (2005).

**Velocity, wave action, and debris impacts:** Each of these components of dynamic loads can result in structural damage if buildings are not designed to resist overturning, repetitive pounding by waves, or short-duration impact loads generated by floating debris (see Figure 3-16).

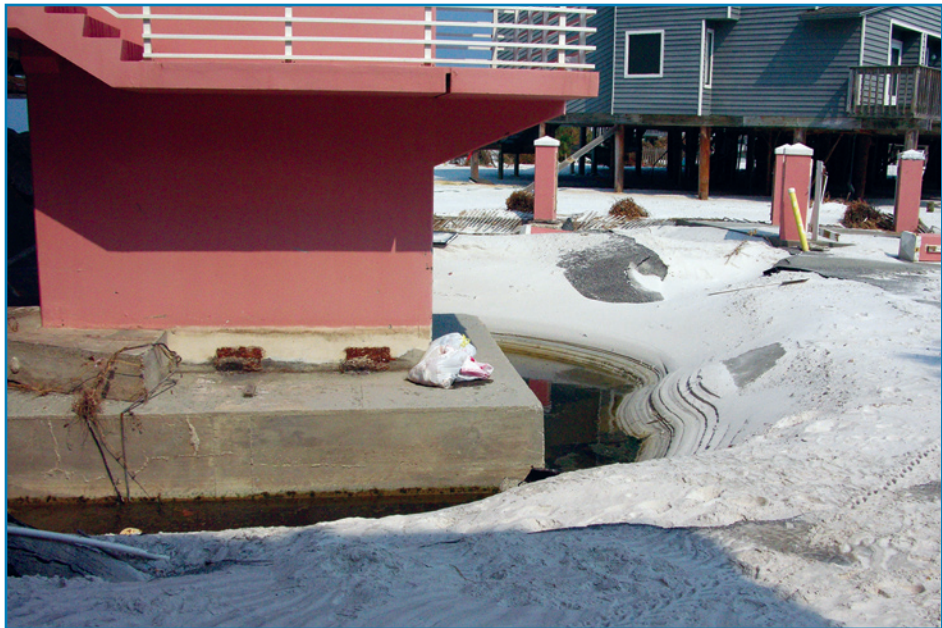
**Figure 3-17:**  
Local scour undermined the footing of this exterior stair tower (Hurricane Ivan, 2004).

**Erosion and scour:** Structural damage is associated with foundation failure when erosion or scour results in partial or complete removal of supporting soil (see Figure 3-17). Erosion of slopes, especially unprotected slopes, can lead to slope failures and loss of foundation supporting soil.

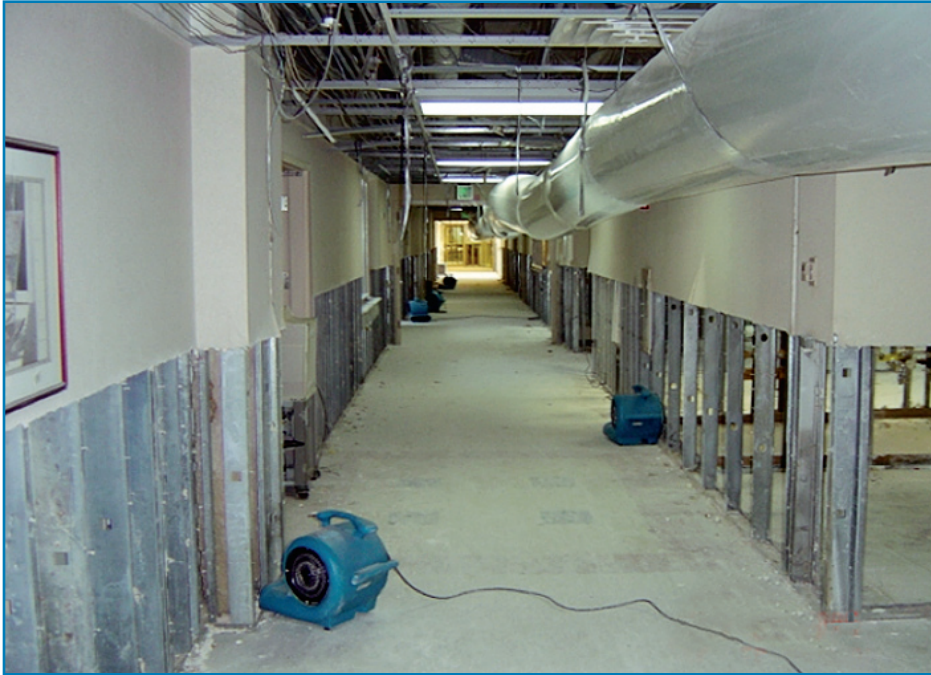
**Figure 3-18:**  
Drying out the ground  
floor at Hancock  
Medical Center  
(Hurricane Katrina,  
2005)

taminated with chemicals, petroleum products, and sewage. Under such circumstances, recovery generally involves removal of nonstructural materials and finishes because cleanup and decontamination are expensive and time-consuming (see Figure 3-18). Damage to contents is discussed in Section 3.2.2.6.

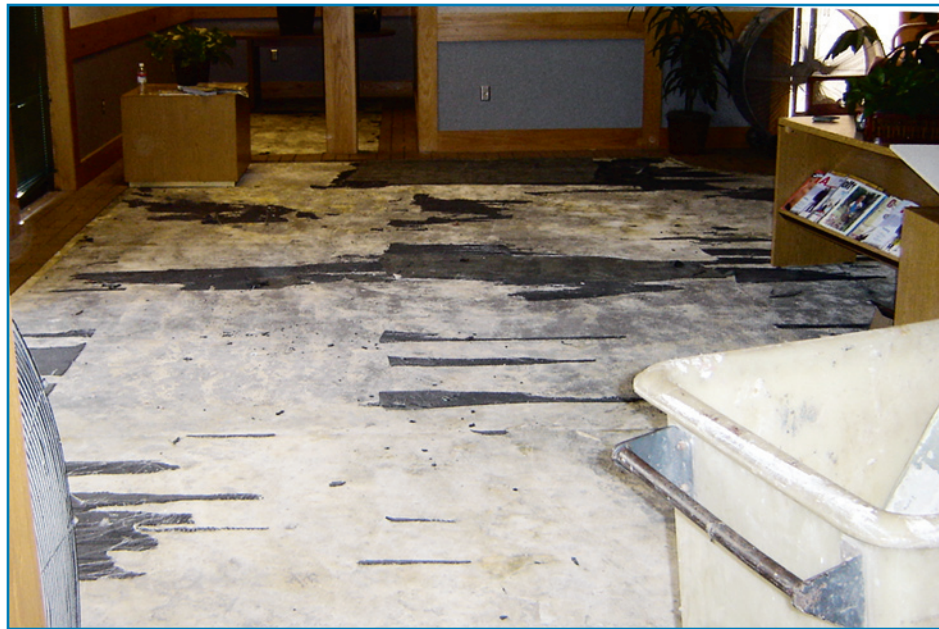
**Figure 3-19:**  
Floor damage at West  
Jefferson Medical  
Center (Hurricane  
Katrina, 2005)

**Flooring:** Many hospitals have durable floors that resist water damage. Ground floors are often slab-on-grade and finished with tile or sheet products. Flooring adhesives in use since the early 1990s likely are latex-based and tend to break down when saturated (see Figure 3-19). Most carpeting, even the indoor-outdoor kind, is difficult to clean.

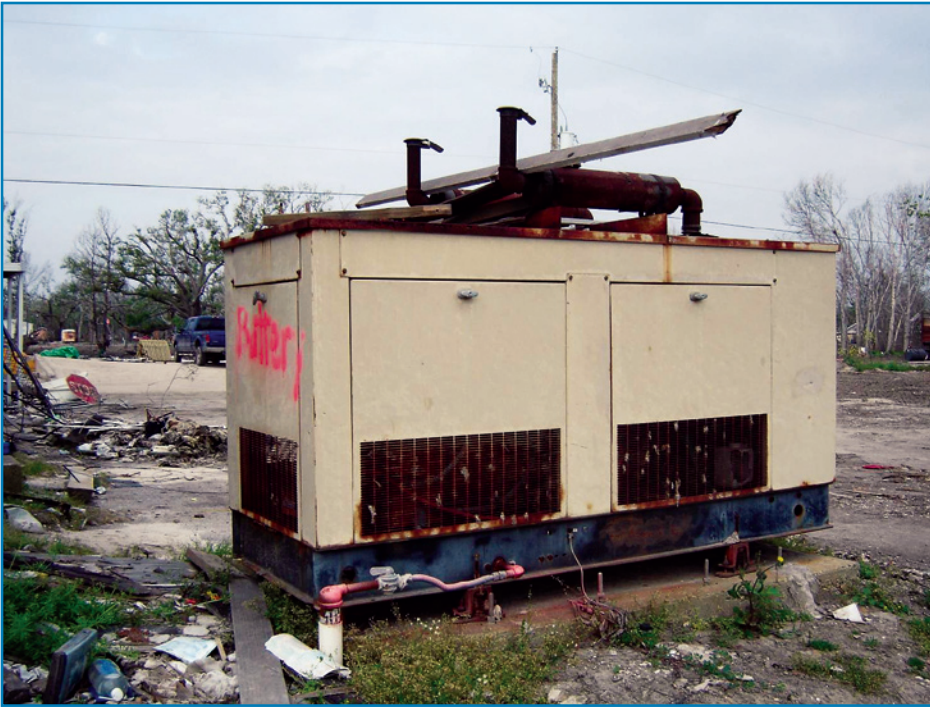
**Figure 3-21:** Although it was anchored and not displaced by floodwaters, this generator was out of service after being submerged (Hurricane Katrina, 2005).

**Emergency power generators:** Generators that are installed at-grade are susceptible to inundation and will be out of service after a flood (see Figure 3-21). Even if fuel tanks are located above flood level, truck access for refueling would be impaired if the site is flooded for any length of time.

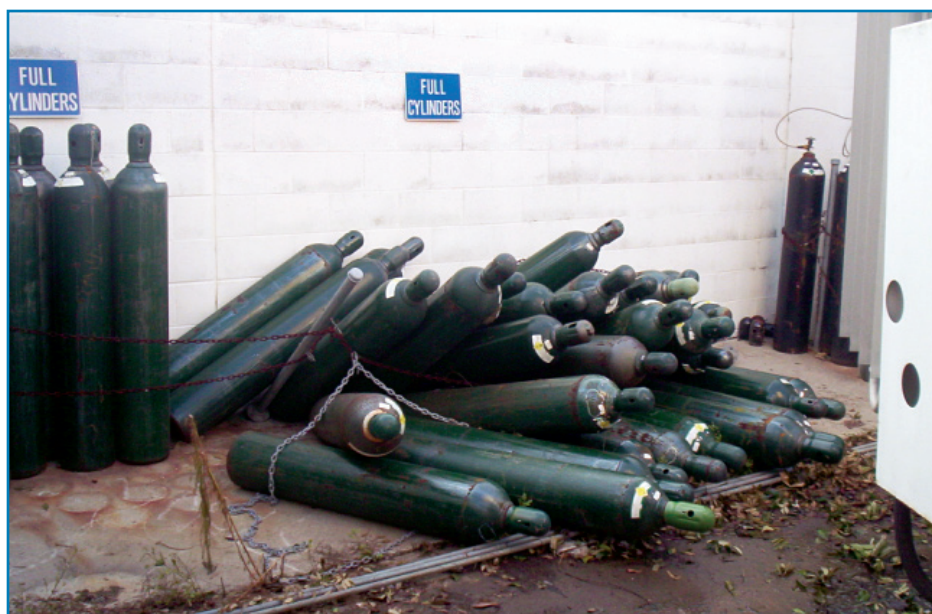
**Figure 3-22:**

Oxygen tanks stored outside of the Hancock Medical Center were dislodged by flooding (Hurricane Katrina, 2005).

**Tanks (aboveground):** Permanently installed aboveground storage tanks are subject to buoyant forces and displacement caused by moving water. Standard strapping of propane tanks may be inadequate for the anticipated loads. Tank inlets, fill openings, and vents should be above the DFE, or designed to prevent the inflow of floodwaters or outflow of tank contents during flood conditions. Even temporary storage of tanks can be problematic (see Figure 3-22).

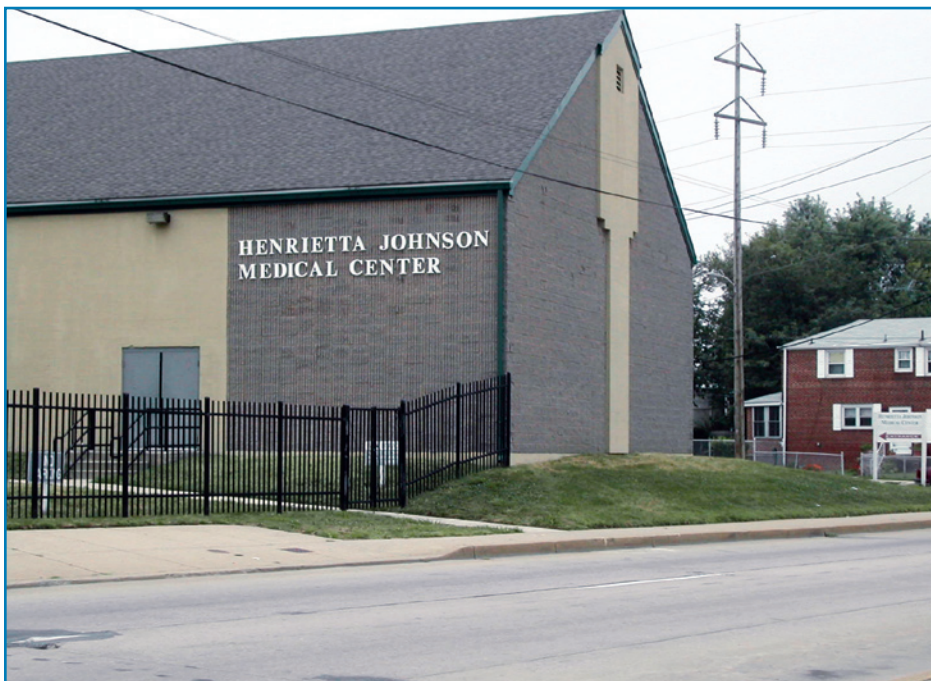
**Figure 3-27:** Structural fill was placed to elevate the Henrietta Johnson Medical Center above the shallow flood hazard area in Wilmington, DE.

**Slab-on-grade foundation on structural fill:** This is considered to be the safest method to elevate a building in many flood hazard areas, except those where waves and high velocity flows may cause erosion. Consequently, this foundation type is not allowed in V Zones. Structural fill can be placed so that even if water rises up to the DFE, the building (see Figure 3-27) and building access would still be protected from flooding. The fill must be designed to minimize adverse impacts, such as increasing flood elevations on adjacent properties, increasing erosive velocities, and causing local drainage problems. To ensure stability, especially as floodwaters recede and the soils drain, fill must be designed for the anticipated water depths and duration. A geotechnical engineer or soil scientist may need to examine underlying soils to determine if the bearing capacity is sufficient to carry the added weight of fill, or if consolidation over time may occur. In addition, the effects of long-term compaction of the fill should be considered, and may prompt additional elevation as a factor of safety. The horizontal extent of the fill, away from the foundation, should be designed to facilitate access by emergency vehicles, with a minimum 25-foot width recommended. Engineered concrete slabs supported by piers should have sufficient resistance to erosion and scour if designed for anticipated flood conditions. Designers are cautioned to avoid excavating a basement into fill without added structural protection (and certification that the design meets the requirements for dry floodproofing), due to the potential for significant hydrostatic loads and uplift on basement floors.

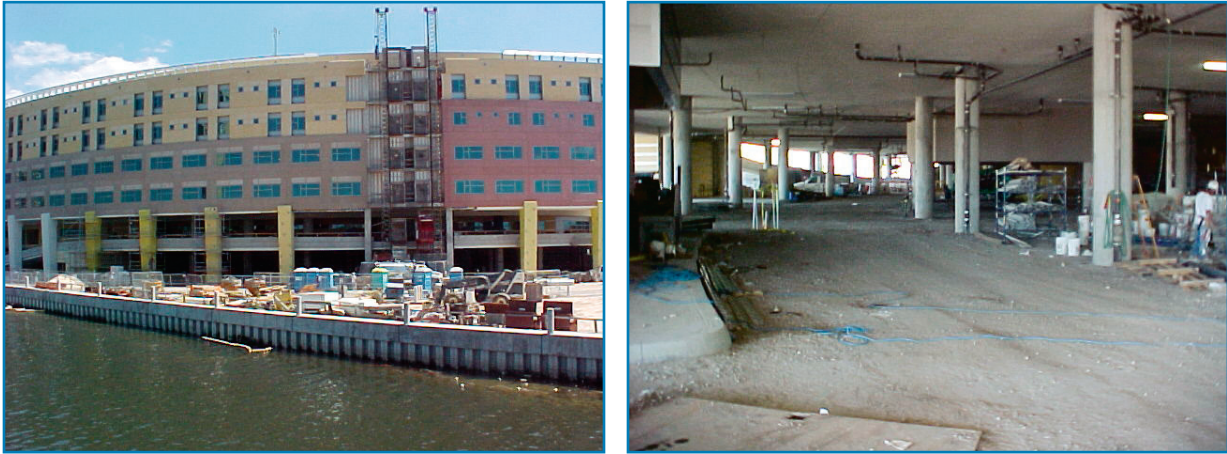
**Figure 3-29:** Tampa General Hospital had its new Emergency Department wing designed to be elevated on columns, well above hurricane storm surge flooding elevations.

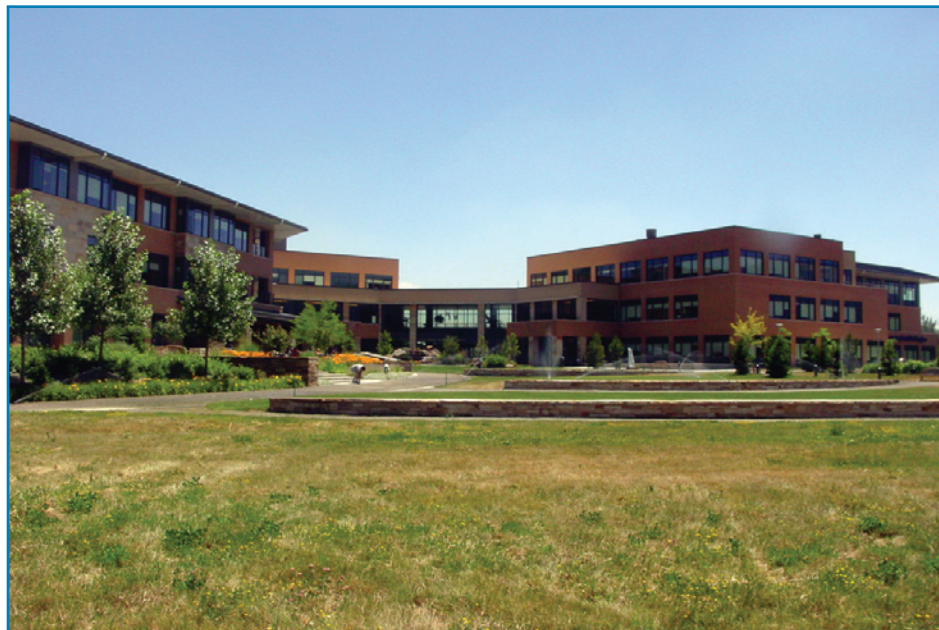
**Figure 3-32:**  
Boulder Community Foothills Hospital main entrance, with landscaping and retaining walls for portion of site filled to the 500-year flood elevation (Boulder Creek is behind photographer).

The 17 acres of the site that were needed for the campus, entirely outside of the designated floodway, were proposed to be filled to an elevation of one-foot above the 100-year flood elevation. The remaining 22 acres were placed in conservation easement. Engineering analyses were performed to demonstrate that no increase in flood elevations would result. The city required approval of a Conditional Letter of Map Revision from FEMA prior to approving the plans. The fill was required to be compacted to 95 percent of the maximum density obtainable with the Standard Proctor Test method. The earthen fill is gently sloped to natural grade and various landscaping elements and retaining walls provide a pleasing transition (Figure 3-32).
