# Design Guide

for Improving Hospital Safety  
in Earthquakes, Floods, and High Winds

*FEMA 577 / June 2007*

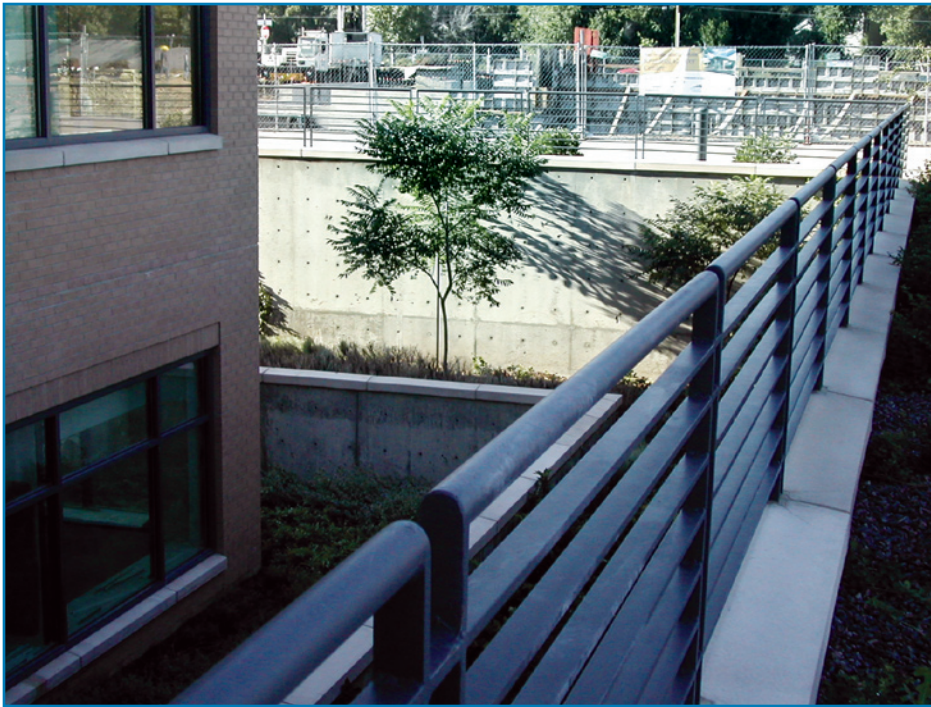
**Figure 3-33:** Below-grade office spaces provide natural light by construction of reinforced moat designed to provide flood protection for a foot above the 500-year flood elevation.

materials management, and building service and equipment. To provide natural light, a portion of these below-grade floors are surrounded by a moat (Figure 3-33). Because of anticipated high groundwater and the fact that the below-grade areas are constructed into fill that is subject to saturation during flooding, all below-grade areas are designed and certified as floodproofed spaces. Floodproofing extends 2 feet above the 100-year flood elevation, and 1 foot above the 500-year flood elevation.

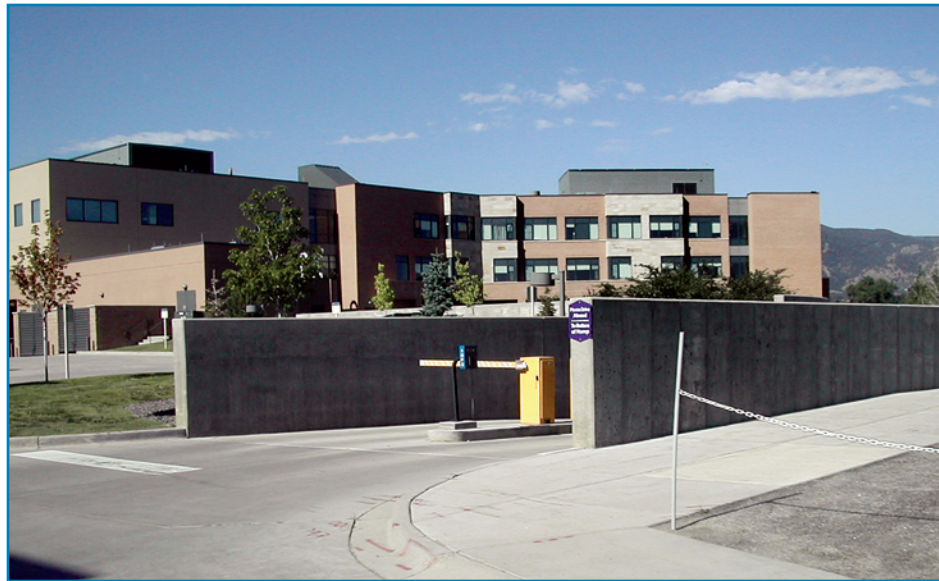
**Figure 3-34:**  
Ramp entrance to below-grade parking garage. Note retaining walls on either side; ramp crests at about 16-inches above the 500-year flood elevation.

Although the risk of flooding is very low, hospital personnel have identified low points where floodwaters that rise higher than the predicted 500-year flood could begin to affect the facility. The lowest point of entry is the ramp to the parking garage, which is more than a foot higher than the 500-year water surface elevation (Figure 3-34). A supply of sandbags is kept onsite for placement across the ramp. The next most susceptible location is the air handler, although its ground elevation is somewhat higher than the 500-year flood level (Figure 3-35).

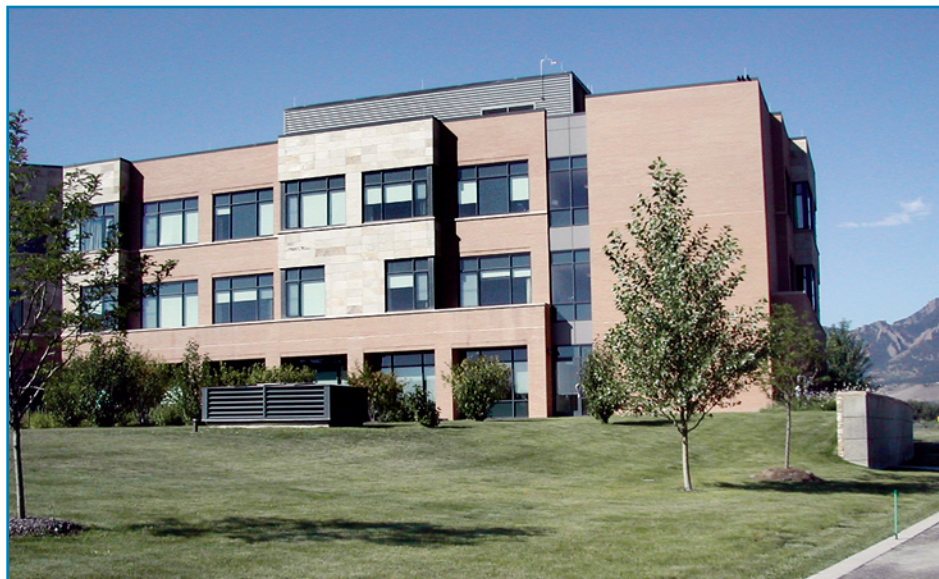
**Figure 3-35:**  
The upper floors provide patient care. The top of the retaining wall (on right) and the air handler (left of center) are approximately one-foot above the 500-year flood elevation.

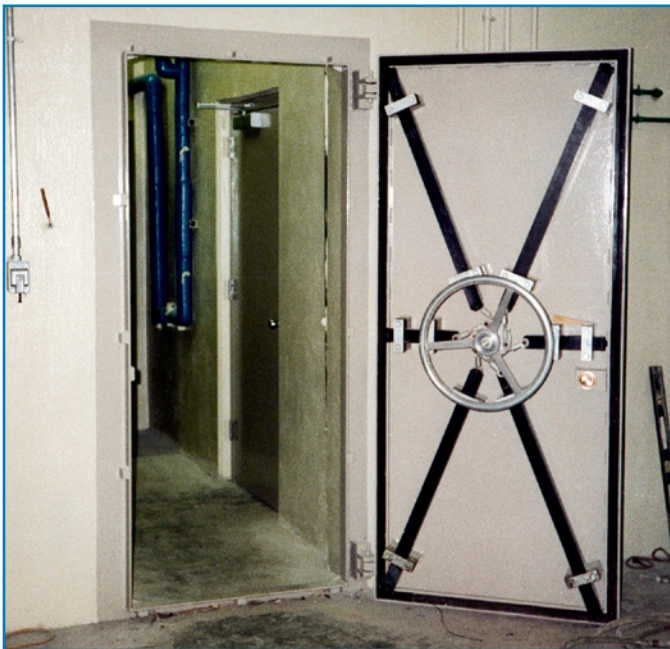
**Figure 3-36:** Permanent watertight doors designed for deep water

specially designed units (see Figure 3-36) or be fitted with gasketed, mountable panels that are designed for the anticipated flood conditions and loads. Generally speaking, it is difficult to protect window and door openings from water more than a few feet deep. The framing and connections must be specifically designed for these protective measures, or water pressure may cause window and door frames to separate from the building.

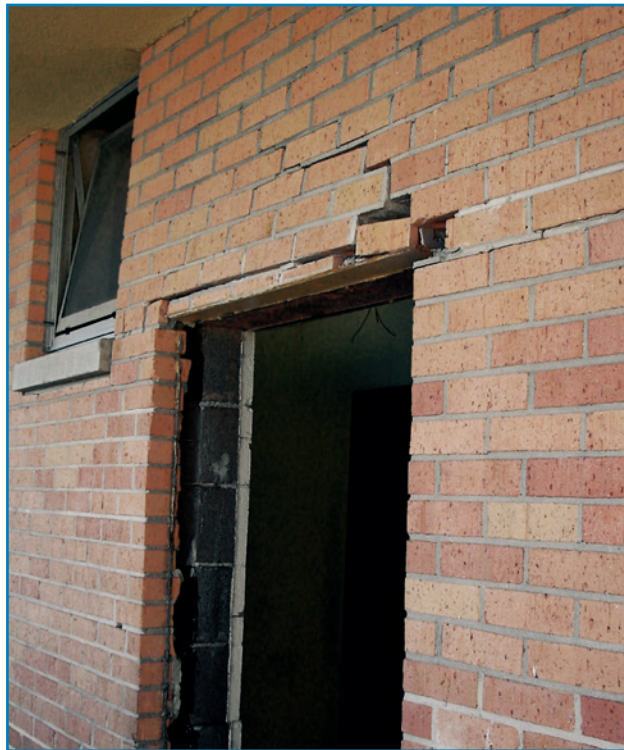
**Figure 3-37:**  
Brick facing separated from masonry wall  
(Hurricane Katrina, 2005).

Concrete and masonry that are designed and constructed in compliance with applicable standards are generally considered to be flood-resistant. However, masonry facings are undesirable finishes unless extra anchoring is added to prevent separation (see Figure 3-37). Wood and timber members exposed to floodwaters should be naturally decay-resistant species, or pressure treated with appropriate preservatives.

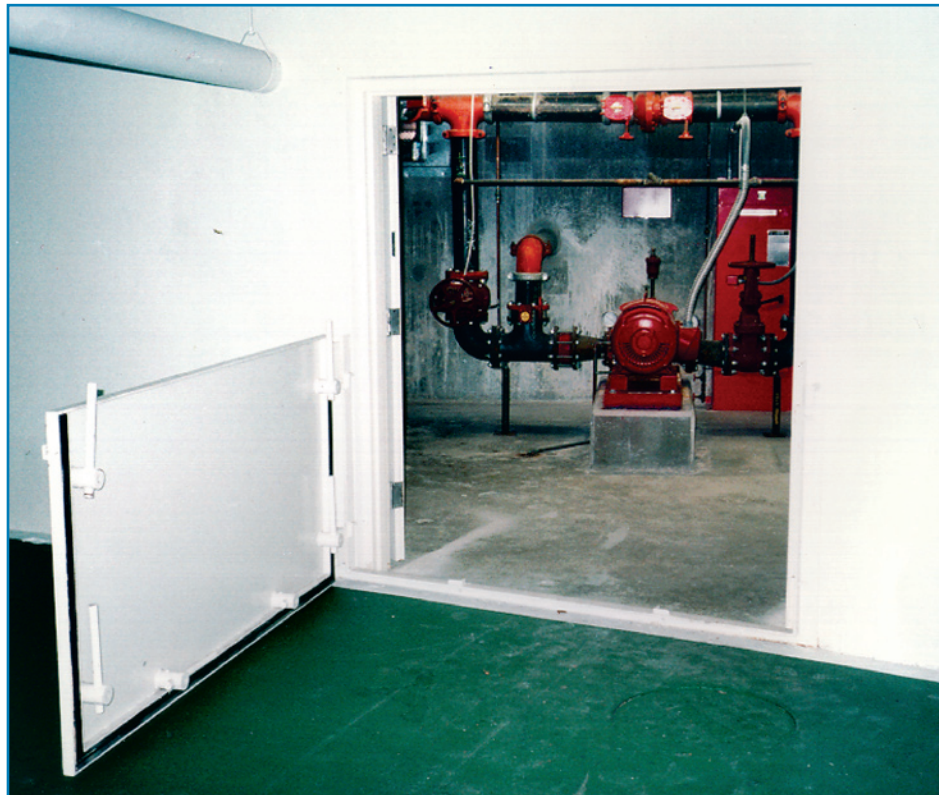
**Figure 3-38:**  
Equipment room with  
watertight door

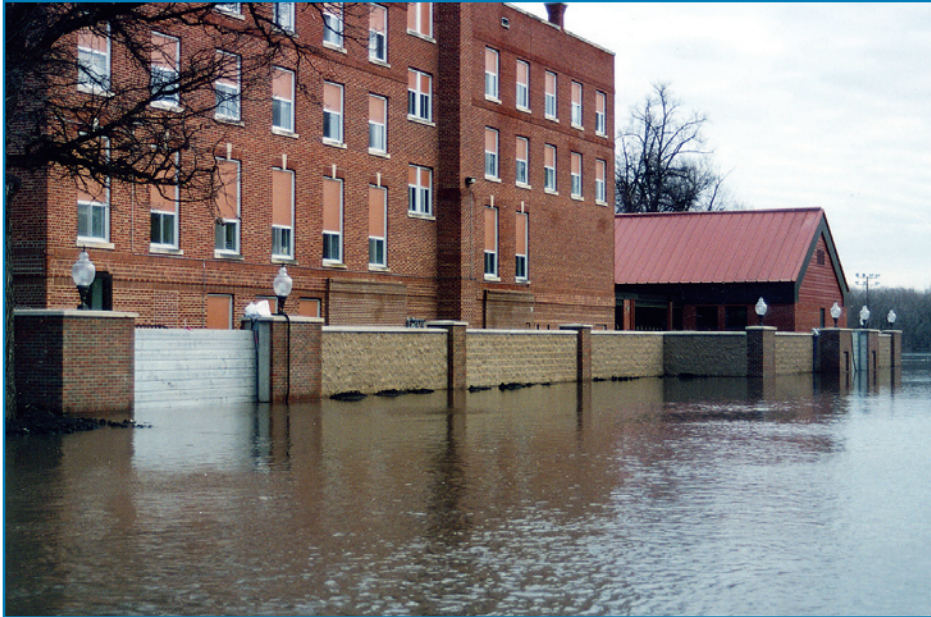
**Figure 3-39:** A masonry floodwall with multiple engineered openings in Fargo, ND during flooding in 2001.

modification of the existing building is not required. Depending on the topography of the site, floodwalls may protect only the low side (in which case they must “tie” into high ground) or completely surround a site (which may affect access because special closure structures are required and must be installed before the onset of flooding, see Figure 3-39).

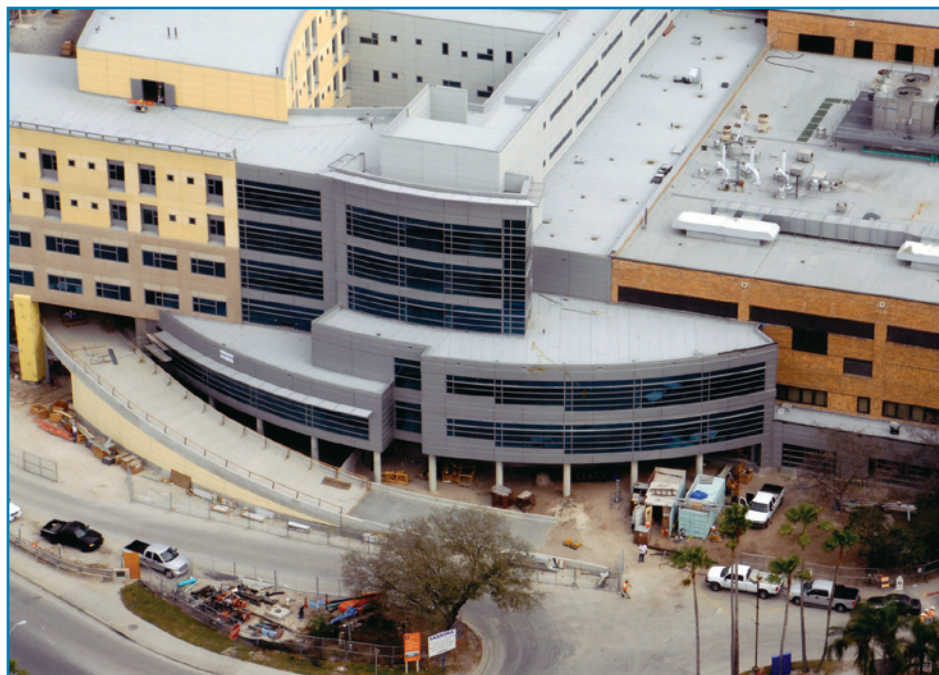
**Figure 3-40:**  
Tampa General Hospital solved the problem of access to the new elevated Emergency Department by designing a vehicle ramp. Visitors and ambulatory patients take elevators from the ground floor.

With respect to code compliance and designing additions to resist flood damage, one of the more significant issues to be considered is ease of access. If the lowest floor of the existing facility is below the DFE, steps, ramps, or elevators will be required for the transition to the new addition (See Figure 3-40). Some jurisdictions may contemplate allowing variances to the requirement for elevation, because alternative means of access are available, such as ramps and elevators. Under the regulations of the NFIP and FEMA guidance, it is not considered appropriate to grant such a variance.

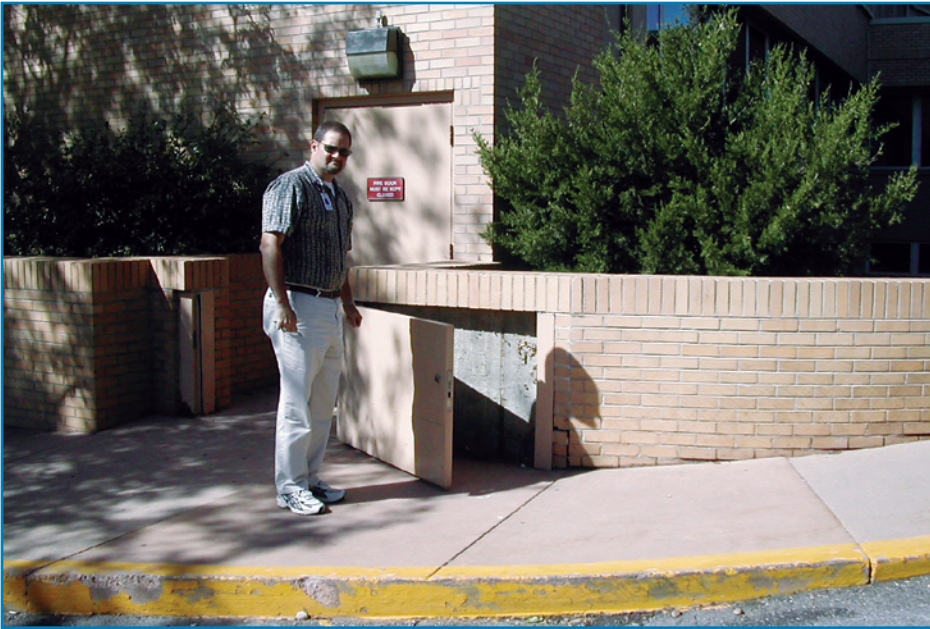
**Figure 3-41:** Boulder Community Hospital, Boulder, CO, installed this permanently mounted floodgate in a low floodwall; the floodgate swings to the left to keep water away from the mechanical equipment room.

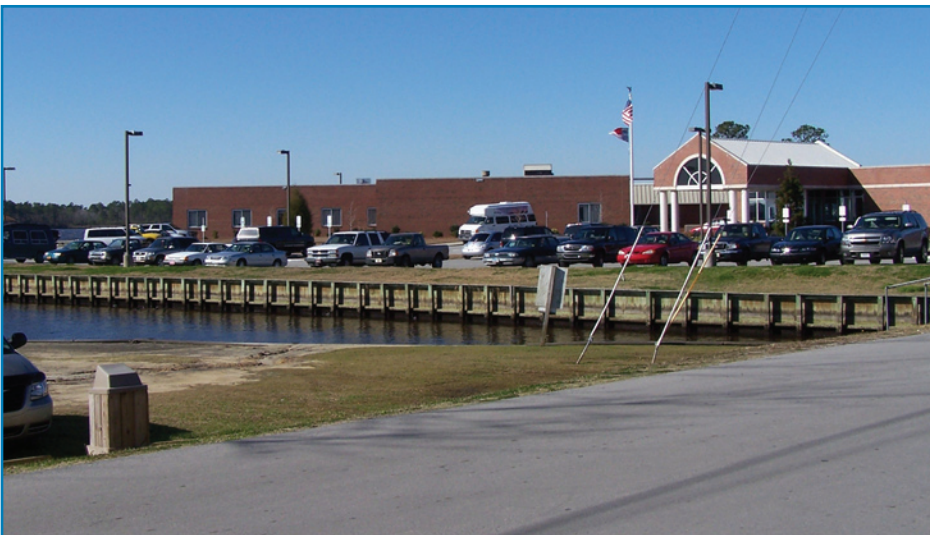
**Figure 3-42:** Pungo District Hospital is situated adjacent to a canal and Pantego Creek, a tidal tributary to the Pungo River in eastern North Carolina.

The Pungo District Hospital has served the waterfront town of Belhaven, North Carolina, and the surrounding area for nearly 60 years (Figure 3-42). The facility is only about 100 feet back from the waters of a canal and Pantego Creek, a tidal tributary to the Pungo River in Beaufort County. As with the rest of coastal North Carolina, Beaufort County has seen more than its share of hurricanes. Notable named storms that affected the area in just the past decade include Hurricanes Fran (1996), Dennis (1999), Floyd (1999), and Isabel (2003).

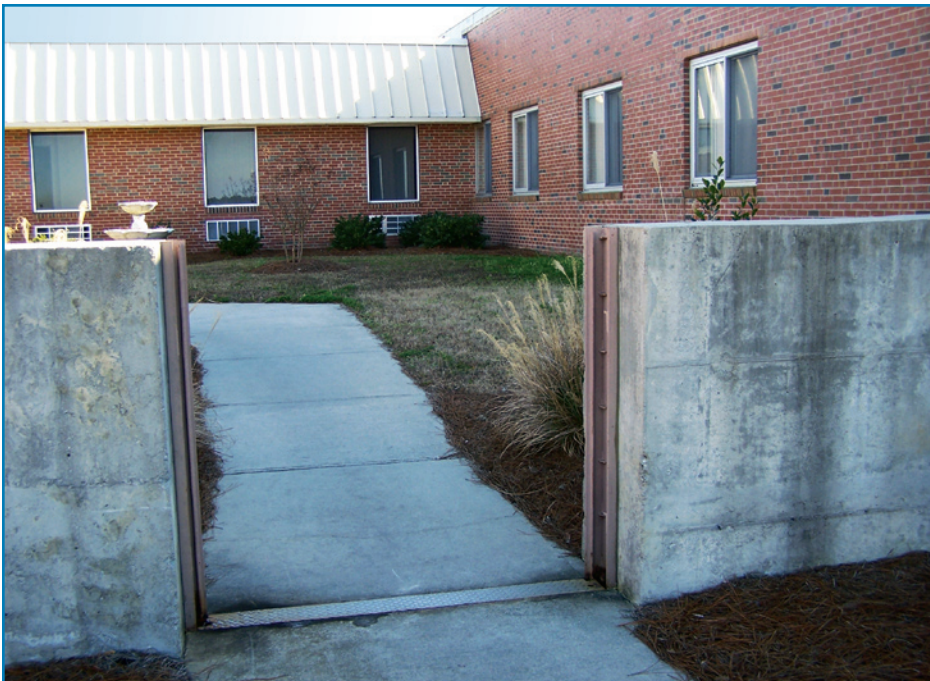
**Figure 3-43:**

A special floodproofing panel is manually installed in this concrete floodwall to keep floodwater away from the rear courtyard and patient rooms.

The engineer's examination determined that the exterior walls of the existing building were sufficiently strong to resist the flood loads anticipated during the 100-year flood conditions, provided the entrances and other openings through the exterior wall were sealed to prevent entry of water. The dry floodproofing measures proposed entailed construction of low concrete walls in certain areas and installation of specially fabricated frames and metal panels for some doors, floodwall openings, and crawlspace ventilation openings (Figures 3-43 and 3-44). The top of the concrete wall and the tops of the panels were set about 2 feet higher than the BFE, providing 2 feet of freeboard as a factor of safety. To provide additional protection to the new addition, a rubber membrane was installed between the brick facing and the block wall. The total cost of the floodproofing measures was \$125,000 (1997 dollars).

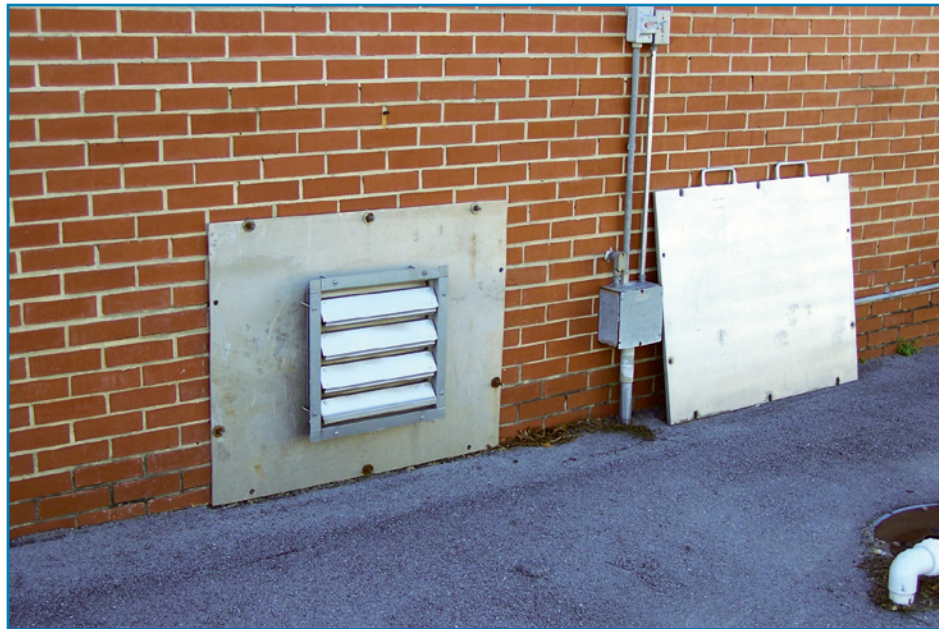
**Figure 3-44:**  
The ventilation openings for the original building's crawlspace are protected with floodproofing panels that are bolted in place when flooding is predicted.

The frames that hold the floodproofing panels are permanently-mounted and sealed against the building to prevent seepage. The frames are designed with an aluminum cover to keep the channels free of dirt and debris. The metal panels that fit into the channels have rubber gaskets that are inspected each year as part of the hospital's routine maintenance program. The manufacturer recently advised replacement of the gaskets, as the 10-year anniversary of installation nears.

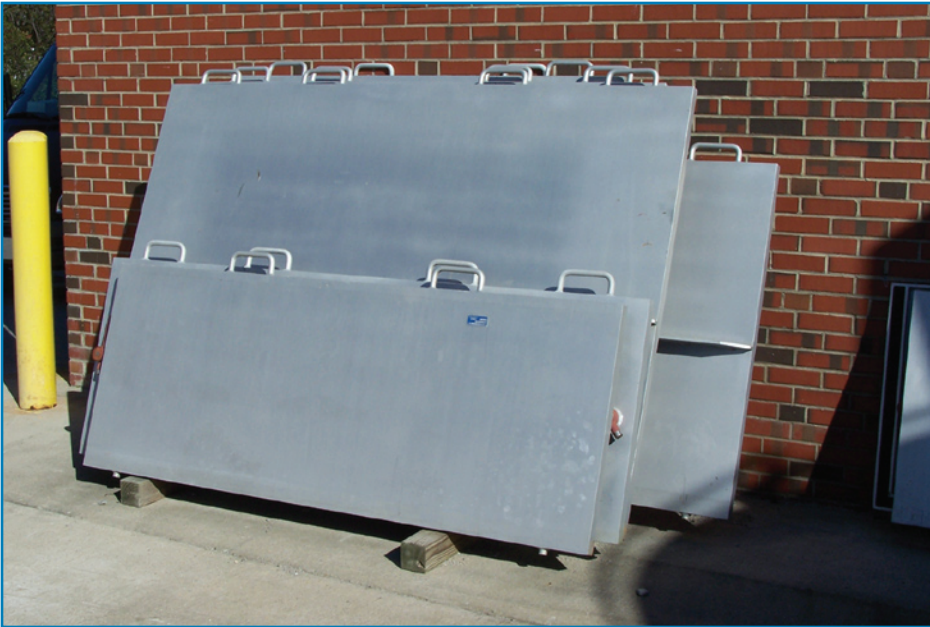
A total of 15 panels of different sizes are stored onsite (Figure 3-45). Although the panels can be handled by two people (Figure 3-46), the hospital has an on-call agreement with a local rental company to use a forklift to facilitate moving them into place. All panels can be installed in about 3 hours.

**Figure 3-45:**  
Large floodproofing panels are stored at the hospital, ready for installation when coastal flooding is predicted.

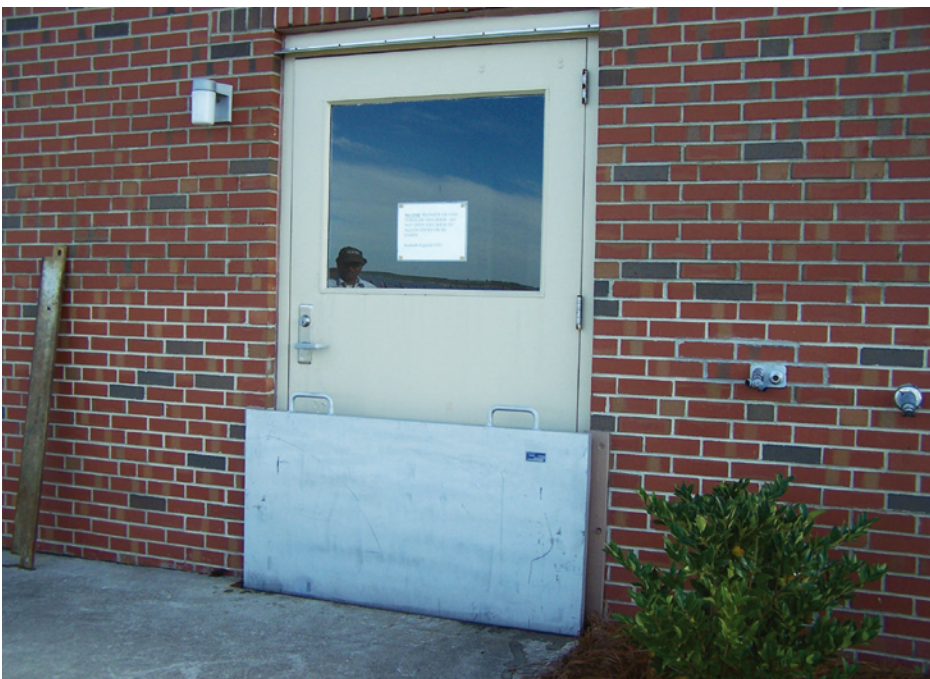
**Figure 3-46:**  
Most of the panels can be installed by hand. Note the protective metal strip leaning against the building on the left; normally this strip covers the horizontal channel into which the panel is inserted.

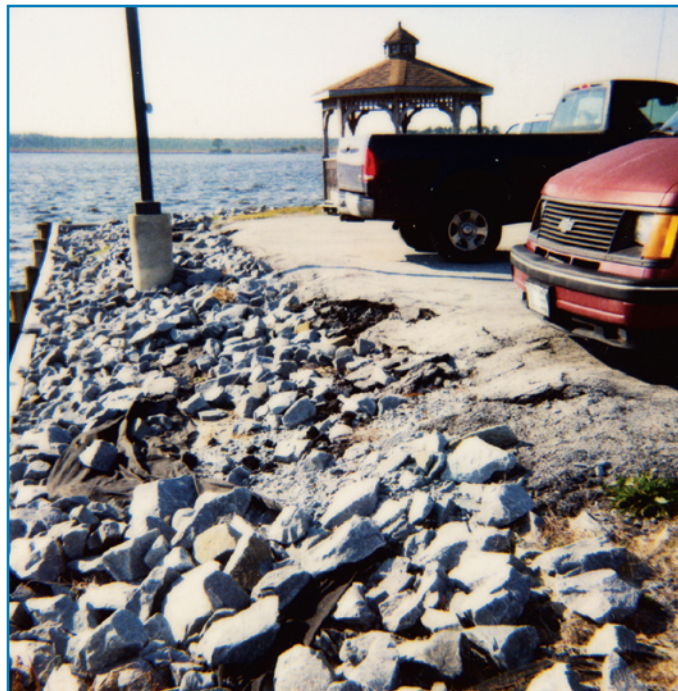
**Figure 3-47:**

Despite decades of weathering hurricanes, the Pungo District Hospital has not sustained major wind damage. The absence of trees or other buildings between the hospital and the water prevents major wind-borne debris damage. Water-borne debris is deposited around the facility every time high water crests the bulkhead that lines creek. One corner of the parking lot, which extends nearly to the bulkhead, sustained damage as Hurricane Isabel's rising water lifted and displaced the asphalt (Figure 3-47).

High water and waves eroded the slope between the parking lot and the bulkhead and shifted a portion of the asphalt.

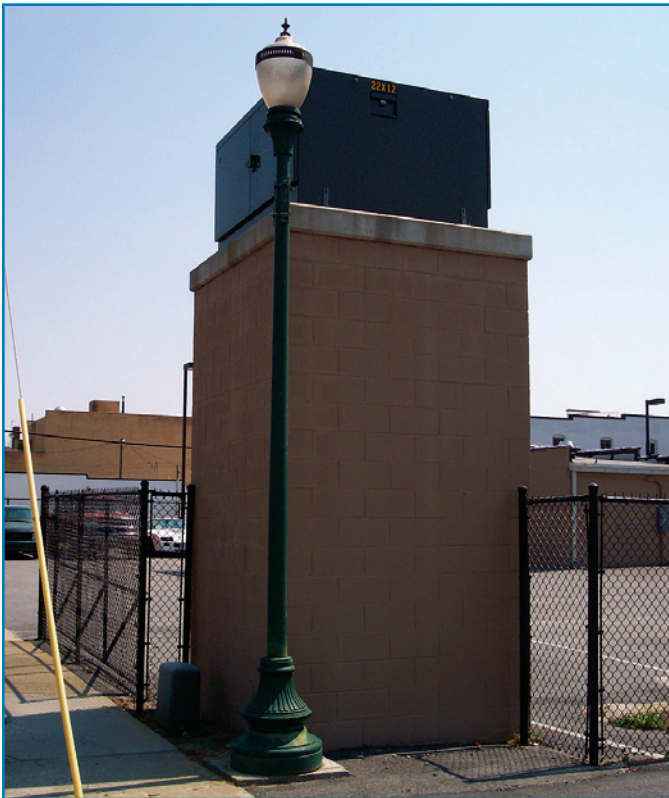
**Elevate components:** Whether located inside or outside of the building, some components of utility systems can be elevated-in-place on platforms, including electric transformers, communication switch boxes, water heaters, air-conditioning compressors, generators, furnaces, boilers, and heat pumps (see Figure 3-48).

Figure 3-48:  
Elevated utility box

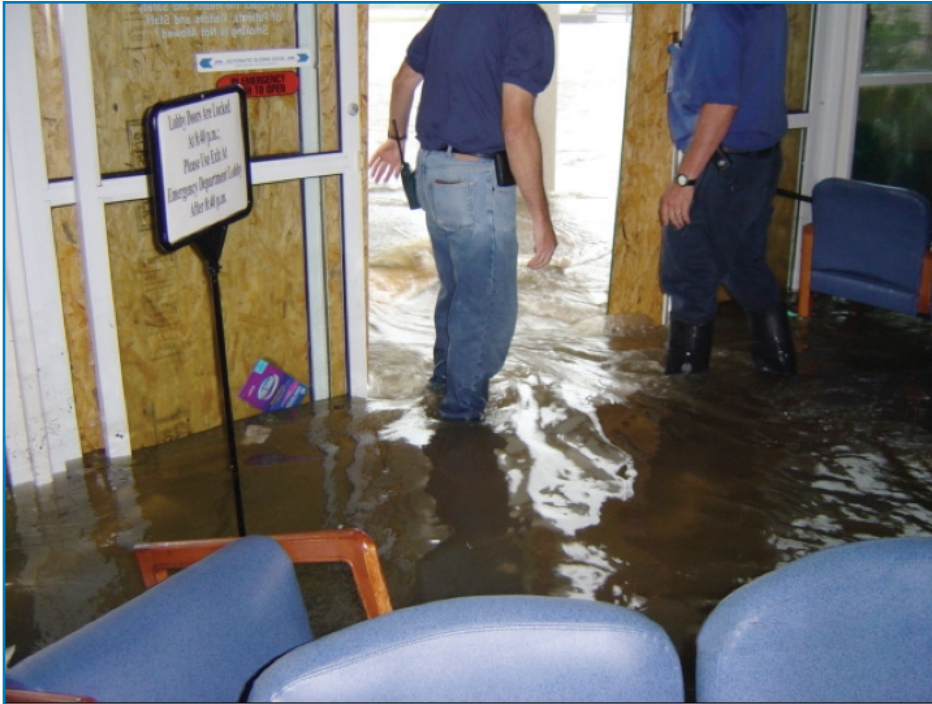
**Panels for doors:** For shallow and short-duration flooding, panels of sturdy material can be made to fit doorways to minimize the entry of floodwaters, although failure is common (see Figure 3-49). Effectiveness is increased significantly if a flexible gasket or sealant is provided, and the mounting hardware is designed to apply even pressure. Personnel must know where the materials are stored and be trained in

**Figure 3-49:**  
Flooding at Hancock  
Medical Center during  
Hurricane Katrina

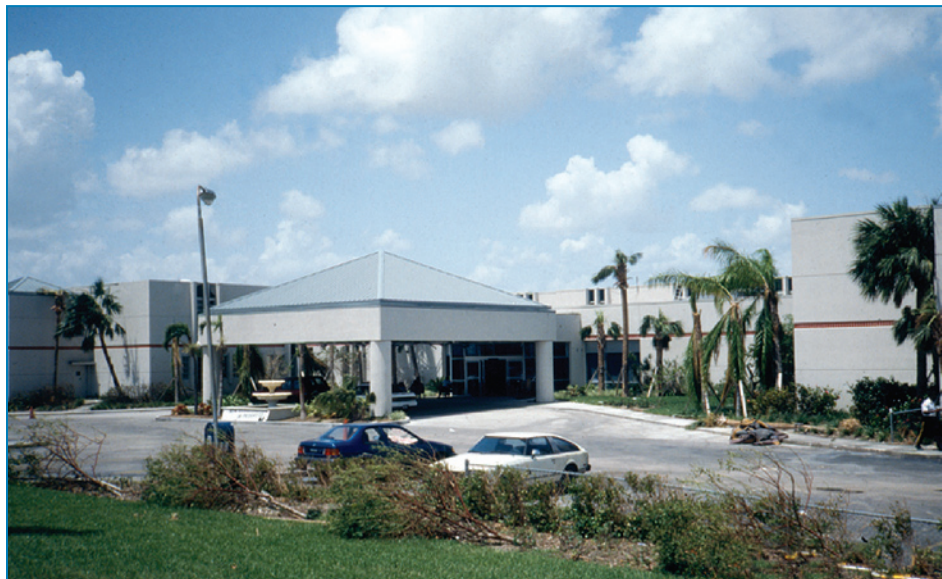
**Figure 4-1:**  
Deering Hospital was evacuated after Hurricane Andrew due to water infiltration caused by roof covering, window, and door damage.

The 200-bed Deering Hospital opened shortly before Hurricane Andrew struck south Florida in 1992. Aggregate from the hospital's built-up roofs broke several windows, the roof covering was blown off in some areas (Figure 4-9), and the entrance doors at the emergency room were blown away. Because of extensive interior water damage, the entire hospital was evacuated after the storm and remained closed for 9 months.

**Property damage:** Property damage requires repairing/replacing the damaged components (or replacing the entire facility), and may require repairing/replacing interior building components, furniture, and other equipment, and mold remediation. As illustrated by Figures 4-1 and 4-8, even when damage to the building envelope is limited, such as blow-off of a portion of the roof covering or broken glazing, substantial water damage frequently occurs because heavy rains often accompany strong winds (particularly in the case of thunderstorms, tropical storms, hurricanes, and tornadoes).

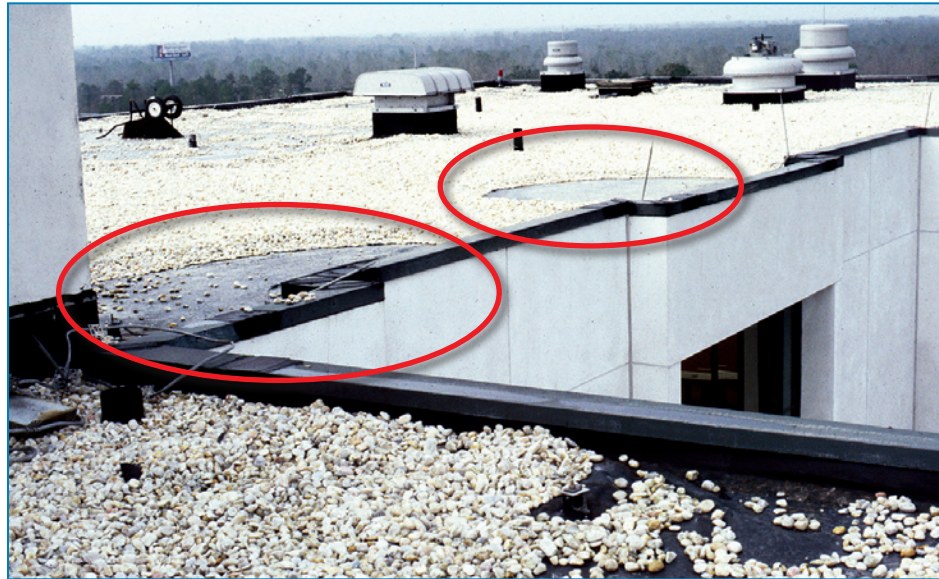
Building irregularities, such as re-entrant corners, bay window projections, a stair tower projecting out from the main wall, dormers, and chimneys can cause localized turbulence. Turbulence causes wind speed-up, which increases the wind loads in the vicinity of the building irregularity, as shown in Figures 4-5 and 4-6. Figure 4-5 shows the aggregate ballast on a hospital's single-ply membrane roof blown away at the re-entrant corner and in the vicinity of the corners of the wall projections at the window bays. The irregular wall surface created turbulence, which led to wind speed-up and loss of aggregate in the turbulent flow areas.

**Figure 4-5:**  
Aggregate blow-off associated with building irregularities. Hurricane Hugo (South Carolina, 1989)

**Wall collapse:** Collapse of non-load-bearing exterior walls is common during hurricanes and tornadoes, but is less common during other storms. At the hospital shown in Figure 4-11, a portion of the non-load-bearing wall collapsed. Several windows were also broken by aggregate ballast blown from the hospital's roof (see Figure 4-5).

Of the single-ply attachment methods, the paver-ballasted and fully adhered methods are the least problematic. Systems with aggregate ballast are prone to blow-off, unless care is taken in specifying the size of aggregate and the parapet height (see Figures 4-5, 4-46, and 4-47). The performance of protected membrane roofs (PMRs) with a factory-applied cementitious coating over insulation boards is highly variable. When these boards are installed over a loose-laid membrane, it is critical that an air retarder be incorporated to prevent the membrane from ballooning and disengaging the boards. ANSI/SPRI RP-4 (which is referenced in the IBC) provides wind guidance for ballasted systems using aggregate, pavers, and cementitious-coated boards.

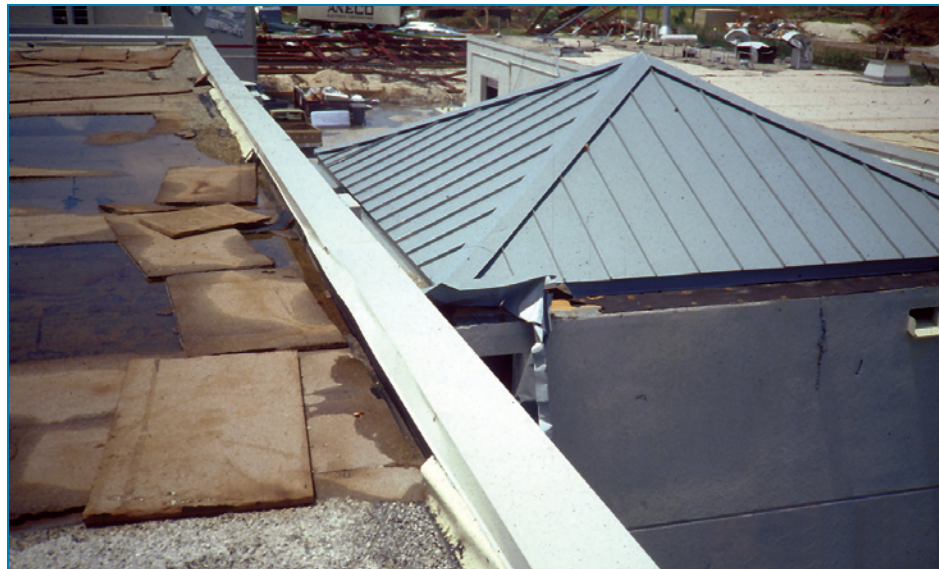
Figure 4-6 shows a stair tower at a hospital that caused turbulence resulting in wind speed-up. The speed-up increased the suction pressure on the base flashing along the parapet behind the stair tower. The built-up roof's base flashing was pulled out from underneath the coping because its attachment was insufficient to resist the suction pressure. The base flashing failure propagated and caused a large area of the roof membrane to lift and peel. Some of the wall covering on the stair tower was also blown away. Had the stair tower not existed, the built-up roof would likely not have been damaged. To avoid damage in the vicinity of building irregularities, attention needs to be given to the attachment of building elements located in turbulent flow areas.

**Figure 4-6:**  
The irregularity created by the stair tower (covered with a metal roof) caused turbulence resulting in wind speed-up and roof damage. Hurricane Andrew (Florida, 1992)

To avoid the roof membrane damage shown in Figure 4-6, it would be prudent to use corner uplift loads in lieu of perimeter uplift loads in the vicinity of the stair tower, as illustrated in Figure 4-7. Wind load increases due to building irregularities can be identified by wind tunnel studies; however, wind tunnel studies are rarely performed for hospitals. Therefore, identification of wind load increases due to building

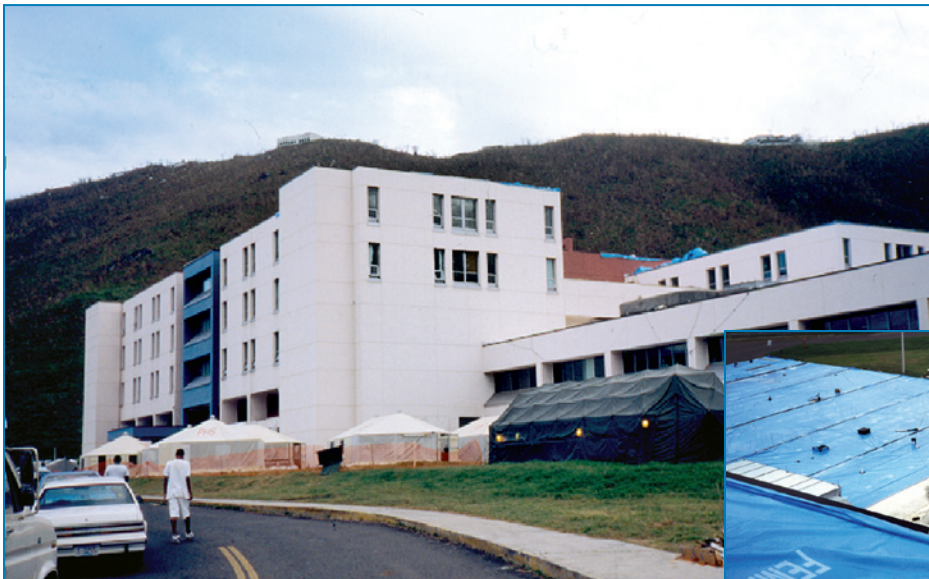
When damaged by wind, hospitals typically experience a variety of building component damage. For example, at the hospital shown in Figure 4-8, the roof covering was severely damaged, windows were broken, and rooftop equipment was blown away. The subsequent water infiltration required that most of the hospital be evacuated. The most common types of damage are discussed below in descending order of frequency.

**Figure 4-8:**  
Field military hospital in tents set up to replace evacuated hospital in U.S. Virgin Islands following Hurricane Marilyn (1995)

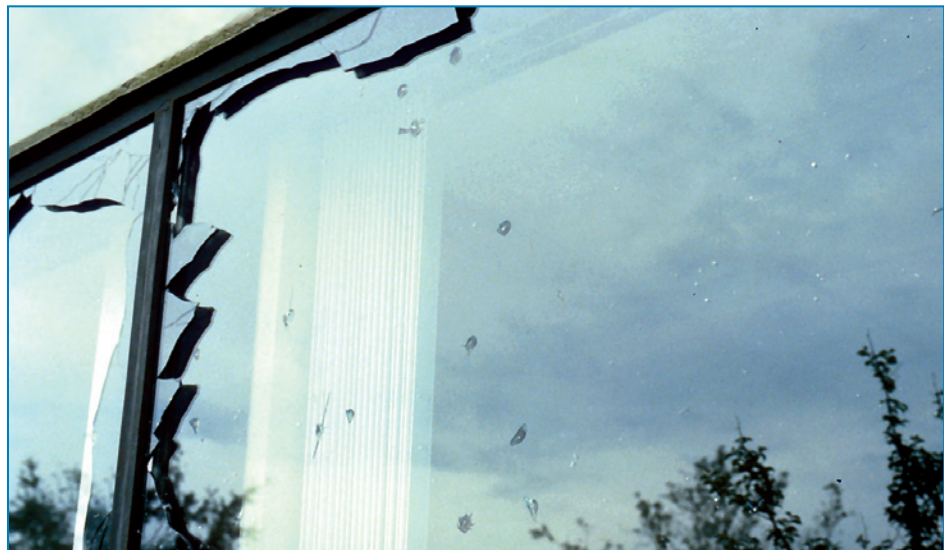
**Glazing:** Exterior glazing damage is very common during hurricanes and tornadoes, but is less common during other storms. The glass shown in Figure 4-10 was broken by the aggregate from a built-up roof. The inner panes had several impact craters. In several of the adjacent windows, both the outer and inner panes were broken. The aggregate flew more than 245 feet (the estimated wind speed was 104 mph, measured at 33 feet in Exposure C).

**Figure 4-10:**  
The outer window panes were broken by aggregate from a built-up roof. Hurricane Hugo (South Carolina, 1989)

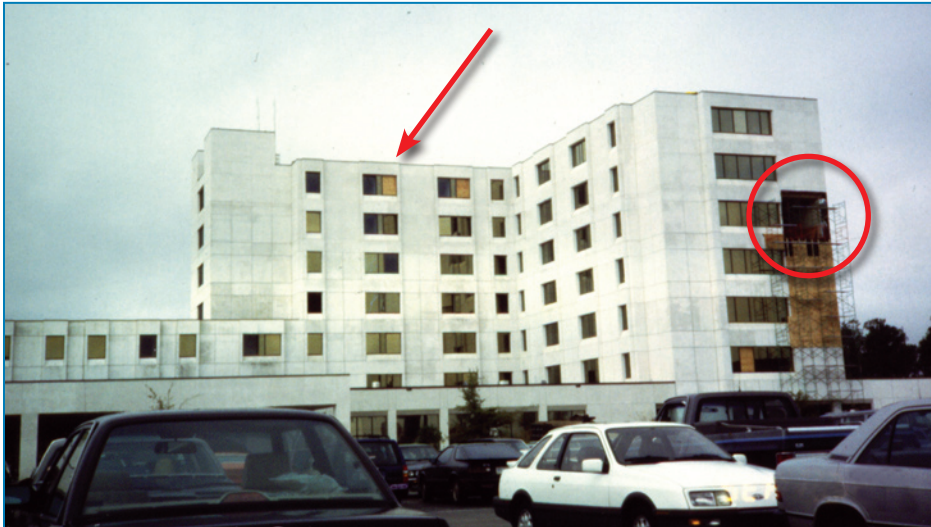
**Figure 4-11:** Collapse of non-load-bearing wall (red circle) and broken glazing from roof aggregate (red arrow). Hurricane Hugo (South Carolina, 1989)

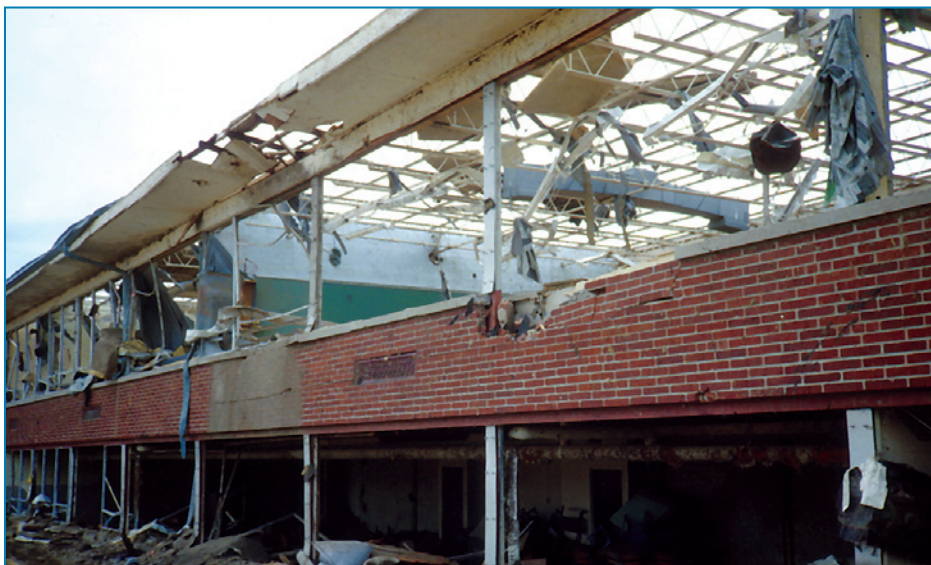
**Structural system:** Structural damage (e.g., roof deck blow-off, blow-off or collapse of the roof structure, collapse of exterior bearing walls, or collapse of the entire building or major portions thereof) is the principal type of damage that occurs during strong and violent tornadoes (see Figure 4-12)

**Figure 4-12:** This building in Northern Illinois was heavily damaged by a strong tornado in 1990.

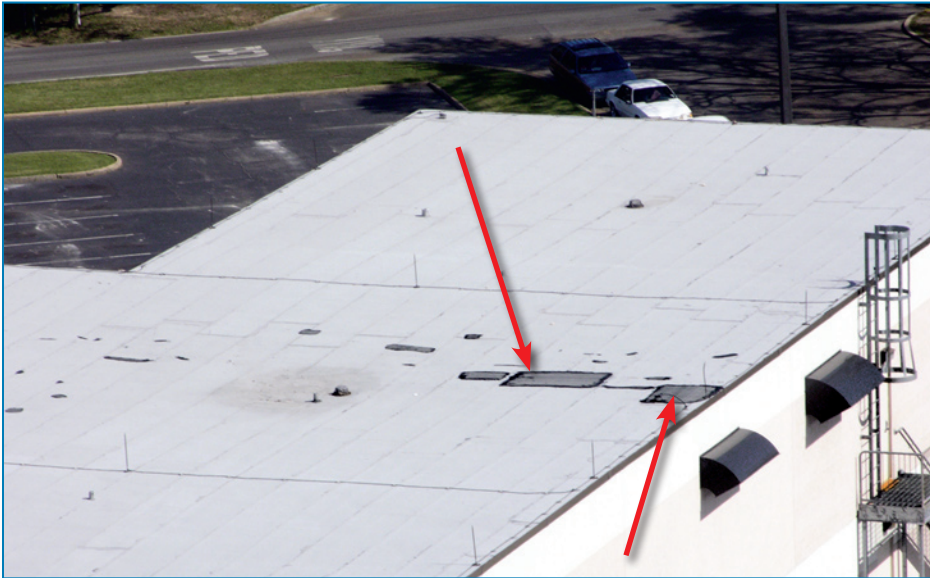
The West Florida Hospital (J on Figure 4-13) and several of the other buildings on the campus experienced a variety of damages during the storm. The roof membrane was punctured in several places by windborne missiles and by damaged rooftop equipment (see Figures 4-14 to 4-16).

**Figure 4-14:** Numerous repairs where the modified bitumen roof membrane was punctured by missiles. Water from the punctured membrane entered the surgical suite.

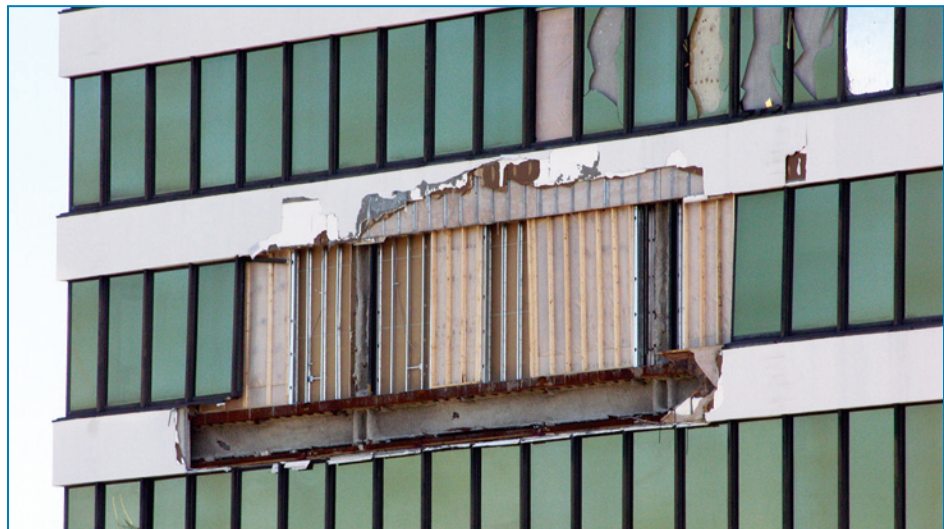
**Figure 4-17:**  
Broken windows in the MOB. Wood studs and gypsum board had been temporarily installed after the hurricane to prevent patients from inadvertently falling out of the MOB.

Exterior insulation finish system (EIFS) blew off the hospital and caused significant glass breakage in the MOB (Figure 4-17) and the walkway connecting the hospital to the MOB. Some of the lower-level windows may have been broken by wind-blown aggregate ballast from the roof over the dialysis unit and urgent care facility. In addition, some window frames

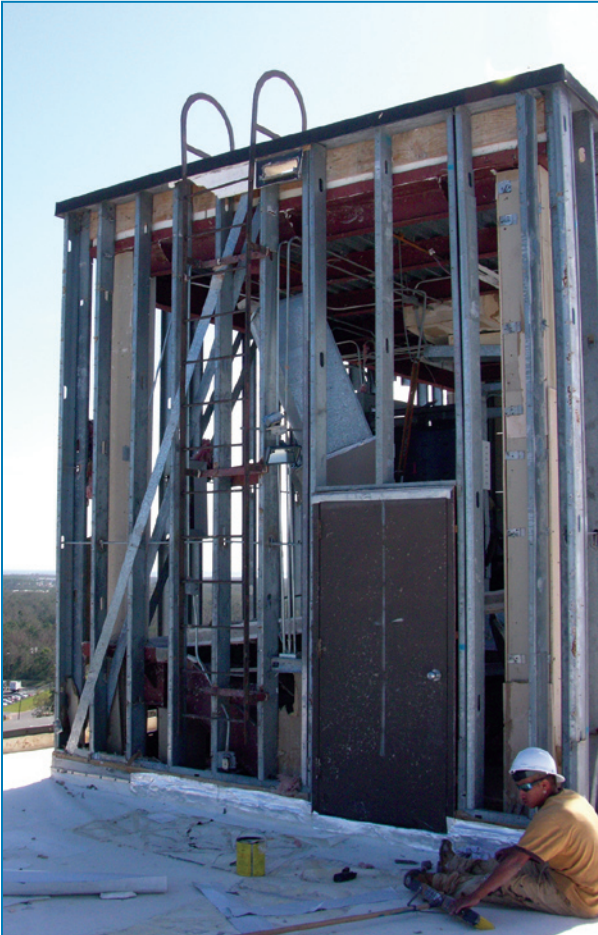
**Figure 4-22:** The only remaining portion of the exterior wall surrounding the elevator penthouse on the MOB was the steel studs.

With loss of the EIFS wall covering, wind-driven rain destroyed the elevator control equipment (see Figure 4-22). Water damage to the elevator control equipment resulted in failure of the MOB stair tower elevator. As a result, several people were trapped in the MOB stair tower elevator shown in Figure 4-18 during the hurricane. Fortunately, the MOB had another bank of elevators in the core of the building that was not damaged, so vertical transportation was still possible, although handicapped by the loss of the stair tower elevator. At the MOB stair tower, some of the gypsum board on the interior side of the studs collapsed into the stairway, thus trapping a maintenance worker who had gone to the mechanical penthouse during the hurricane.

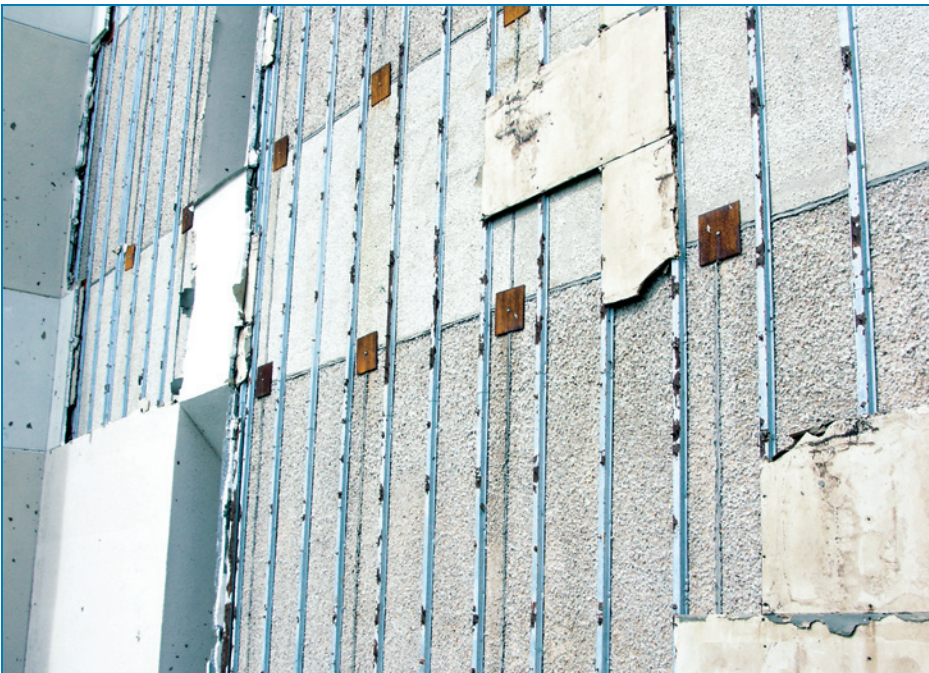
**Figure 4-23:** Close-up of the damaged EIFS at the hospital. In this area most of the insulation and gypsum board was blown from the steel furring channels.

The hospital originally had exposed concrete walls. However, in a subsequent refurbishing, the walls were faced with EIFS. Steel hat channels were installed over the concrete, followed by gypsum board, insulation, and synthetic stucco. In areas where the EIFS blew off, the gypsum board typically pulled over the screw heads and blew away (Figure 4-23). The screws and hat channels were moderately corroded. Although the corrosion could have eventually caused loss of the EIFS, it did not play a role in this failure.

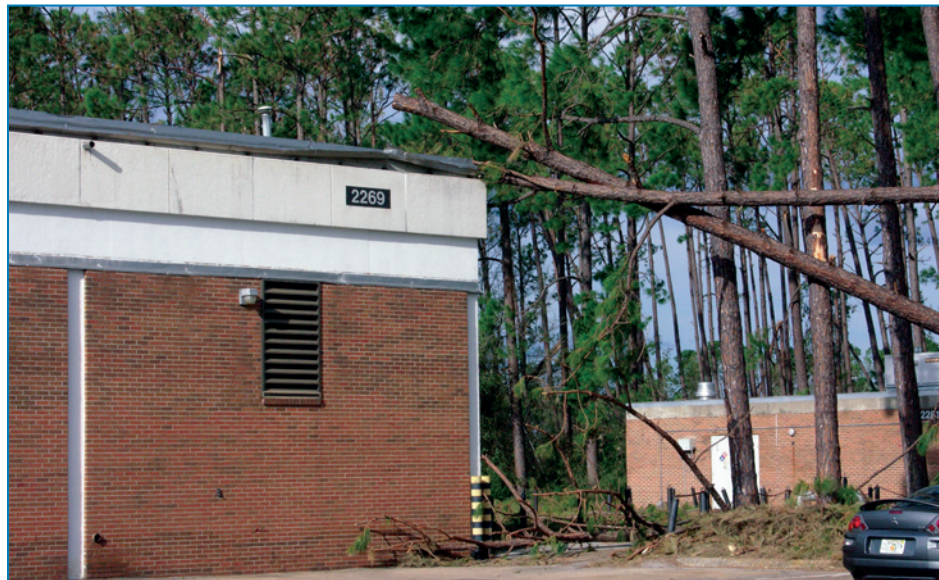
**Figure 4-24:**

The roof membrane on this hospital's materials management facility was ruptured by falling trees. Hurricane Ivan (Florida, 2004)

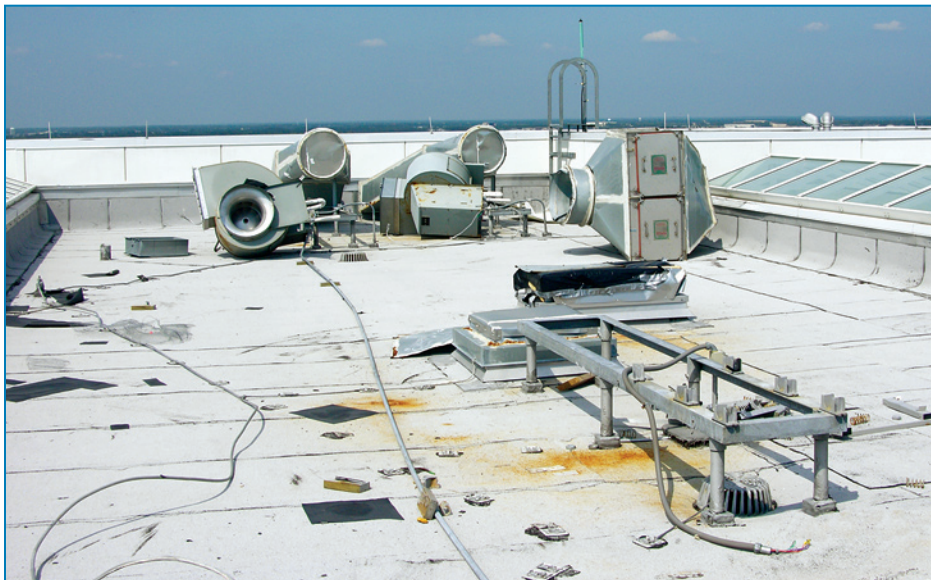
**Figure 4-25:** Temporary coverings placed over two large openings in the roof that were left after the ductwork blew away. Hurricane Katrina (Mississippi, 2005)

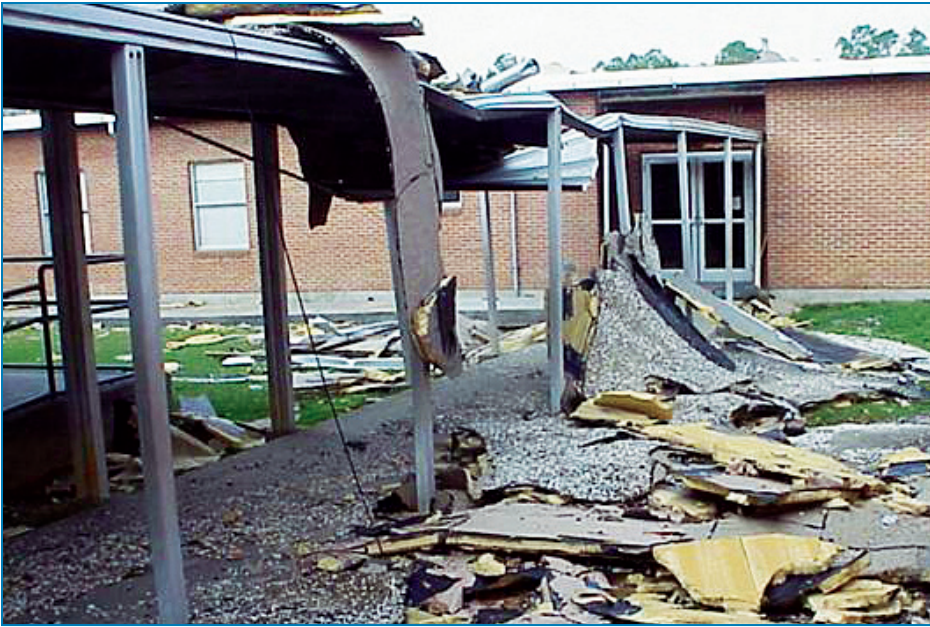
**Figure 4-27:**  
Open walkways do not provide protection from wind-borne debris. (Hurricane Katrina, Mississippi)

- In cases where multiple buildings are occupied during a storm, it is recommended that enclosed walkways be designed to connect the buildings. The enclosed walkways (above- or below-grade) are particularly important for protecting people moving between buildings during a hurricane (e.g., to retrieve equipment or supplies) or for situations when it is necessary to evacuate occupants from one building to another during a hurricane (see Figure 4-27).

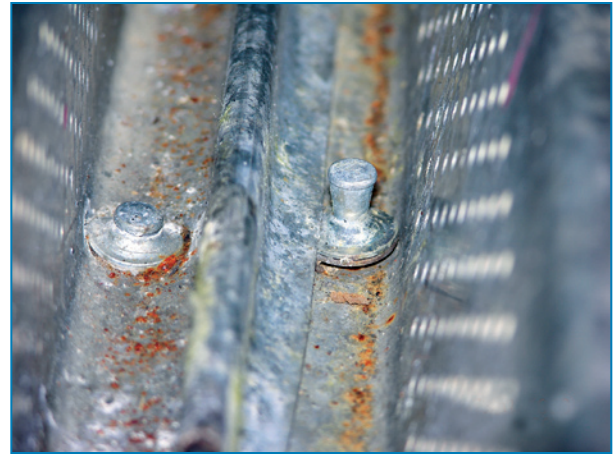
**Figure 4-30:**  
View looking along a sidelap of a deck attached with powder-driven pins. The right pin does not provide adequate uplift and shear resistance.
