# Design Guide

for Improving Hospital Safety  
in Earthquakes, Floods, and High Winds

*FEMA 577 / June 2007*

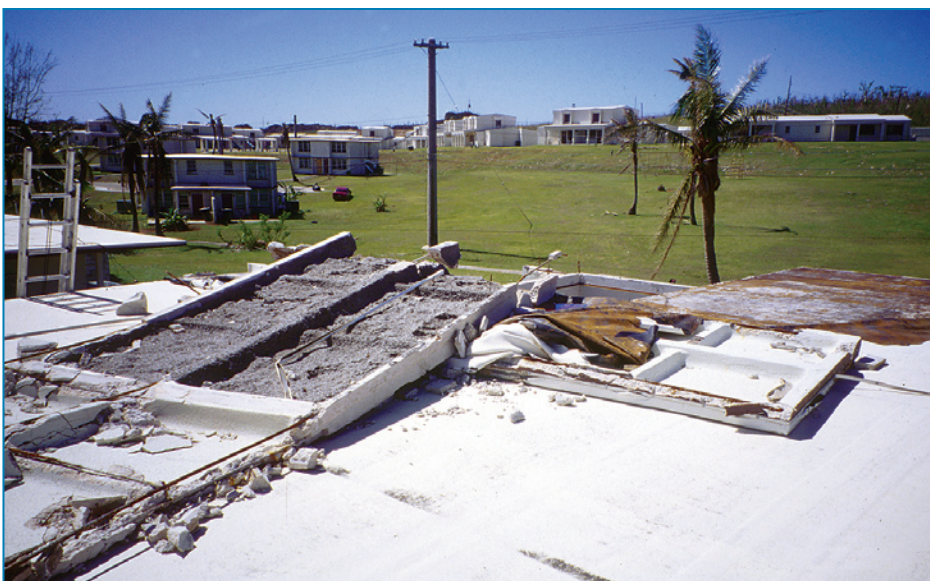
**Figure 4-31:**  
Portions of this waffled precast concrete roof deck were blown off. Typhoon Paka (Guam, 1997)

- For attaching wood-sheathed roof decks, screws, ring-shank, or screw-shank nails are recommended in the corner regions of the roof. Where the basic wind speed is greater than 90 mph, these types of fasteners are also recommended for the perimeter regions of the roof.
- For precast concrete decks it is recommended that the deck connections be designed to resist the design uplift loads because the deck dead load itself is often insufficient to resist the uplift. The deck in Figure 4-31 had bolts to provide uplift resistance; however, anchor plates and nuts had not been installed. Without the anchor plates, the dead load of the deck was insufficient to resist the wind uplift load.

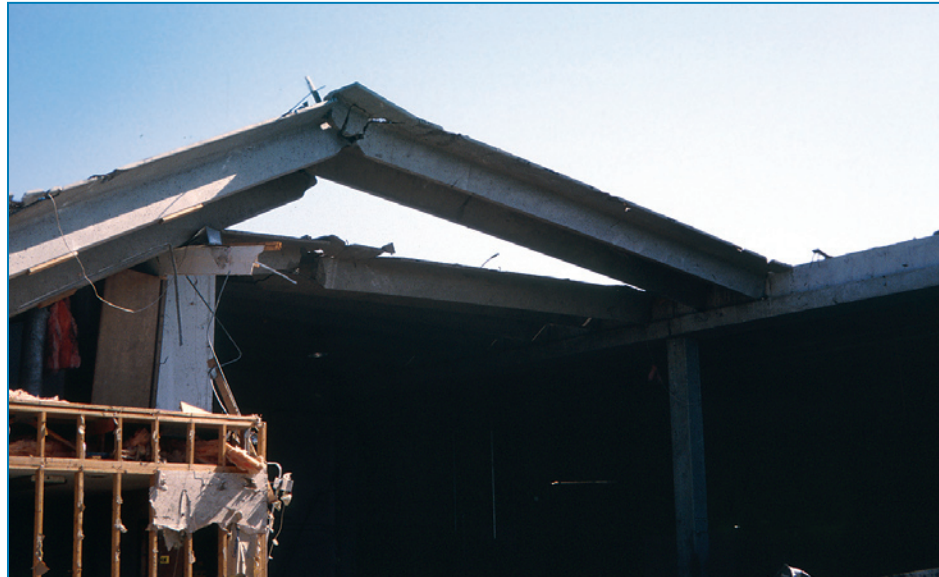
**Figure 4-32:**  
Twin-Tee roof panel lifted as a result of the combined effects of wind uplift and pre-tension. Tornado (Missouri, May 2003)

- For precast Tee decks, it is recommended that the reinforcing be designed to accommodate the uplift loads in addition to the gravity loads. Otherwise, large uplift forces can cause member failure due to the Tee's own pre-stress forces after the uplift load exceeds the dead load of the Tee. This type of failure occurred at one of the roof panels shown in Figure 4-32, where a panel lifted because of the combined effects of wind uplift and pre-tension. Also, because the connections between the roof and wall panels provided very little uplift load resistance, several other roof and wall panels collapsed.

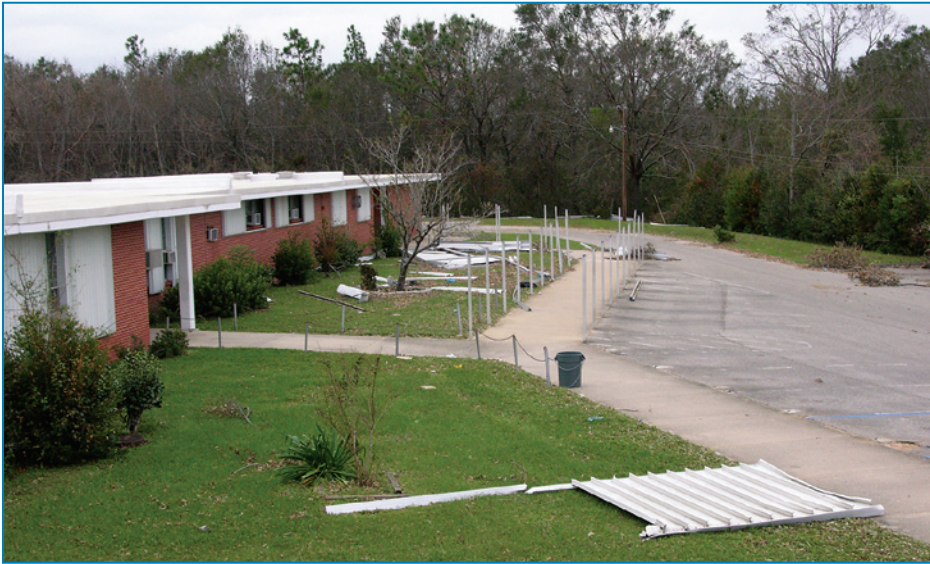
**Figure 4-33:**  
The destroyed walkway canopy in front of this building became wind-borne debris. Hurricane Ivan (Florida, 2004)

- Walkway and entrance canopies are often damaged during high winds (see Figure 4-33). Wind-borne debris from damaged canopies can damage nearby buildings and injure people, hence these elements should also receive design and construction attention.

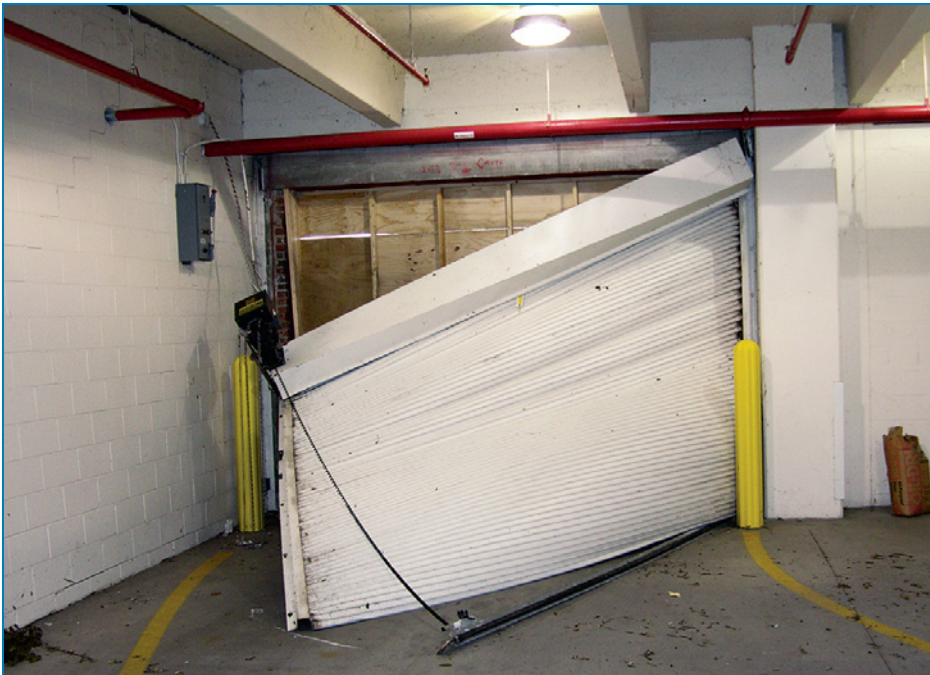
**Figure 4-35:**  
This new rolling door failed because the CMU spalled at the door frame's expansion bolts, which were too close to the end of the CMU. Hurricane Charley (Florida, 2004)

insufficient wind resistance, or by inadequate attachment of the tracks or nailers to the wall (see Figure 4-35).

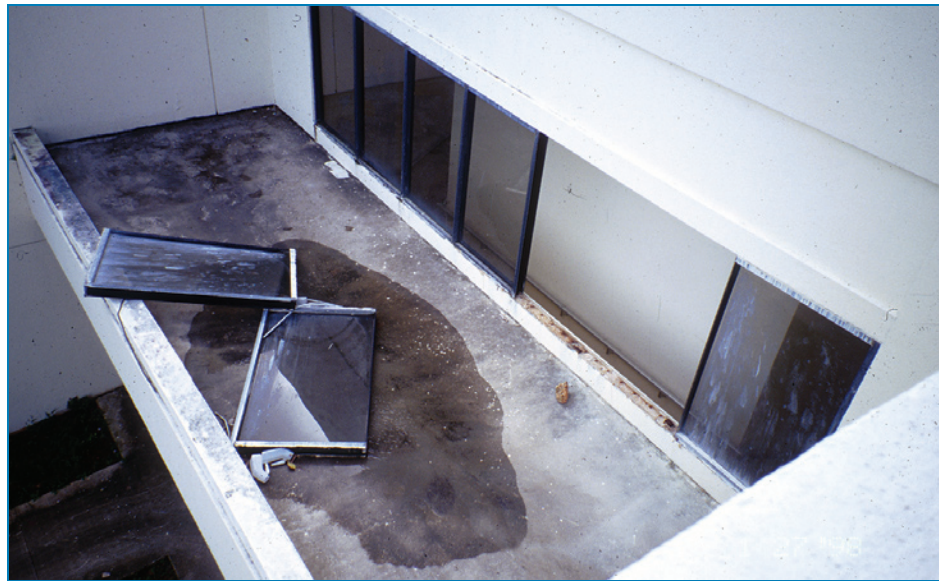
**Figure 4-43:**  
Two complete windows, including frames, blew out as a result of an inadequate number of fasteners. Typhoon Paka (Guam, 1997)

The IBC requires that windows, curtain walls, and skylight assemblies (i.e., the glazing, frame, and frame attachment to the wall or roof) have sufficient strength to resist the positive and negative design wind pressure (see Figure 4-43). Design professionals should specify that these assemblies comply with wind load testing in accordance with ASTM E 1233. It is important to specify an adequate load path and to check its continuity during submittal review.

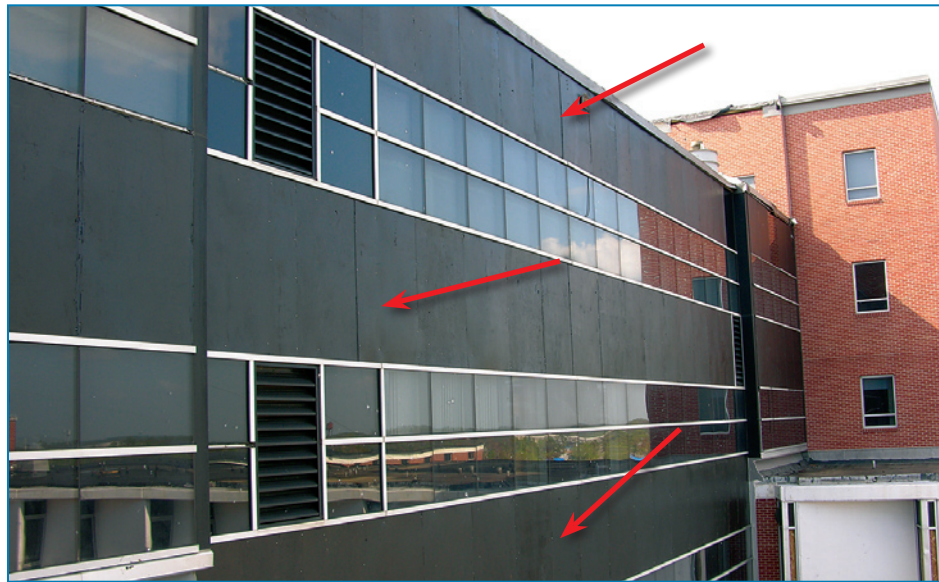
**Figure 4-46:**  
Plywood panels (black continuous bands) installed after the glass spandrel panels were broken by roof aggregate.<sup>9</sup> Hurricane Katrina (Mississippi, 2005)

Exterior glazing that is not impact-resistant (such as laminated glass or polycarbonate) or protected by shutters is extremely susceptible to breaking if struck by wind-borne debris. Even small, low-momentum missiles can easily break glazing that is not protected (see Figures 4-46 and 4-47). At the hospital shown in Figure 4-46, approximately 400 windows were broken. Most of the breakage was caused by wind-blown aggregate from the hospital's aggregate ballasted single-ply membrane roofs, and

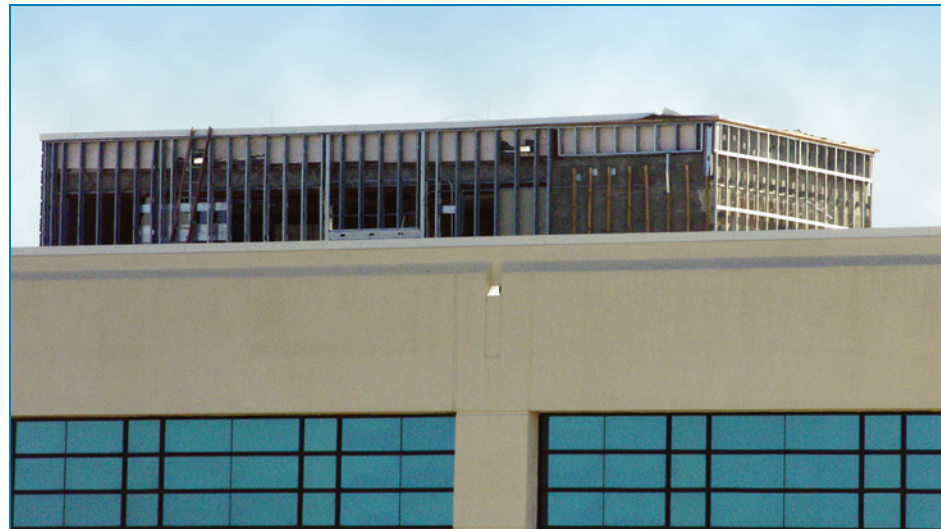
**Figure 4-48:**

The wall covering blew off the penthouse at this hospital complex, allowing rainwater to destroy the elevator controls. Hurricane Ivan (Florida, 2004)

To ensure the continuity of elevator service, elevator penthouse walls must possess adequate wind and water resistance. If the walls blow away or water leaks through the wall system, the elevator controls and/or motors can be destroyed. Loss of elevators may critically affect facility operations (see Figures 4-22 and 4-48). The restoration of elevator service can take weeks, even with expedited work.

**EIFS:** Figure 4-59 shows typical EIFS assemblies. Figure 4-48 and several figures in Section 4.2.1.3 show EIFS blow-off. In these cases, the molded expanded polystyrene (MEPS) was attached to gypsum board, which in turn was attached to metal studs or hat channels. The gypsum board detached from the studs/hat channels, which is a common EIFS failure mode. When the gypsum board on the exterior side of the studs is blown away, it is common for gypsum board on the interior side to also be blown off. The opening allows the building to become fully pressurized and allows the entrance of wind-driven rain. Other common types of failure include wall framing failure, separation of the MEPS from its substrate, and separation of the synthetic stucco from the MEPS.

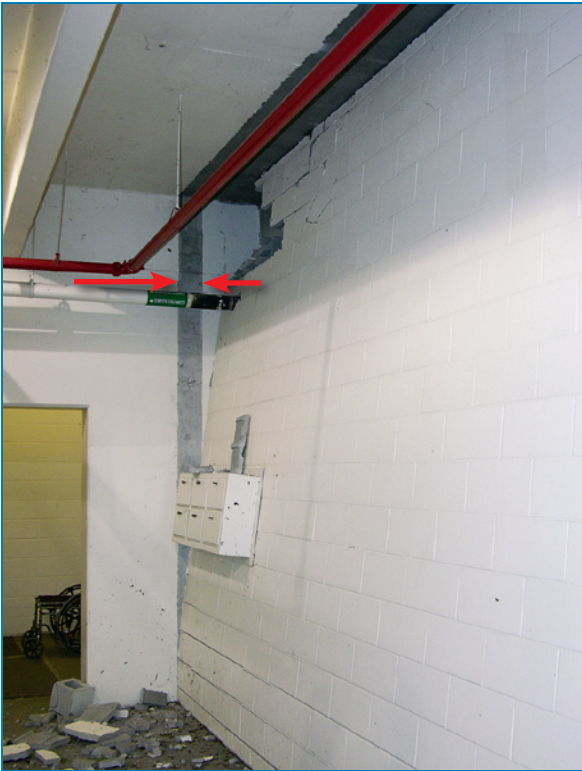
**Figure 4-51:**  
The red arrows show the original location of a CMU wall that nearly collapsed following a rolling door failure. Hurricane Charley (Florida, 2004)

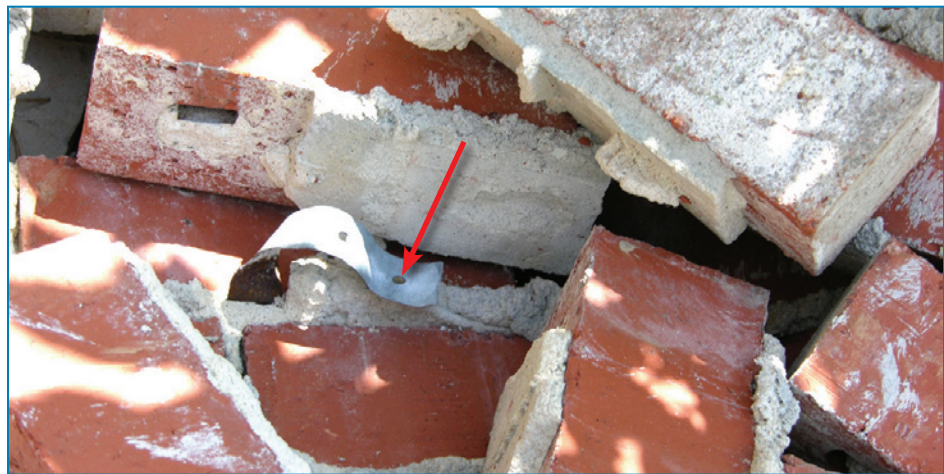
**Figure 4-52:**  
The brick veneer failure on this building was attributed to tie corrosion. Hurricane Ivan (Florida, 2004)

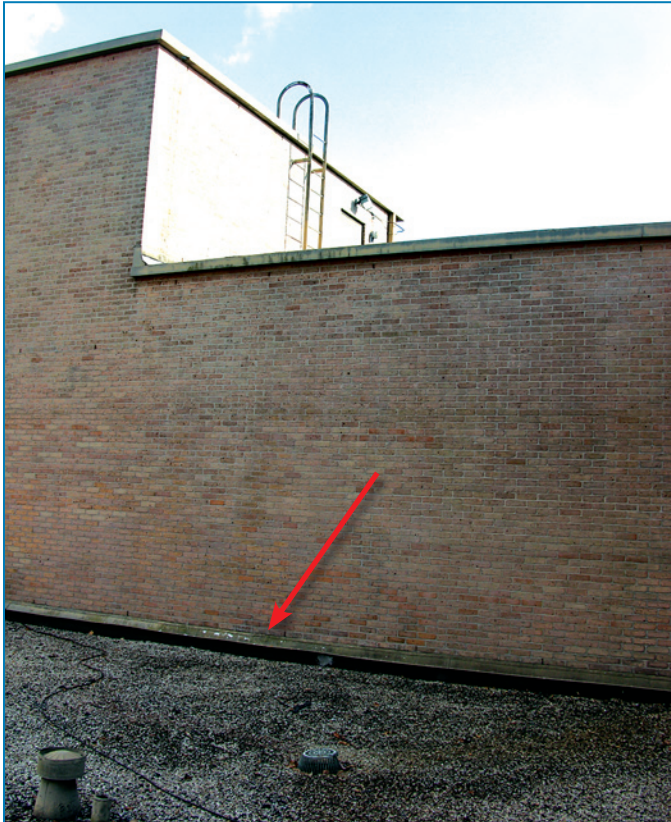
**Figure 4-58:** Water leaked inside along the base of the brick veneer walls (red arrow). Hurricane Katrina (Louisiana, 2005)

To avoid water leaking into the building, it is important that weep holes be adequately spaced and not be blocked during brick installation, and that through-wall flashings be properly designed and installed. When the base of the brick veneer occurs near grade, the grade should be designed so that it occurs several inches below the weeps so that drainage from the weeps is not impeded. Also, landscaping should be kept clear of weeps so that vegetation growth does not cause blockage of weeps. At the hospital shown in Figure 4-58, water leaked into the building along the base of many of the brick veneer walls. When high winds accompany heavy rain, a substantial amount of water can be blown into the wall cavity.

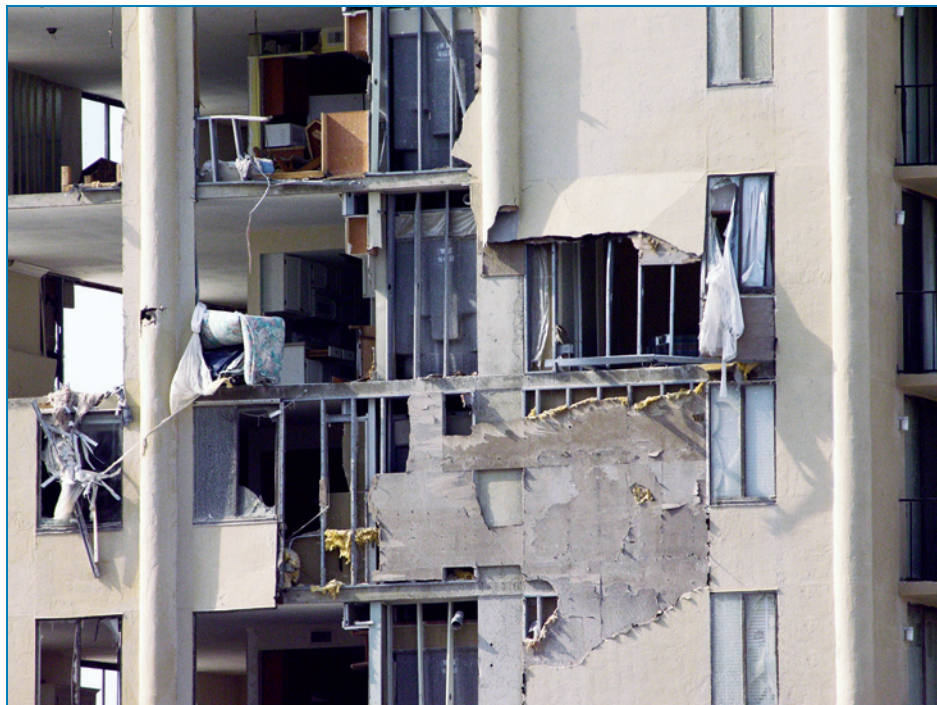
**Figure 4-61:**  
The stucco wall failure was caused by inadequate attachment between the stud tracks and the building's structure. Hurricane Ivan (Florida, 2004)

**Stucco over studs:** Wind performance of traditional stucco walls is similar to the performance of EIFS, as shown in Figure 4-61. In several areas the metal stud system failed; in other areas the gypsum sheathing blew off the studs; and in other areas, the metal lath blew off the gypsum sheathing. The failure shown in Figure 4-61 illustrates the importance of designing and constructing wall framing (including attachment of stud tracks to the building and attachment of the studs to the tracks) to resist the design wind loads.

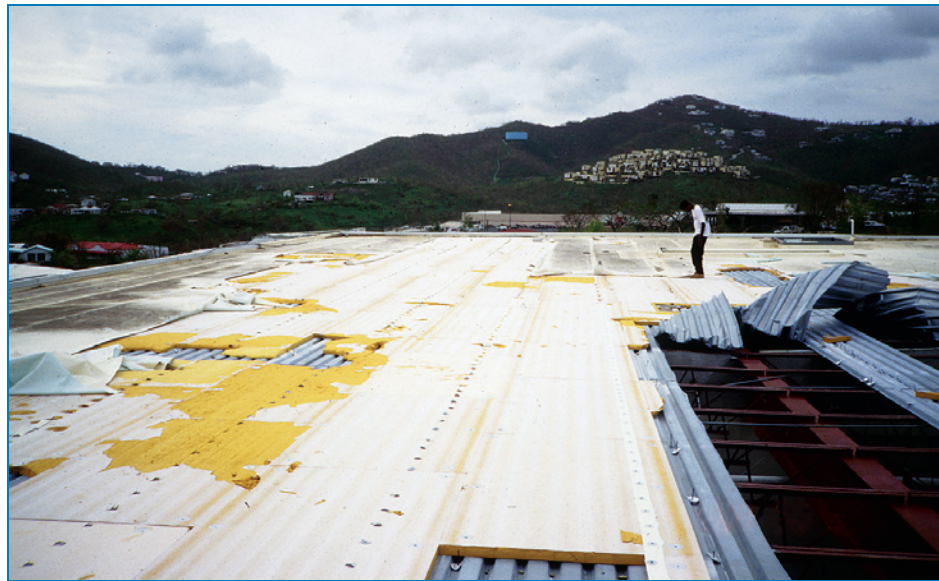
**Figure 4-63:**

The orientation of the membrane fastener rows led to blow-off of the steel deck. Hurricane Marilyn (U.S. Virgin Islands, 1995)

If a steel deck is selected, it is critical to specify that the membrane fasteners be attached in rows perpendicular to the steel flanges to avoid overstressing the attachment of the deck to the deck support structure. At the building shown in Figure 4-63, the fastener rows of the mechanically attached single-ply membrane ran parallel to the top flange of the steel deck. The deck fasteners were overstressed and a portion of the deck blew off and the membrane progressively tore. At another building, shown in Figure 4-64, the membrane fastener rows also ran parallel to the top flange of the steel deck. When membrane fasteners run parallel to the flange, the flange with membrane fasteners essentially carries the entire uplift load because of the deck's inability to transfer any significant load to adjacent flanges. Hence, at the joists shown in Figure 4-64, the deck fasteners on either side of the flange with the membrane fasteners are the only connections to the joist that are carrying substantial uplift load.

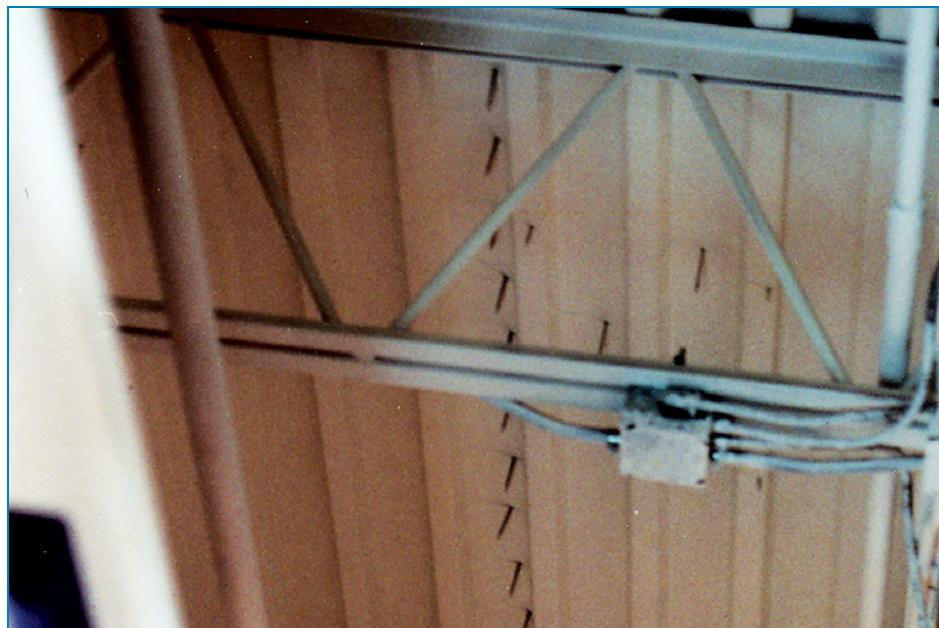
**Figure 4-64:**

View of the underside of a steel deck showing the mechanically attached single-ply membrane fastener rows running parallel to, instead of across, the top flange of the deck.

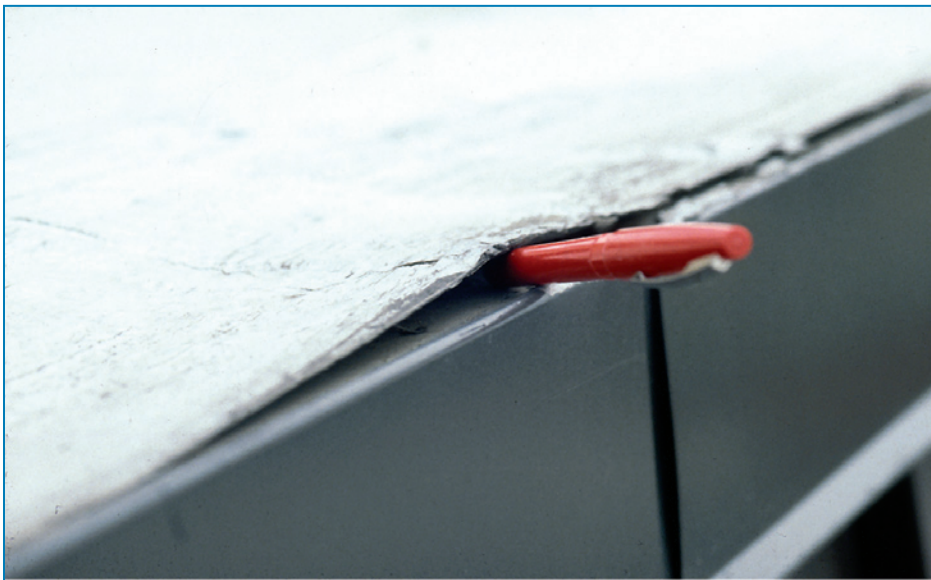
**Figure 4-65:**  
The ink pen shows an opening that the wind can catch, and cause lifting and peeling of the membrane.

Roof membrane blow-off is almost always a result of lifting and peeling of the metal edge flashing or coping, which serves to clamp down the membrane at the roof edge. Therefore, it is important for the design professional to carefully consider the design of metal edge flashings, copings, and the nailers to which they are attached. The metal edge flashing on the modified bitumen membrane roof shown in Figure 4-65 was installed underneath the membrane, rather than on top of it, and then stripped in. In this location, the edge flashing was unable to clamp the membrane down. At one area, the membrane was not sealed to the flashing. An ink pen was inserted into the opening prior to photographing to demonstrate how wind could catch the opening and lift and peel the membrane.

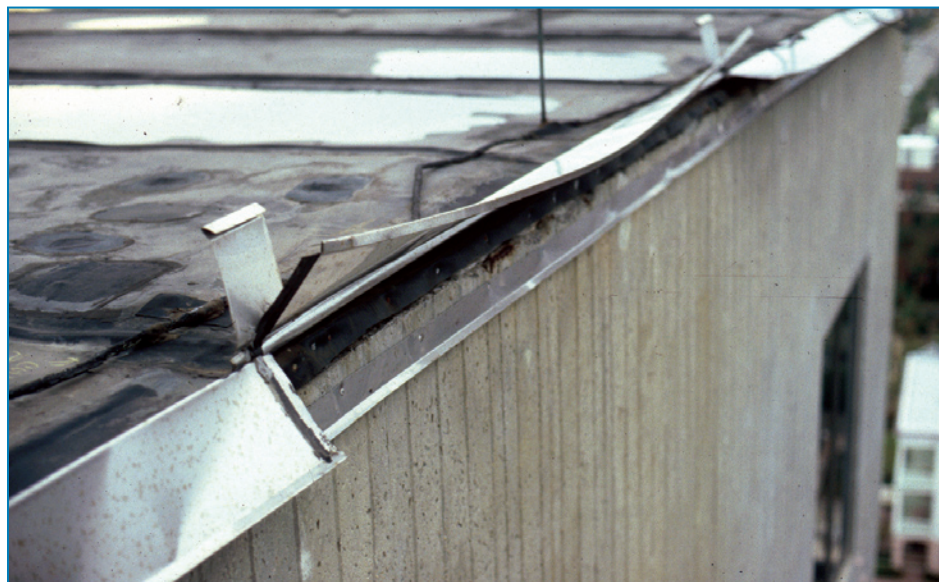
**Figure 4-66:**  
The metal edge flashing on this hospital disengaged from the continuous cleat and the vertical flange lifted. Hurricane Hugo (South Carolina, 1989)

The traditional edge flashing/coping attachment method relies on concealed cleats that can deform under wind load and lead to disengagement of the flashing/coping (see Figure 4-66) and subsequent lifting and peeling of the roof membrane. When a vertical flange disengages and lifts up, the edge flashing and membrane are very susceptible to failure. Normally, when a flange lifts the failure continues to propagate and the metal edge flashing and roof membrane blows off.

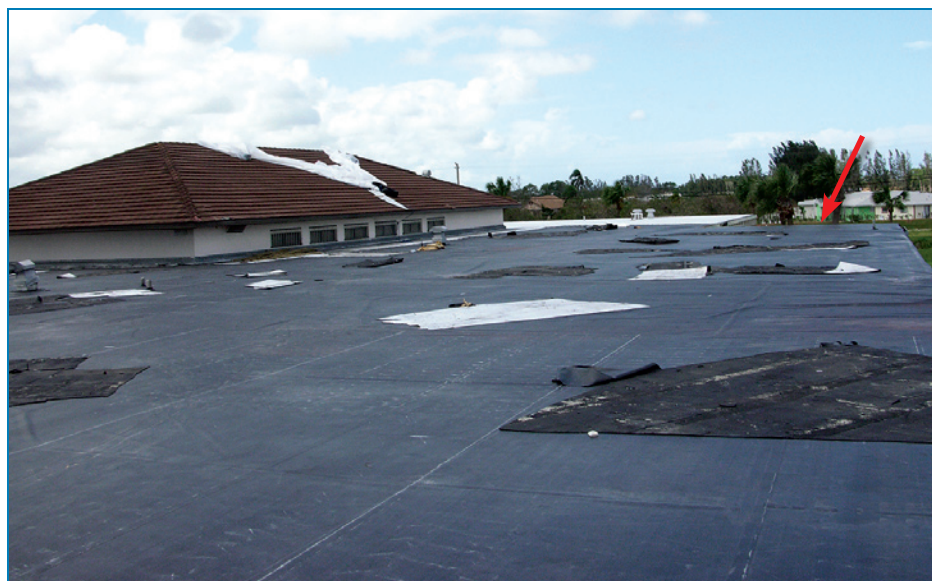
**Figure 4-69:**  
The original modified bitumen membrane was blown away after the gutter lifted in the area shown by the red arrow (the black membrane is a temporary roof). Hurricane Francis (Florida, 2004)

Storm-damage research has shown that gutters are seldom constructed to resist wind loads (see Figure 4-68). When a gutter lifts, it typically causes the edge flashing that laps into the gutter to lift as well. Frequently, this results in a progressive lifting and peeling of the roof membrane. The membrane blow-off shown in Figure 4-69 was initiated by gutter uplift. The gutter was similar to that shown in Figure 4-68. The membrane blow-off caused significant interior water damage.

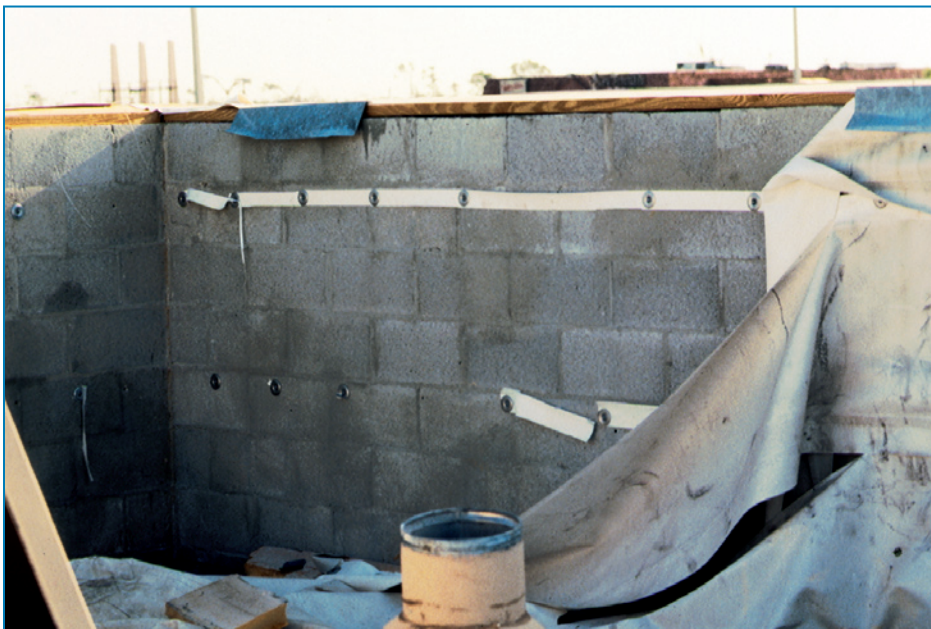
**Figure 4-70:** If mechanically attached base flashings have an insufficient number of fasteners, the base flashing can be blown away. Hurricane Andrew (Florida, 1992)

Information on loads for parapet base flashings was first introduced in the 2002 edition of ASCE 7. The loads on base flashings are greater than the loads on the roof covering if the parapet's exterior side is air-permeable. When base flashing is fully adhered, it has sufficient wind resistance in most cases. However, when base flashing is mechanically fastened, typical fastening patterns may be inadequate, depending on design wind conditions (see Figure 4-70). Therefore, it is imperative that the base flashing loads be calculated, and attachments designed to accommodate these loads. It is also important for designers to specify the attachment spacing in parapet corner regions to differentiate them from the regions between corners.

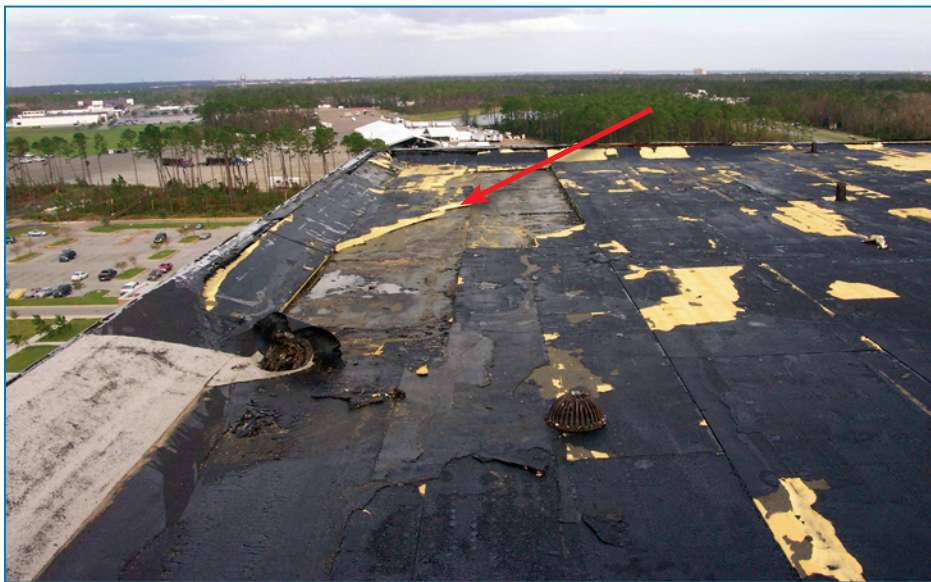
**Figure 4-71:** The blown off insulation (red arrow) may have initiated blow off of the roof membrane. Hurricane Ivan (Florida, 2004)

When fully adhering insulation boards, it is recommended that the boards be no larger than 4 feet by 4 feet. It is also recommended that the board thickness not exceed 2 inches ( 1½ inches is preferable). Use of small thin boards makes it easier for the contractor to conform the boards to the substrate. At the hospital shown in Figure 4-71, 4 foot by 8 foot insulation boards were set in hot asphalt over a concrete deck. A few of the boards detached from the deck. The boards may have initiated the membrane blow off, or the membrane blow off may have been initiated by lifting and peeling of the metal edge flashing, in which case, loss of the insulation boards was a secondary failure.

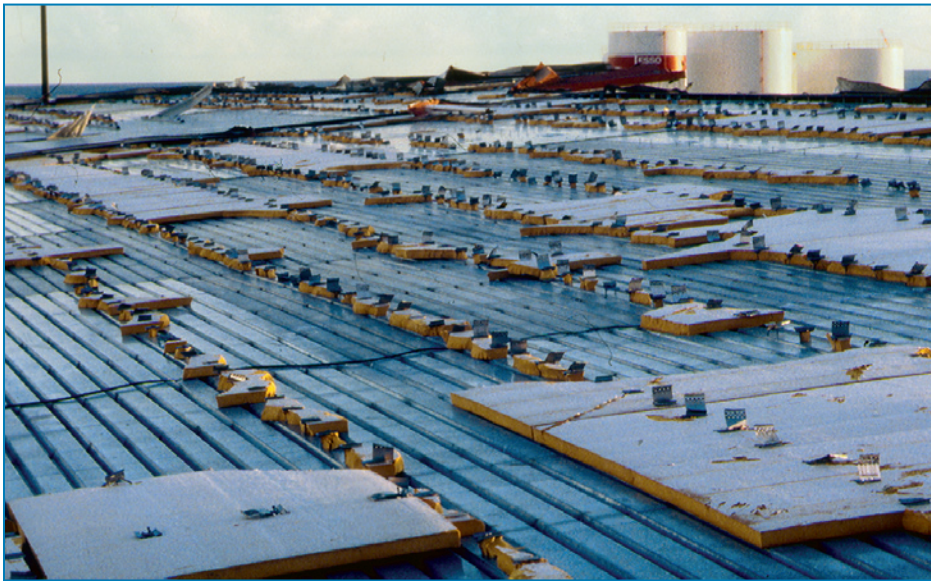
**Figure 4-73:** Significant interior water damage and facility interruption occurred after the standing seam roof blew off. Hurricane Marilyn (U.S. Virgin Islands, 1995)

If the metal panels are blown off or punctured during a hurricane, the secondary membrane should provide watertight protection unless the roof is hit with missiles of very high momentum. At the roof shown in Figure 4-73, the structural standing seam panel clips bore on rigid insulation over a steel deck. Had a secondary membrane been installed over the steel deck, the membrane would have likely prevented significant interior water damage and facility disruption.

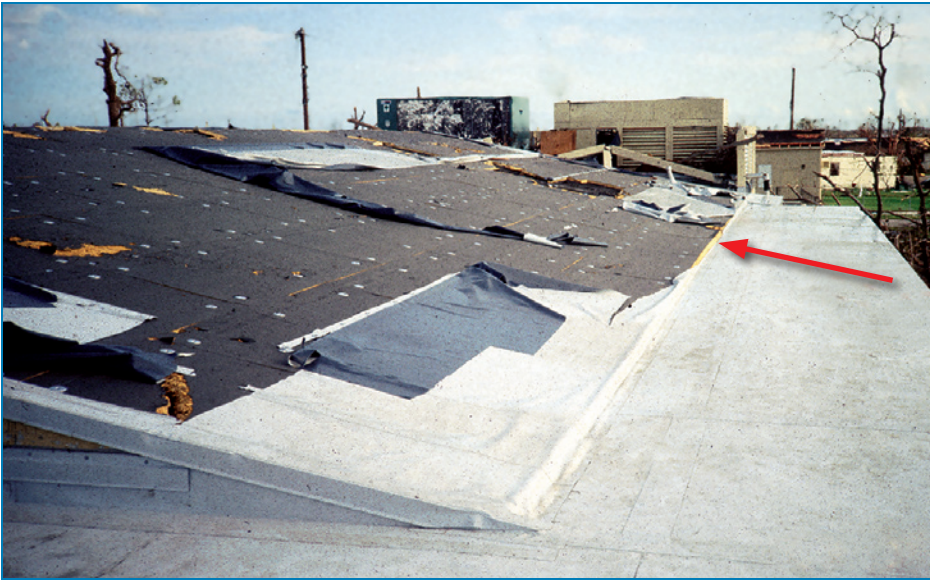
**Figure 4-75:** Mechanically attached single-ply membrane progressively tore after being cut by wind-borne debris. Hurricane Andrew (Florida, 1992)

Mechanically attached and air-pressure equalized single-ply membrane systems are susceptible to massive progressive failure after missile impact, and are therefore not recommended for hospitals in hurricane-prone regions. At the building shown in Figure 4-75, a missile struck the fully adhered low-sloped roof and slid into the steep-sloped reinforced mechanically attached single-ply membrane in the vicinity of the red arrow. A large area of the mechanically attached membrane was blown away as a result of progressive membrane tearing. Fully adhered single-ply membranes are very vulnerable to missile puncture and are not recommended unless they are ballasted with pavers. At the hospital shown in Figure 4-76, several missiles, including exhaust fans and copings struck the roof.

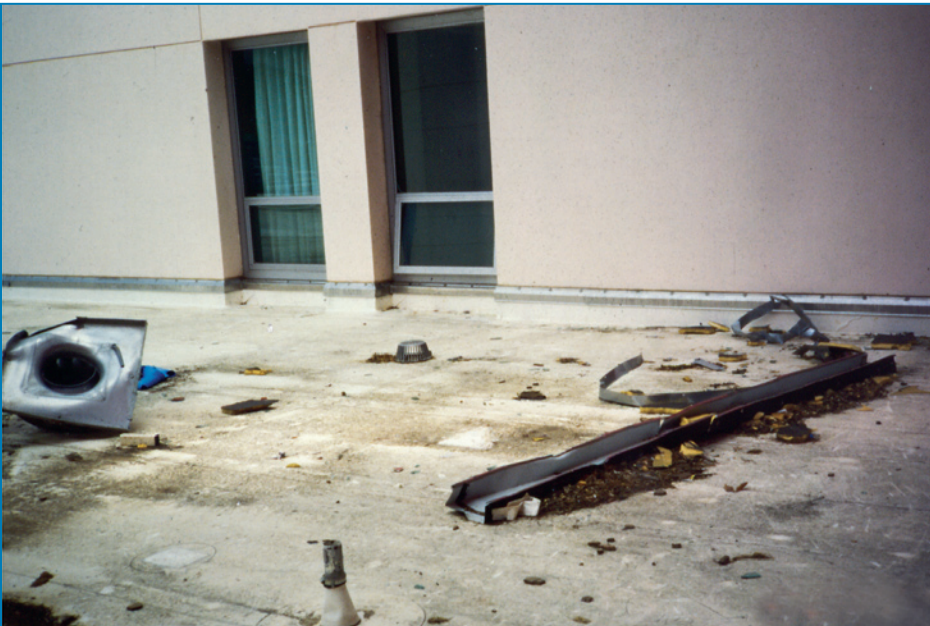
**Figure 4-76:** This fully adhered single-ply roof membrane was struck by a variety of missiles. Hurricane Marilyn (U.S. Virgin Islands, 1995)

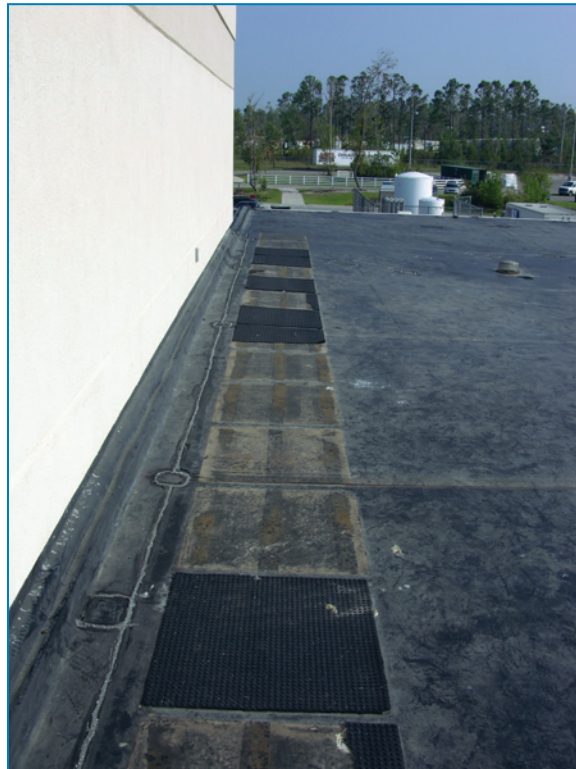
**Figure 4-78:**

Several rubber walkway pads were blown off the single-ply membrane roof on this hospital. Hurricane Katrina (Mississippi, 2005)

**Walkway pads:** Roof walkway pads are frequently blown off during hurricanes (Figures 4-78 and 4-82). Pad blow-off does not usually damage the roof membrane. However, wind-borne pad debris can damage other building components and injure people. Currently there is no test standard to evaluate uplift resistance of walkway pads. Walkway pads are therefore not recommended in hurricane-prone regions.

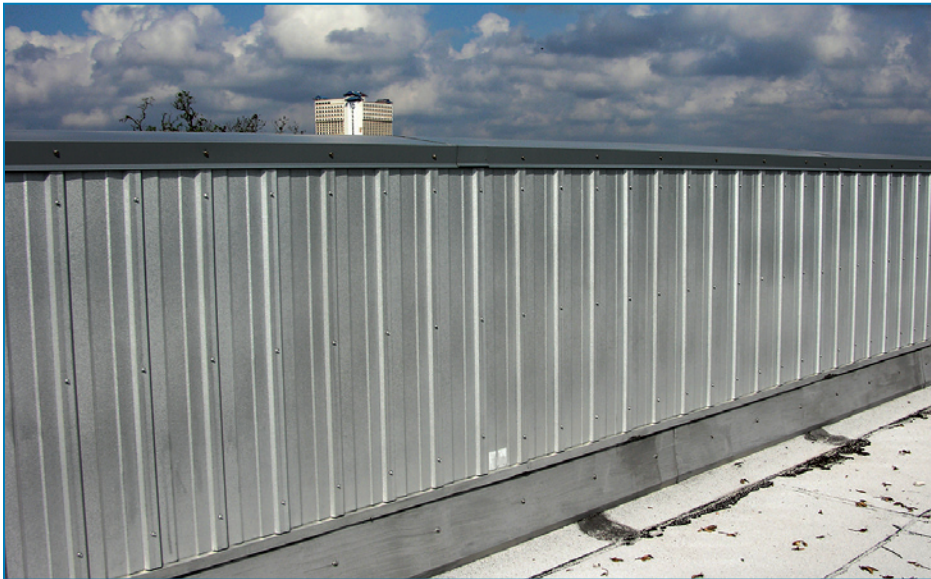
**Figure 4-79:**  
Base flashing protected by metal panels attached with exposed screws. Hurricane Katrina (Mississippi, 2005)

- For a PMR, it is recommended that pavers weighing a minimum of 22 psf be specified. In addition, base flashings should be protected with metal (such as shown in Figure 4-79) to provide debris protection. Parapets with a 3-foot minimum height (or higher if so indicated by ANSI/SPRI RP-4, 2002) are recommended at roof edges. This manual recommends that PMRs not be used for hospitals in hurricane-prone regions where the basic wind speed exceeds 130 mph.

If the roof has a parapet, it is recommended that the inside of the parapet be properly prepared to receive the new base flashing. In many instances, it is prudent to re-skin the parapet with sheathing to provide a suitable substrate. Base flashing should not be applied directly to brick parapets because they have irregular surfaces that inhibit good bonding of the base flashing to the brick (see Figure 4-120). Also, if moisture drives into the wall from the exterior side of the parapet with base flashing attached directly to brick, the base flashing can inhibit drying of the wall. Therefore, rather than totally sealing the parapet with membrane base flashing, the upper portion of the brick can be protected by metal panels (as shown in Figure 4-79), which permit drying of the brick.

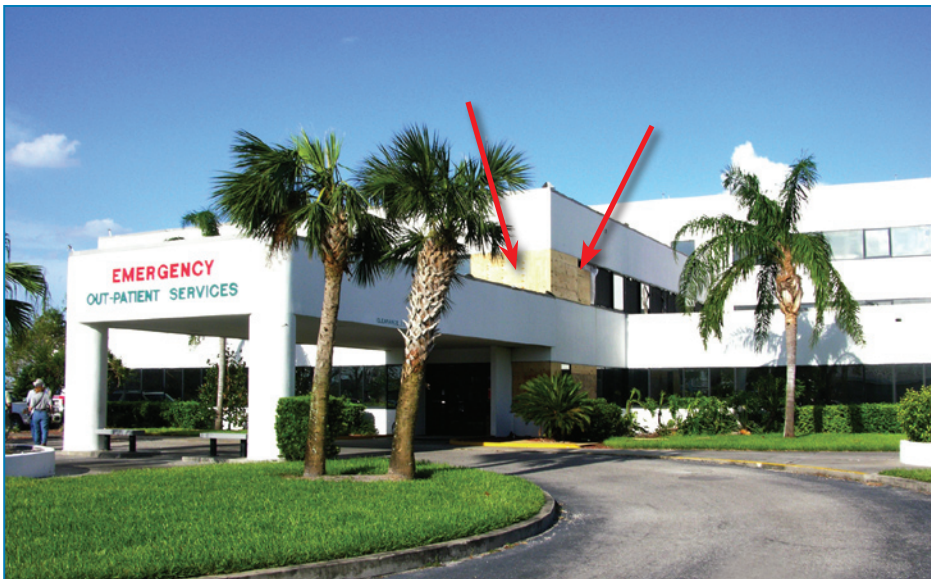
**Figure 4-80:**  
The second floor beyond the canopy houses the ICU. Several windows along the two ICU walls that are visible were broken.

The hospital sustained damage to windows, rooftop equipment, and a freestanding storage building on the campus. Thirty-three windows were broken, including patient room windows and windows at three of the eight ICU rooms (Figures 4-80 and 4-81). Windows were also broken in many vehicles in the parking lot. The majority of the glass breakage was caused by aggregate blown from the hospital built-up roofs. Some of the glass breakage may have been due to blown-off gutters and walkway pads from the hospital's roof (Figure 4-82) or other missiles such as tree limbs; blown off gutters can be high-momentum missiles that can travel a substantial distance (see Figure 4-81).

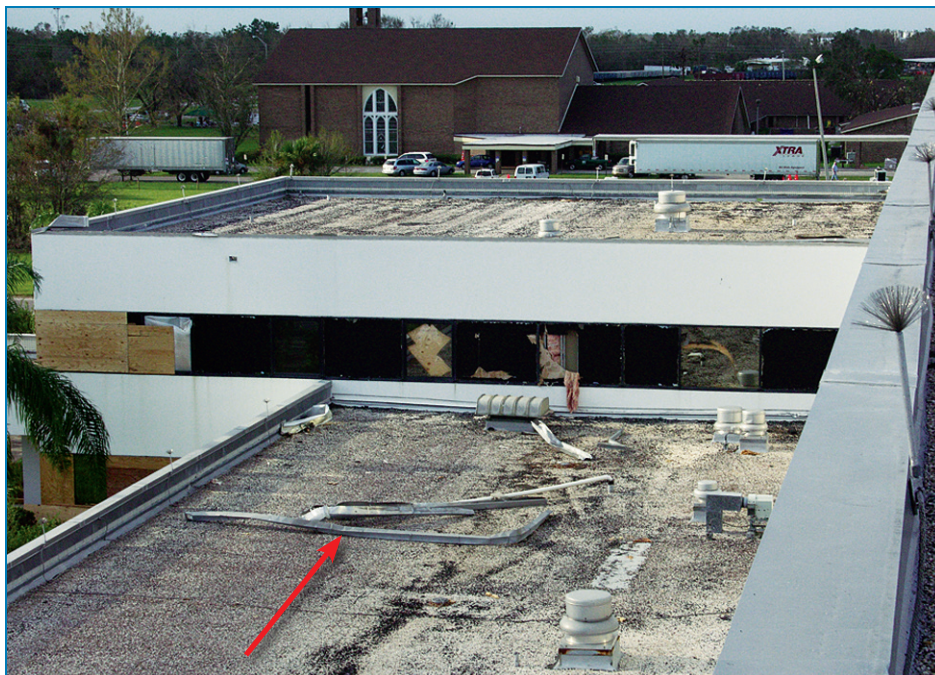
**Figure 4-81:**  
A view of the ICU  
from the third floor  
roof. The gutters (red  
arrow) are from the  
back side of the third  
floor roof.

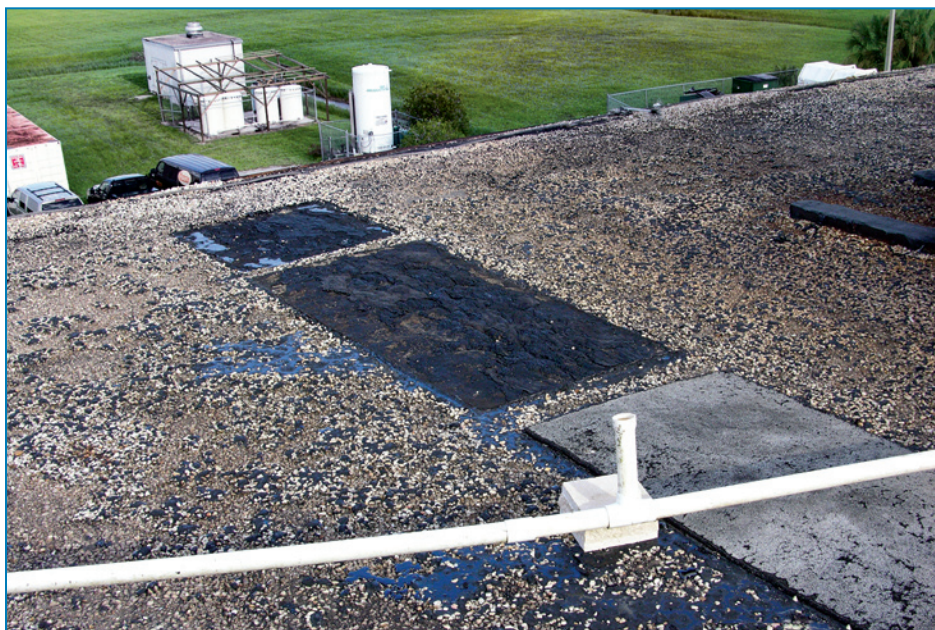
**Figure 4-82:**  
View of the back  
side of the third  
floor roof where the  
gutter and an asphalt  
plank walkway pad  
were blown away.  
The loose aggregate  
surfacing was also  
blown away.

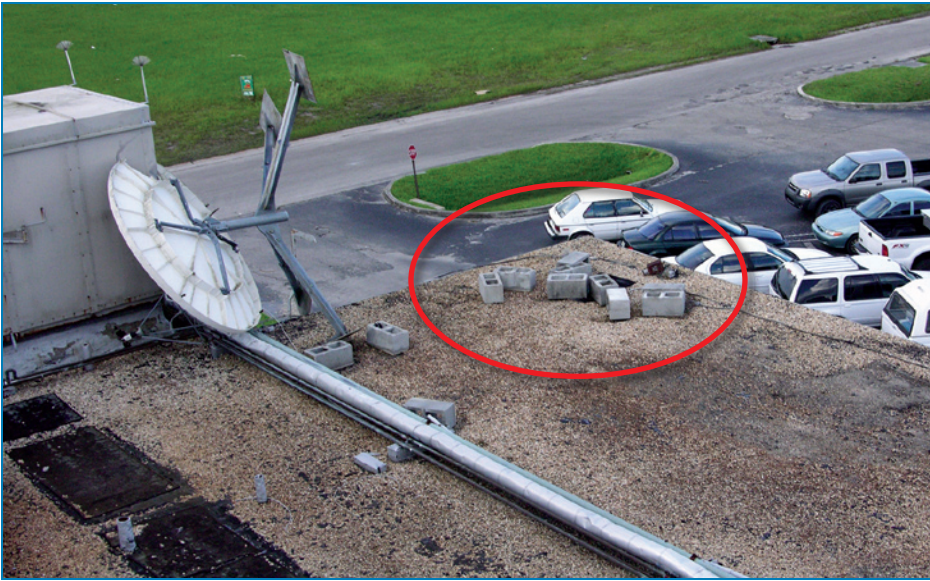
**Figure 4-83:**  
This satellite dish was held down only with CMU. Note the displaced LPS at the corner (circled).

A portion of the roof covering was blown off and the satellite dish was nearly blown off too. The LPS was displaced in a few areas (see Figure 4-83). As a result of the damage to the roof covering and to rooftop equipment, water leaked into the building in several areas, which caused the closing of the operating room (OR), sterile processing, portions of the lab, and numerous offices. The OR was temporarily relocated to the Caesarian section (C-section) room. It was about a month before the OR was repaired and reoccupied.

**Satellite dishes:** For the satellite dish shown in Figure 4-96, the dish mast was anchored to a large metal pan that rested on the roof membrane. CMU was placed on the pan to provide overturning resistance. This anchorage method should only be used where calculations demonstrate that it provides sufficient resistance. In this case the wind approached the satellite dish in such a way that it experienced very little wind pressure. In hurricane-prone regions, use of this anchorage method is not recommended (see Figures 4-83 and 4-97).

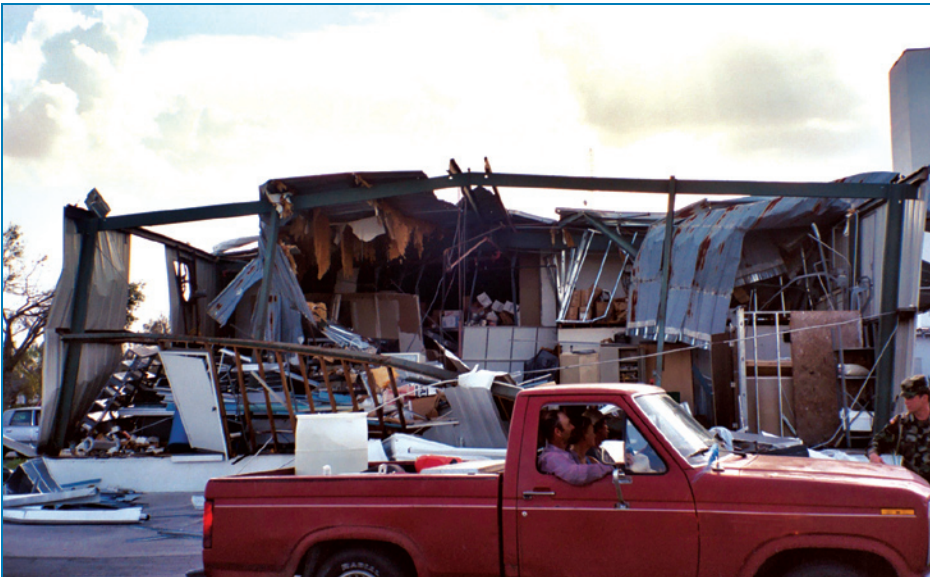
**Figure 4-84:**  
This pre-engineered storage building contained the hospital supplies and maintenance shop.

The metal storage building that contained the hospital's supplies, maintenance shop, environmental services, and shipping and receiving collapsed, and its loss was significant for the hospital operations. Almost all of the tools and stock materials for repairs were lost (Figure 4-84). Tents were set up after the hurricane to provide storage. Because of subsequent storms in the next several weeks (including two hurricanes), the stored items had to be moved in and out of the tents on several occasions.

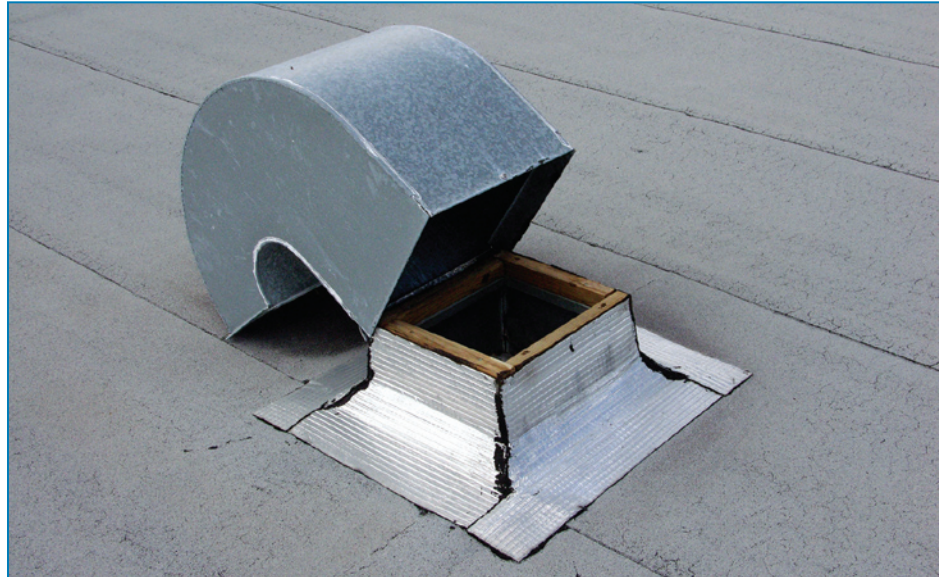
**Figure 4-85:**

This gooseneck was attached with only two small screws. A substantial amount of water was able to enter the building during Hurricane Francis. (Florida, 2004)

enter the facility where equipment was displaced (see Figure 4-85). The most common problems typically relate to inadequate equipment anchorage, inadequate strength of the equipment itself, and corrosion.

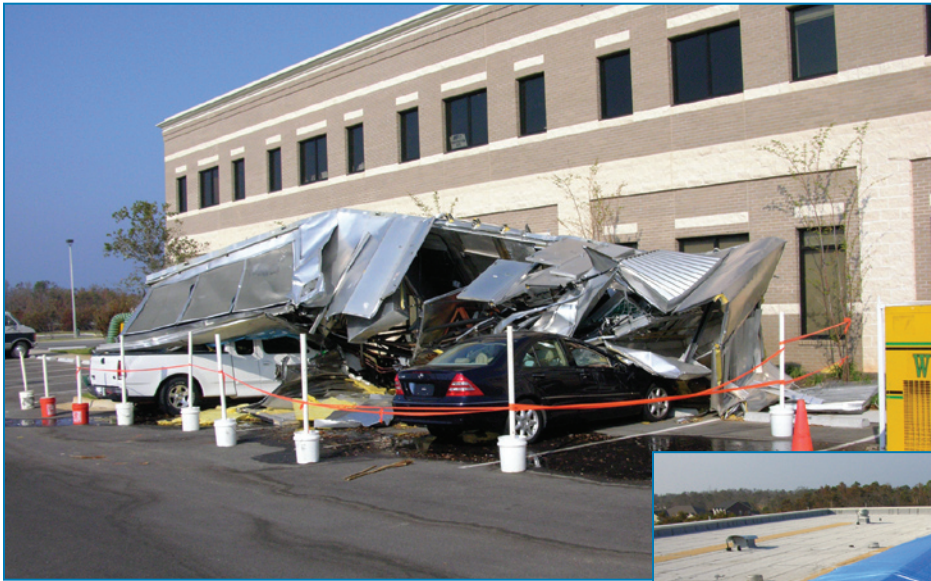
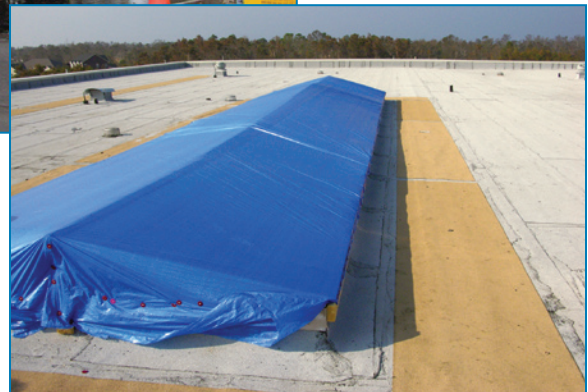
**Figure 4-86:** Although this 18,000-pound HVAC unit was attached to its curb with 16 straps, it blew off during Hurricane Ivan. (Florida, 2004)

to resist the design wind load. The 30' x 10' x 8' 18,000-pound HVAC unit shown in Figure 4-86 was attached to its curb with 16 straps (one screw per strap). Although the wind speeds were estimated to be only 85 to 95 miles per hour (peak gust), the HVAC unit blew off the medical office building. The inset at Figure 4-86 shows the curb upon which the unit was attached. A substantial amount of water entered the building at the curb openings before the temporary tarp was placed.
