# Design Guide

for Improving Hospital Safety  
in Earthquakes, Floods, and High Winds

*FEMA 577 / June 2007*

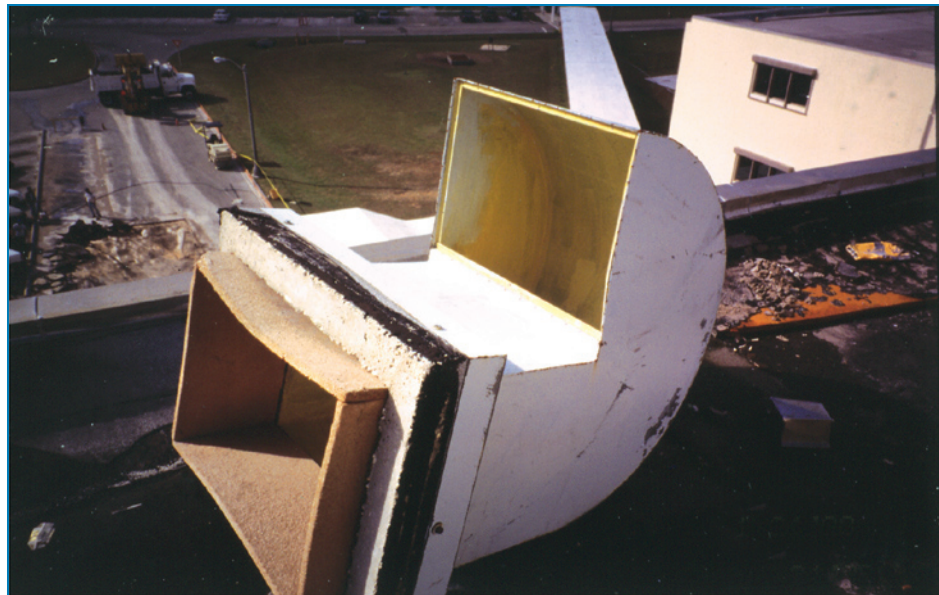
**Figure 4-87:**

The gooseneck on this hospital remained attached to the curb, but the curb detached from the deck. Typhoon Paka (Guam, 1997)

To anchor fans, small HVAC units, and relief air hoods, the minimum attachment schedule provided in Table 4-1 is recommended. The attachment of the curb to the roof deck also needs to be designed and constructed to resist the design loads. The cast-in-place concrete curb shown in Figure 4-87 was cold-cast over a concrete roof deck. Dowels were not installed between the deck and the curb, hence a weak connection occurred.

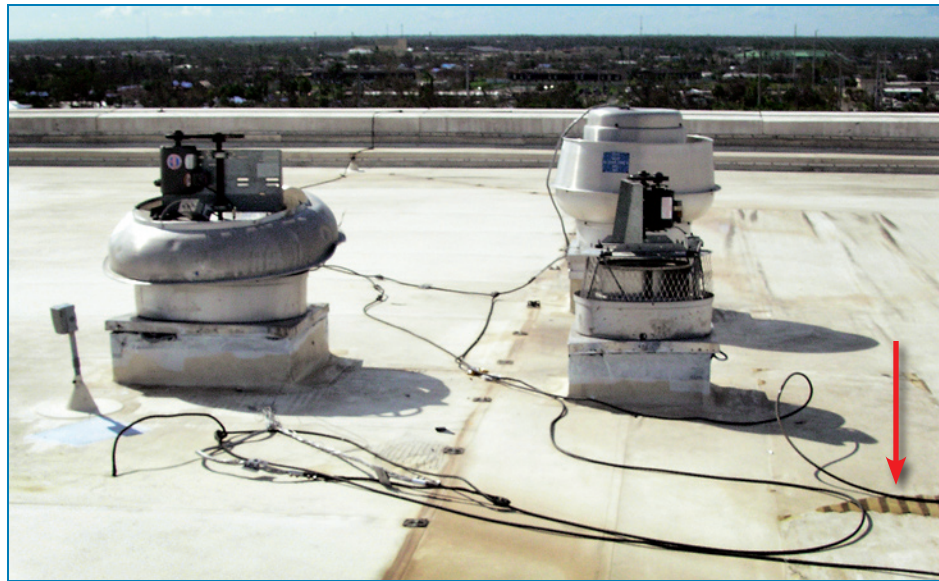
**Figure 4-88:**

Cowlings blew off two of the three fans. Note also the loose lightning protection system conductors and missing walkway pad (red arrow). Hurricane Charley (Florida, 2004)

**Fan cowling attachment:** Fans are frequently blown off their curbs because they are poorly attached. When fans are well attached, the cowlings frequently blow off (see Figure 4-88). Blown off cowlings can tear roof membranes and break glazing. Unless the fan manufacturer specifically engineered the cowling attachment to resist the design wind load, cable tie-downs (see Figure 4-89) are recommended to avoid cowling blow-off. For fan cowlings less than 4 feet in diameter, 1/2-inch diameter stainless steel cables are recommended. For larger cowlings, use 3/16-inch diameter cables. When the basic wind speed is 120 mph or less, specify two cables. Where the basic wind speed is greater than 120 mph, specify four cables. To minimize leakage potential at the anchor point, it is recommended that the cables be adequately anchored to the equipment curb (rather than anchored to the roof deck). The attachment of the curb itself also needs to be designed and specified.

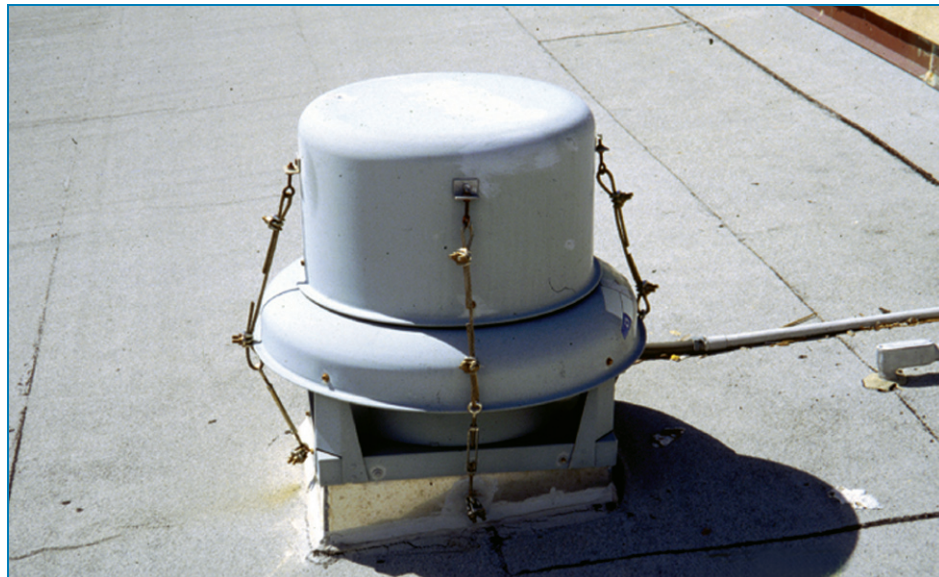
**Figure 4-89:**

Cables were attached to prevent the cowling from blowing off. Typhoon Paka (Guam, 1997)

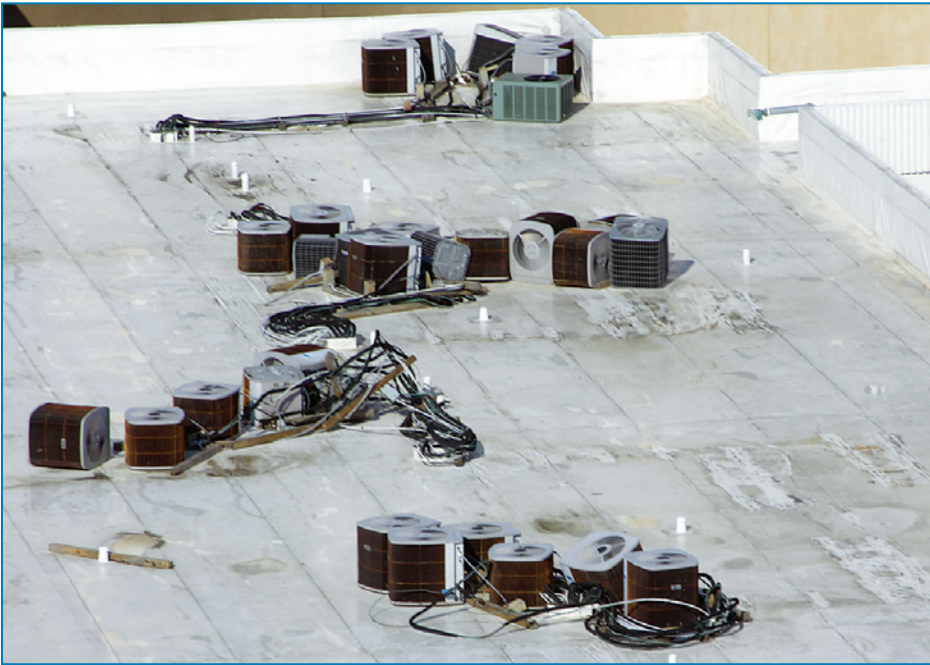
**Figure 4-90:**  
Sleeper-mounted  
condensers displaced  
by high winds.  
Hurricane Katrina  
(Mississippi, 2005)

**Condenser attachment:** In lieu of placing rooftop-mounted condensers on wood sleepers resting on the roof (see Figure 4-90), it is recommended that condensers be anchored to equipment stands. The attachment of the stand to the roof deck also needs to be designed to resist the design loads. In addition to anchoring the base of the condenser to the stand, two

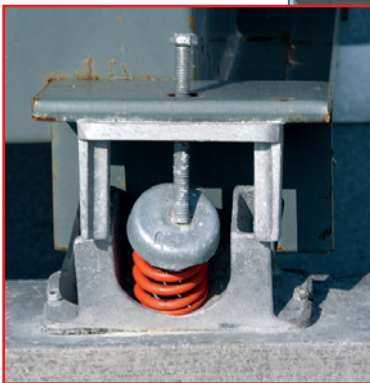
**Figure 4-92:** Failure of vibration isolators that provided lateral resistance but no uplift resistance caused equipment damage. A damaged vibration isolator is shown in the inset. Hurricane Katrina (Mississippi, 2005)

**Vibration isolators:** If vibration isolators are used to mount equipment, only those able to resist design uplift loads should be specified and installed, or an alternative means to accommodate uplift resistance should be provided (see Figure 4-92).

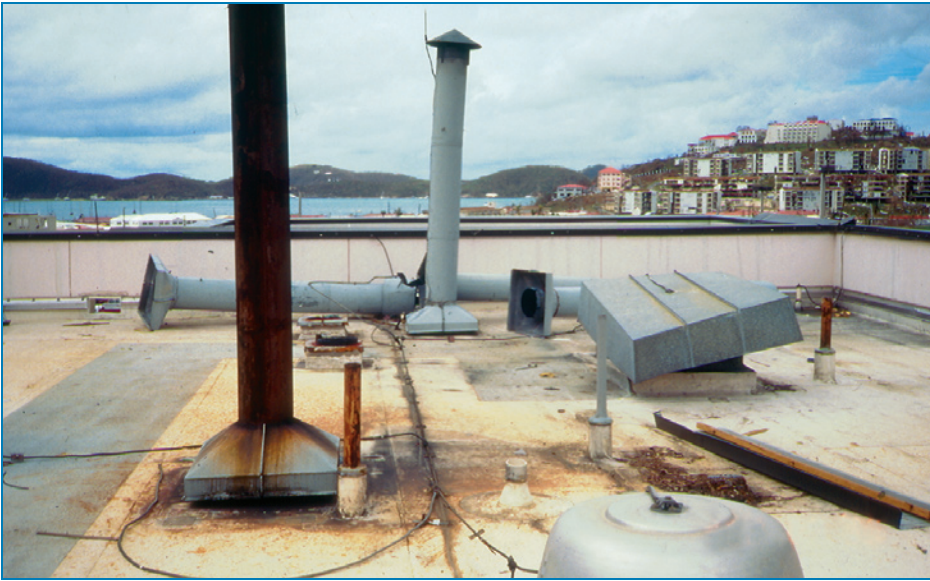
**Figure 4-93:** Three of the five stacks that did not have guy-wires were blown down. Hurricane Marilyn (U.S. Virgin Islands, 1995)

**Boiler and exhaust stack attachment:** To avoid wind damage to boiler and exhaust stacks, wind loads on stacks should be calculated and guy-wires should be designed and constructed to resist the loads. Topped stacks, as shown at the hospital in Figure 4-93, can allow water to enter the building at the stack penetration, damage the roof membrane, and become wind-borne debris. The designer should advise the building owner that guy-wires should be inspected annually to ensure they are taut.

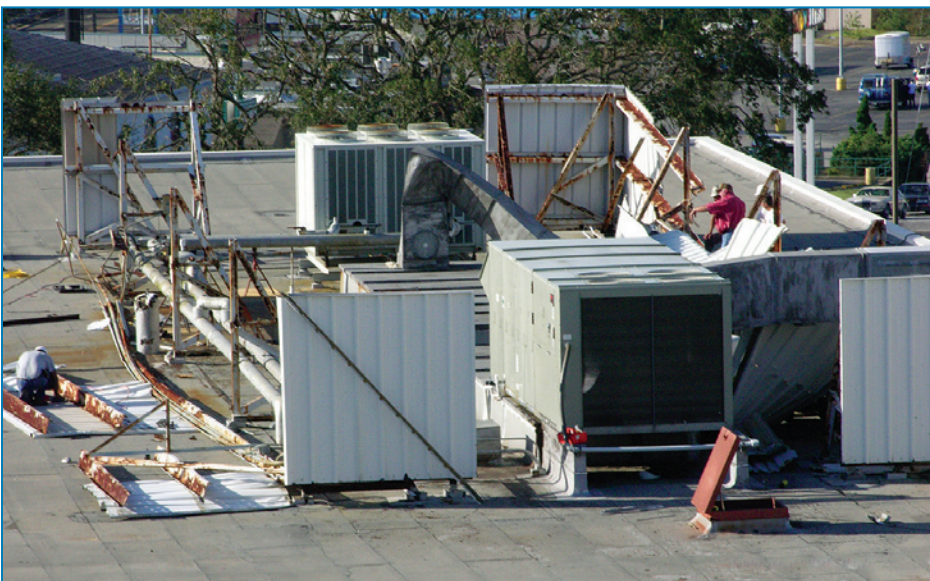
**Figure 4-94:** Equipment screen panels, such as these blown away at a hospital, can break glazing, puncture roof membranes, and cause injury. Hurricane Ivan (Florida, 2004)

**Equipment screens:** Screens around rooftop equipment are frequently blown away (see Figure 4-94). Screens should be designed to resist the wind load derived from ASCE 7. Since the effect of screens on equipment wind loads is unknown, the equipment attachment behind the screens should be designed to resist the design load.

**Mechanical Penthouses:** By placing equipment in mechanical penthouses rather than leaving them exposed on the roof, equipment can be shielded from high-wind loads and wind-borne debris. Although screens (such as shown in Figure 4-94) could be designed and constructed to protect equipment from horizontally-flying debris, they are not effective in protecting equipment from missiles that have an angular trajectory. It is therefore recommended that mechanical equipment be placed inside mechanical penthouses. The penthouse itself should be designed and constructed in accordance with the recommendations given in Sections 4.3.2.1, 4.3.3.6, and 4.3.3.8.

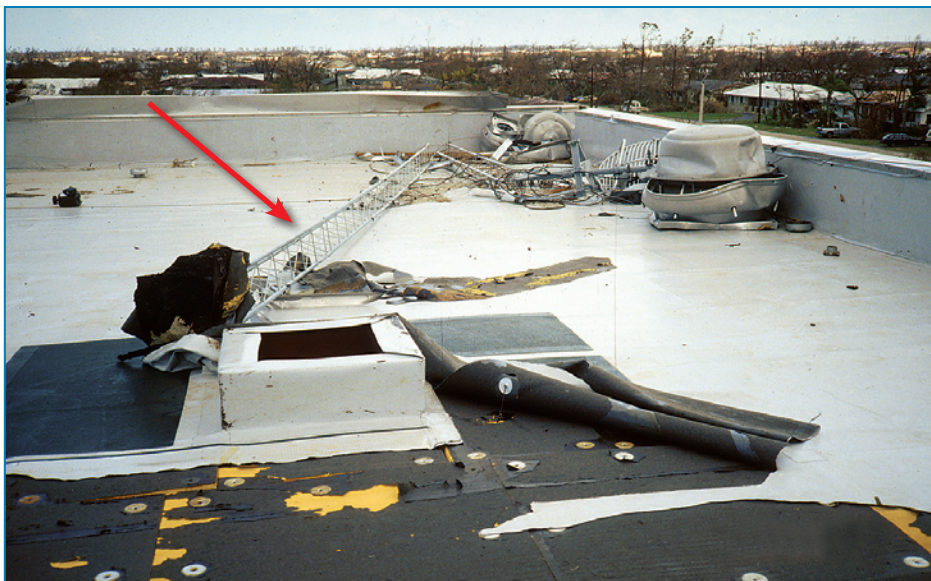
**Figure 4-95:**

The collapse of the antenna tower caused progressive peeling of the roof membrane. Also note that the exhaust fan blew off the curb, but the high parapet kept it from blowing off the roof. Hurricane Andrew (Florida, 1992)

Collapse of both large and small communication towers at hospitals is quite common during high-wind events (see Figures 4-15 and 4-95). These failures often result in complete loss of communication capabilities. In addition to the disruption of communications, collapsed towers can puncture roof membranes and allow water leakage into the hospital, unless the roof system incorporated a secondary membrane (as discussed in Section 4.3.3.8). At the tower shown in Figure 4-95, the anchor bolts were pulled out of the deck, which resulted in a progressive peeling of the fully adhered single-ply roof membrane. Tower collapse can also injure or kill people.

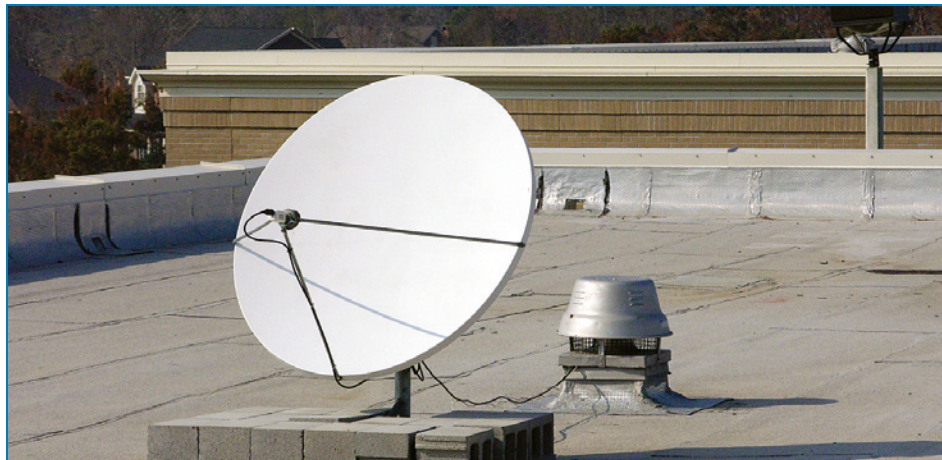
**Figure 4-96:**  
Common anchoring method for satellite dish. Hurricane Ivan (Florida, 2004)

**Parapets:** For low-sloped roofs, minimum 3-foot high parapets are recommended. With parapets of this height or greater, the uplift load in the corner region is substantially reduced (ASCE 7 permits treating the corner zone as a perimeter zone). Also, a high parapet (as shown in Figures 4-96) may intercept wind-borne debris and keep it from blowing off the roof and damaging other building components or injuring people. To protect base flashings from wind-borne debris damage and subsequent water leakage, it is recommended that metal panels on furring strips be installed over the base flashing (Figure 4-79). Exposed stainless steel screws are recommended for attaching the panels to the furring strips, because using exposed fasteners is more reliable than using concealed fasteners or clips (as were used for the failed panels shown in Figure 4-62).

**Satellite dishes:** For the satellite dish shown in Figure 4-96, the dish mast was anchored to a large metal pan that rested on the roof membrane. CMU was placed on the pan to provide overturning resistance. This anchorage method should only be used where calculations demonstrate that it provides sufficient resistance. In this case the wind approached the satellite dish in such a way that it experienced very little wind pressure. In hurricane-prone regions, use of this anchorage method is not recommended (see Figures 4-83 and 4-97).

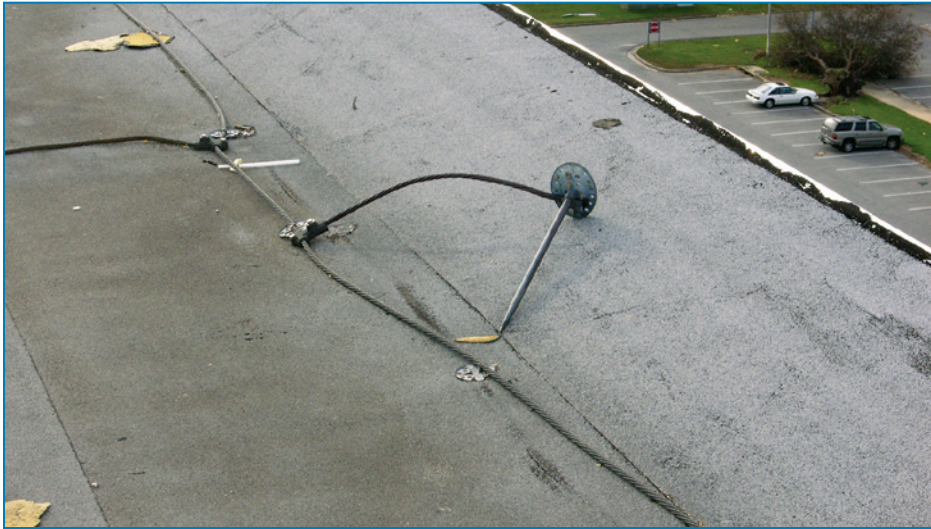
**Figure 4-98:** An air terminal debonded from the hospital's roof. Displaced air terminals can puncture tough membranes, such as this modified bitumen membrane. Hurricane Ivan (Florida, 2004)

Lightning protection systems frequently become disconnected from rooftops during hurricanes. Displaced LPS components can puncture and tear roof coverings, thus allowing water to leak into buildings (see Figures 4-98 and 4-99). Prolonged and repeated slashing of the roof membrane by loose conductors (“cables”) and puncturing by air terminals (“lightning rods”) can result in lifting and peeling of the membrane. Also, when displaced, the LPS is no longer capable of providing lightning protection in the vicinity of the displaced conductors and air terminals.

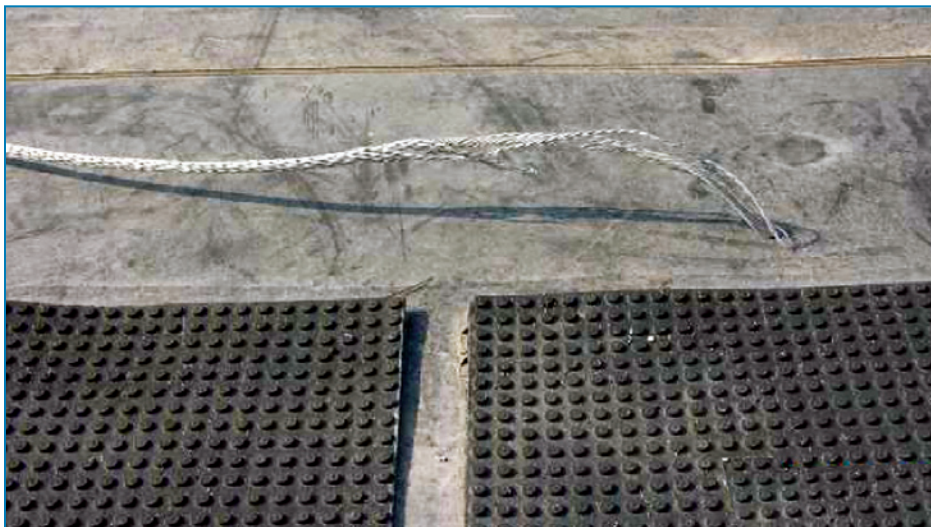
**Figure 4-99:** View of an end of a conductor at a hospital that became disconnected. Hurricane Katrina (Mississippi, 2005)

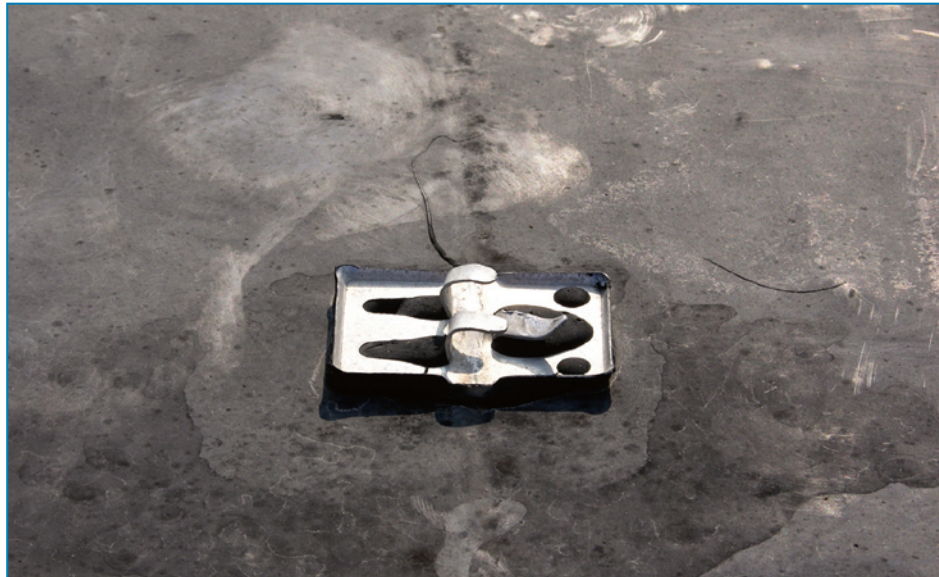
**Figure 4-100:**  
The conductor deformed the prongs under wind pressure, and pulled away from the connector. Hurricane Katrina (Mississippi, 2005)

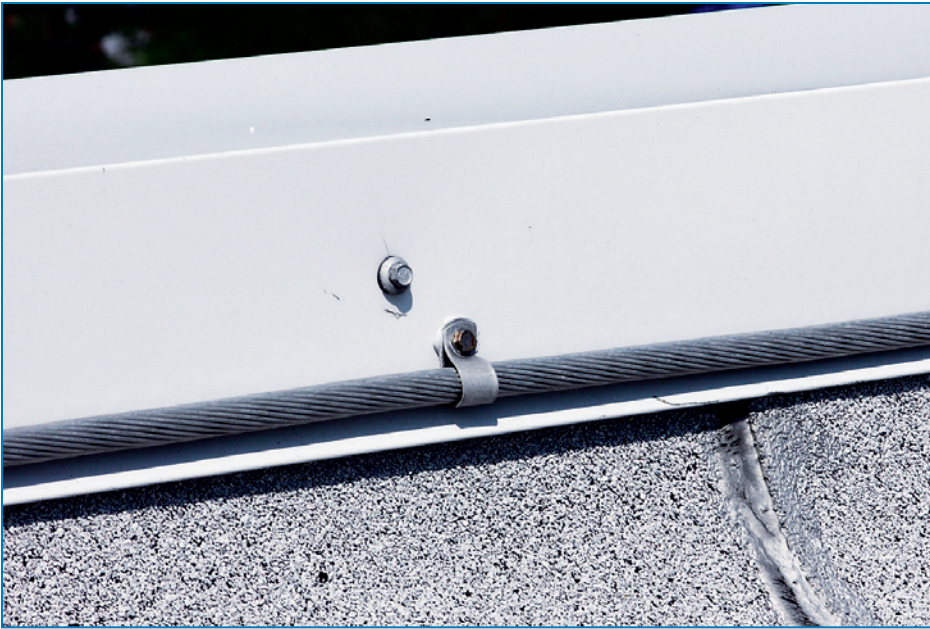
**Figure 4-101:**  
This conductor was attached to the coping with a looped connector. Hurricane Katrina (Mississippi, 2005)

**Parapet attachment:** When the parapet is 12-inches high or greater, it is recommended that the air terminal base plates and conductor connectors be mechanically attached with #12 screws that have minimum 1¼-inch embedment into the inside face of the parapet nailer and are properly sealed for watertight protection. Instead of conductor connectors that have prongs, it is recommended that mechanically attached looped connectors be installed (see Figure 4-101).

**Standing seam metal roofs:** It is recommended that pre-manufactured, mechanically attached clips that are commonly used to attach various items to roof panels be used. After anchoring the clips to the panel ribs, the air terminal base plates and conductor connectors are anchored to the panel clips. In lieu of conductor connectors that have prongs, it is recommended that mechanically attached looped connectors be installed (see Figure 4-101).

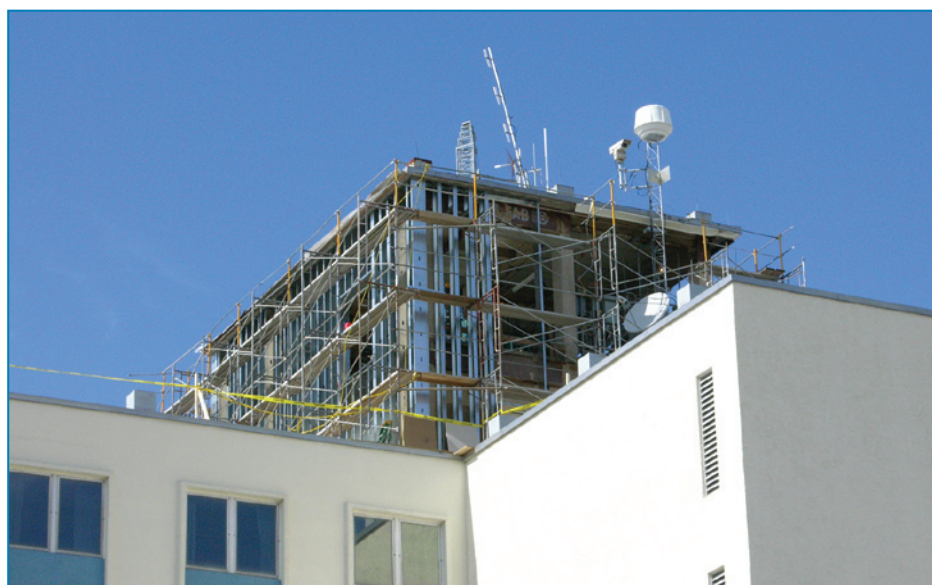
**Figure 4-106:**  
View of the reconstruction of the damaged walls at the elevator penthouse

The hospital sustained damage to the elevator penthouse, roof covering, and roof-mounted equipment. Many of the metal panels on the elevator penthouse of the North Tower that were blown off during Hurricane Frances (Figure 4-106) tore the roof membrane on the tower roof as well as on lower roofs. Mechanical equipment was damaged on the tower roof (Figure 4-107) and on lower roofs. The LPS was displaced on the tower roof (Figure 4-108) and on lower roofs. Unlike the windows on the first floor that were protected with shutters, the upper-level windows were not protected. However, none of them were broken, although a significant amount of water leaked through many of these windows. The second hurricane (Jeanne) caused additional water infiltration and interrupted reconstruction work.

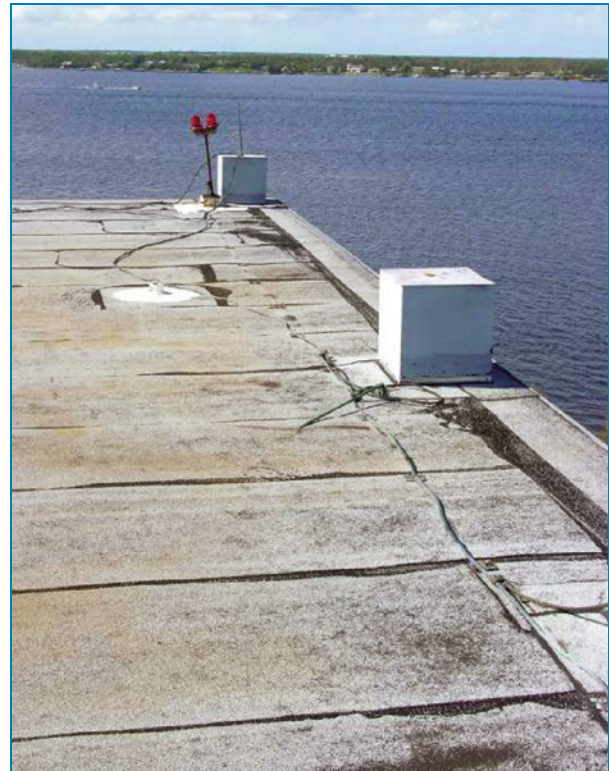
**Figure 4-108:**  
Displaced LPS

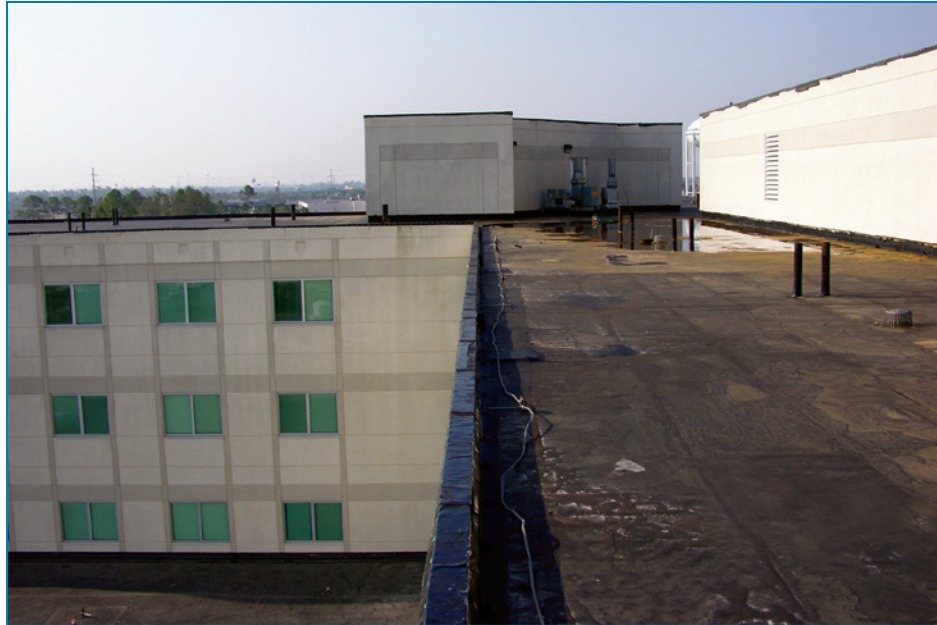
**Figure 4-109:**

The roof on this 5-year old hospital blew off. Water leaked into the patient floor below. The floor was taken out of service for more than a month. Hurricane Katrina (Mississippi, 2005)

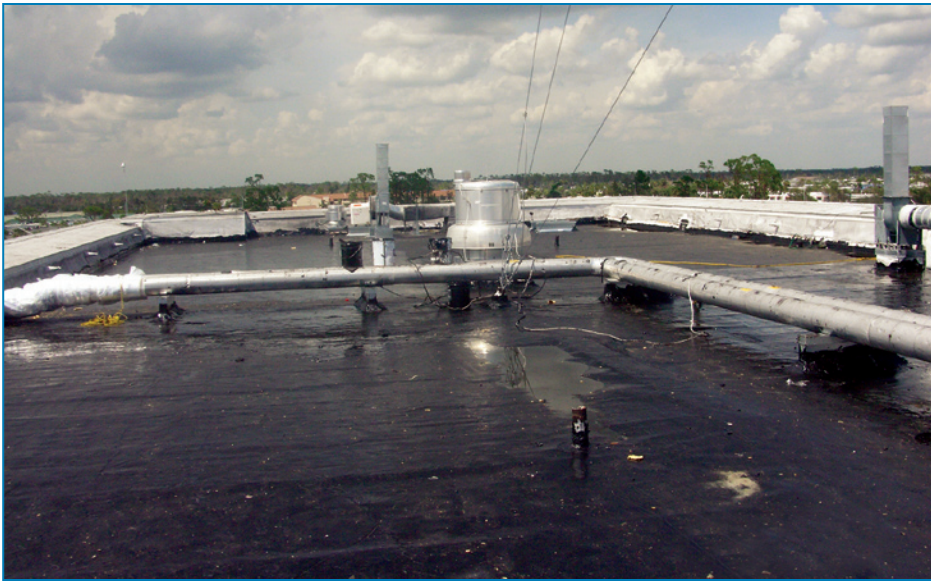
**Figure 4-110:**  
The roof membrane and some of the rooftop equipment blew off. Although the deck was cast-in-place concrete, water leaked into the patient floor below. Hurricane Charley (Florida, 2004)

By performing a vulnerability assessment, items that need to be strengthened or replaced can be identified and prioritized. A proactive approach in mitigating weaknesses can save significant sums of money and decrease disruption or total breakdown in hospital operations after a storm. For example, a vulnerability assessment on a hospital such as that shown in

Figure 4-110 may identify weakness of the roof membrane and/or rooftop equipment. Replacing weak components before a hurricane is much cheaper than replacing them and repairing consequential damages after a storm, and proactive work avoids the loss of use while repairs are made.

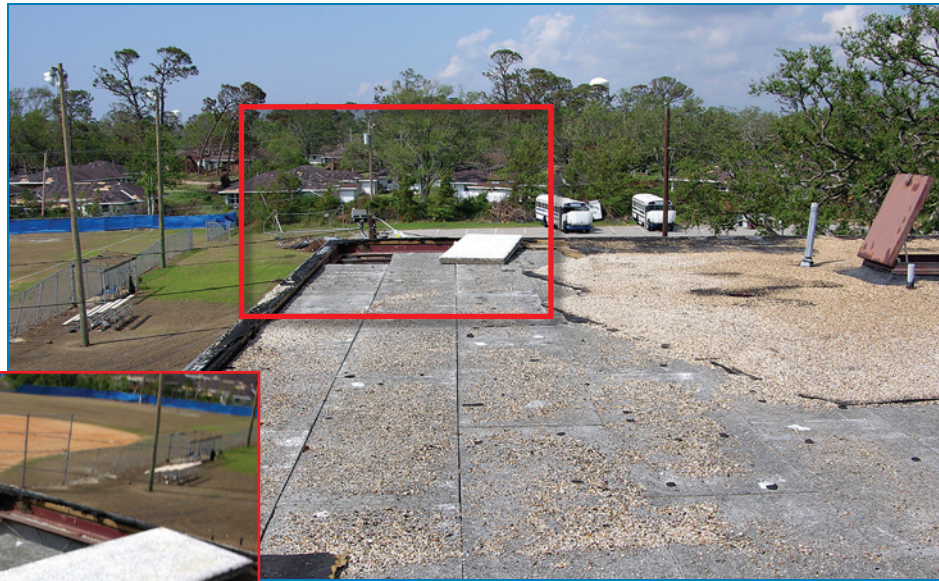
**Figure 4-111:**  
The built-up roof blew off after one of the cementitious wood-fiber deck panels detached from the joists. Hurricane Katrina (Mississippi, 2005)

As discussed in Section 4.1.4.1, roof decks on many facilities designed prior to the 1982 edition of the SBC and UBC and the 1987 edition of the NBC are very susceptible to failure. Poorly attached decks that are not upgraded are susceptible to blow-off, as shown in Figures 4-111 and 4-132. Decks constructed of cementitious wood-fiber, gypsum, and lightweight insulating concrete over form boards were commonly used on buildings built in the 1950s and 1960s. In that era, these types of decks, as well as precast concrete decks, typically had very limited uplift resistance due to weak connections to the support structure. Steel deck attachment is frequently not adequate because of an inadequate number of welds, or welds of poor quality. Older buildings with overhangs are particularly susceptible to blow-off, as shown in Figure 4-112, because older codes provided inadequate uplift criteria.

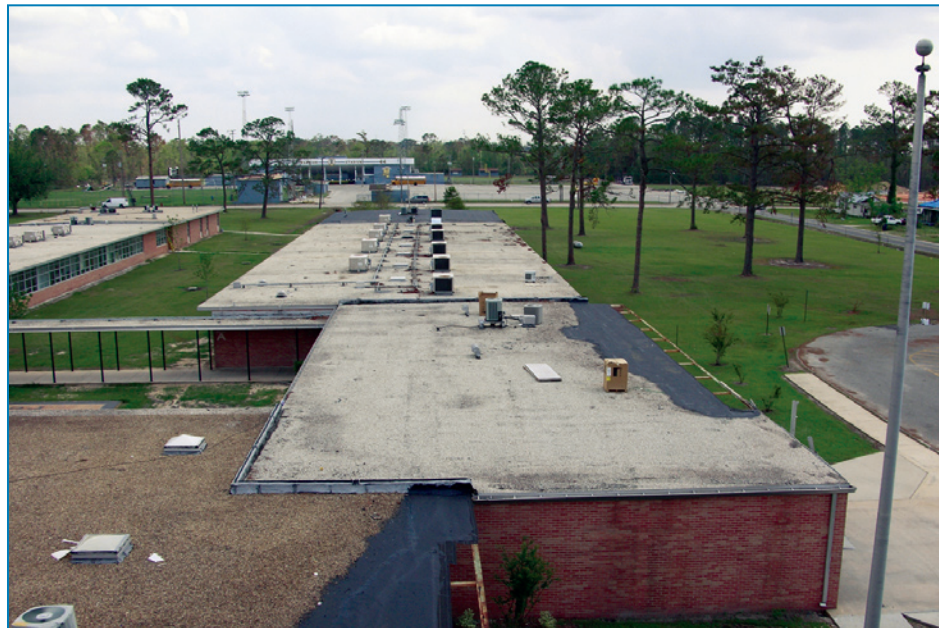
**Figure 4-112:**  
The cementitious wood-fiber deck panels detached from the joists along the overhangs and caused the built-up membranes to lift and peel. Hurricane Katrina (Mississippi, 2005)

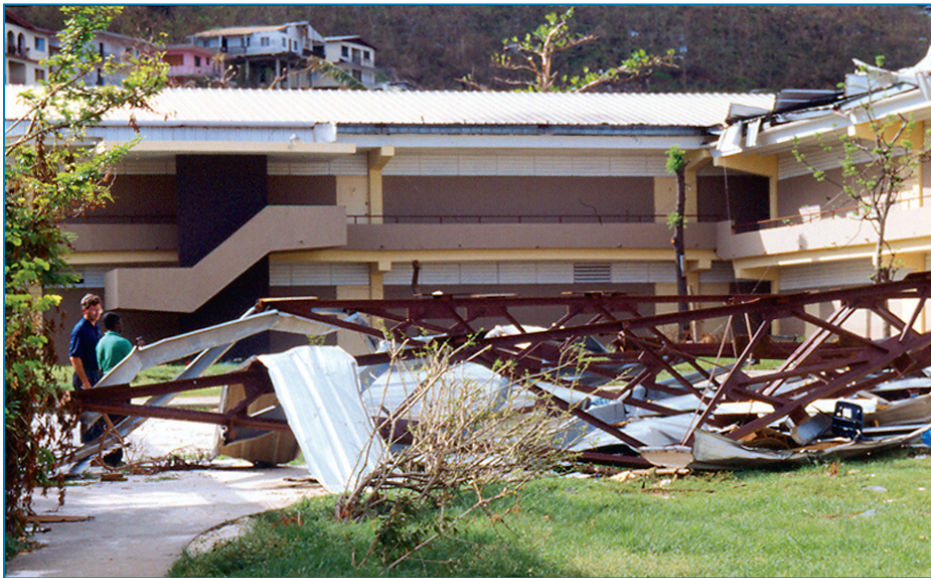
**Figure 4-113:**  
The steel truss superstructure installed as part of a steep-slope conversion blew away because of inadequate attachment. Hurricane Marilyn (U.S. Virgin Islands, 1995)

If a low-slope roof is converted to a steep-slope roof, the new support structure should be engineered and constructed to resist the wind loads and avoid the kind of damage shown in Figure 4-113.

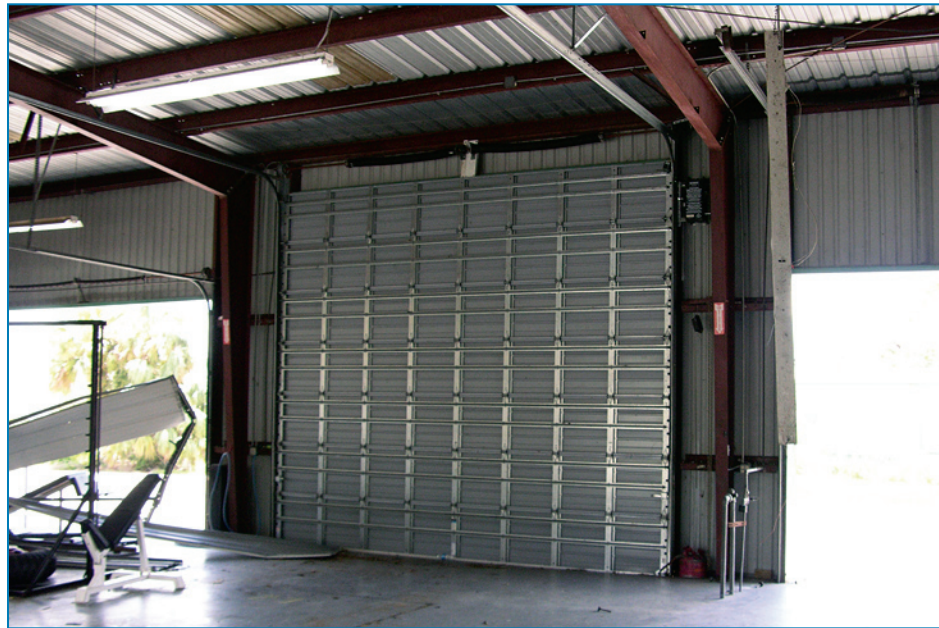
**Figure 4-114:**  
The new door in the center performed very well, but the older doors on either side of it were blown away. Hurricane Charley (Florida, 2004)

If a facility has more than one sectional or rolling door, all doors should be replaced, rather than just replacing one of the doors. The building shown in Figure 4-114 had six sectional doors. One door had been replaced before a hurricane. It performed very well, but three of the older doors were blown away and two of the older doors remained in place but had some wind damage.

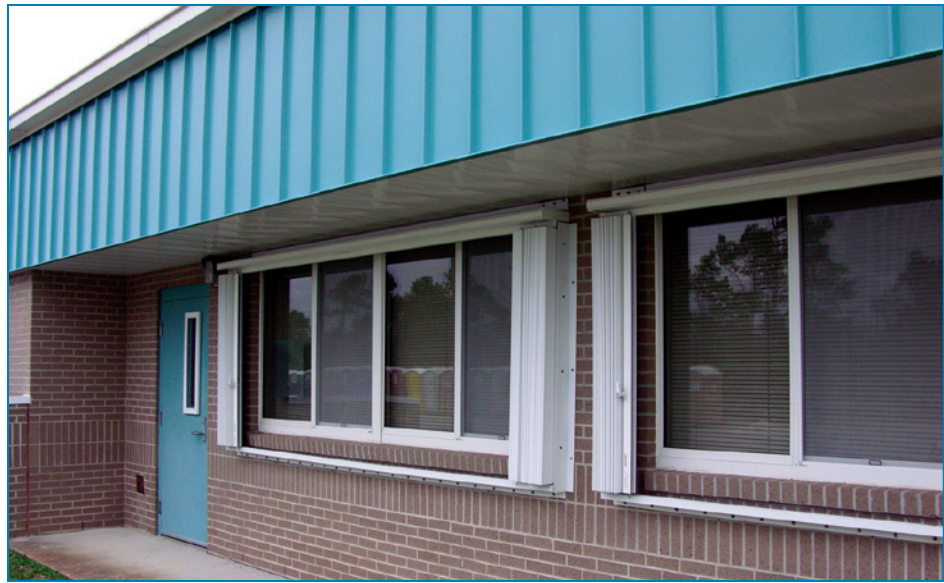
**Figure 4-117:**  
A metal panel shutter.  
Hurricane Georges  
(Puerto Rico, 1998)

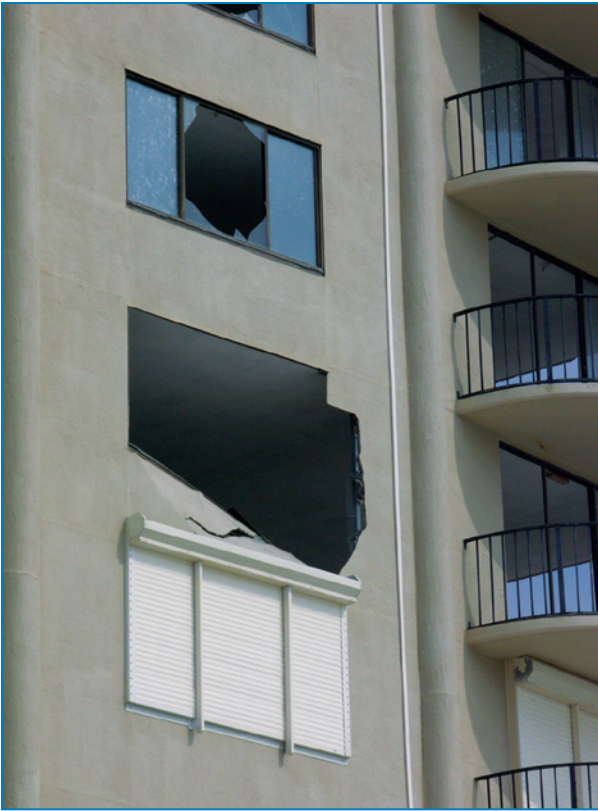
**Figure 4-118:**  
The lower window assembly was protected with a motorized shutter. Hurricane Ivan (Florida, 2004)

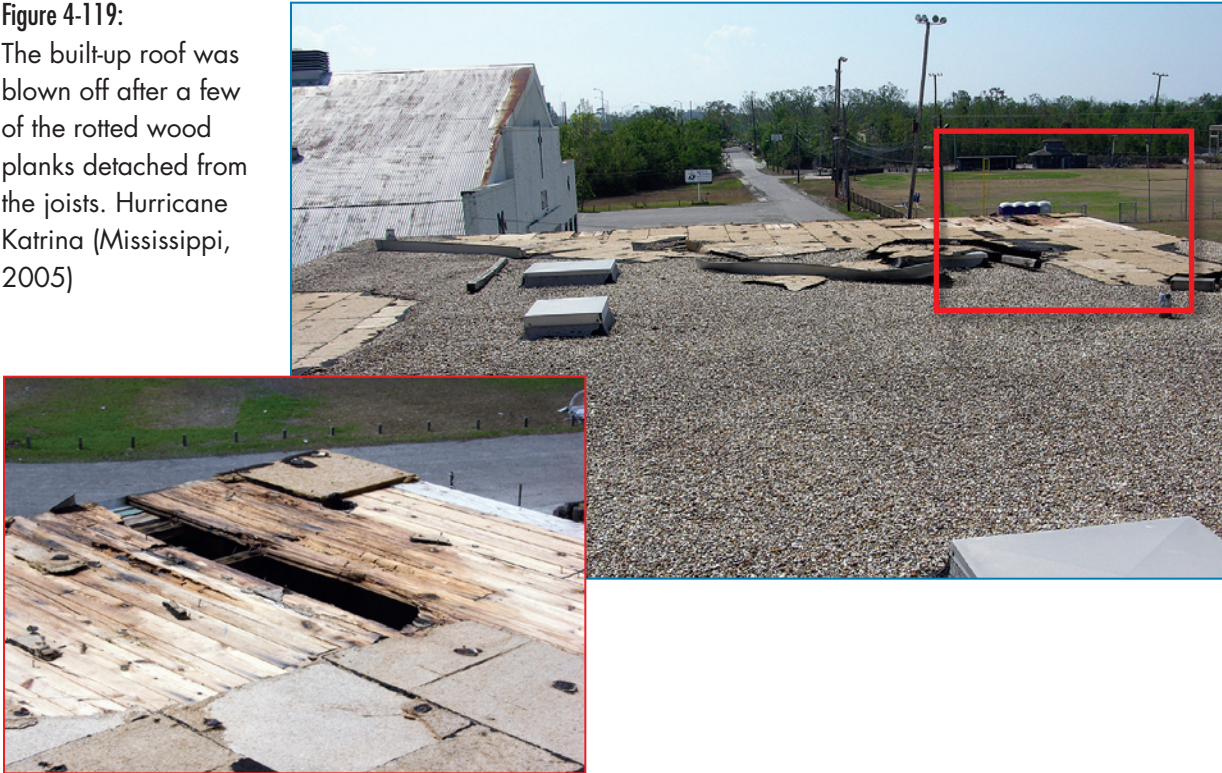
**Figure 4-119:**

The built-up roof was blown off after a few of the rotted wood planks detached from the joists. Hurricane Katrina (Mississippi, 2005)

When planning the replacement of a roof covering, it is recommended that all existing roof covering be removed down to the deck rather than simply re-covering the roof. Tearing off the covering provides an opportunity to evaluate the structural integrity of the deck and correct deck attachment and other problems. For example, if a roof deck was deteriorated due to roof leakage (see Figure 4-119), the deterioration would likely not be identified if the roof was simply re-covered. By tearing off

down to the deck, deteriorated decking like that shown in Figure 4-119 can be found and replaced. In addition, it is recommended that the attachment of the wood nailers at the top of parapets and roof edges be evaluated and strengthened where needed, to avoid blow-off and progressive lifting and peeling of the new roof membrane (see Figure 4-126).

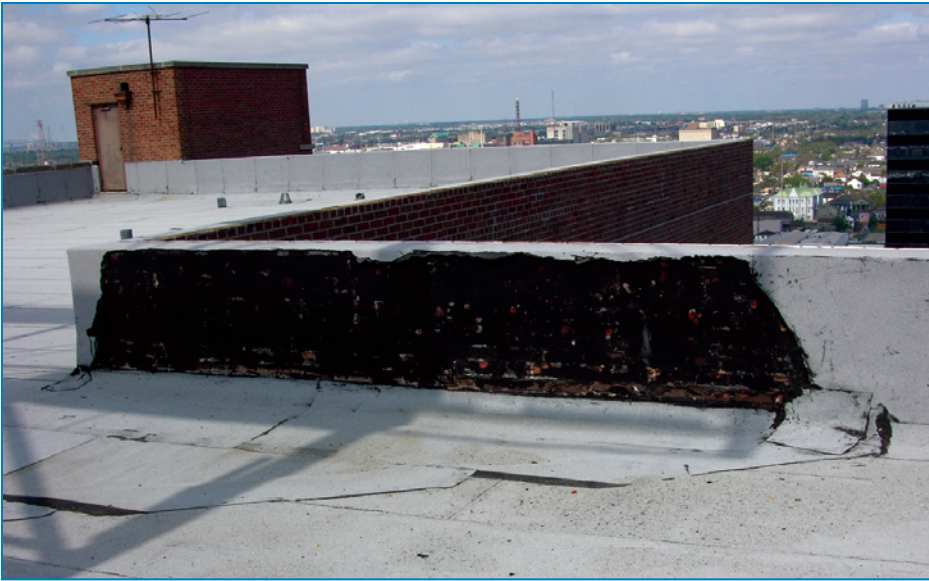
**Figure 4-120:**  
Failed base flashing  
adhered directly to  
the brick parapet.  
Hurricane Katrina  
(Louisiana, 2005)

If the roof has a parapet, it is recommended that the inside of the parapet be properly prepared to receive the new base flashing. In many instances, it is prudent to re-skin the parapet with sheathing to provide a suitable substrate. Base flashing should not be applied directly to brick parapets because they have irregular surfaces that inhibit good bonding of the base flashing to the brick (see Figure 4-120). Also, if moisture drives into the wall from the exterior side of the parapet with base flashing attached directly to brick, the base flashing can inhibit drying of the wall. Therefore, rather than totally sealing the parapet with membrane base flashing, the upper portion of the brick can be protected by metal panels (as shown in Figure 4-79), which permit drying of the brick.

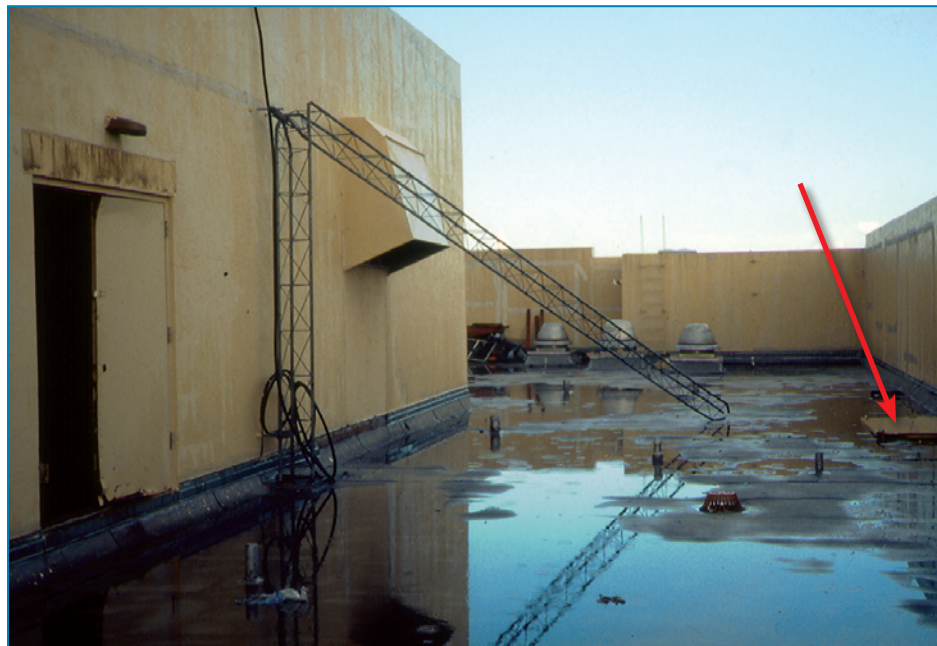
**Figure 4-121:**

The antenna at this hospital collapsed and was whipped back and forth across the roof membrane. Hurricane Andrew (Florida, 1992)

Antenna collapse is very common. Besides loss of communications, collapsed masts can puncture roof membranes or cause other building damage as shown in Figure 4-121. This case also demonstrates the benefits of a high parapet. Although the roof still experienced high winds that blew off this penthouse door, the parapet prevented the door from blowing off the roof (red arrow in Figure 4-121).

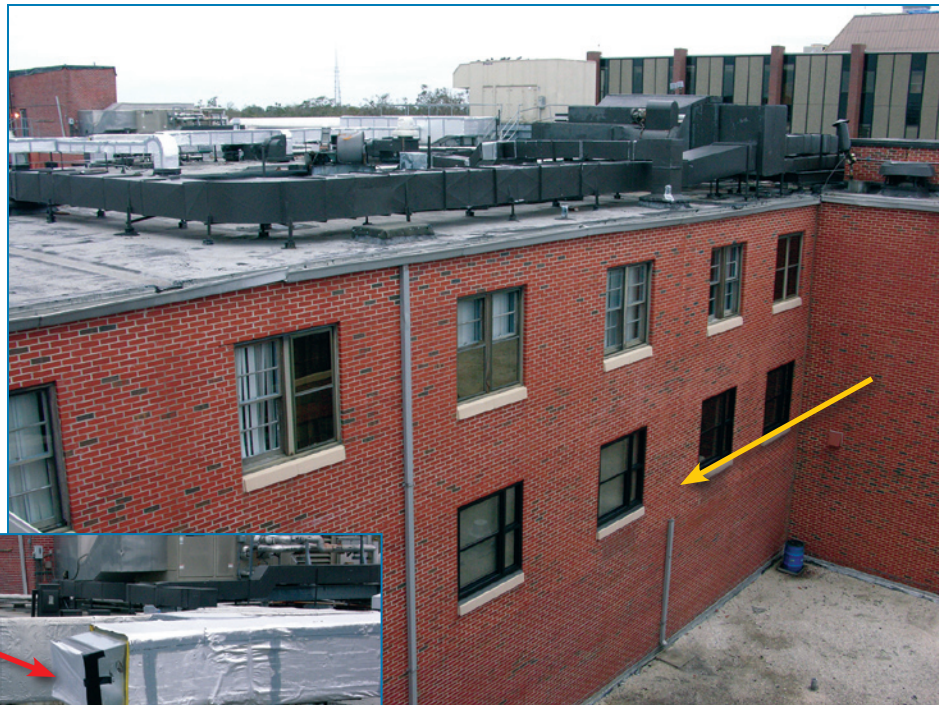
**Figure 4-124:**

This hospital had a substantial amount of rooftop ductwork. Ductwork and fan units were damaged in several locations (see inset). Some of the windows in this area were also broken. Note the missing downspout (yellow arrow).

Water entered the hospital at damaged rooftop equipment (Figure 4-124), and at areas where the roof membrane blew off (Figures 4-125 and 4-126) and where it was punctured. The roof failure shown in Figure 4-126 was caused by an inadequately attached edge nailer anchored to the brick wall. Failure of the nailer caused a progressive lifting and peeling of the roof membrane. Gutters and downspouts were blown off and a few windows were broken. The elevator penthouse roof was damaged at the psychiatric hospital (Figure 4-127) and the MOBs (Figure 4-125).

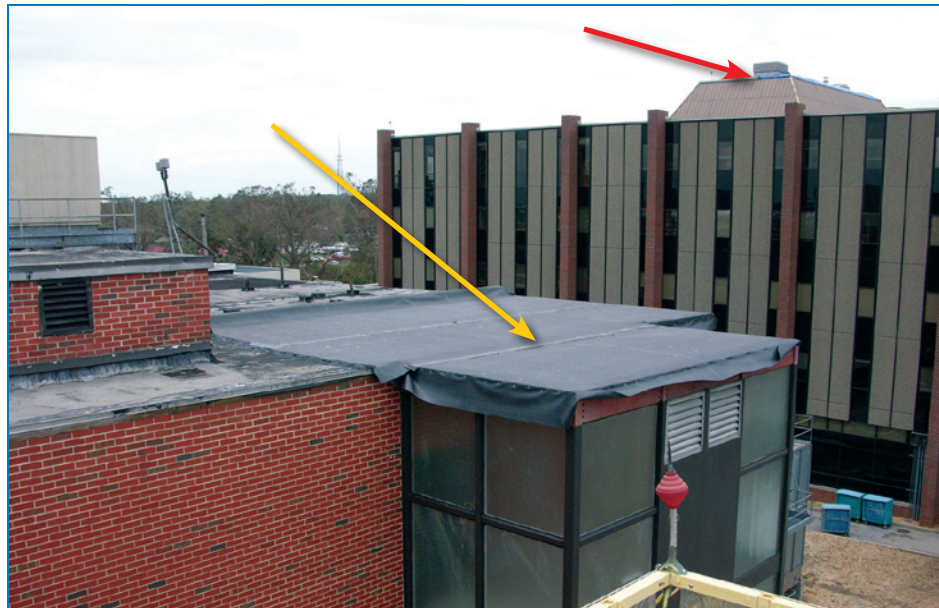
**Figure 4-125:**

The roof covering blew off – an emergency roof covering had been installed (yellow arrow). Note the damaged MOB penthouse beyond (red arrow).

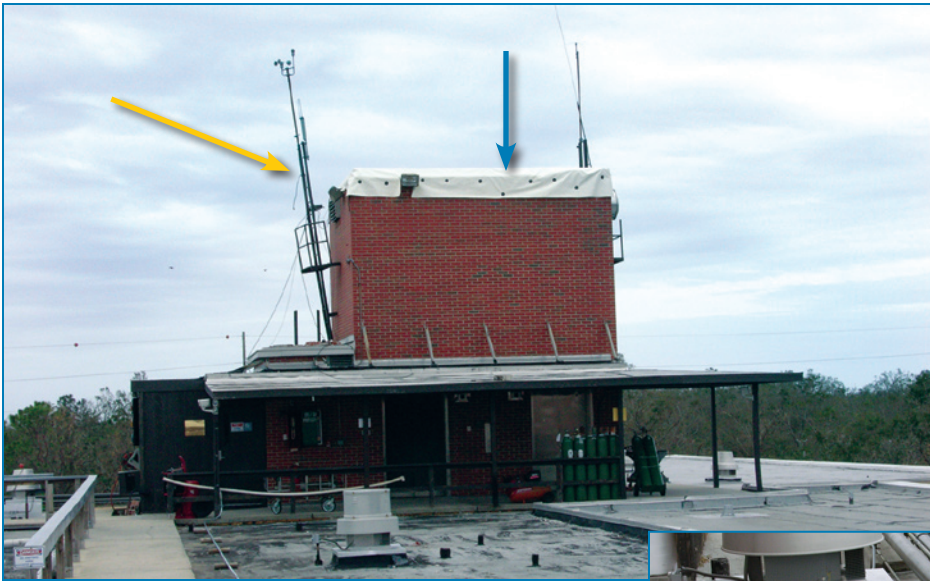
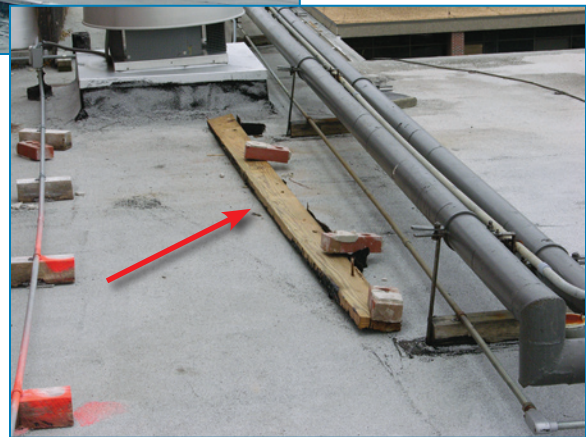
**Figure 4-126:**

The roof covering blew off – an emergency roof covering had been installed (blue arrow). The failure was caused by the inadequately attached nailer (see inset). The leaning mast at the right is a ladder (yellow arrow), with an extension for communications and an anemometer for the nearby heliport.

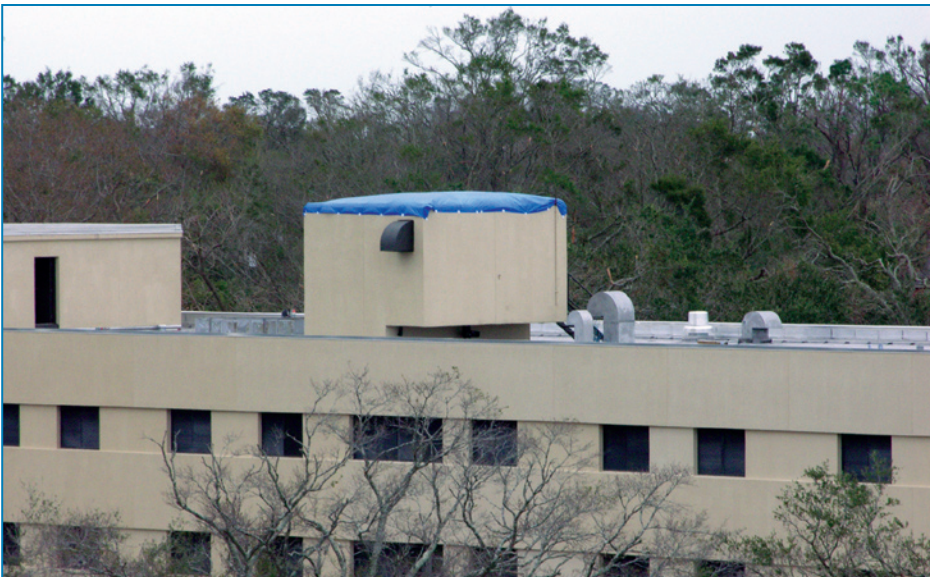
**Figure 4-127:**

An emergency roof covering had been installed over the elevator penthouse at the psychiatric hospital.

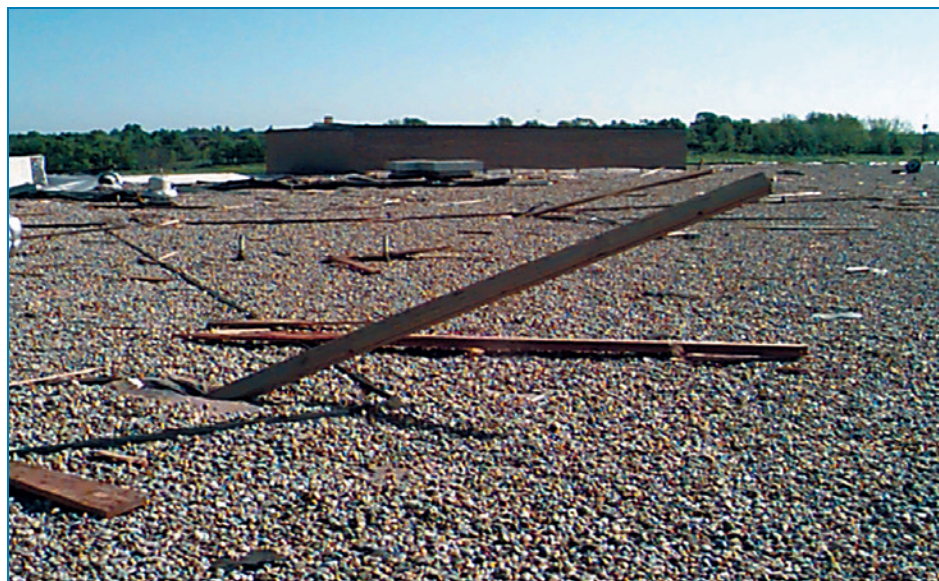
**Figure 4-128:**  
A violent tornado showered the roof with missiles. (Oklahoma, 1999)

Strong and violent tornadoes can generate very powerful missiles. Experience shows that large and heavy objects, including vehicles, can be hurled into buildings at high speeds. The missile sticking out of the roof in the foreground of Figure 4-128 is a double 2-inch by 6-inch wood member. The portion sticking out of the roof is 13 feet long. It penetrated a ballasted ethylene propylene diene monomer (EPDM) membrane, approximately 3 inches of polyisocyanurate roof insulation, and the steel roof deck. The missile lying on the roof just beyond is a 2-inch by 10-inch by 16-foot long wood member.
