# Design Guide

for Improving Hospital Safety  
in Earthquakes, Floods, and High Winds

*FEMA 577 / June 2007*

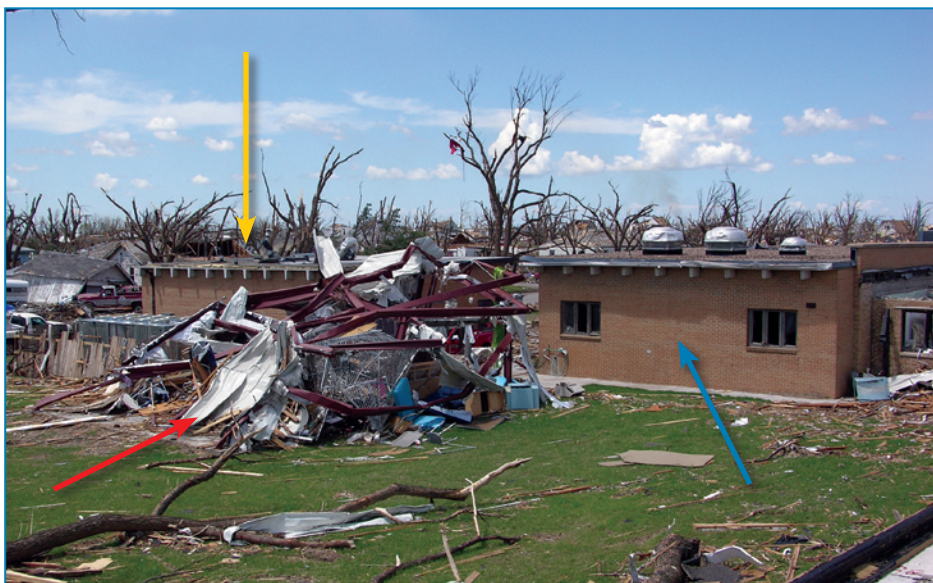
Figure 4-131:  
The building housing the generator is shown by the yellow arrow. The kitchen facility is shown by the blue arrow. The red arrow shows the collapsed storage building.

The case of Kiowa County Memorial Hospital illustrates damage that is indicative of smaller, older facilities that are struck by strong tornadoes. The hospital is a 28-bed, one-story facility. The original hospital comprised three separate buildings (two of these are shown in Figure 4-131): a patient wing, a kitchen facility, and an equipment building, and was constructed in 1950. Additions were built in 1965 and 1982. A separate, ambulance garage was built prior to 1979, and a separate pre-engineered metal storage building was added in 2006. The original buildings had precast twin-tee roof structures and at the time of the storm, they had aggregate ballasted single-ply membrane roof systems. The additions all had different structural systems. The 1965 patient wing addition had a concrete topping slab over metal form deck over steel roof joists. The 1982 addition, which housed the emergency room, semi-intensive care, operating room, MRI, lab, medical records, and business offices, had a plywood roof deck over wood joists. The ambulance garage had a precast twin-tee roof structure.

The building shown in Figure 4-131 (yellow arrow) and in Figure 4-138 housed the emergency generator. The sectional door collapsed and allowed wind-borne debris to strike the generator. All window panes in the wall adjacent to the sectional door were broken (see inset at Figure 4-138). The wall louver adjacent to the window, which served the generator room, escaped damage.

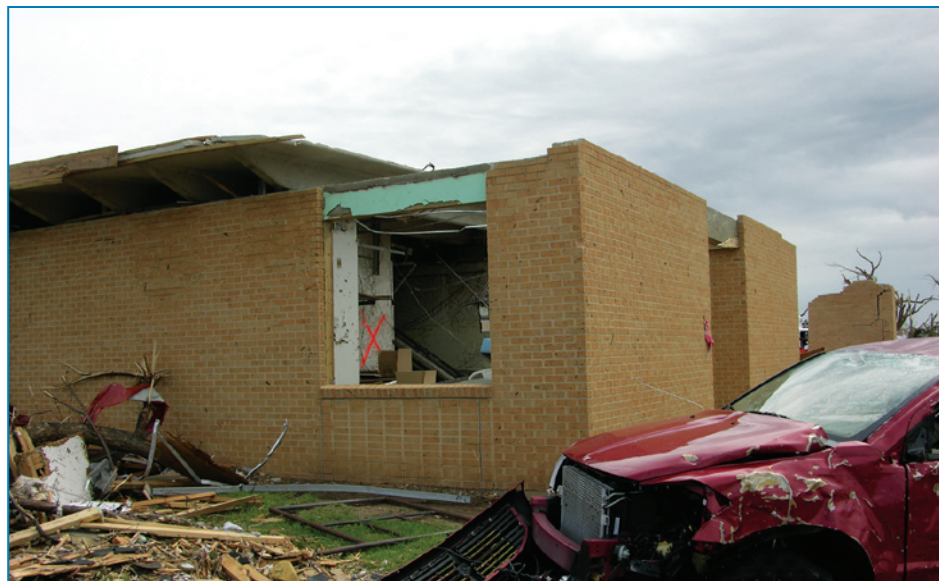
**Figure 4-132:**

View of the end of the patient wing where the twin-tee blew off. Note the missing window.

One of the precast twin-tees from the original building blew off and flew approximately 80 feet (Figures 4-132 and 4-133). Where the tees rested on the bearing wall, steel bearing plates were embedded in the tee's beams, and bearing plates were embedded on top of the wall. At the wall in the foreground of Figure 4-132, the bearing plates had not been welded together. Hence, at that end of the tee, no uplift resistance was provided other than the tee's dead load. At the opposite bearing wall, the bearing plates were welded, but the bolts anchoring the plates to the wall failed in tension as the tee lifted. Both of the bearing plates had two small anchor bolts (about  $\frac{3}{8}$ -inch diameter).

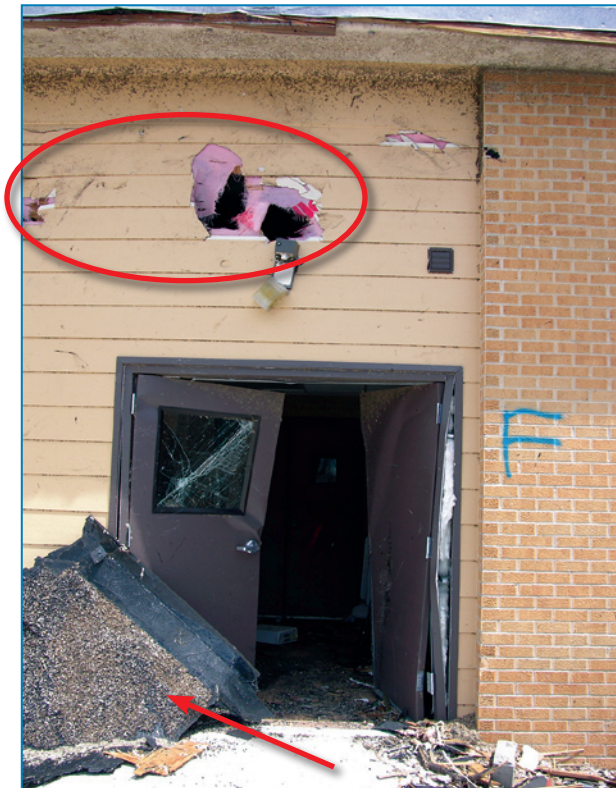
**Figure 4-134:**  
The BUR missile (red arrow) struck the right door. Missiles also punctured the siding and wood sheathing (red oval).

The hospital complex was struck with a very large number of missiles. Virtually all of the hospital's exterior glazing was broken. Figure 4-134 shows a damaged door at the kitchen facility. A piece of built-up roof (BUR) membrane struck the right door. Although the doors were out-swinging, the missile pushed the door inward. The lower right hinge was broken, and the right side of the door frame buckled and pulled from the rough opening. The laminated glass in the door was broken, but remained in place.

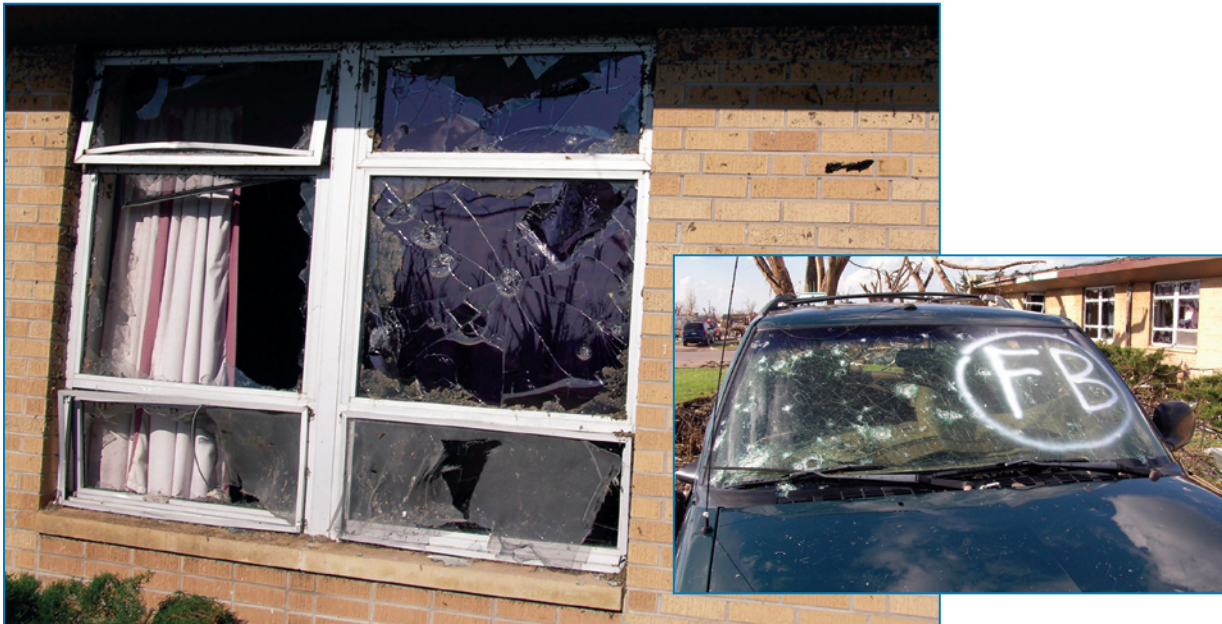
**Figure 4-135:**

All six panes of glass were broken. The craters shown in the right center pane and at the vehicle windshield were caused by the large aggregate blown from the ballasted single-ply membranes.

Aggregate from the ballasted single-ply membrane roofs broke several windows (Figure 4-135), and pieces of the large aggregate (1½-inches in diameter, nominal) were found inside the building. Windows were also broken by 2x wood framing (Figure 4-136).

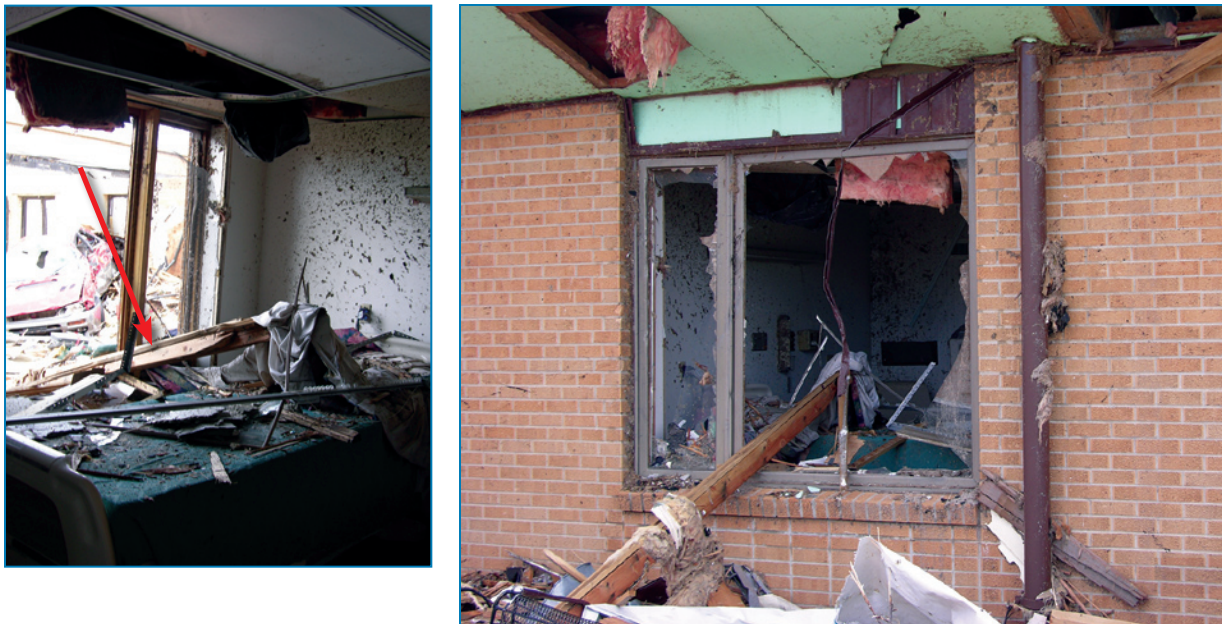
**Figure 4-136:**

A large missile (2x framing) penetrated this patient room. Note the debris on the bed in the inset (the arrow shows the same 2x missile).

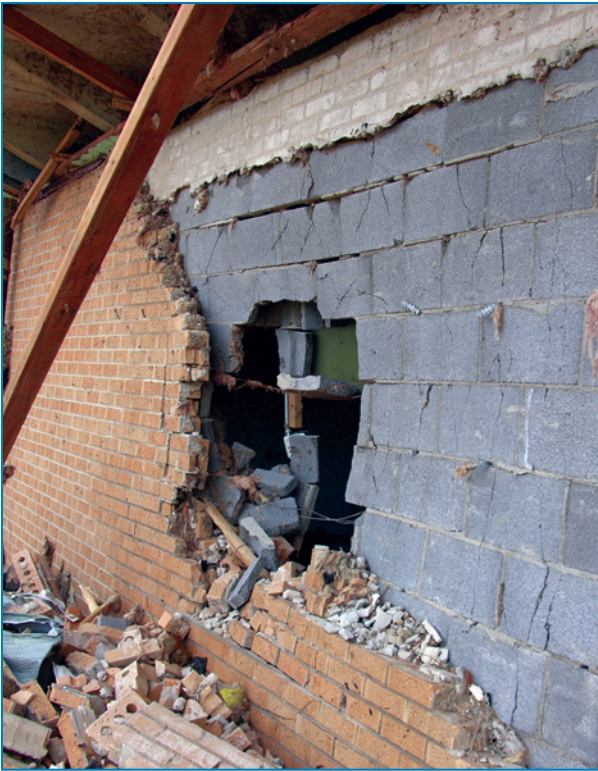
**Figure 4-137:**

A missile impact created an opening in the brick veneer and unreinforced CMU.

Figure 4-137 illustrates an opening through the entire exterior wall.

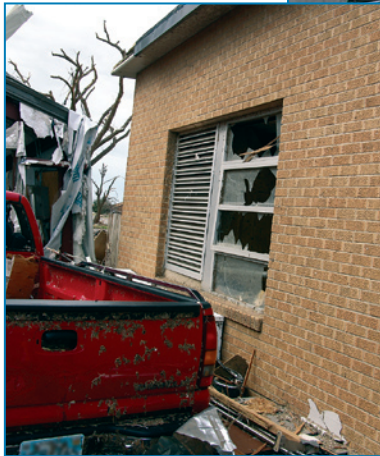
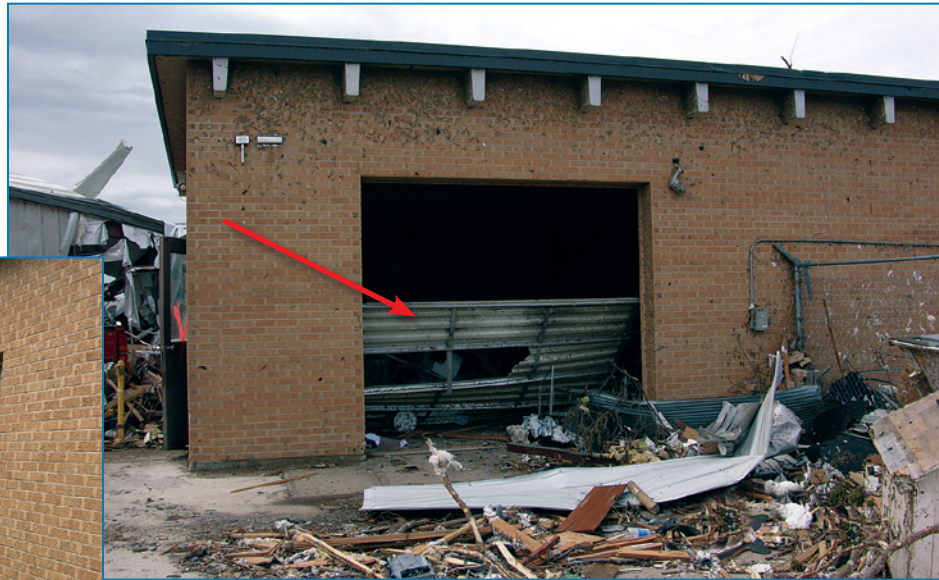
**Figure 4-138:**  
The sectional door (red arrow) at the generator building was blown in and windows were broken by debris.

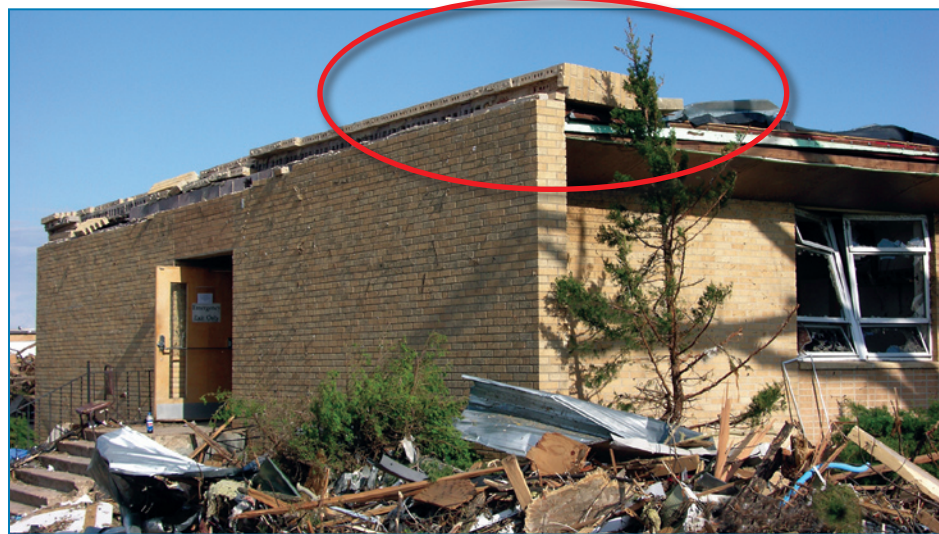
**Figure 4-139:**  
Collapsed unreinforced masonry parapet. Note the broken windows.

There was no apparent structural damage to the 1965 addition. However, the unreinforced brick/CMU parapet shown in Figure 4-139 fell onto the roof, rather than in the other direction, where it would have blocked the entry and possibly could have caused injuries. Virtually all of the exterior windows were broken (see Figures 4-135 and 4-136). The roof insulation and aggregate-ballasted single-ply roof membrane were blown off. The wood roof structure blew off the majority of the 1982 addition (Figures 4-133 and 4-140), and virtually all of the exterior windows were broken.

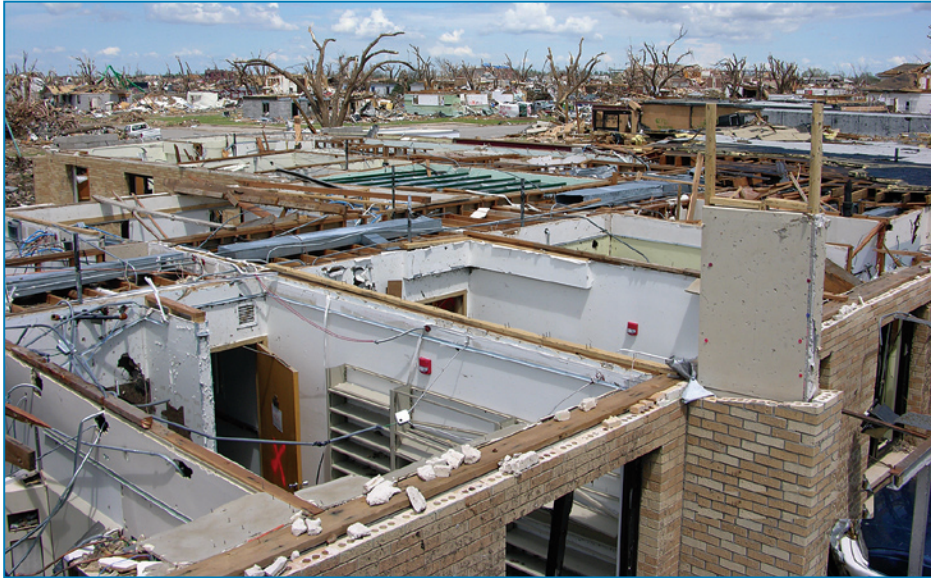
**Figure 4-140:**  
Loss of the wood  
roof structure at the  
1982 addition.

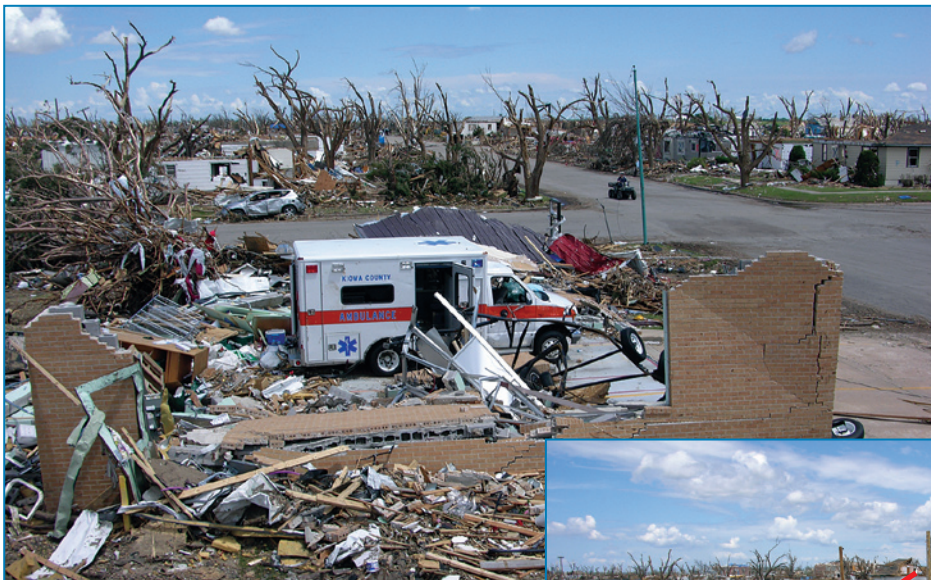
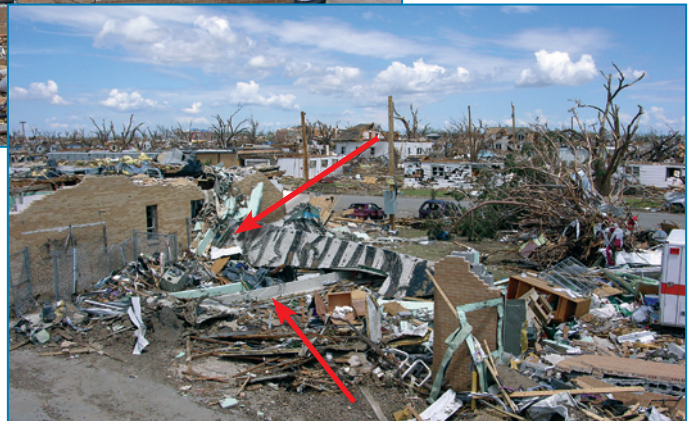
**Figure 4-141:**  
View of the collapsed  
ambulance garage.  
The twin-tees (red  
arrows) flew to the left,  
as shown in the inset.

The precast twin-tees on the ambulance garage blew off and landed against the wall of the 1982 addition (Figures 4-133 and inset at 4-141). The garage door and virtually all of the exterior unreinforced brick/CMU bearing walls collapsed (Figure 4-141). Where the tees rested on the bearing wall, steel bearing plates were embedded in the tee's beams. However, bearing plates had not been embedded on top of the support walls. Rather, where

the tee's beams rested on the wall, a piece of roof membrane had been installed between the beams and the wall. Hence, at the ends of the tees, no uplift resistance was provided other than the tee's dead load.

uation was completed by around 2:45 a.m. (about 5 hours after the tornado). None of the occupants were injured during the storm or evacuation. The ambulance shown in Figure 4-141 was not usable because of missile damage. Even though some portions of the facility could be salvaged, significant demolition and reconstruction will be necessary.

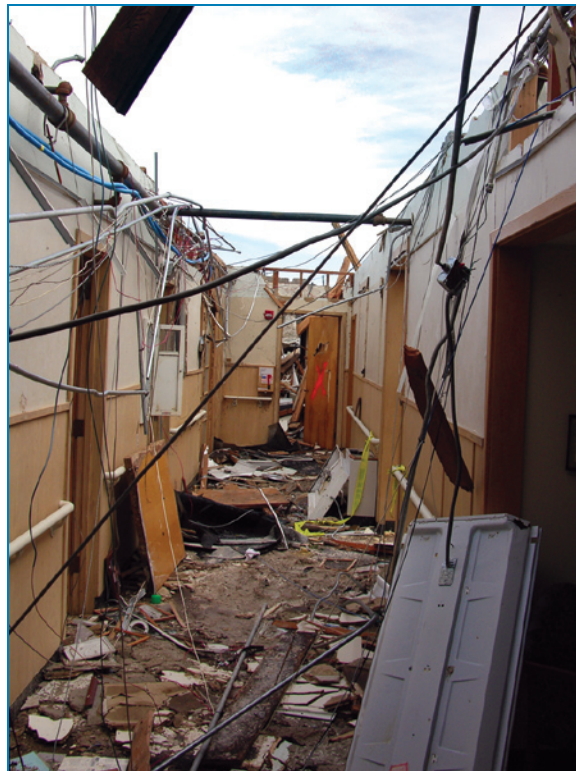
**Figure 4-142:**  
View of a main  
corridor in the 1982  
addition

in a particular facility; by that time, it will be too late. If refuge areas have not been identified beforehand, occupants will take cover wherever they can, frequently in very dangerous places. Corridors, as shown in Figure 4-142, sometimes provide protection, but they can also be death traps.

The loss of life and avoidance of injuries was attributed to three factors. 1) A tornado warning was issued by the National Weather Service about 20 minutes before the tornado struck, and the hospital's staff was aware of the warning. 2) The hospital had a tornado evacuation plan and there was sufficient time to execute the plan. 3) Although it is believed that the basement was not specifically designed as a tornado shelter, it provided a safe area of refuge for patients and staff. For hospitals located in tornado-prone regions, the experience from this tornado demonstrates the importance of having a pre-identified, best available refuge area (or preferably a FEMA 361-compliant shelter). Although small interior rooms and corridors sometimes provide adequate protection during tornadoes, unless specifically designed as a tornado shelter, they often provide inadequate protection, as shown in Figure 4-142.

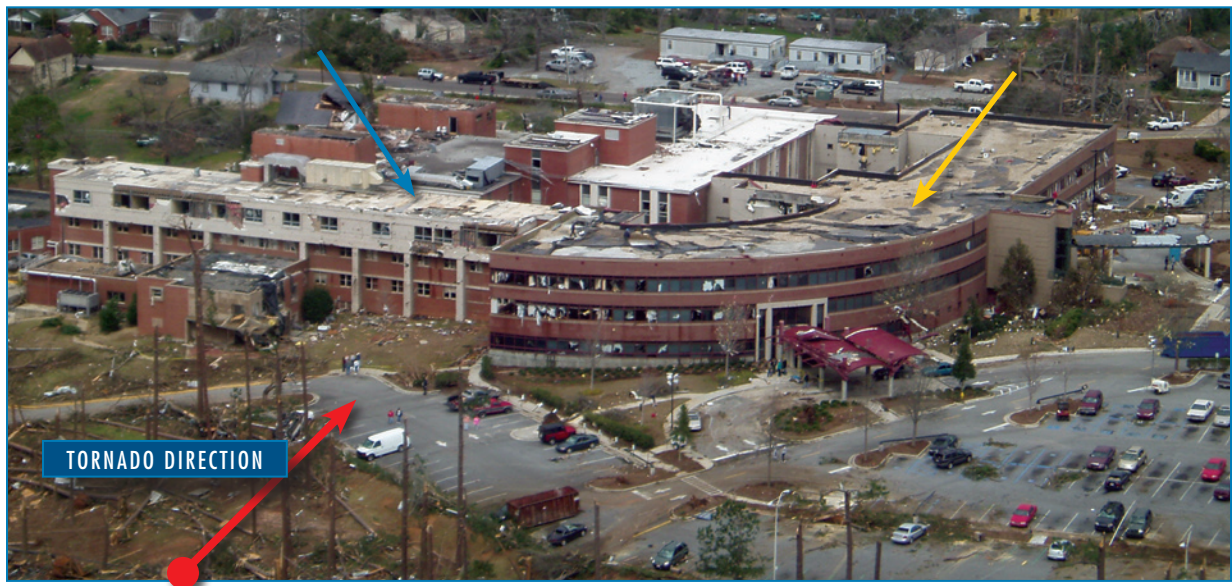
Figure 4-143:

Aerial view of the facility after it was struck by the tornado. The red arrow indicates the general direction of the tornado. The blue arrow shows the 1953 building, and the yellow arrow shows the 1999 building. The 1975 and 1983 additions are adjacent to and behind the 1953 and 1999 buildings.

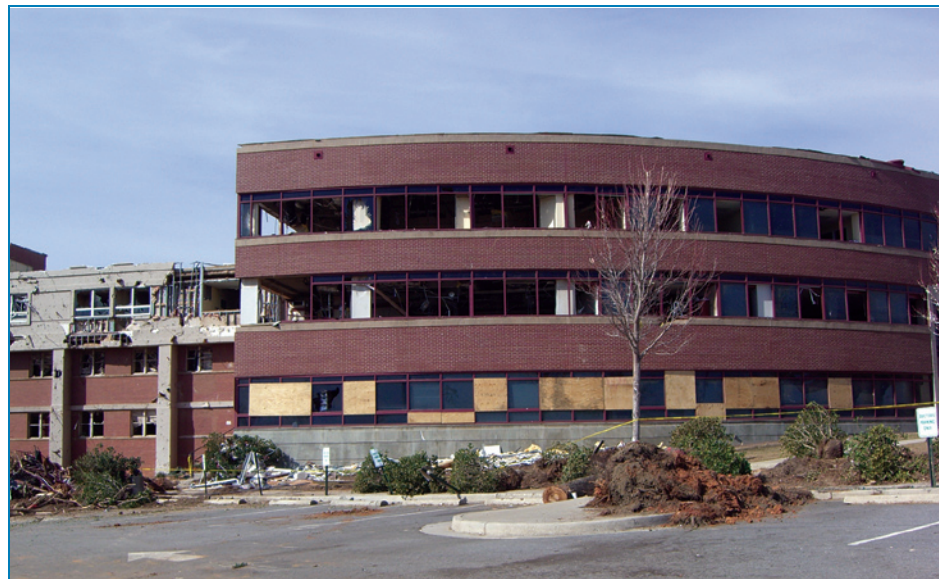
**Figure 4-144:**

The 1999 addition is on the right, and the 1953 building is to the left. Virtually all of the glass on these facades was broken.

As the tornado approached the southwest side of the hospital, numerous tree branches from trees in front of the hospital were thrown against the building. Missiles broke virtually all of the glass in the southwest walls (Figures 4-144 and 4-145), and missiles penetrated the EIFS and landed inside the building. Roof decking and steel joists were blown off of portions of the 1953 building, and the roof

The right (curved) portion of the building in Figure 4-144 is the 1999 addition. This portion of the first floor housed waiting and exam rooms. Offices were on the second floor, and medical offices were on the third floor. Figures 4-144 and 4-146 also show part of the 1953 building. Offices were on the first floor, and patient rooms were on the second and third floors.

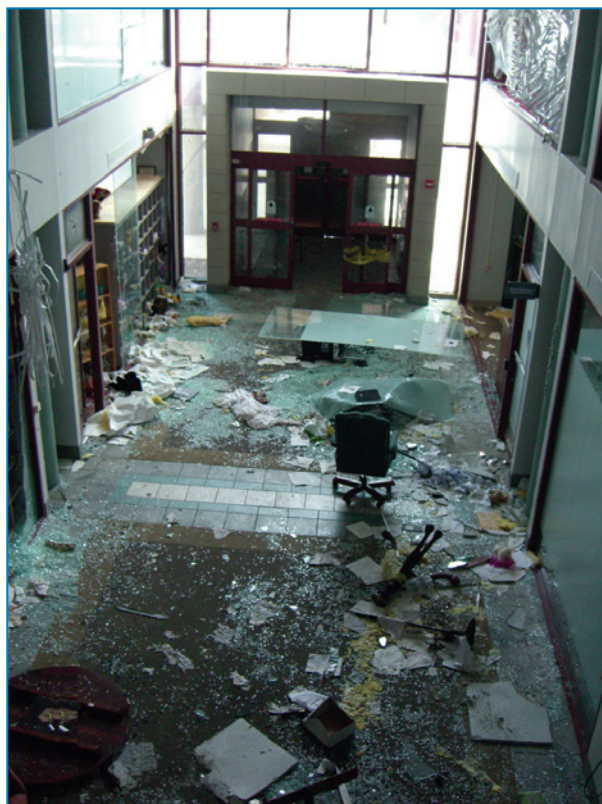
**Figure 4-147:**  
Glass shards and other debris in the lobby area housing retail shops and offices.

Broken glass showered the rooms along the exterior walls. The breach of the building envelope allowed strong winds to enter the rooms and corridors, which led to the collapse of suspended acoustical ceilings and light fixtures. Figure 4-147 illustrates the extent of the interior damage.

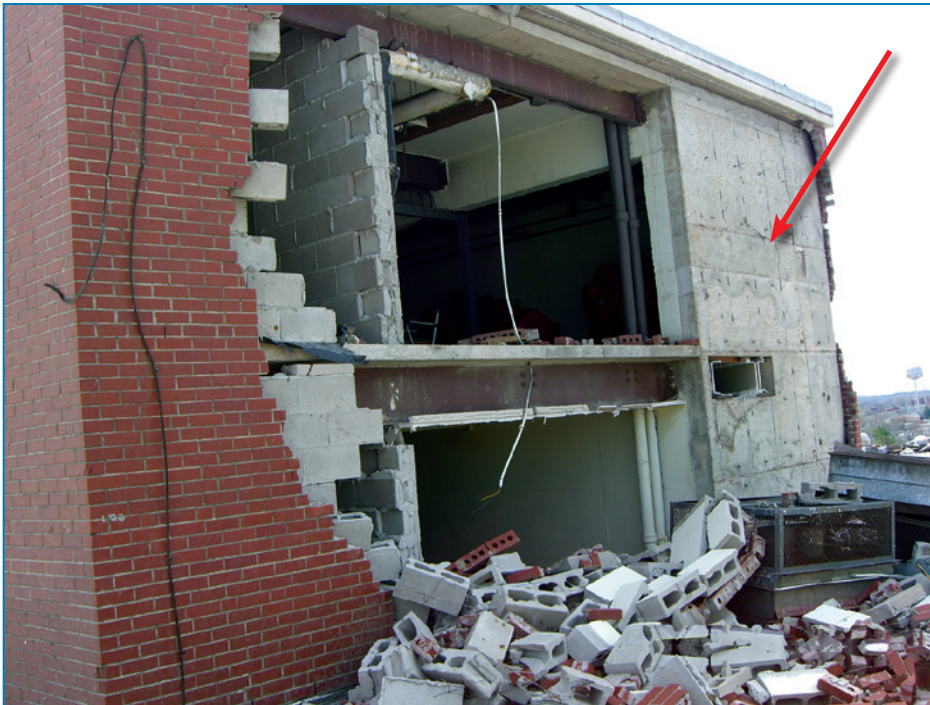
**Figure 4-148:** Collapsed brick veneer/CMU wall at a mechanical room. The cast-in-place concrete wall (arrow) remained, but the brick veneer was blown away.

Damage also occurred on other facades, including collapse of a glass curtain wall and a portion of a brick veneer/unreinforced CMU wall (Figure 4-148). A large unreinforced brick chimney collapsed on a roof, and a large rooftop air handling unit (20 x 7 x 9 feet) was shifted several feet. A substantial amount of water entered the building at various places where the envelope was breached.
