Emergency Dam Break Analyses Following the Cerro Grande Fire near Los Alamos, New Mexico

Abstract

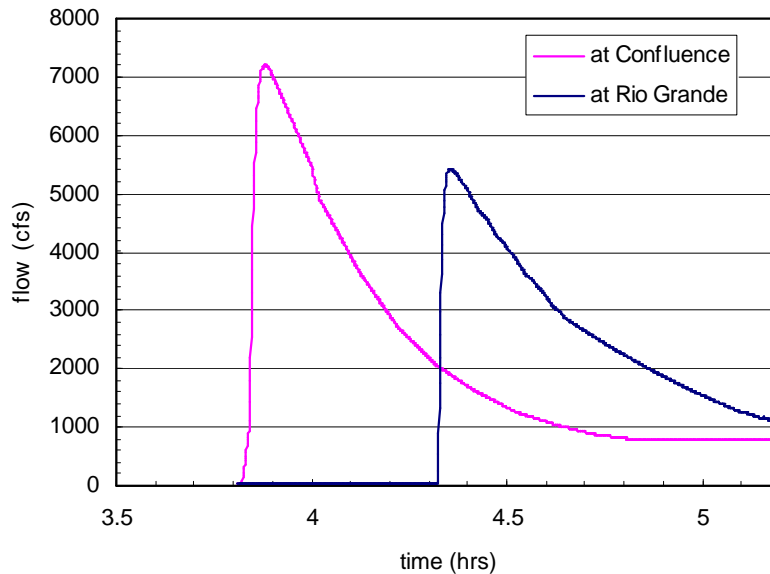
Figure 1. Flood hydrographs at the confluence of Pueblo and Los Alamos Canyons, and Rio Grande River.

Figure 1 shows the flood hydrographs at the confluence of Los Alamos and Pueblo Canyons and at the confluence with the Rio Grande River. The time shown in Figure 1 is relative to the beginning of the storm. The peak flow rate at the confluence was 7,200 ft³/s at the confluence Los Alamos and Pueblo Canyons and attenuates to 5,400 ft³/s near the Rio Grande. Los Alamos Canyon contributes roughly 1,100 ft³/s to the flow and Pueblo canyon contributes roughly 6,100 ft³/s.
