North Rim

Development Plan

September 2006

Figure 1. Planning Area, North Rim Development Plan, Grand Canyon National Park

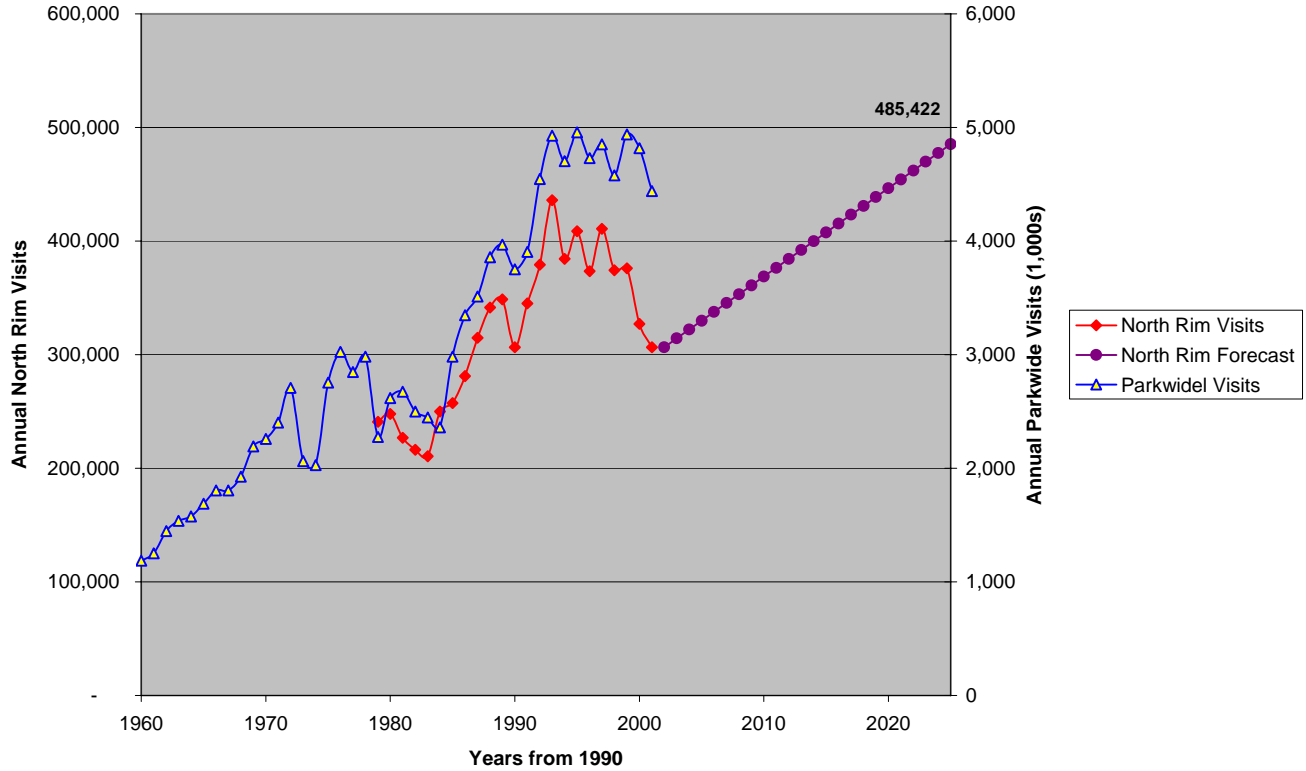
FIGURE 1

**Grand Canyon Visitation History and North Rim Forecast
1960 - 2025**

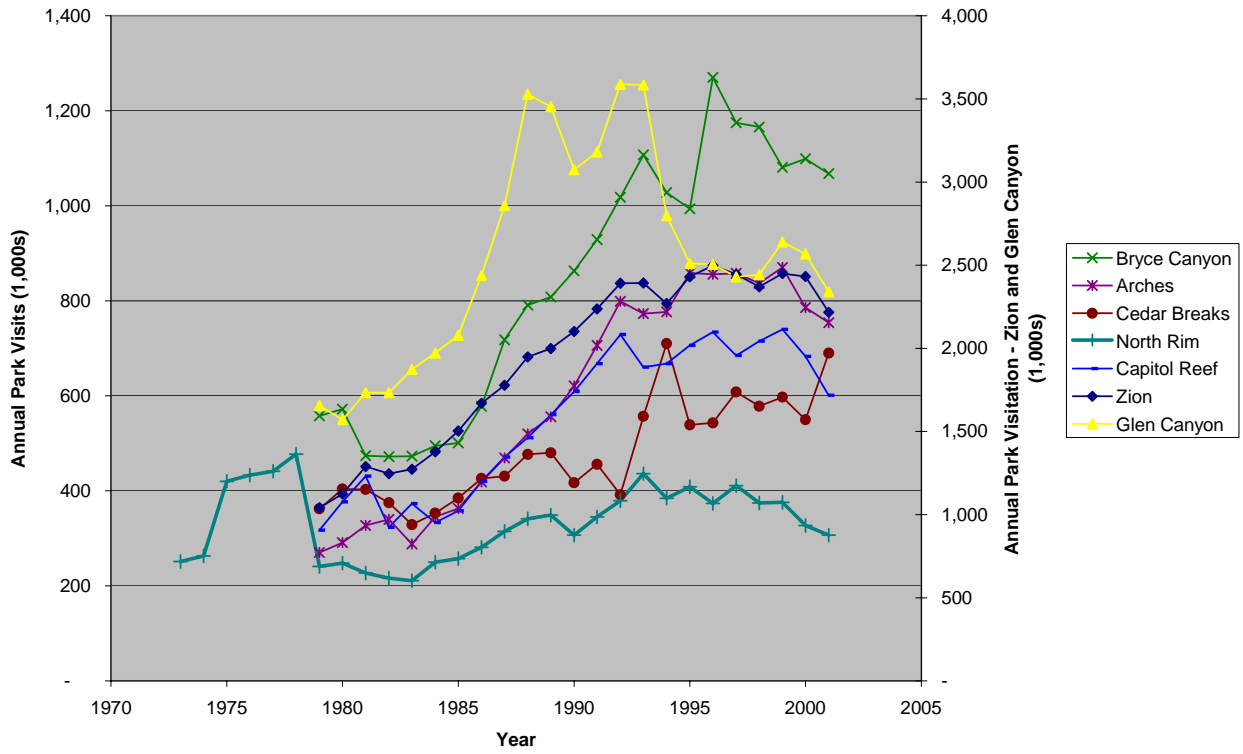
FIGURE 2

Regional NPS Unit Visitation - 1979 - 2001

The chart on the following page shows visitation to the North Rim area along with visitation to several National Park System units in southern Utah. These parks draw from visitor populations similar to the North Rim. As shown in the chart, most of the parks in the region have experienced a pattern of visitation similar to that for the North Rim. Major increases in visitation are evident in the period from the mid-1980s to the early 1990s, followed by a period of level to declining visitation from the mid-1990s to the present. It is evident that visitation patterns at the North Rim (and for Grand Canyon National Park as a whole) are part of a greater trend, rather than being associated with factors unique to the park.
