“On the shore dimly seen...”: an Archeological Overview
Fort McHenry National Monument and Historic Shrine
Baltimore, Maryland

Charles D. Cheek, Ph.D.
Joseph Balicki
and
John Pousson

John Milner Associates, Inc.
5250 Cherokee Avenue, 4th Floor
Alexandria, Virginia 22312

2000

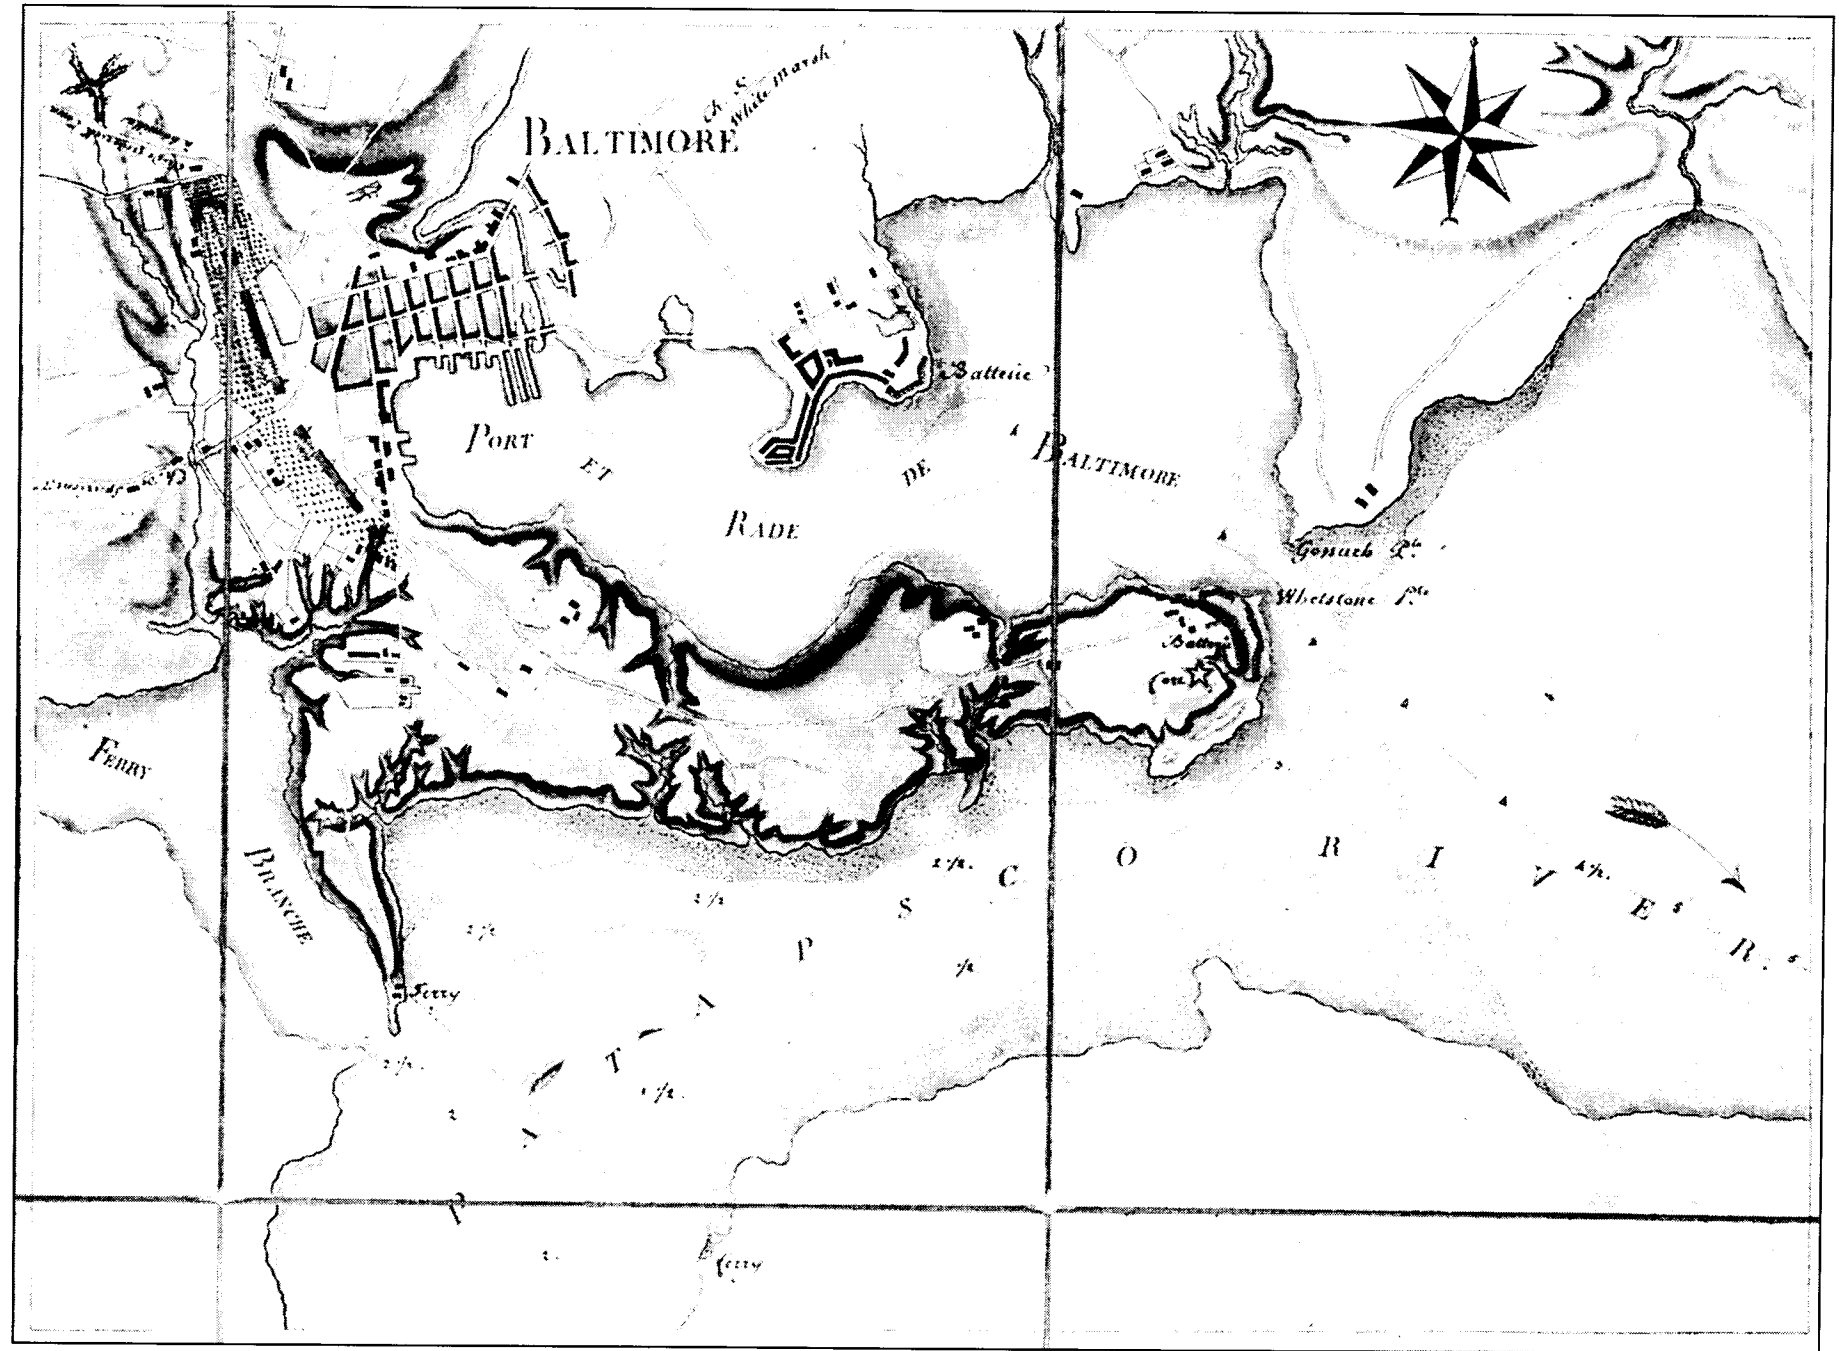
Figure 4. Louis Alexander Berthier's *Port et Rade de Baltimore*, 1782.

As illustrated on maps dating to 1781-92 (Figures 4 and 5), the redoubt had the form of a true heraldic star.¹⁵ No buildings or guns were shown within it. The two water batteries, each with numerous gun embrasures, were located along the shoreline below the fort. Water batteries were then the main deterrent against a naval attack, due to the effectiveness of firing red-hot cannonball so as to ricochet them off the water's surface into any attacking wooden ships. The redoubt served to defend the batteries from landward attack, and as a second line of defense if the batteries were captured. Construction of the defenses at Whetstone Point, in the absence of an effective national War Department, was initiated by the Maryland Council of Safety, and implemented by local residents and militia lacking formal training in military engineering.¹⁶ Nonetheless, the fort and its batteries clearly commanded the channel into the harbor and its approach, and may very well have deterred British naval action against the city. During the later stages of the Revolutionary War, military operations did not threaten Baltimore. Consequently, the city's fortifications were reduced and some of Fort Whetstone's armament was removed for use elsewhere. The fort was evidently never completed once the perceived threat to Baltimore had decreased.¹⁷

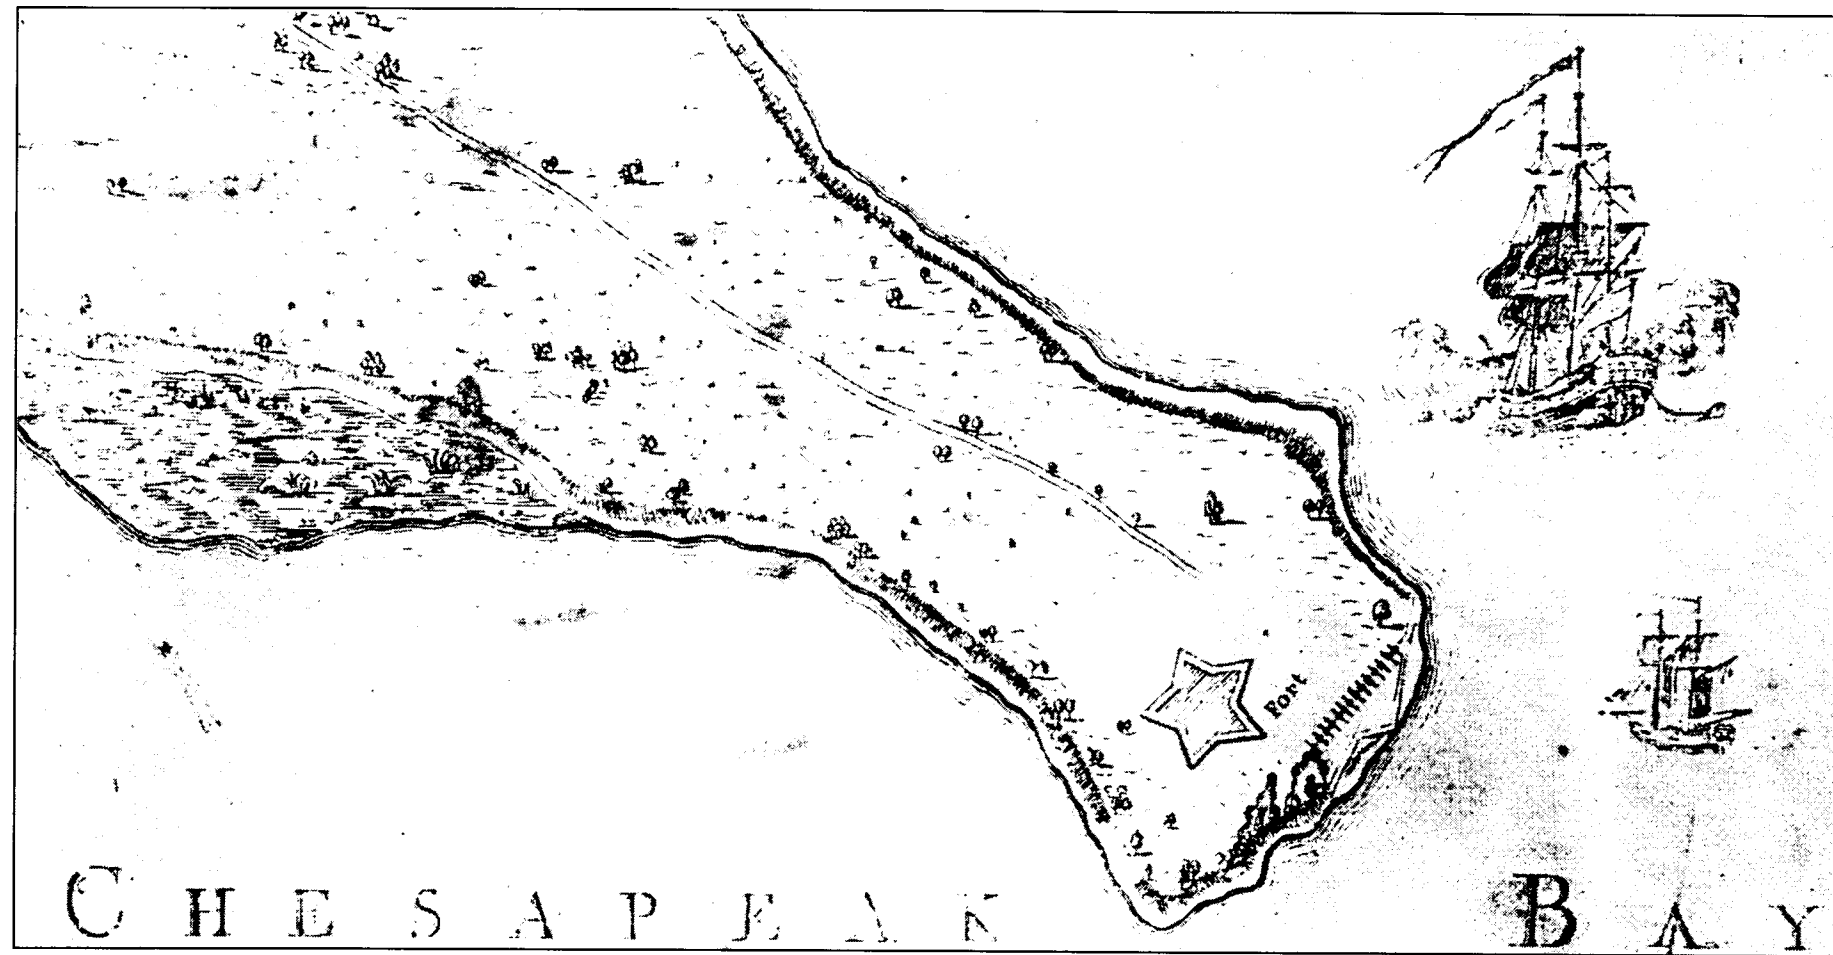
Figure 5. Detail of Folie's *Plan of the Town of Baltimore and Its Environs*, 1792.

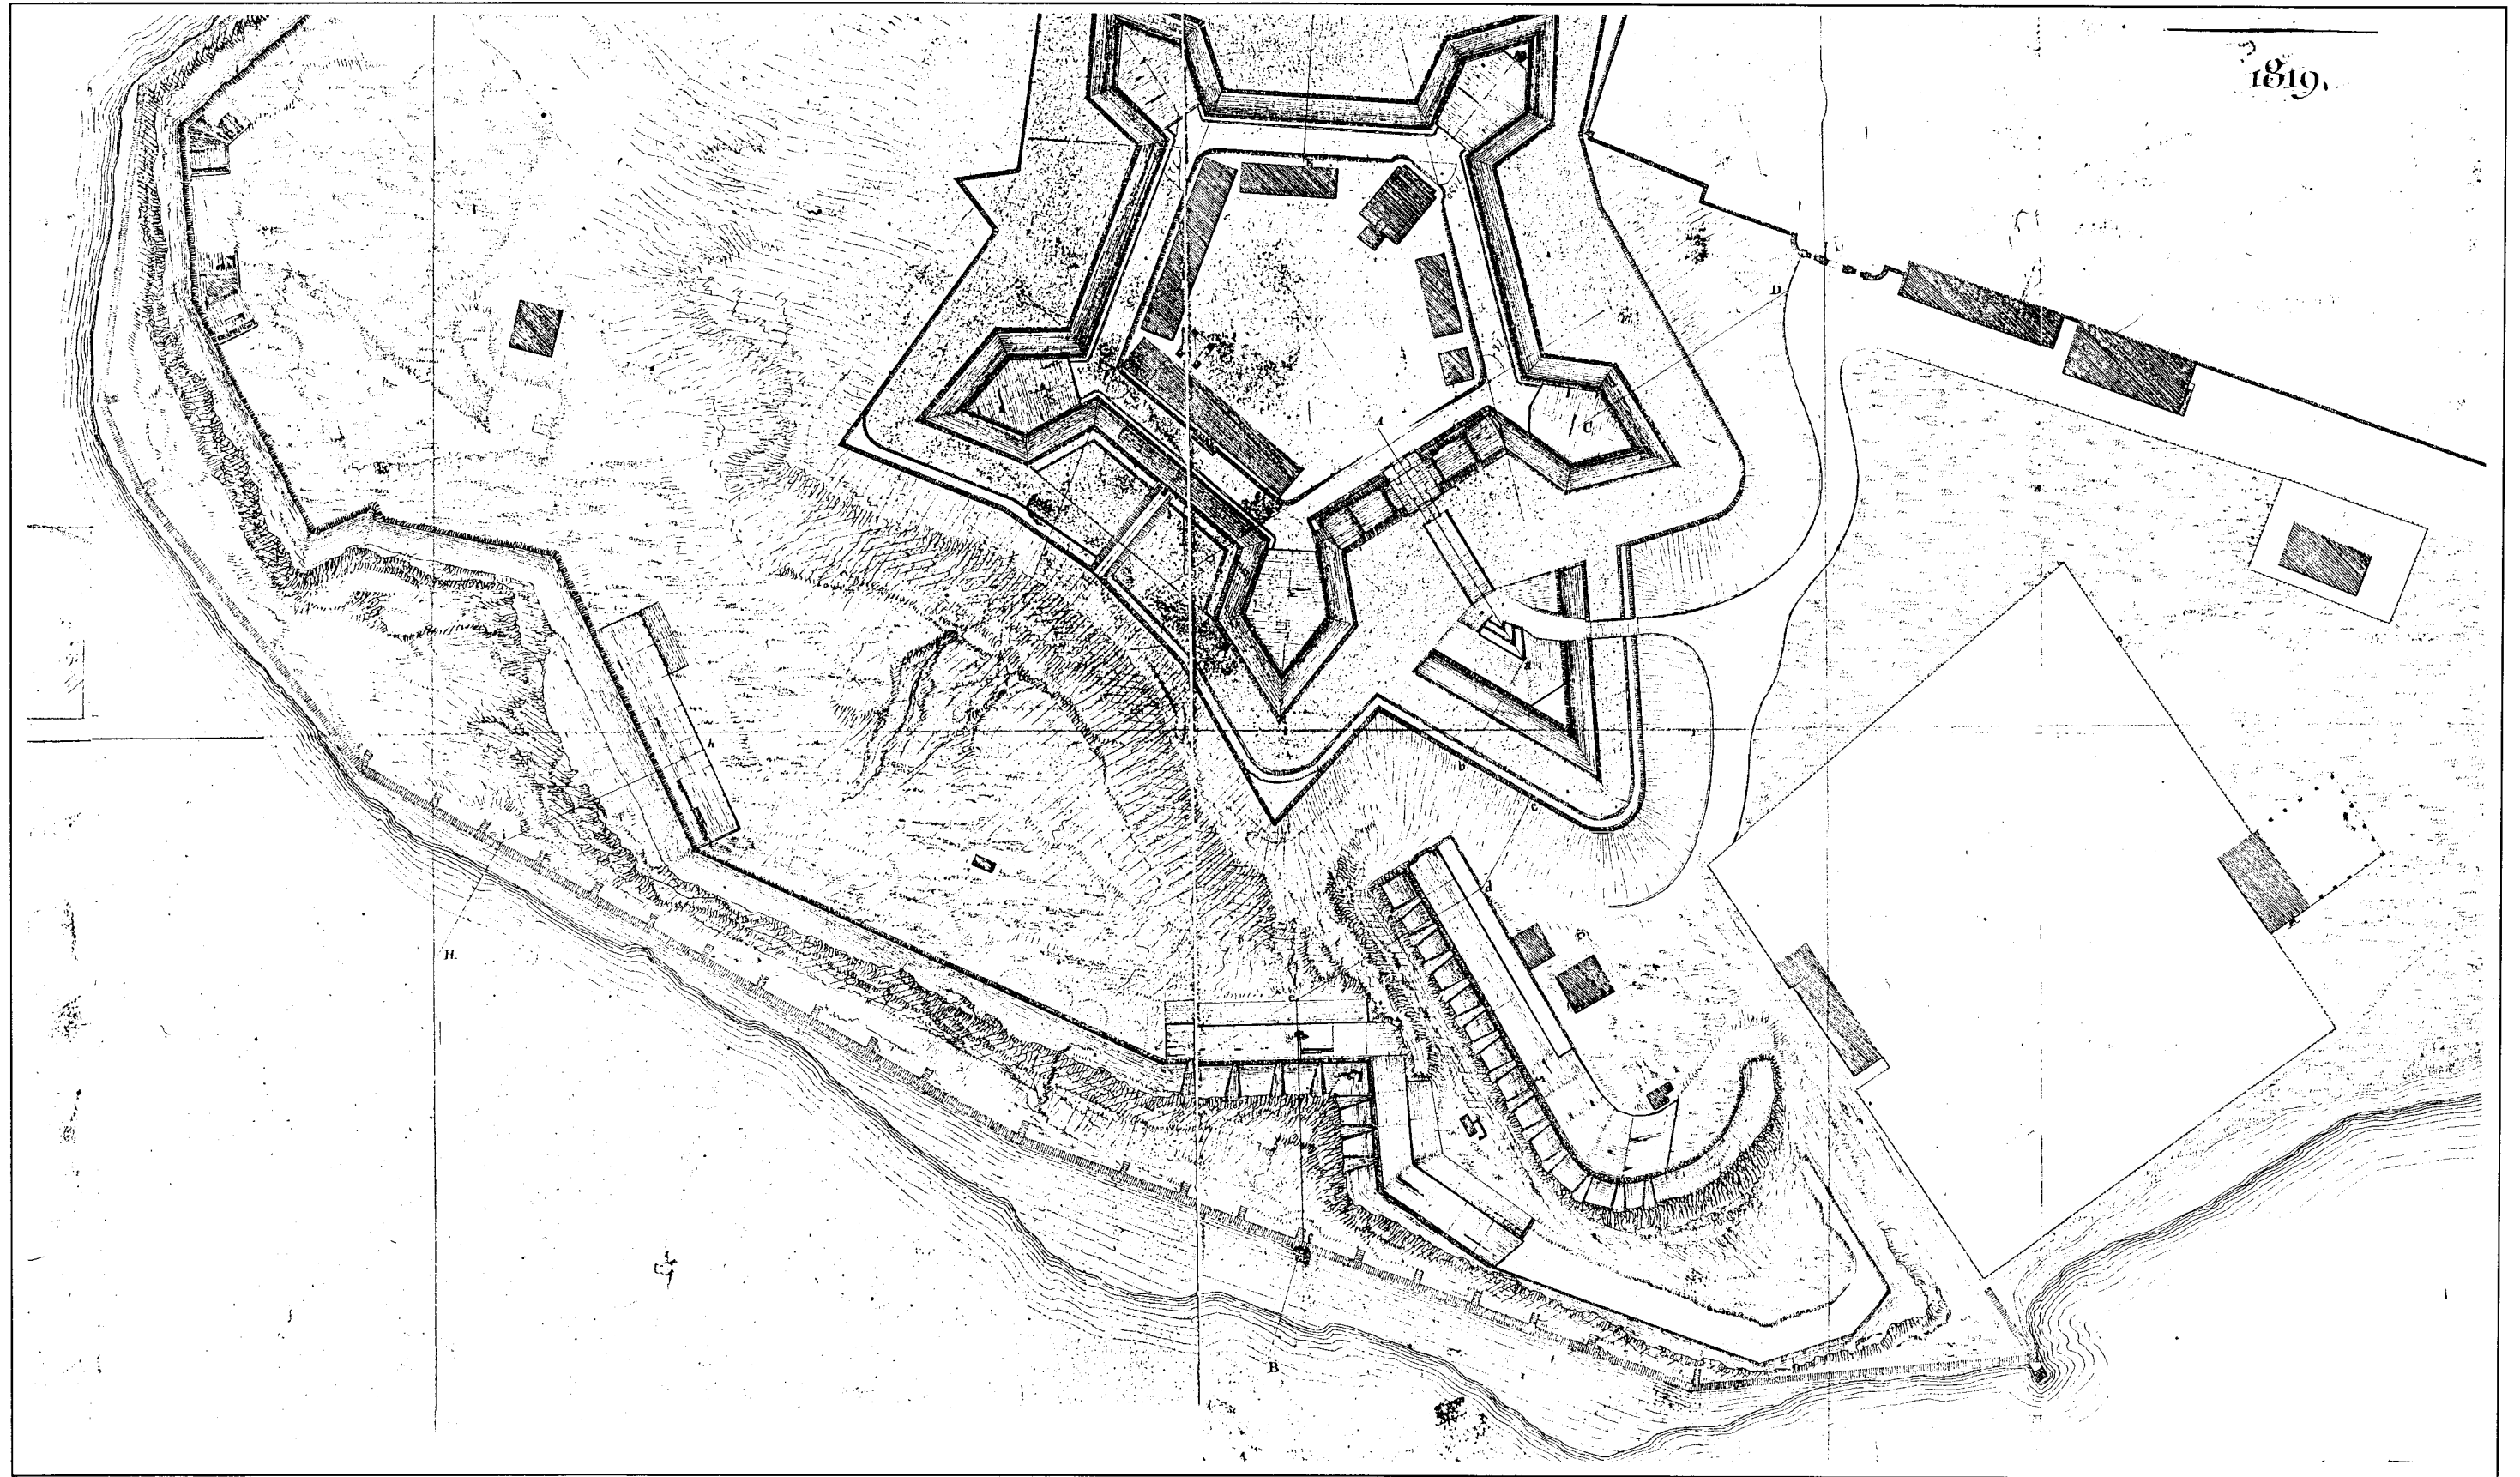
Figure 7. Detail of Capt. William Tell Poussin's *Plan and Profile of Fort McHenry*, 1819, showing the plan of the fort.

The 1819 and 1834 plans, with their hachure-style relief depiction, show the continuation of large-scale landscape modification at the fort. They both document the filling of low ground, that nearest the fort in 1813-14, when the fort's ditch and glacis were completed and the lower battery extended into the area of the point south of the fort. The hillock south of the fort, the site of the fort's original cemetery, is also shown by both plans. The four profiles which accompany the 1819 plan (Figure 18) provide a wealth of elevation data, although much of it is ambiguous due to the apparent underestimation (?) on that plan of the true height of the fort. The ca. 1829-31 removal of the remnants of the water battery parapets, platforms, revetment, etc. is also evident on 1834 plan. One of the reasons given for "graduating the ground around the fort" in 1831 was "to prevent water from standing in low places and becoming stagnant." A "considerable extent of marsh, immediately in front of the fort," was reportedly reclaimed.¹⁷

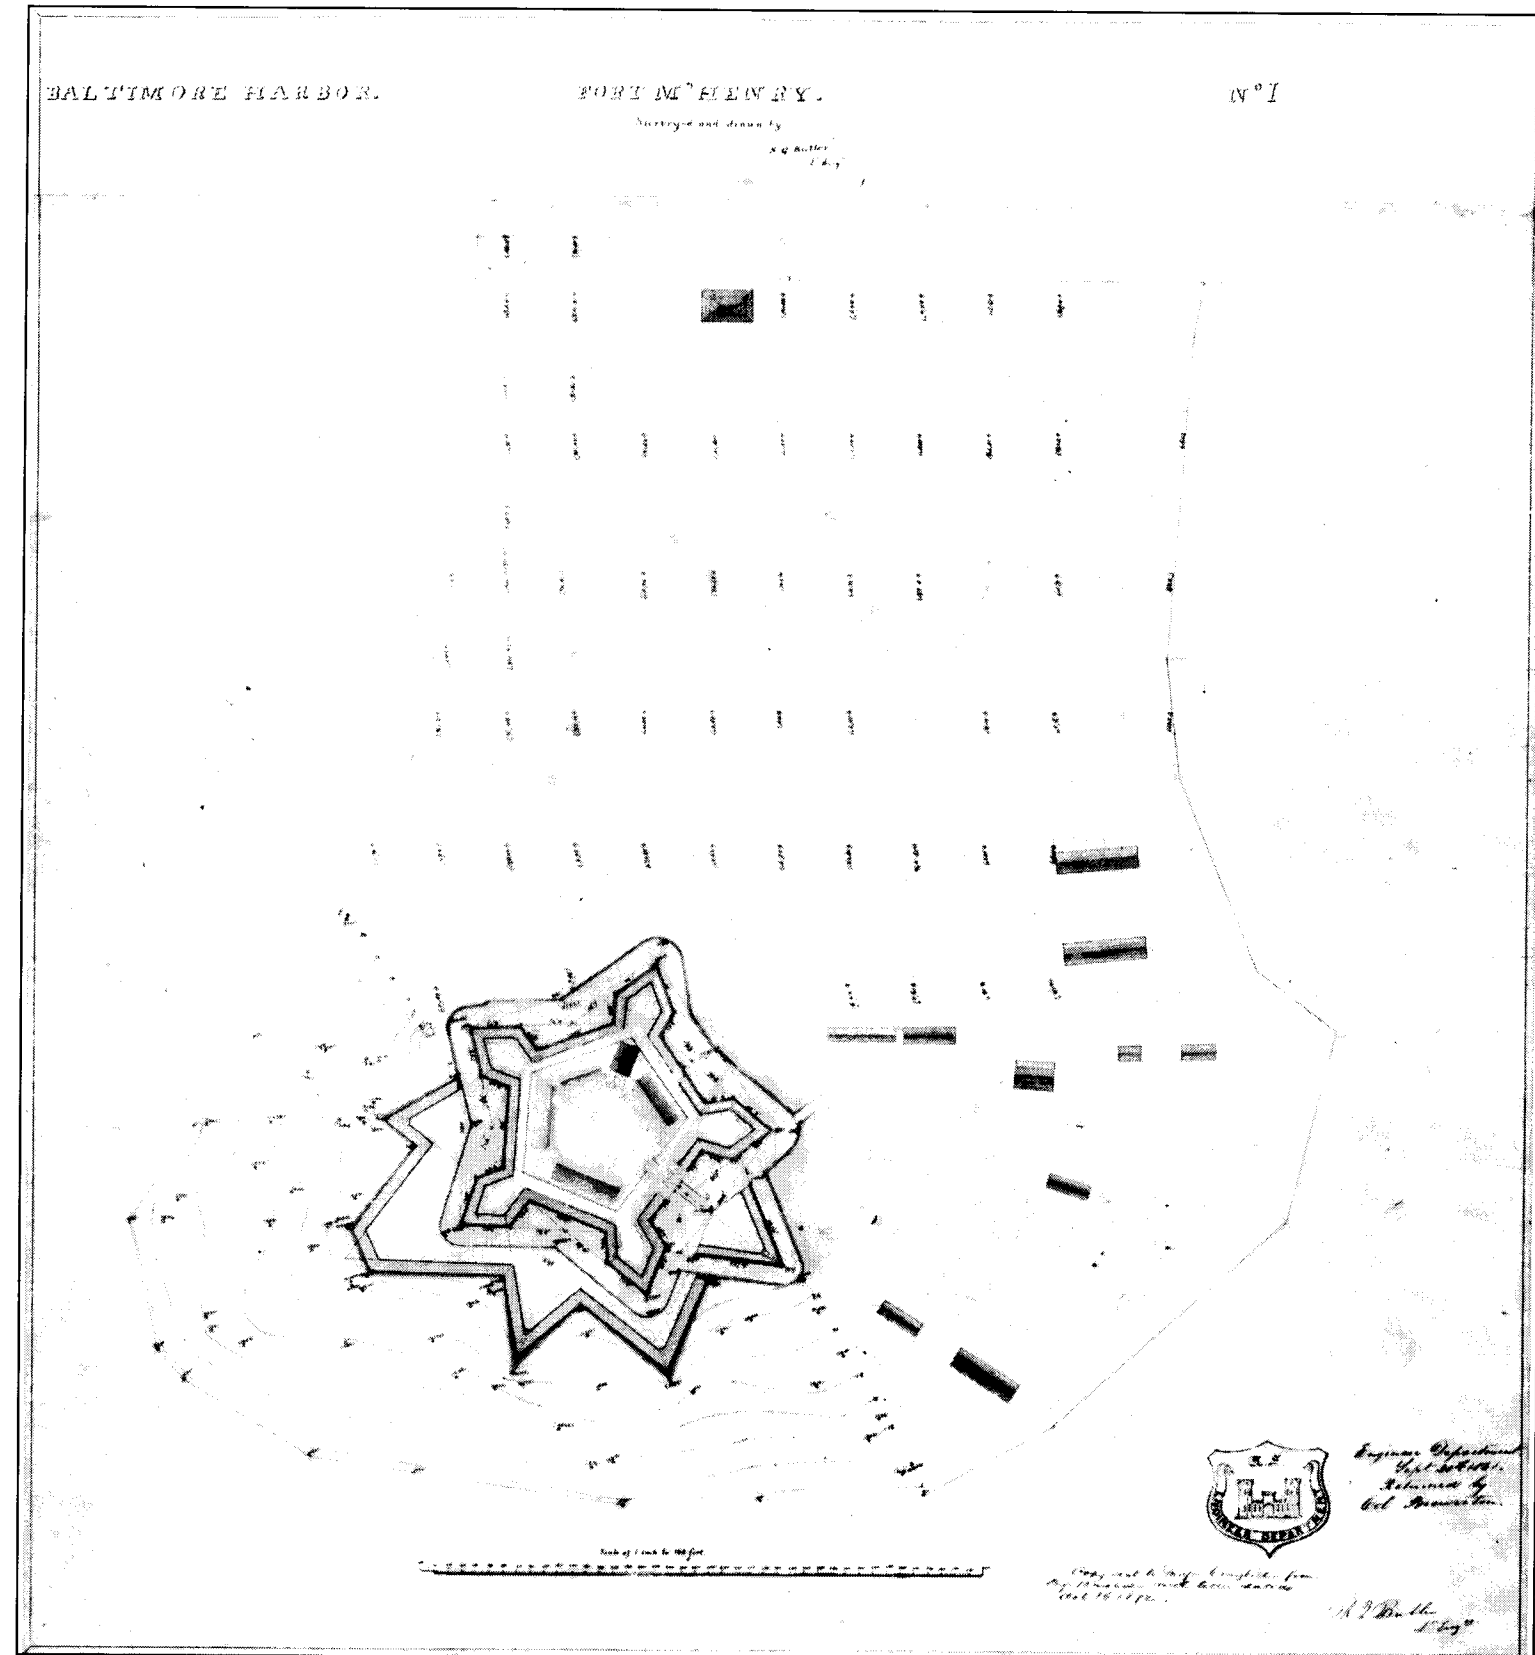
Figure 9. Lt. R. Q. Butler's Fort McHenry, ca. 1840.

Fort McHenry remained the key element in the defensive works protecting Baltimore. Construction of the fort's existing water (outer) battery, was undertaken in the mid-1830s, the original water batteries having been removed ca. 1831, and new guns were mounted in 1840. With the acquisition of adjacent land in 1836-37, the overall size of the fort's property was more than doubled (Figures 9 and 10).

fort's curtains between bastions 3 and 5, and at the shoulders of all the bastions (Figure 9). Of equal importance, work began in 1836 on the existing water (outer) battery.⁶⁶ The slow decay and abandonment of the earlier upper and lower water batteries, a process evidently completed by 1831, had left a gap in the fort's defenses. The new battery, with emplacements for thirty-nine guns (a mix of 24-, 32-, and 42-pounders), was completed in 1840; its two shot furnaces were evidently built in 1842.⁶⁷ As work began on the water battery, the caponniere that had previously extended from the outer end of the postern tunnel and beneath the dry moat and glacis was removed, and in its place an 18 inch diameter cast iron sewer was laid extending beneath the moat and the water battery out to the seawall. Previously, at some point between 1819 and 1834, a brick 'sewer' had been built between the outer end of the (truncated) caponniere and the seawall, along a more easterly alignment than the later cast iron sewer.

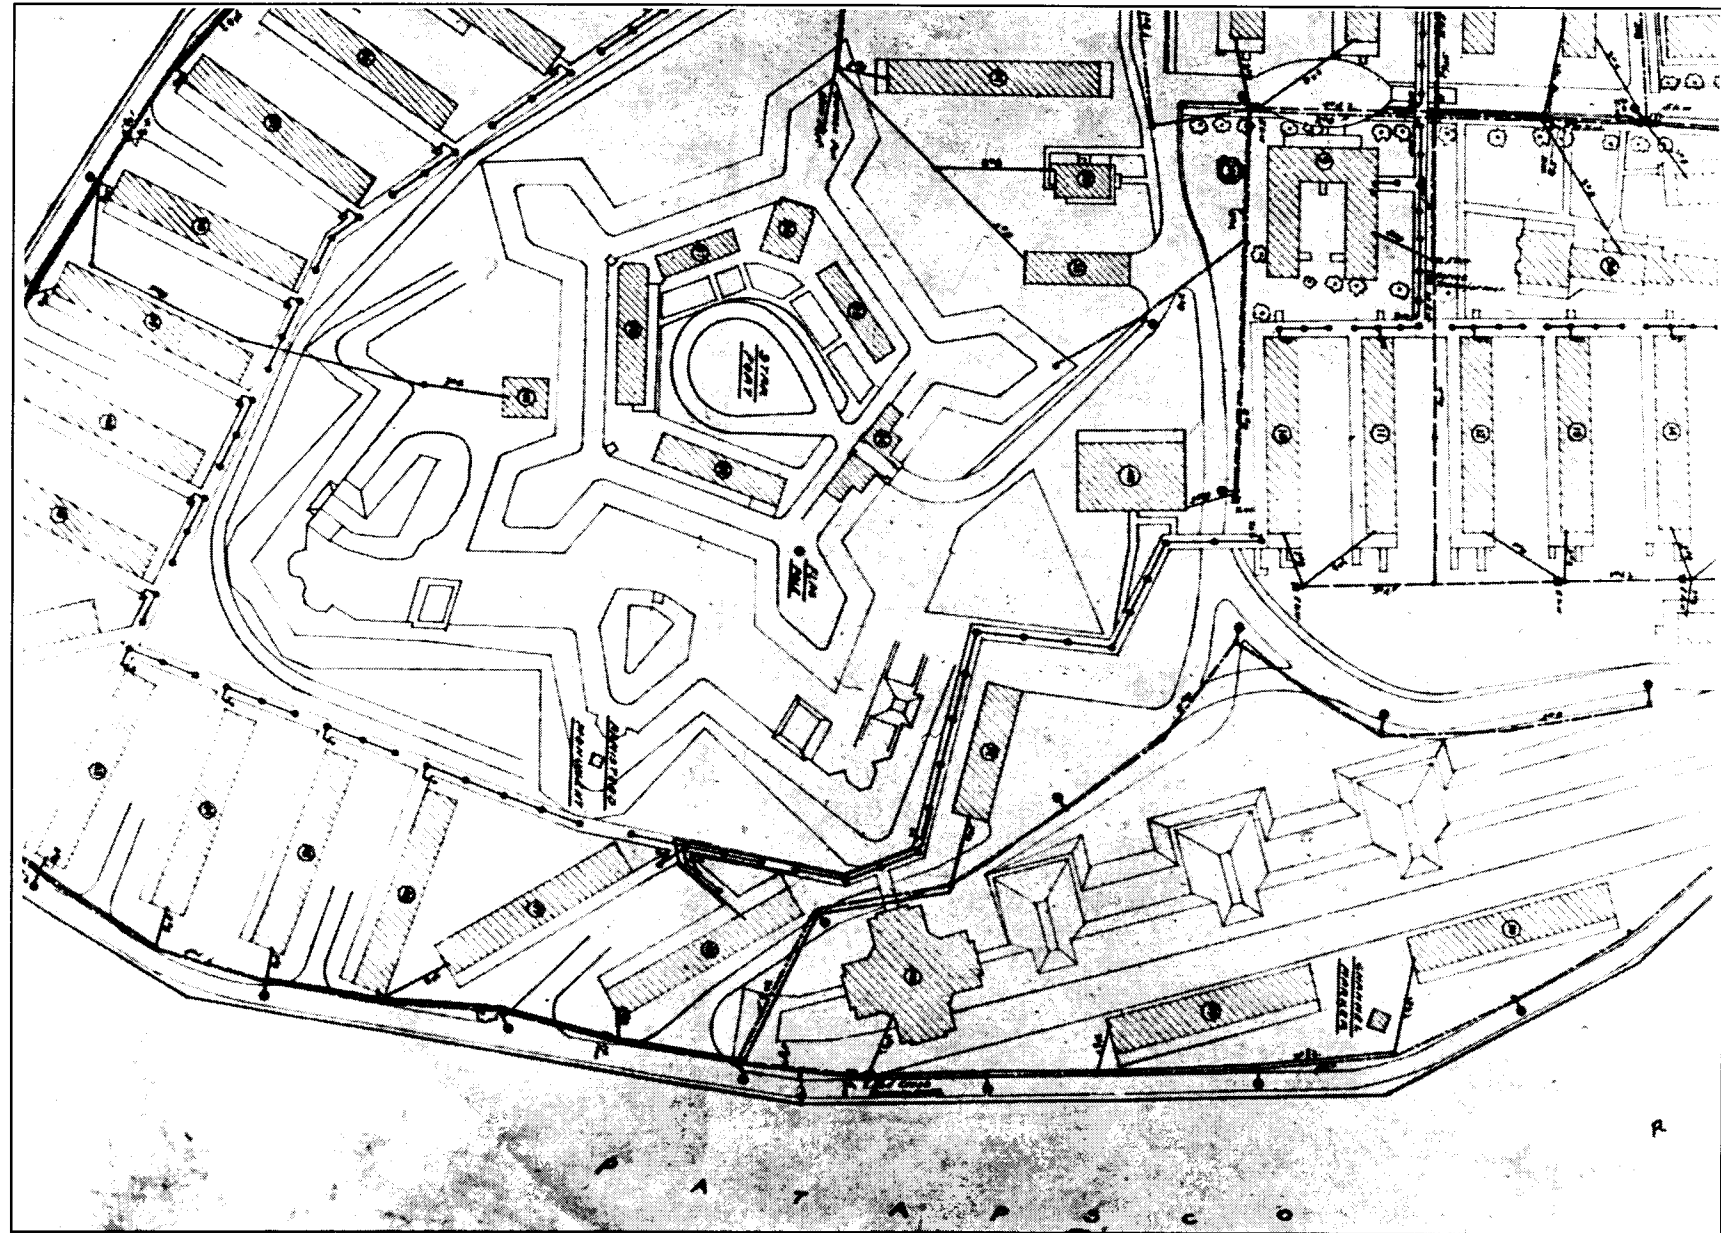
Figure 14. Detail from an electrical system plan, data from Toltz's *General Hospital No. 2, Fort McHenry*, 1917-18.

Fort McHenry remained a military post until 1912, but in its final years functioned only as a garrison. For two years the fort was unused, but in 1915 Baltimore assumed control and established a city park at the fort.⁴³ The army returned in 1917 and Fort McHenry became the site of intense construction activity. U.S. Army General Hospital No. 2, a hospital complex consisting of over 109 buildings with 3,000 beds, was built on the fort grounds.⁴⁴ The star fort, water batteries, and Civil War magazine were minimally affected by construction, but other structures and the grounds elsewhere were extensively altered (Figure 14).

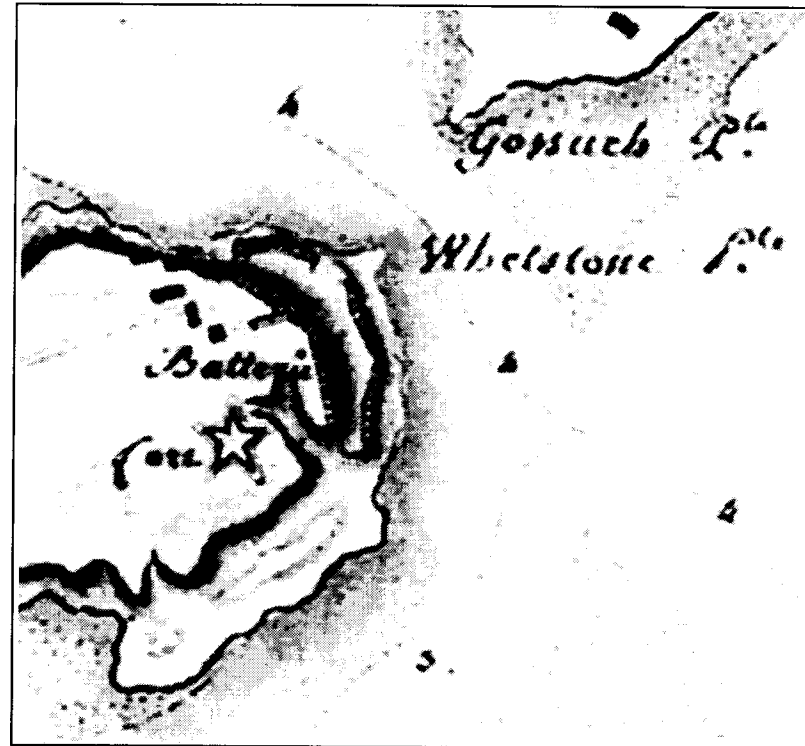
Figure 17. Detail of Berthier's *Port et Rade de Baltimore*, 1782.

The 1782 Rochambeau collection map (Berthier 1782) shows Fort Whetstone, the original earthen redoubt at the site, configured as a 'true' heraldic star, situated on the southeast edge of a plateau at the east end of Whetstone Point (Figure 17). Surrounding this plateau there appears to have been a somewhat less-elevated terrace or bench, on the northeastern part of which the fort's upper water battery had been constructed. Grade was lower still, of course, toward the shoreline of the point, where the lower water battery was located. Intruding into the terrace at the south end of the upper water battery, east of the star fort, is what looks like a small ravine. This ravine-like feature is likely to have been created in establishing a roadway to facilitate communication among the three elements of the fortifications: the redoubt on the plateau, the upper battery on the terrace, and the lower battery along the shoreline. Rivardi's 1794 letters to the Secretary of War and the Governor of Maryland imply this,⁶ but they also suggest that exposure of iron ore deposits in the area had encouraged additional excavation, between 1781 and 1794, to exploit the ore. Along the shoreline south and southwest of the fort there were small hillocks, most likely remnants of the once larger terrace, isolated as a result of erosion or earlier mining activity. Rivardi remarked, in his letter to the Governor, that the easternmost of these hillocks functioned as an epaulement for the right flank of the lower battery. The 1819 and 1834 plans of Fort McHenry indicate that remnants of a hillock to the fort's south served as the site of the fort's original cemetery, prior to its ca. 1836-37 removal.

the fort's existence. As discussed above, Berthier's map (Figure 17) indicates the notable original topographic features at the site: the high-ground plateau at the southeast end of Whetstone Point, with elevations of about 30-35 ft. amsl; an uneven, presumably sloping terrace or bench at the margins of the plateau, with elevations of 15-30 ft. amsl; and a low-lying shoreline area, with elevations of 5-15 ft. amsl. Also depicted, in addition to the fortifications themselves, are hillocks within the area of low ground south and southeast of the redoubt, and what is likely to have been an artificial cut into the terrace, made for the purpose of communication among the fortification components. The low ground, as a distinct element of the landscape, had very likely been at least partially produced by earlier mining activity, accompanied by erosion.

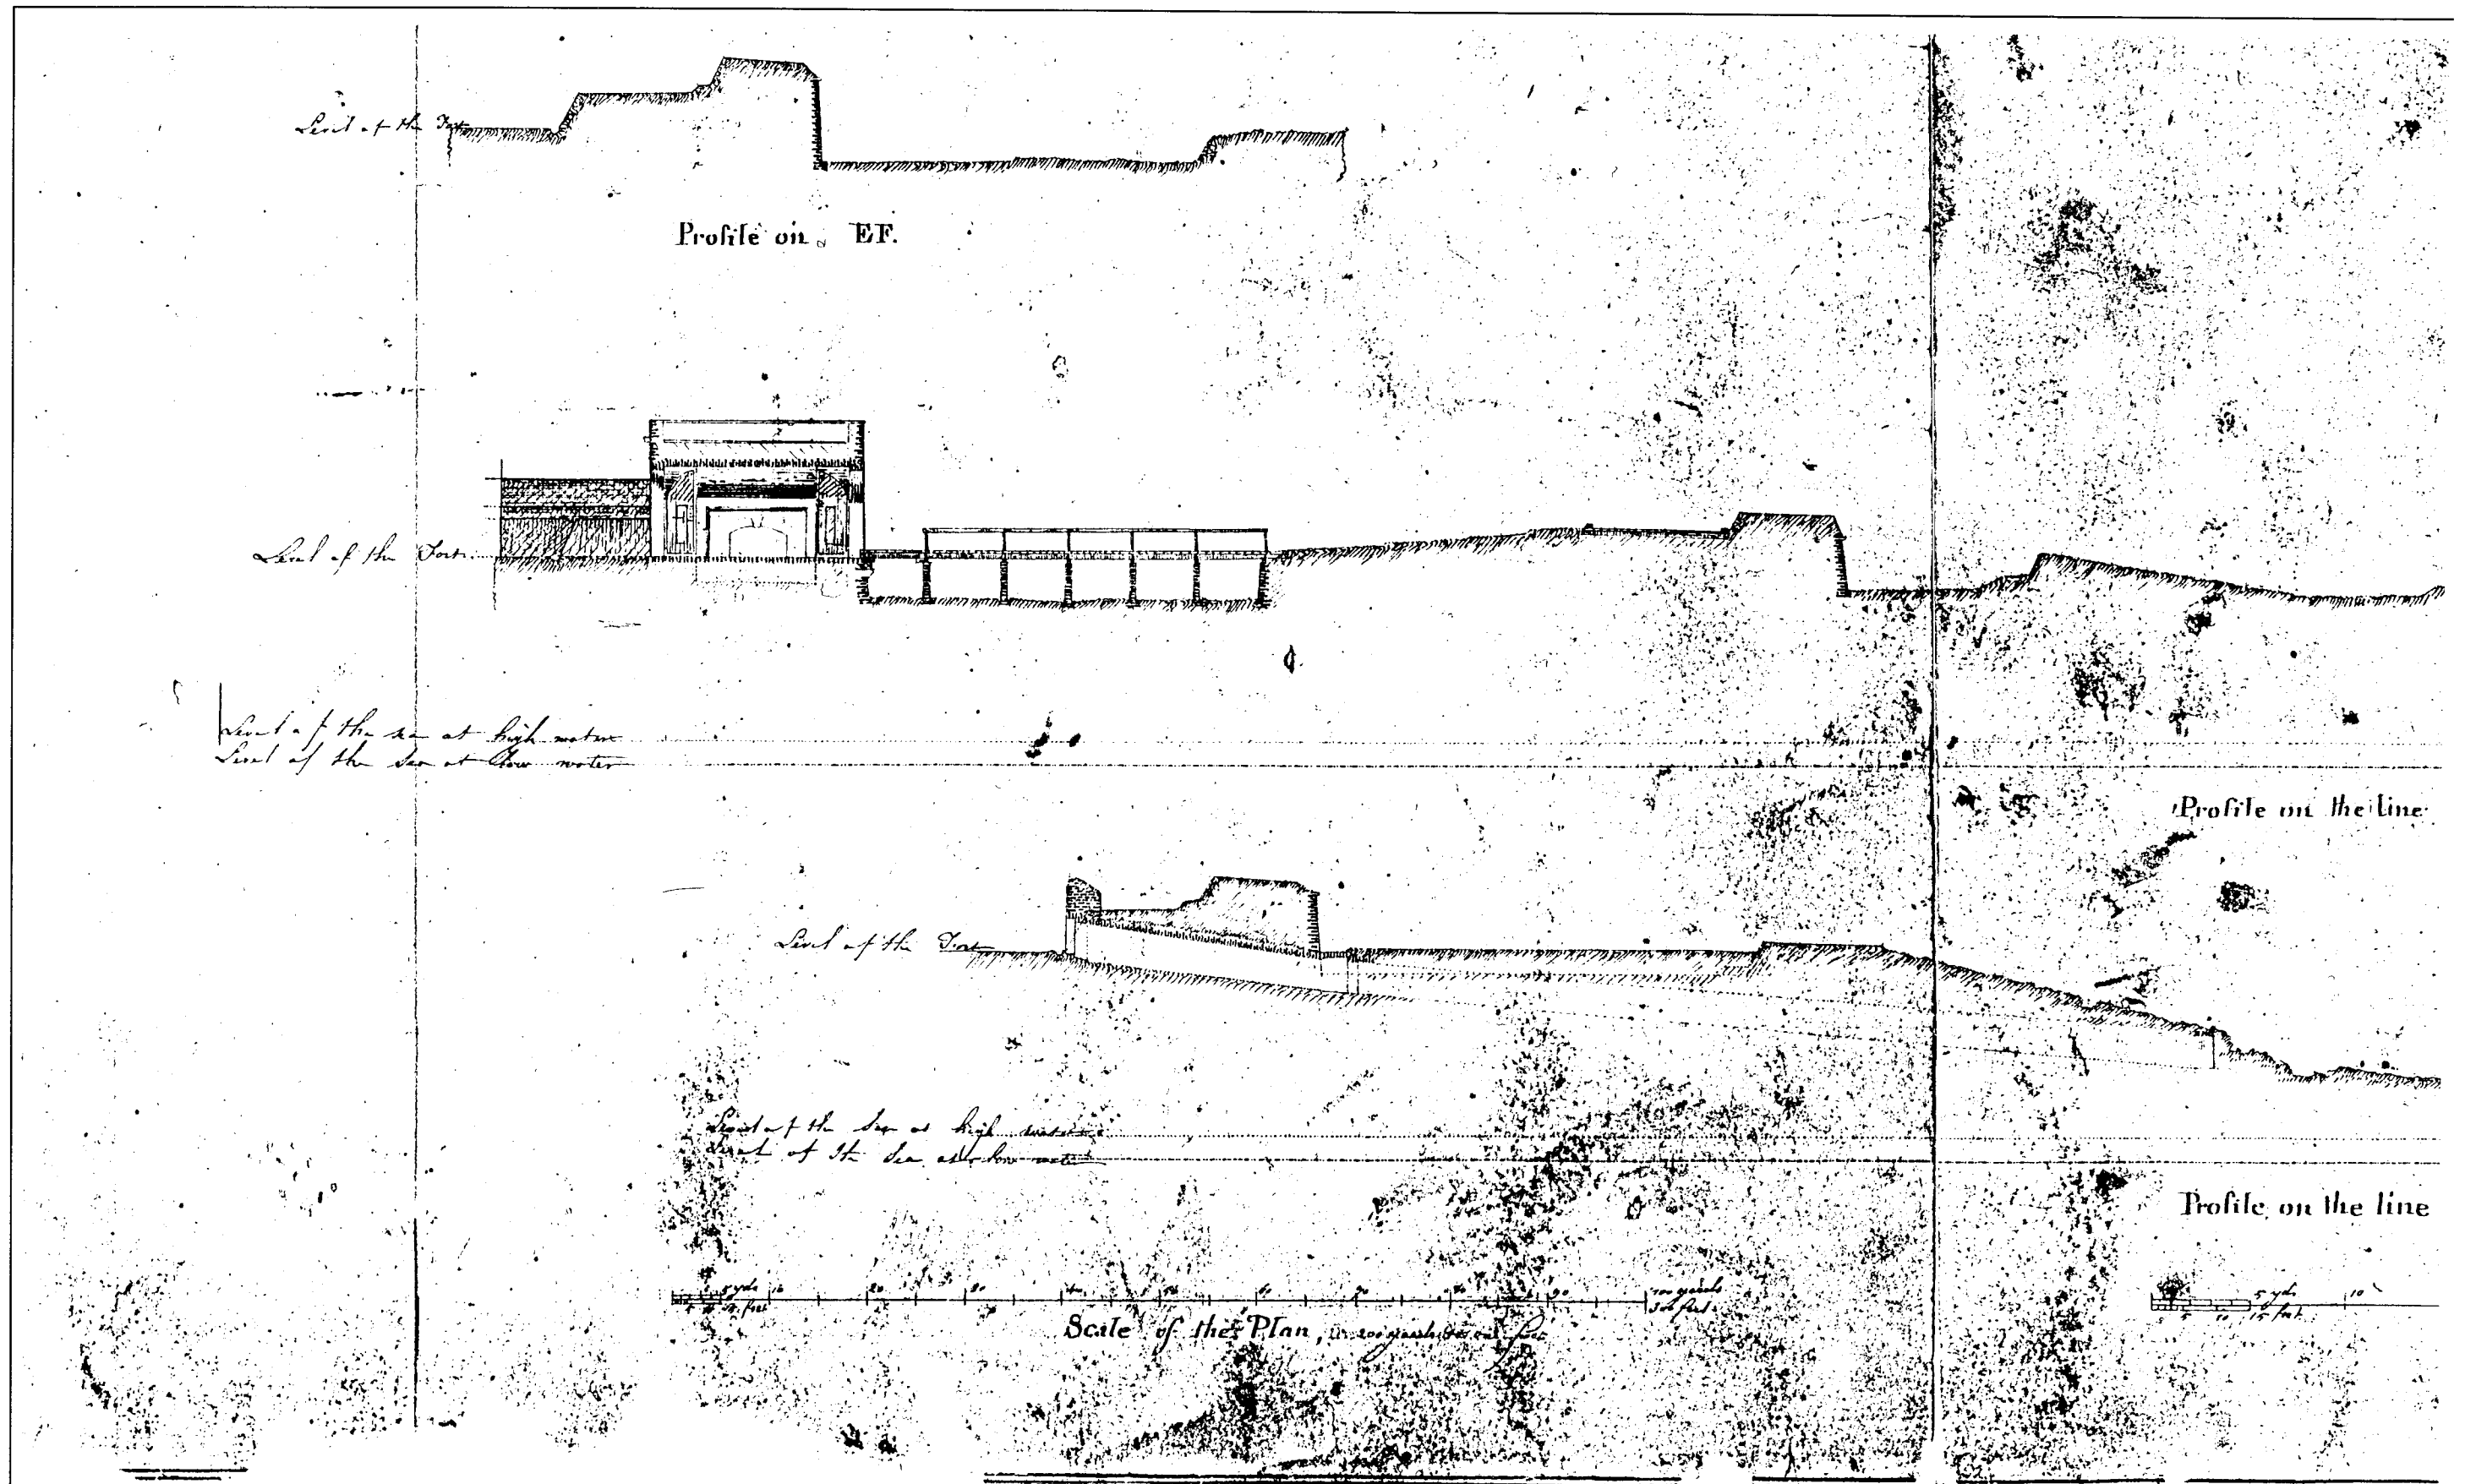
Figure 18. Detail of Capt. William Tell Poussin's *Plan and Profiles of Fort McHenry*, 1819, showing profiles: Aa...fB through sally port, gorge,
