“On the shore dimly seen...”: an Archeological Overview
Fort McHenry National Monument and Historic Shrine
Baltimore, Maryland

Charles D. Cheek, Ph.D.
Joseph Balicki
and
John Pousson

John Milner Associates, Inc.
5250 Cherokee Avenue, 4th Floor
Alexandria, Virginia 22312

2000

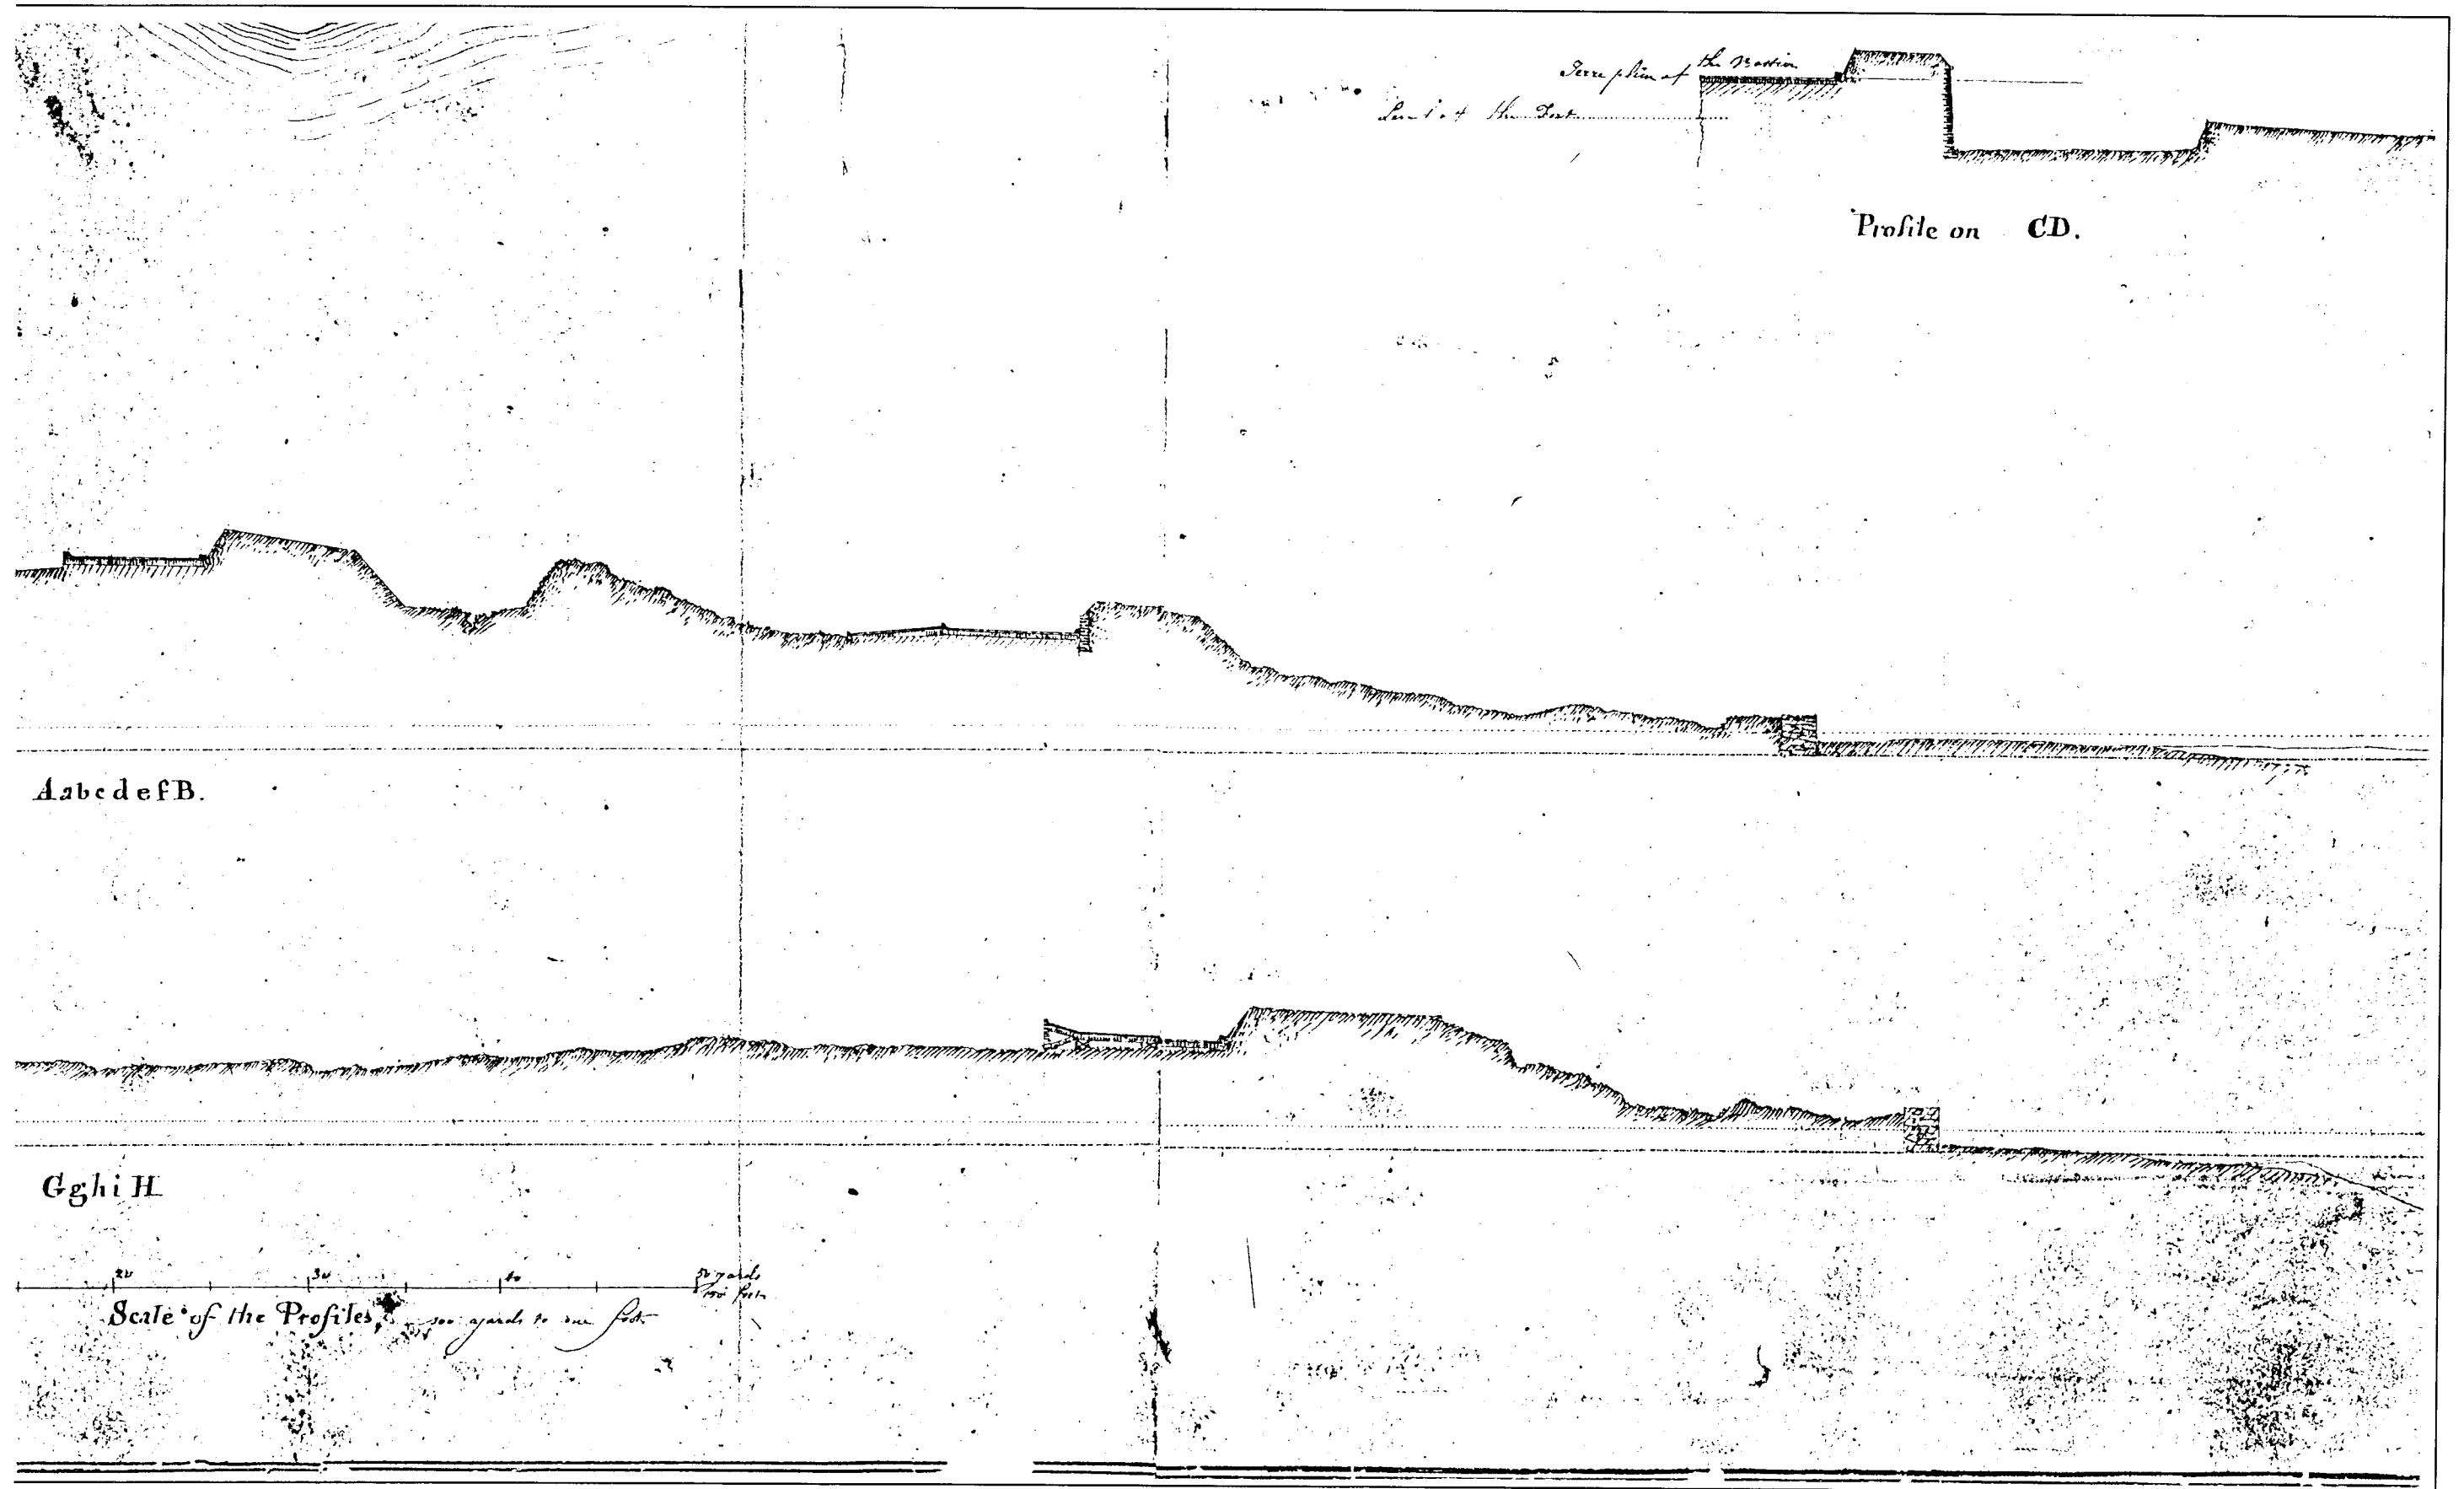
Figure 18. Detail of Capt. William Tell Poussin's *Plan and Profiles of Fort McHenry*, 1819, showing profiles: Aa...fB through sally port, gorge,

ravelin, and water batteries; CD through left face of bastion 1; EF through bastion 2-3 curtain; Gg...iH through postern, moat (caponniere), glacis, and lower water battery.

The scarp wall's height may have been altered slightly when the coping stones were replaced, but historical alterations of grade within the moat, particularly between the fort and the outer battery, are likely also to have contributed to changes in the wall's relative height. The 1819 profiles (Figure 18) indicate that the scarp wall coping was about 12-13 ft. above the moat. Although a profile detail on a ca. 1833-34 plan indicates a 14.5 ft. height for the wall's coping, an 1836 profile (Figure 22) indicates a height of 13.5 ft. in one location, while the plan it accompanied (Figure 19) documents, with spot elevations, that there was roughly 1.5 ft. of variation in the moat's absolute height. Profiles prepared in 1837 and 1839 indicate coping heights of between 13 and 14 ft. (There are discrepancies, however, in the latter profiles, between the configuration of features as drawn, and as indicated by the stated dimensions and annotated elevations within the drawings. Some of the dimensions in the 1840 profiles indicate, for instance, that the scarp wall coping was about 8 ft. above the level of the parade, rather than the 6.5 ft. which the drawings by themselves suggest, and more nearly level with the banquettes than with the terreplein. This naturally raises questions regarding the drawings' precision.)

In any case, one of the 1819 profiles, keyed E-F and located at the center of the curtain between bastions 2 and 3, depicts a 20 ft. wide terreplein (although the accompanying plan indicates an 18 ft. width), 5.5 ft. above the higher, northwestern part of the parade, and 2.25 ft. below the level of the scarp wall cordon. Another 1819 profiles, keyed GghH, and located at the center of the curtain between bastions 4 and 5, has the terreplein, about 17.5 ft. wide, situated 6.5 ft. above a lower part of the parade (where drainage from the parade emptied into the postern), and 2.8-3 ft. below the

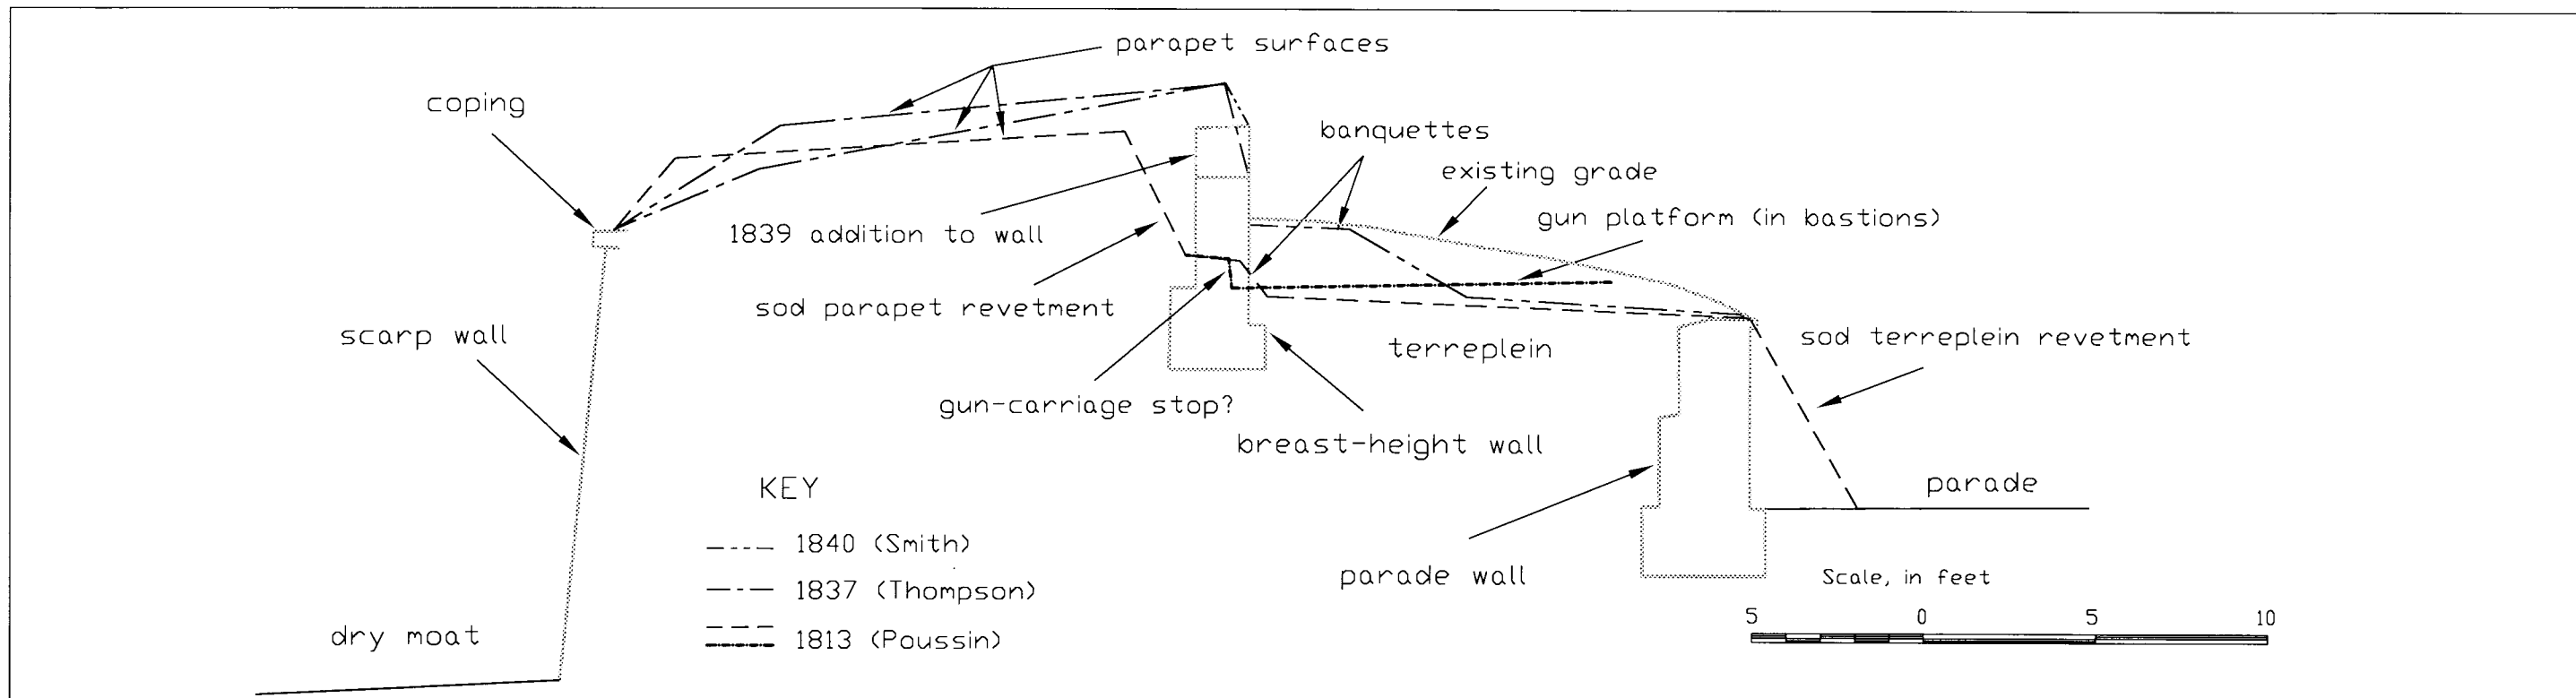
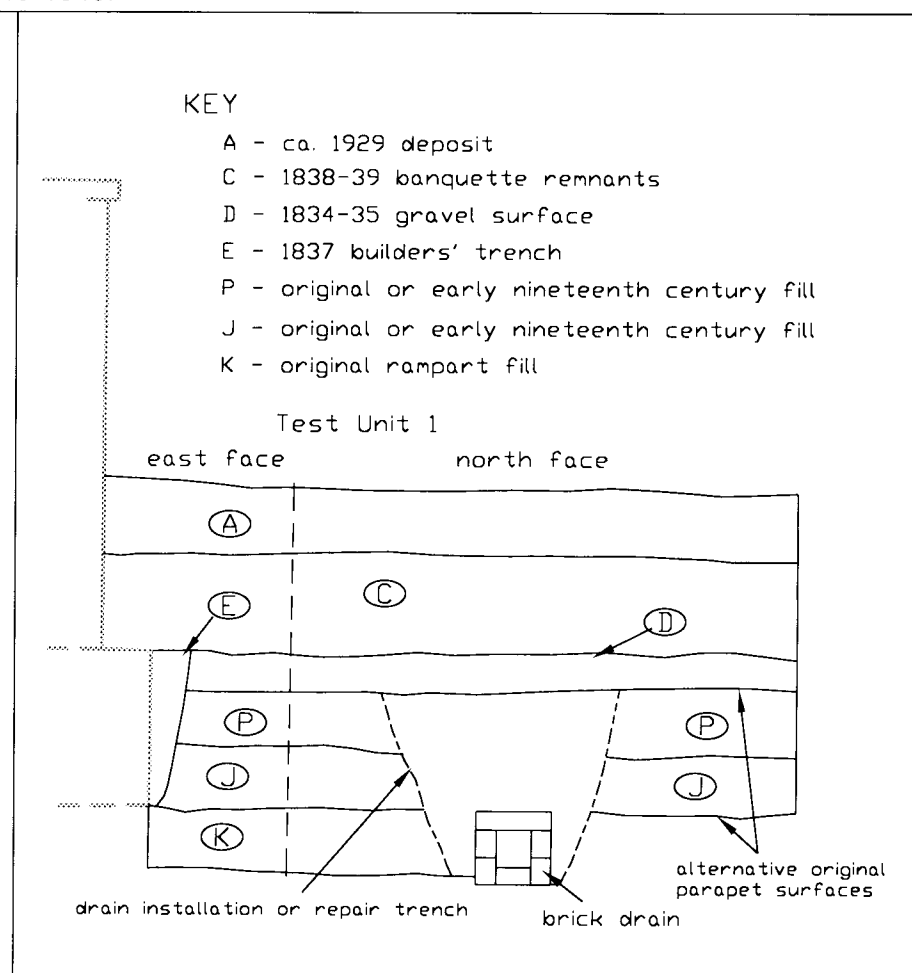
Comparative overlay of historical cross-sections of Fort McHenry's parapet and terreplein, 1819-1840.

Composite archeological profile of Fort McHenry's parapet (Joseph and Cheek 1985: Figure 12)

Reflected profile of terreplein excavation (Cheek et al. 1989: Fig. 4-14)

Figure 21. Comparative overlay of historical cross-sections and archeological profiles of Fort McHenry's parapet and terreplein.

Profiles on Thompson's 1837 plan of the fort indicated the terreplein of bastion 4 was 4.5 ft. above the level of the parade, while the terreplein along the curtain between bastions 1 and 2 was 5.5 ft. above the parade; in both locations the terreplein was depicted as being at the same level as the scarp wall coping. Similar profiles are included on Smith's 1840 plan, which documents the 1839 heightening of the top of the breast-height wall by 1.5 ft. Again, however, there are discrepancies in the 1840 profiles. The dimensions noted within the drawings suggest that the cordon, relative to the fort's interior features, was 1-1.5 ft. higher than as depicted, roughly 8 ft. above the level of the parade, rather than 6.5 ft., and more nearly level with the banquettes than with the terreplein. What the dimensions in the profiles of 1840 indicate, more so than the graphics themselves, is that by comparison with the 1819 profiles, a slope, down from the banquettes to the parade wall, had been established along the curtain walls between the bastions, by deposition of .5-1 ft. of fill along the breast-height wall side of the terreplein, not including the banquettes (Figure 21A).

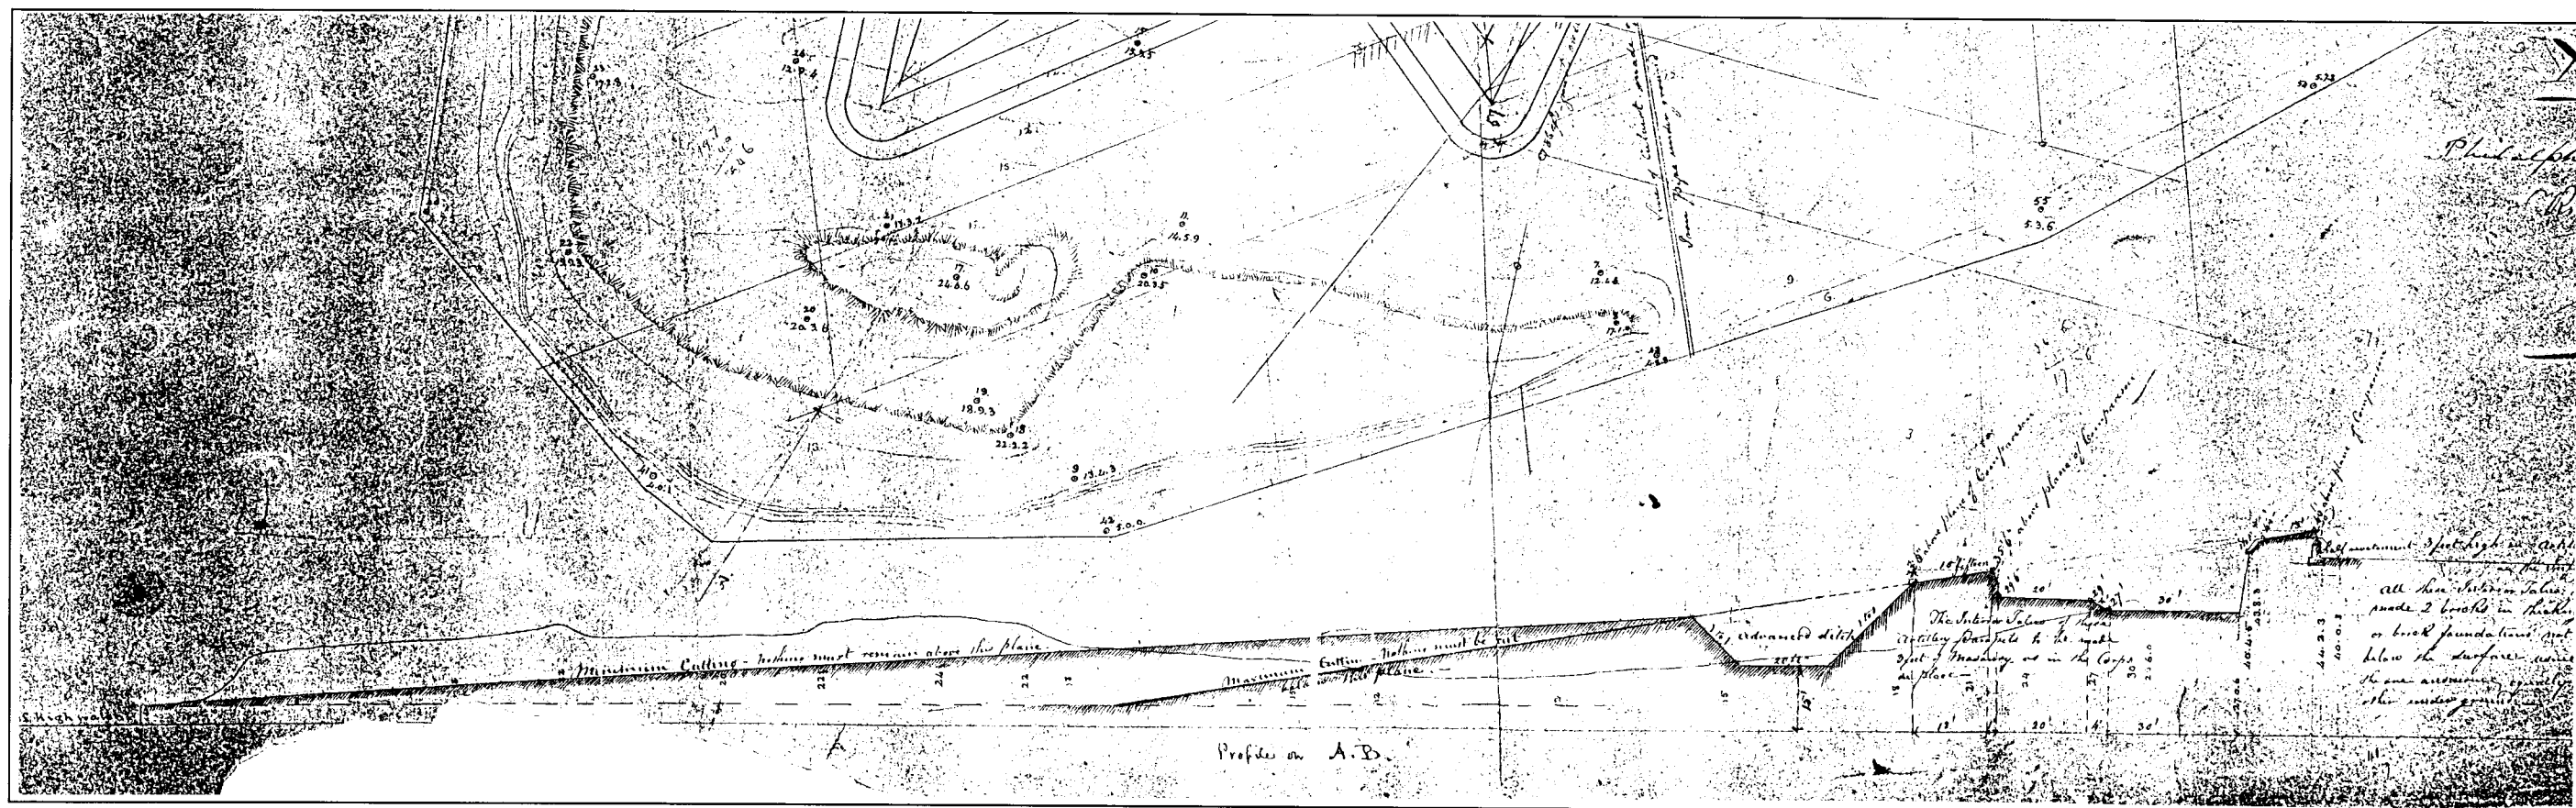
Figure 22. Detail of Capt. Richard Delafield's Project for an exterior battery to Fort McHenry, 1836, showing the profile of the fort and battery.

The crest of the parapet as depicted in the 1819 profiles was approximately 3.5-4 ft. higher than the level of the infantry banquettes, 5-6 ft. higher than the terreplein, 11-12 ft. higher than the fort's parade, and about 39-40 ft. above a high water datum (Figure 22). The precision of all these elevations is questionable, however, and they must be used cautiously. Delafield's 1836 plan and profile (Figure 19 and 22) give elevations for the parade (a surface then not significantly changed from that of 1819) of 33.9-34.5 ft. above high water, compared with the implicit 1819 elevation for the parade of about 28 ft. above high water. The 1836 elevations for the pre-revetment wall parapet were in the 43.8-44.25 ft. range, a height of about 2.5-3 ft. above the cordon and 10 ft. above the parade. It appears that the 1819 profiles generally understate elevations, of at least the higher surfaces and features, by about 5 ft.

As first illustrated in the 1836 plan and profile, the breast-height wall was designed as a "half revetment 3 feet high on artillery parapets and 2 [ft.] 3 [in.] high (above plane of Banquettes) on the infantry parapets," with a foundation which extended 2 ft. below grade (Figure 22). Thompson's 1837 plan and profiles depict the initial construction of the wall, to a height of only 1.5 ft. above the banquettes, while Smith's 1840 plan and profiles document the final as-built characteristics of the wall, as modified by an increase in its height in 1839 to 2.9-3 ft. above the banquettes (Figure 23). With only minor exceptions, the archeological investigations of the parapets, the terreplein, and bastion 3 and 4 confirm the basic reliability of the documentary record.⁵³

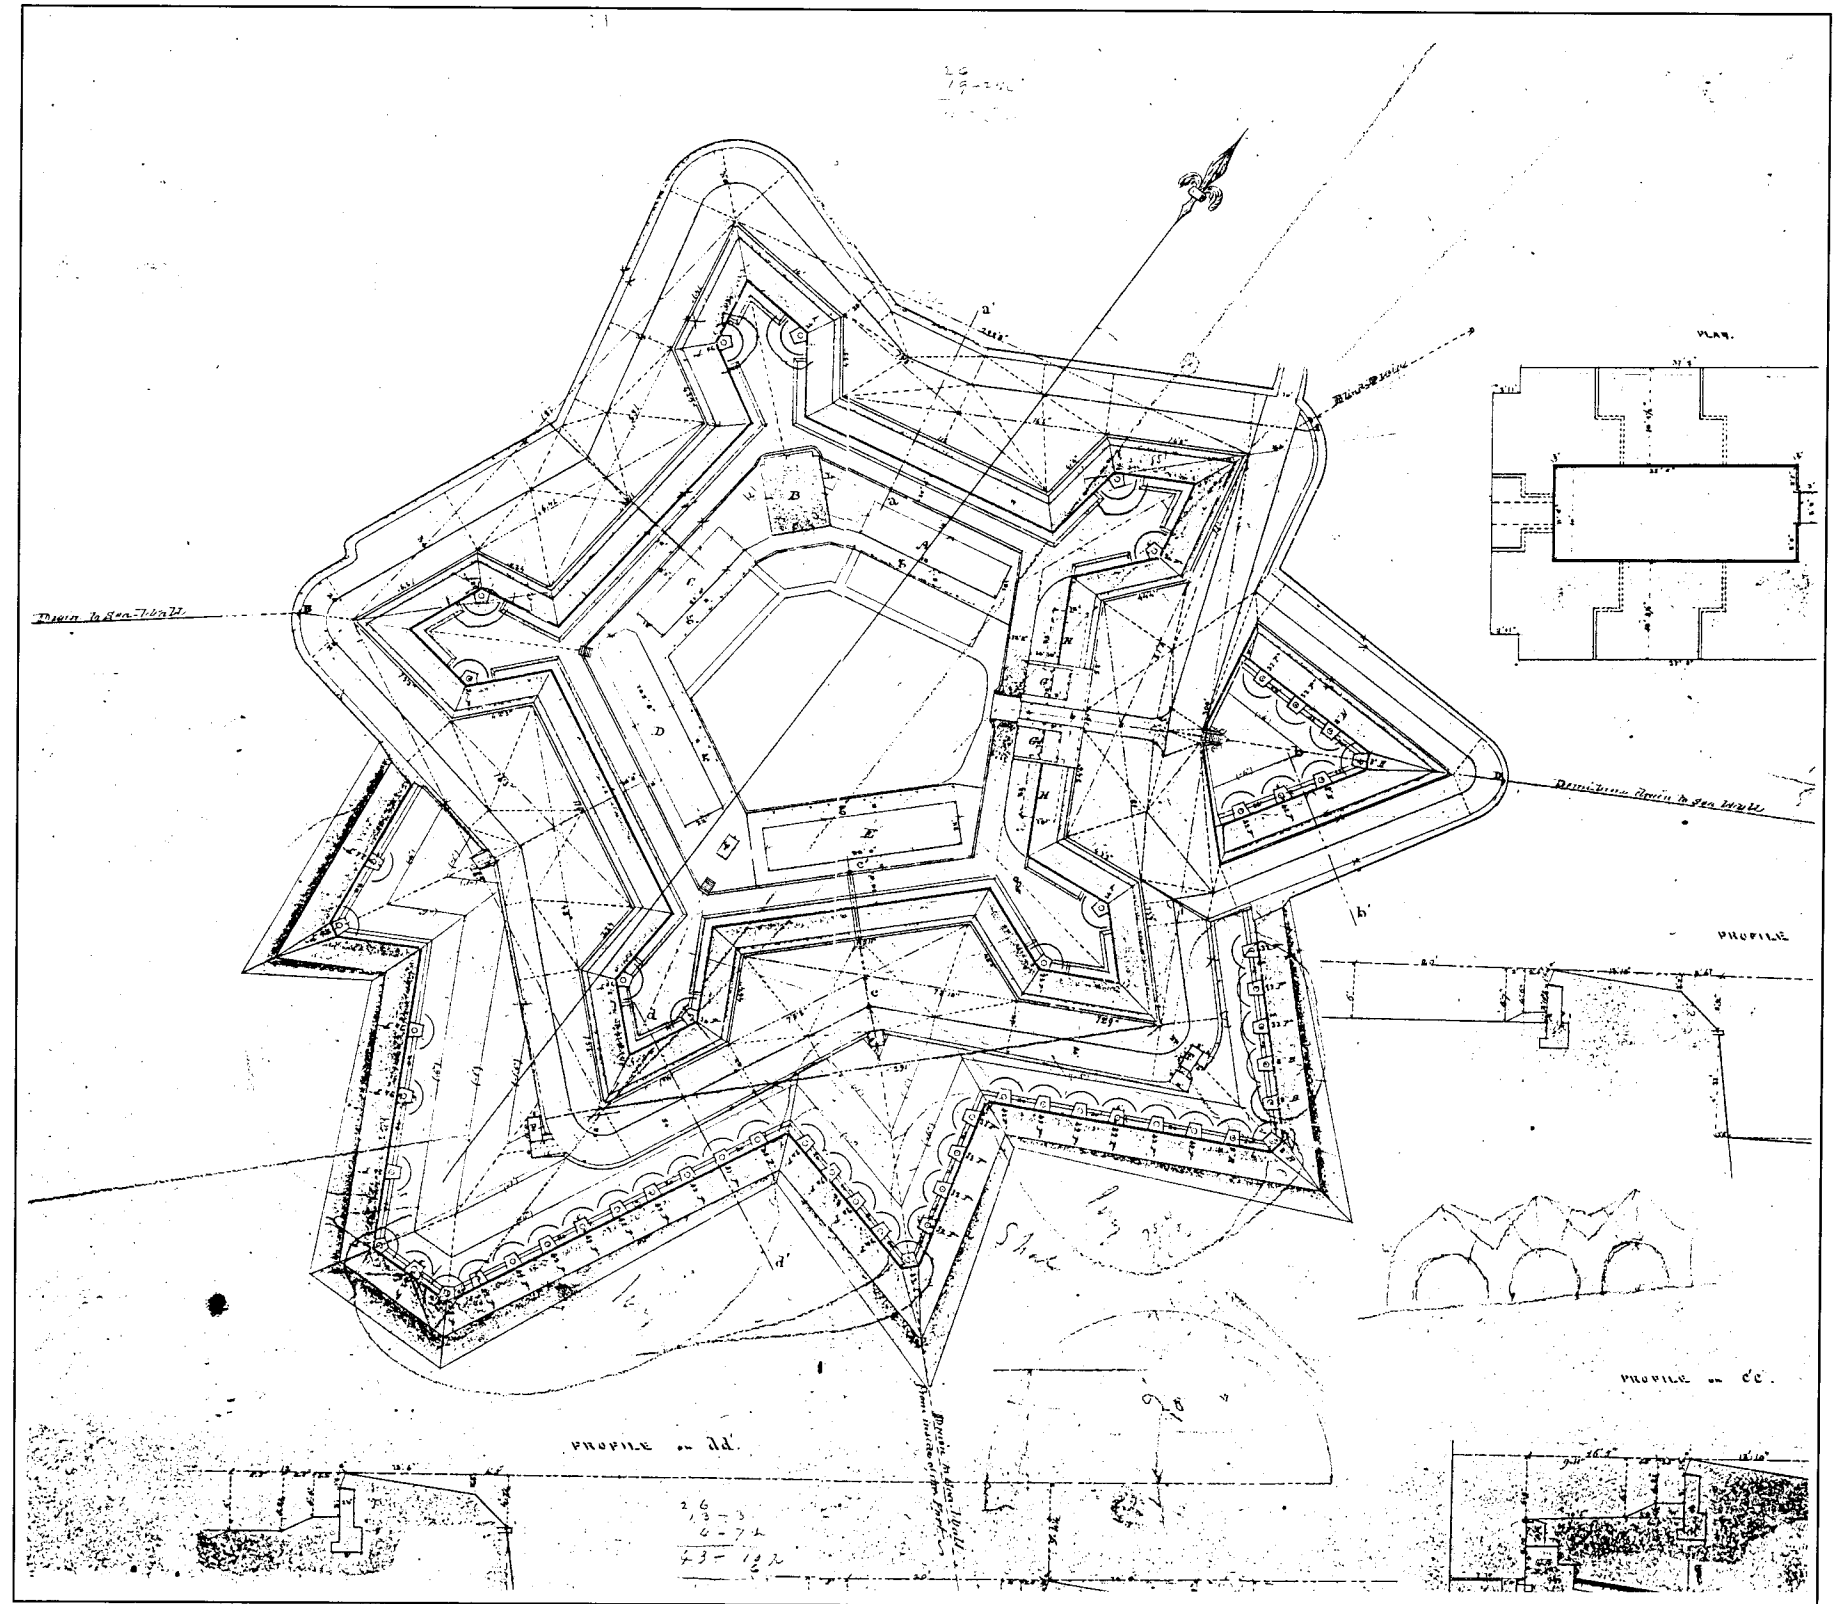
Figure 27. Detail of Capt. Fred A. Smith's *Fort McHenry, Baltimore*, from dimensions furnished by Capt. Henry A. Thompson, 1840.

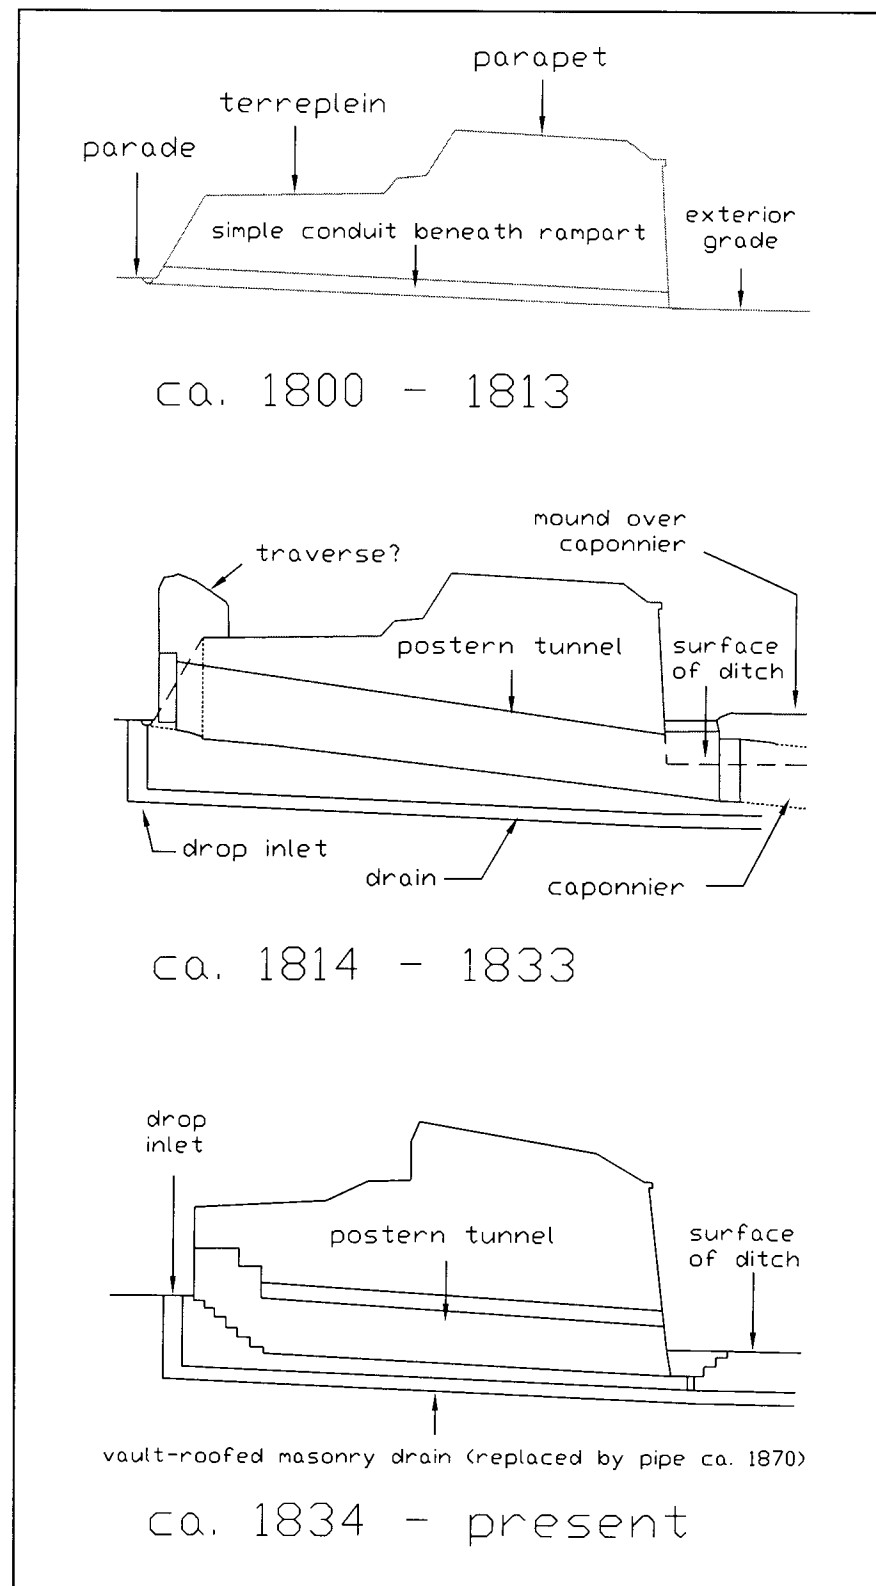
Figure 33. Sequence of development of postern tunnel; the ca. 1800-1813 configuration and the 1814-1833 drain are hypothetical.

across the area, later developed as part of the fort's ditch, between the scarp wall and the low ground further to the southeast, suggesting that outflow from drain was onto the surface of that area. Archeological excavation in the corresponding part of the ditch indicates that original grade was higher than the floor of the lower end of the postern. This suggests that if the original water conduit was as deep as the later tunnel there must have been a continuation of the drain originally, regardless of its absence from the 1803 plan. It is not known if the original "water conduit" was deepened in 1813-14, along with other modifications, in creating the first version of the postern tunnel, or if a entirely new structure was built¹²⁵ (Figure 33).

In 1814-15, beginning immediately after the bombardment, bombproofs were built to either side of the sally port, with entrances adjacent to the passageway (Figure 33). The vaulted roof of the sally port may have been built, or rebuilt, at the same time, and a platform was established over the sally port which became known as the observatory. With the redeposition of fill over the bombproofs, the earlier parapet and terreplein here were replaced by terraces (Figure 7). There was yet another major episode of construction in 1835, when the guardhouses were added on the sides of the

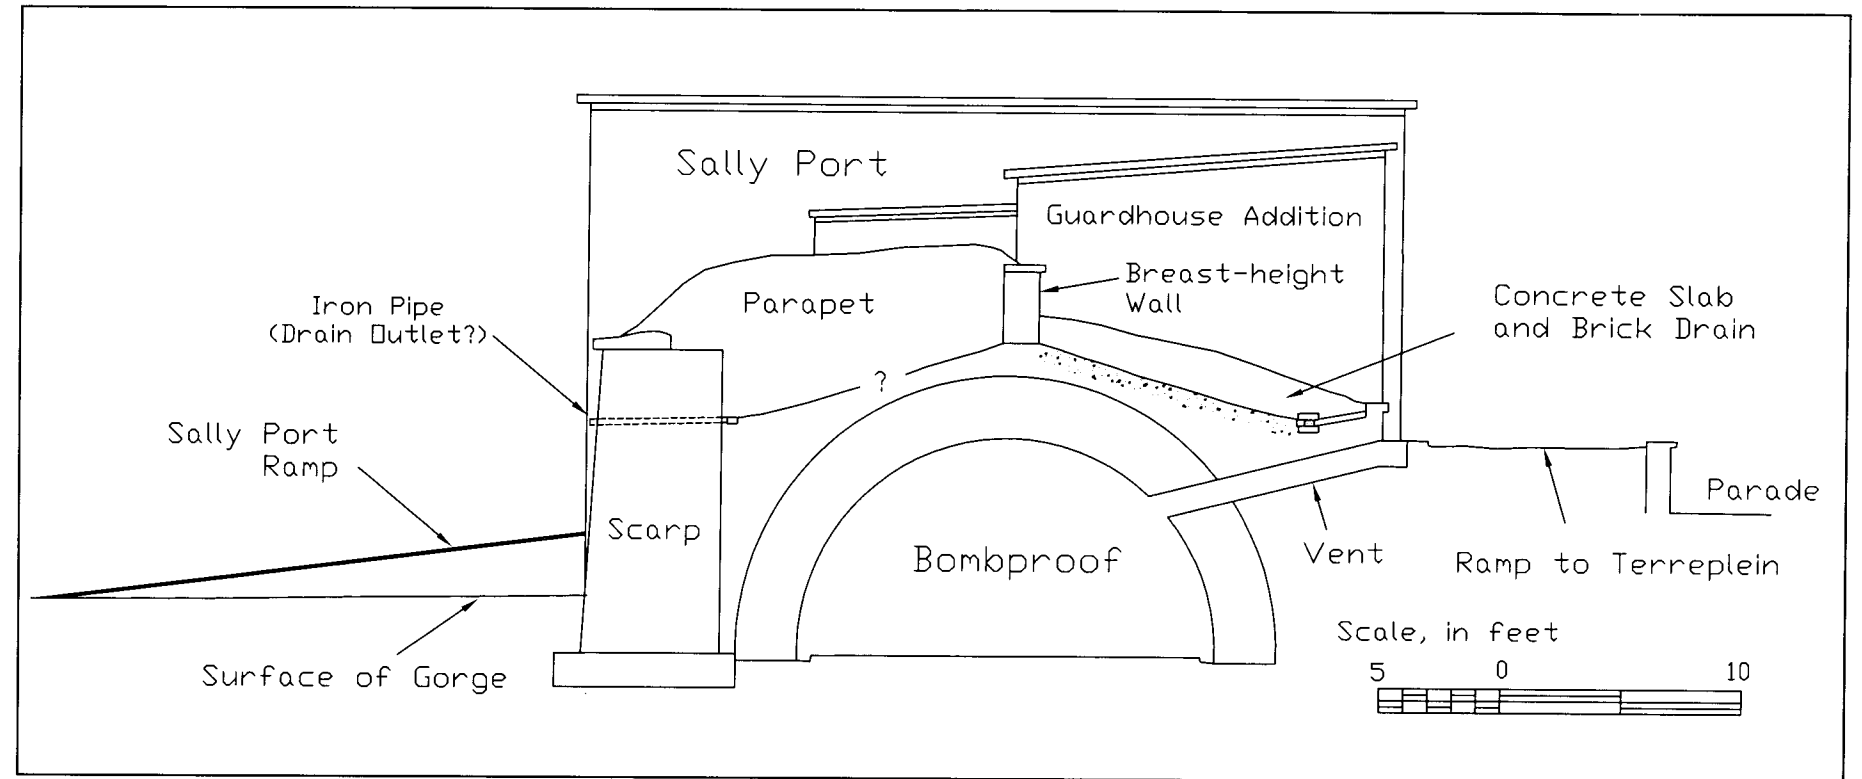
Figure 35. Cross-section through the rampart northwest of the sally port.

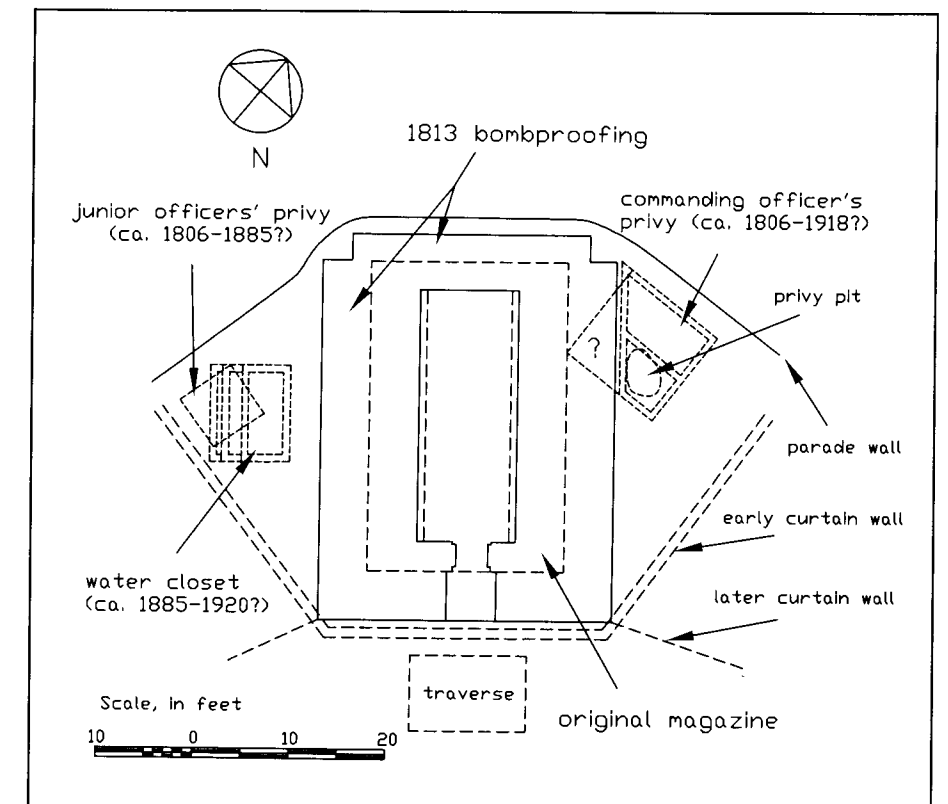
Figure 36. Structures in the powder magazine vicinity.

Consistent with the original role of each of the adjacent quarters, the privy northeast of the magazine is commonly identified as the commanding officer's privy, while the one to the southwest is identified as the junior officers' privy (Figure 36). These privies are first depicted on the 1834 and 1840 plans of the fort, but they most likely existed earlier; how much earlier is not known, but it is noteworthy that they were both within areas enclosed prior to ca. 1806 by the curtain wall on either side of the original magazine, and they would have been aligned with that wall, as well as with the terreplein revetment. As depicted on all the fort plans which show it, and as documented archeologically, the commanding officer's privy abutted the 1814 bombproofing of the magazine; if, as seems likely, it had existed earlier, it was modified when the bombproofing was constructed.

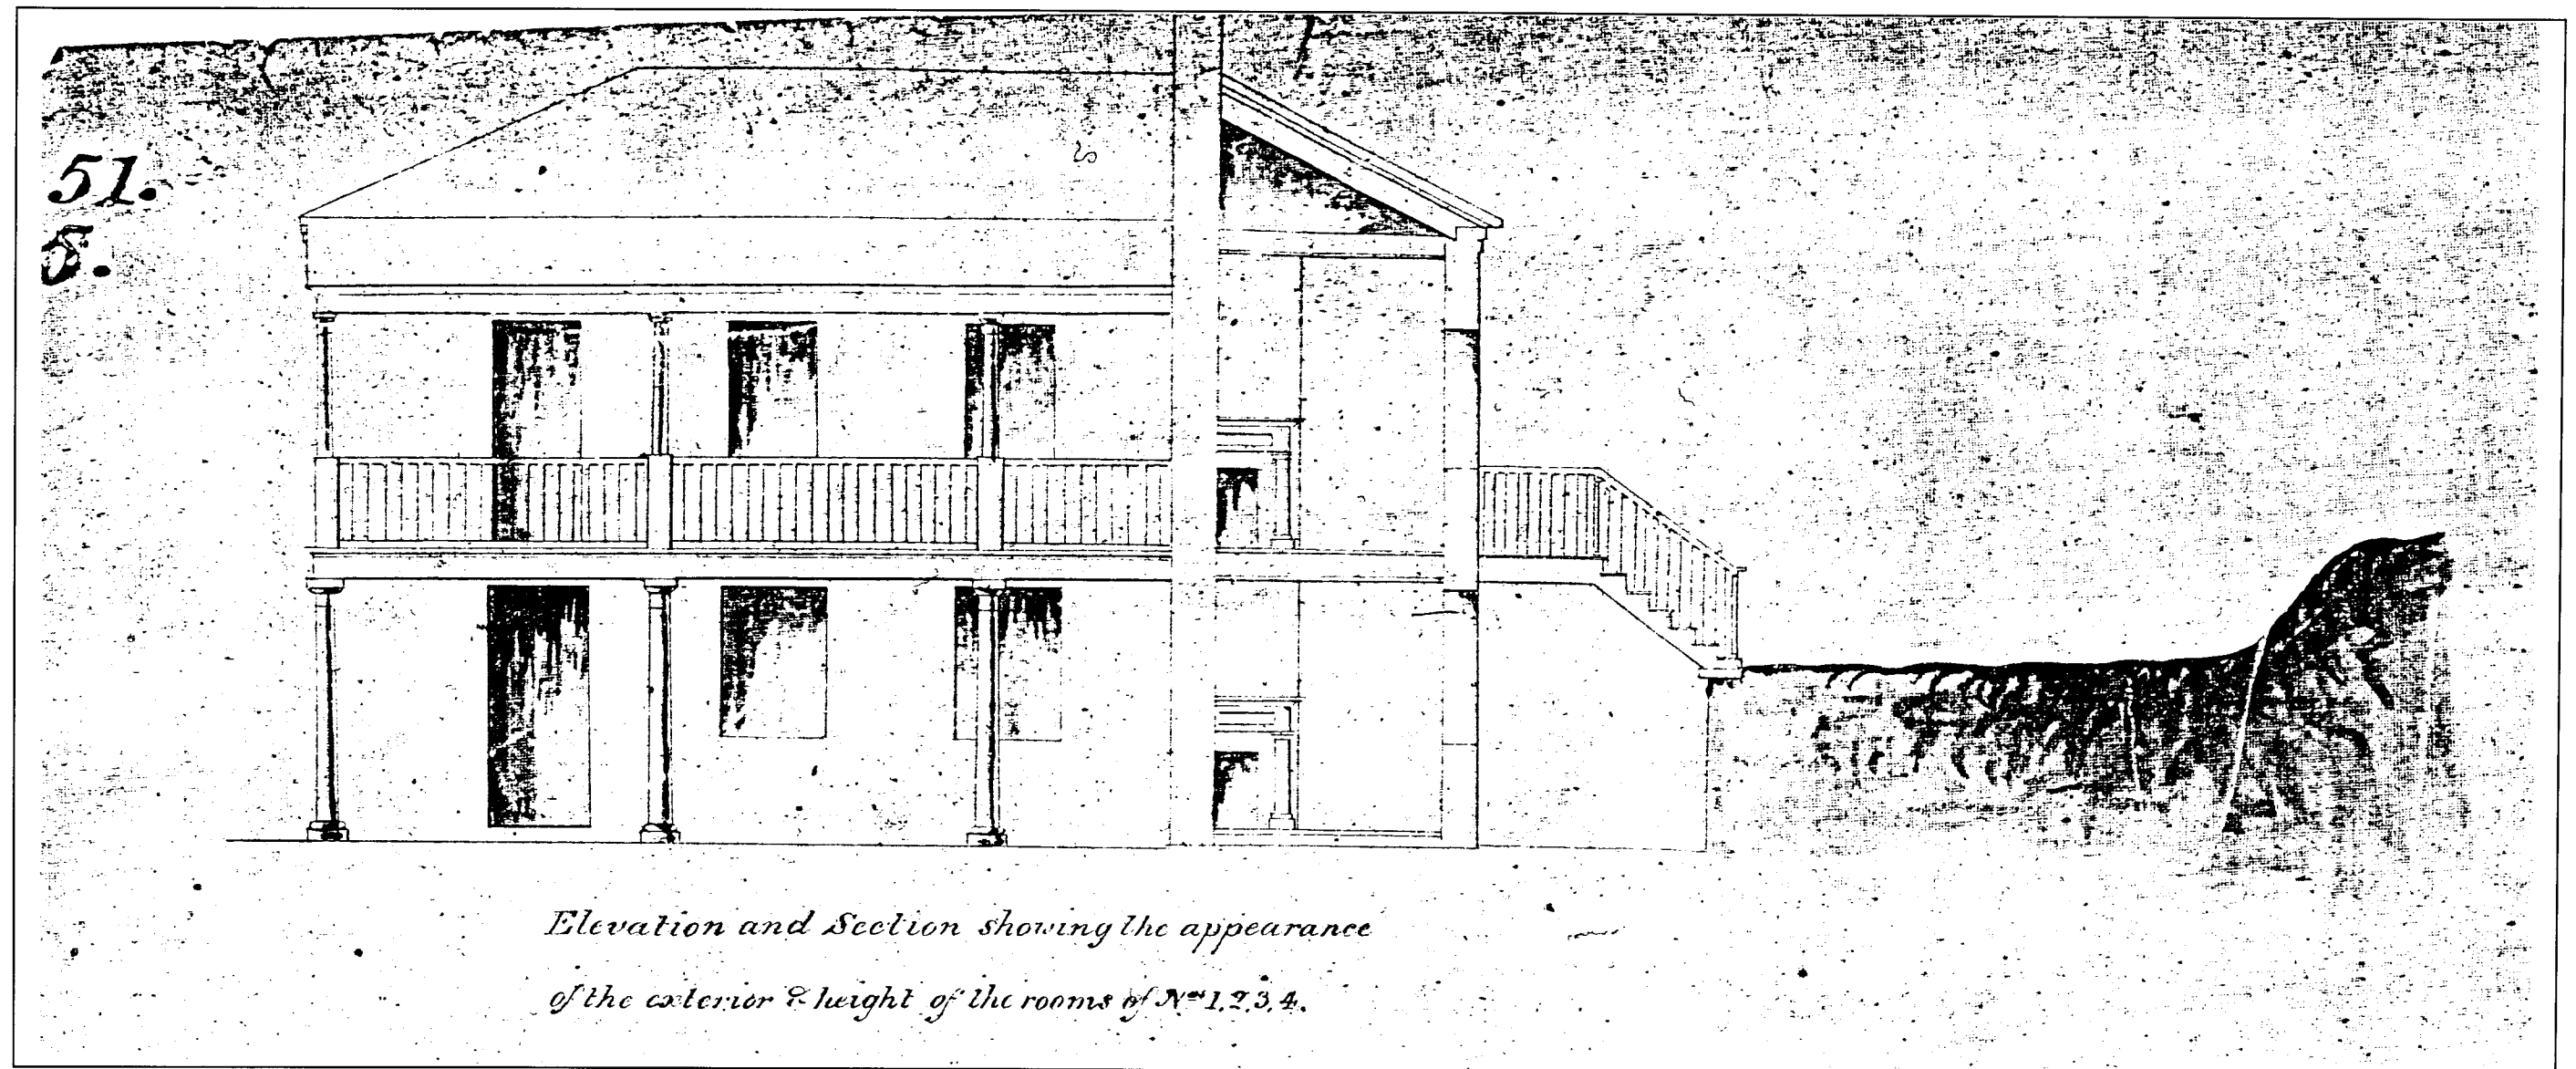
Figure 38. Detail of Lt. Thomas I. Lee's *Fort McHenry*, 1834, showing elevation and cross-section of typical quarters within fort.

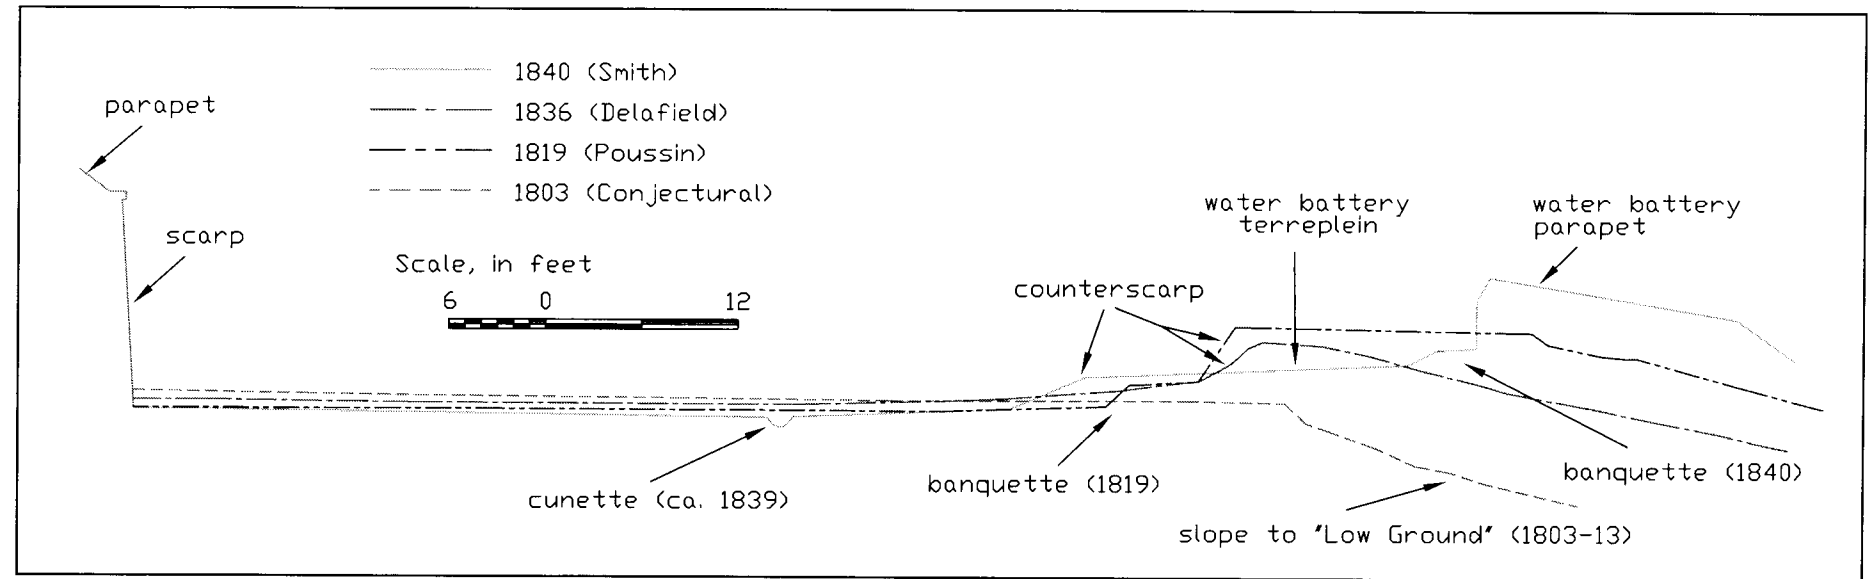
Figure 39. Grade changes along the southeast front of Fort McHenry, 1803-1840.

Underlying the fill composing the water battery's parapet, over most of its footprint, are remnants of the 1813-14 glacis, which was itself constructed by filling an area of low ground (Figure 39). The 1836 plan and profile suggest that remnants of the glacis lie roughly 6 ft. to 18 ft. below the level of the crest of the battery's parapet. The surface of the low ground which the 1803 plan shows had originally intruded into the area may be as deep as 20-25 ft. below the level of the parapet, particularly in the area of the salient southeast of the postern. The deep archeological testing that would be required to document the complete stratigraphic sequence underlying most of the battery's parapet has yet to be performed. A large part of the sequence was documented, however, in excavations made in the magazine 3 vicinity, at the northwestern end of the battery, in 1994 and 1995; a trench excavated over the postern drain line in 1998, exterior to the base of the outer slope of the battery's parapet, established the approximate elevation of the ground surface at that location prior to the battery's construction.
