“On the shore dimly seen...”: an Archeological Overview
Fort McHenry National Monument and Historic Shrine
Baltimore, Maryland

Charles D. Cheek, Ph.D.
Joseph Balicki
and
John Pousson

John Milner Associates, Inc.
5250 Cherokee Avenue, 4th Floor
Alexandria, Virginia 22312

2000

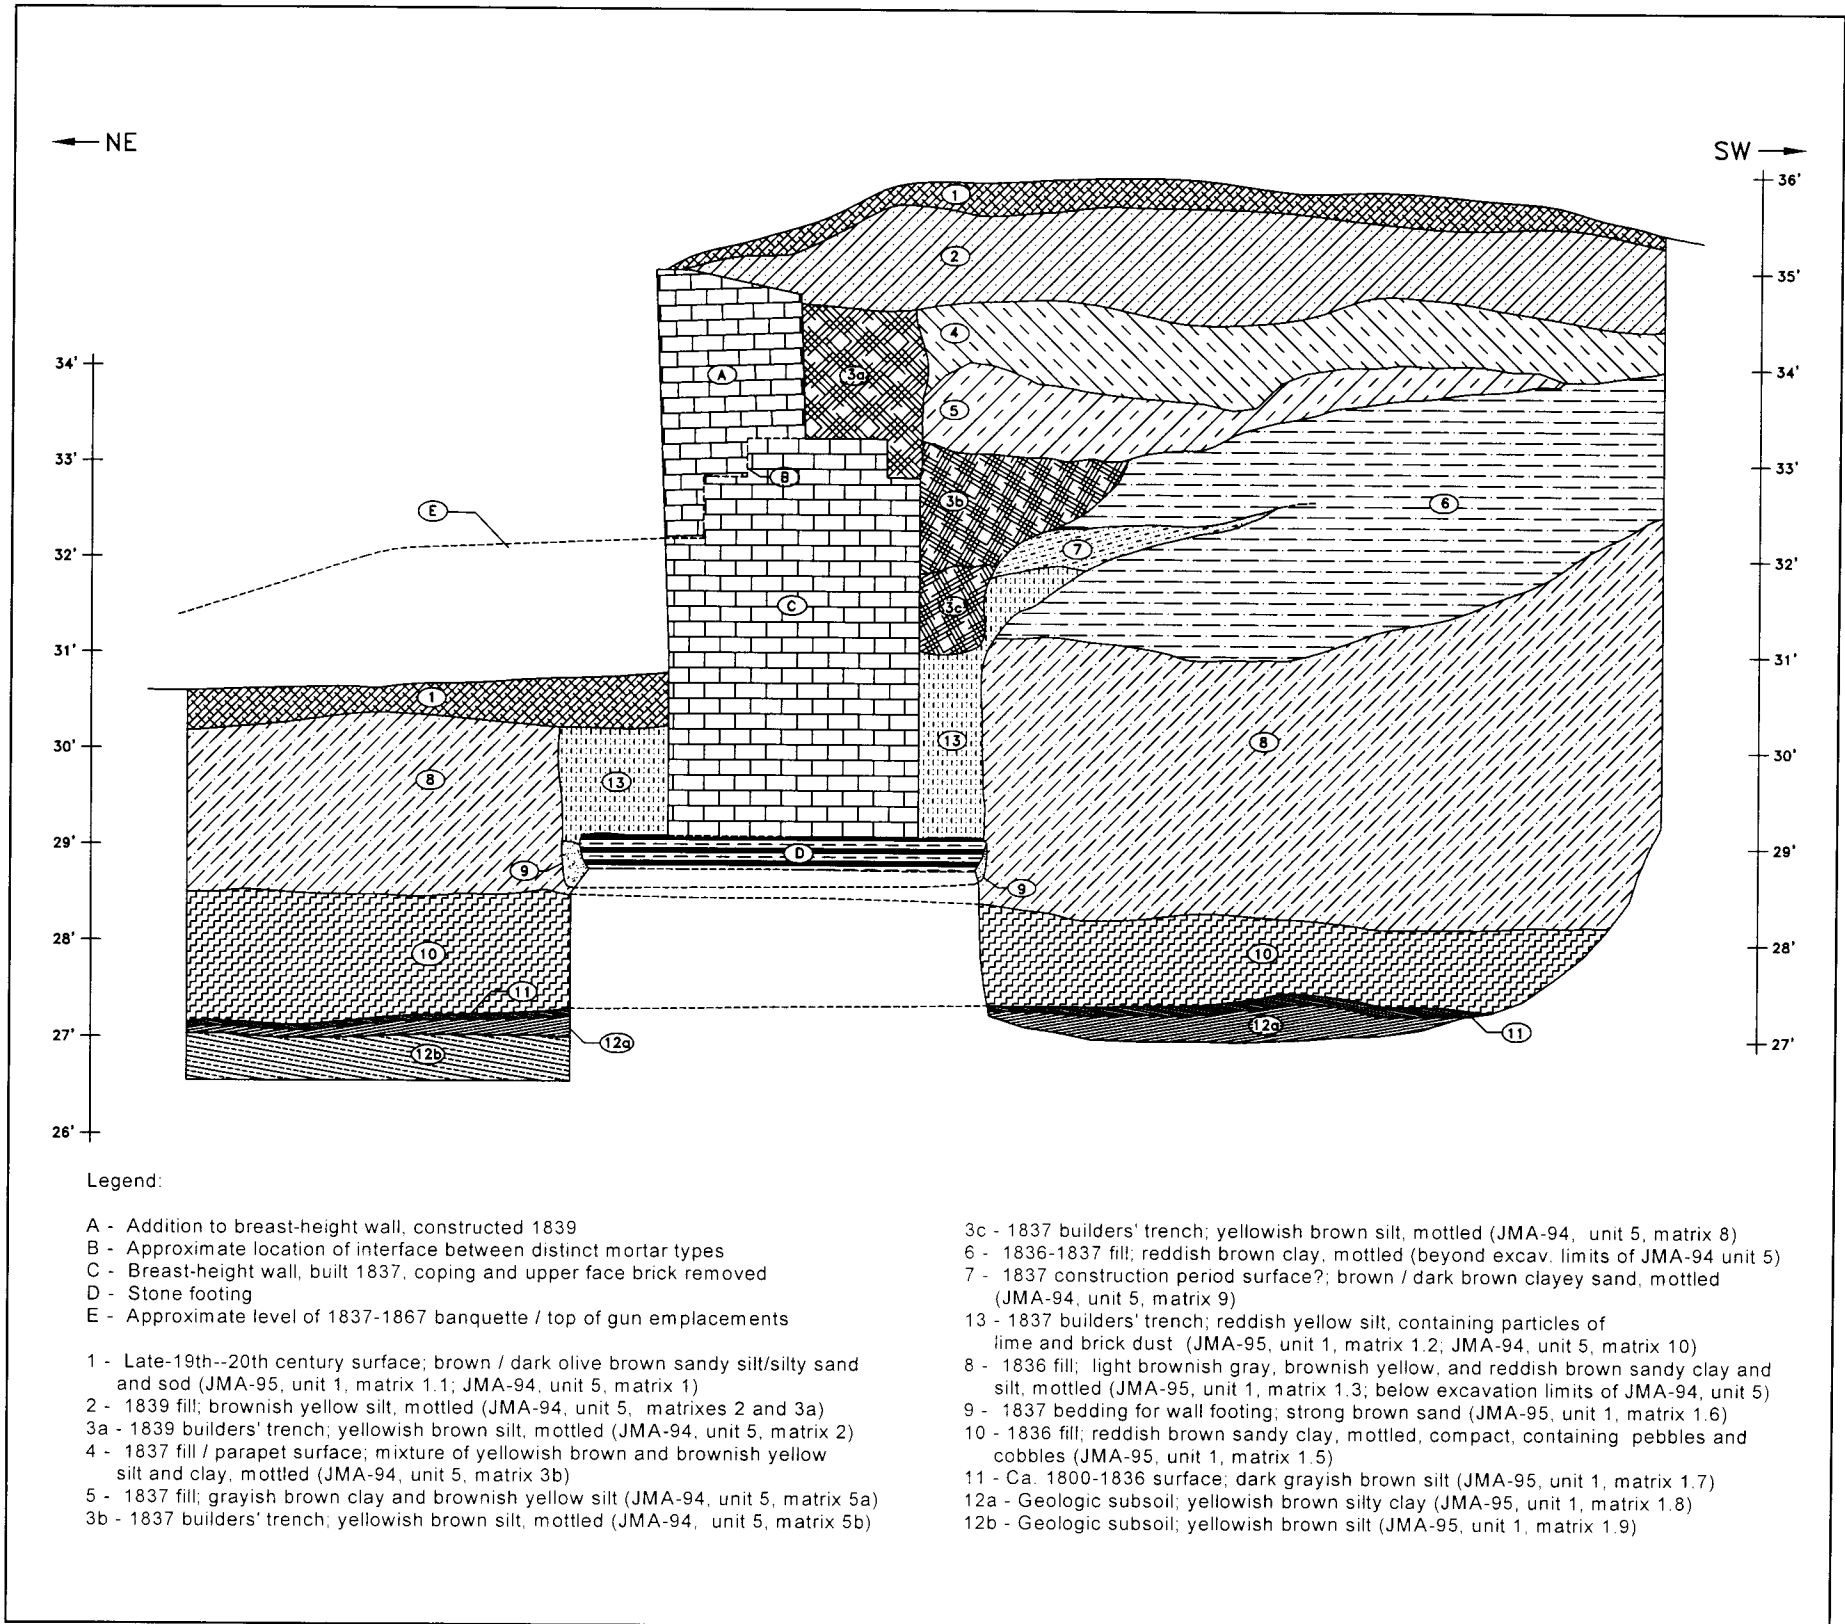
Figure 43. Profiles of archaeological excavations at the water battery's revetment wall, providing a partial cross-section of parapet, wall, and terreplein.

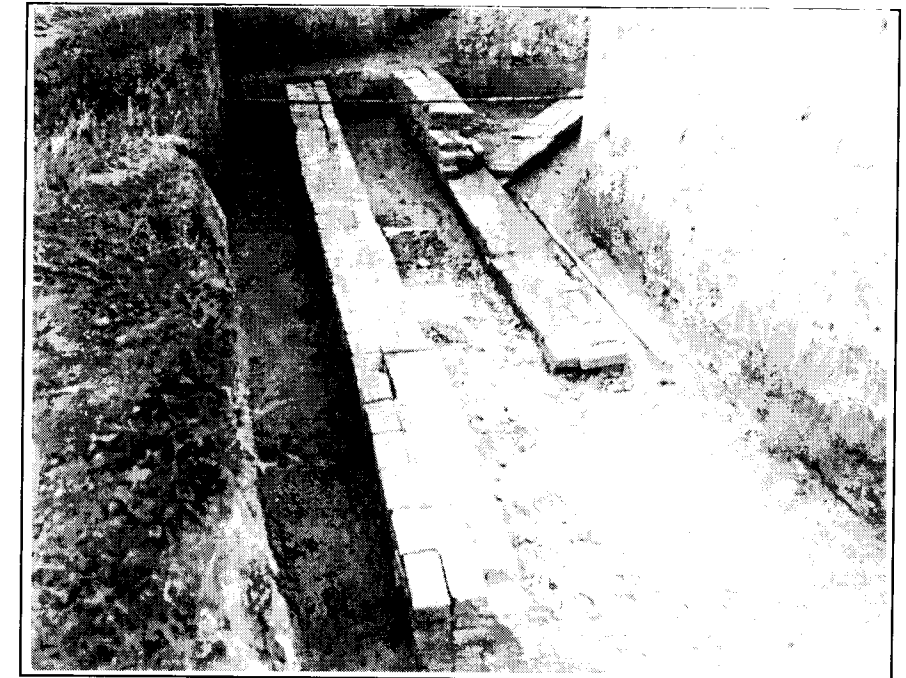
Figure 47. Possible ramp footings, 1776 lower water battery, viewed from the east, 1958.

Although the feature's location apparently positions it beneath the parapet of the ca. 1795-1831 lower battery, there is documentary evidence which implies that, as originally configured, the 1776-82 lower battery at this location was situated slightly further to the southeast, closer to the river.⁷⁵ It is possible, in other words, that the walls had been associated with the water battery as configured during the Revolutionary War. The sloped coursing of their brickwork suggests that the walls may have served as footings for a ramp, extending from the lower end of a road from the upper battery, at the feature's more elevated west-northwest end, down to, the lower battery's gun platform, at its lower east end. It is noteworthy that the distance between the outer edges of the two parallel walls closely matches the 3.5-4 ft. wide wheel-base of a garrison carriage for a 32-pounder of the period. The type of carriage used for the 18-pounders mounted in the original lower water battery, however, is not known.⁷⁶

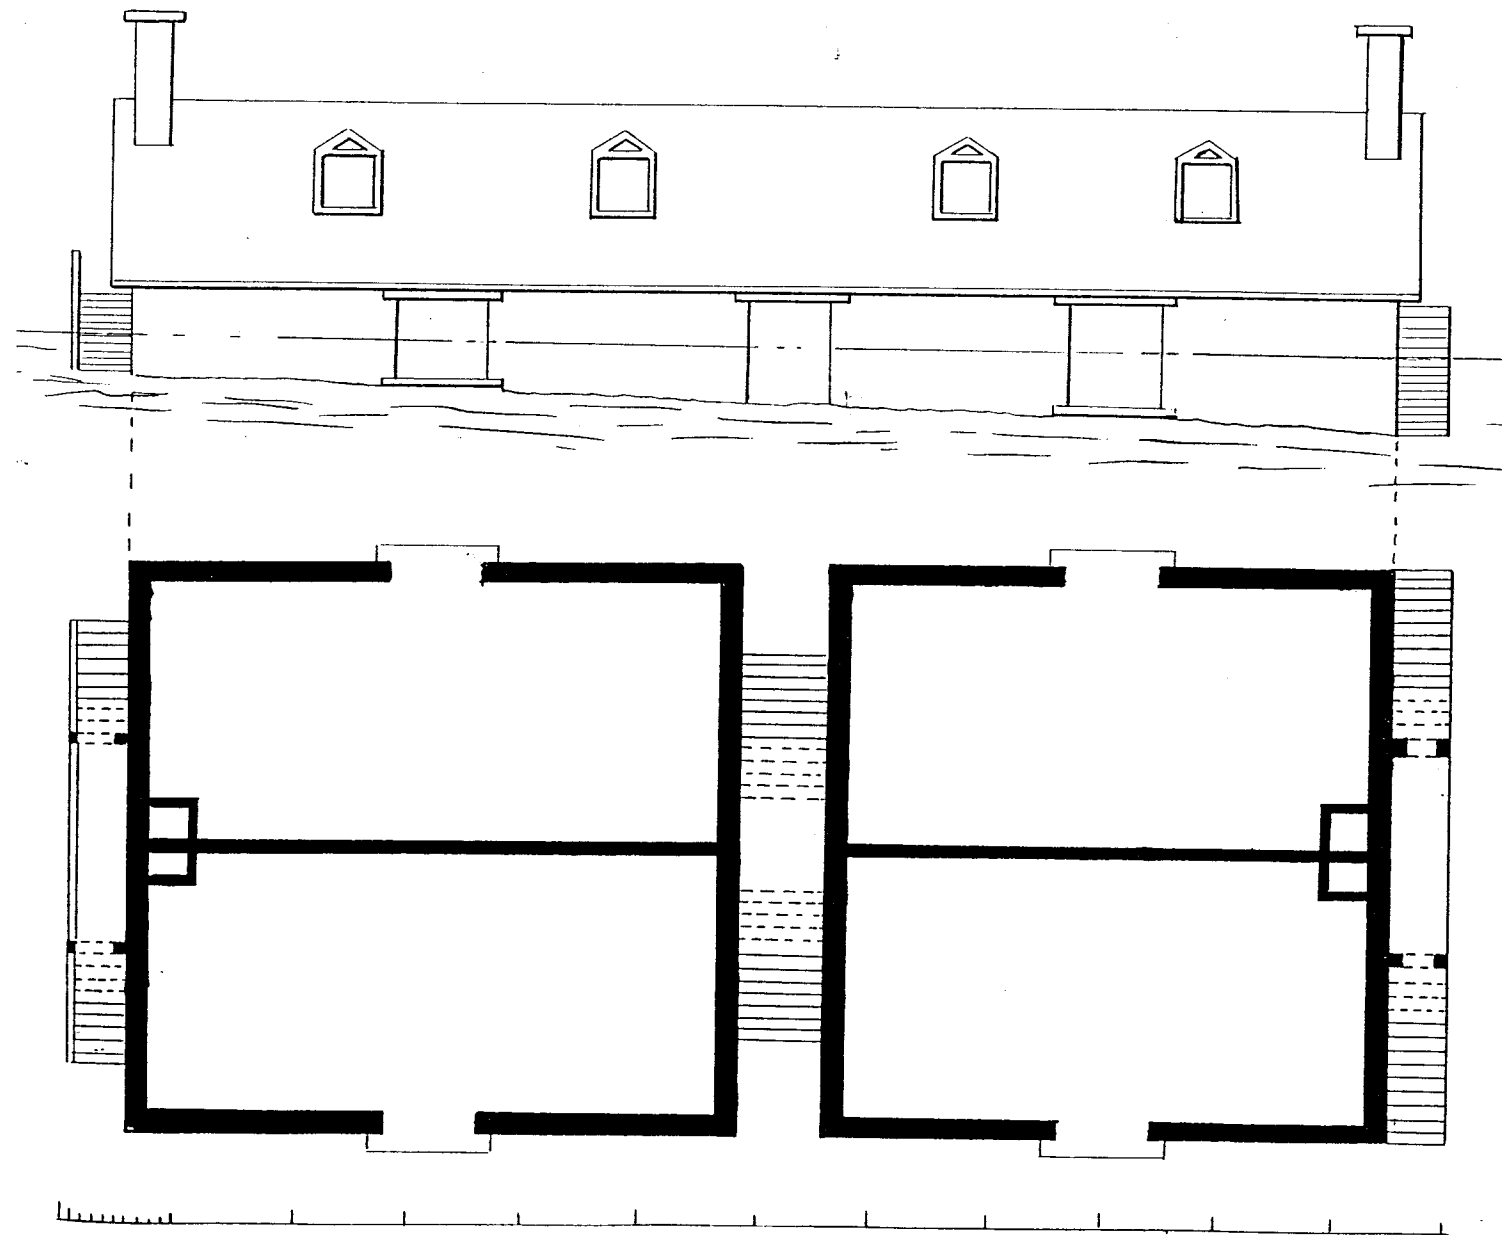
N^o 31 Quartermaster & Ordnance Store House.
Scale 10 feet to 1 inch.

Figure 49. The gun shed and store house ca. 1873.

In 1966, Cotter reported finding an 8 in. wide wall 41 ft. southwest of the gun shed’s (original?) northeast end wall. This must have been the footing of the interior wall on the northeast side of the central stairs hall depicted by the 1873 plan, about 47 ft. northwest of the newer end wall.⁸⁶ Lee’s 1834 plan of the fort shows a partition wall approximately 25 ft. southwest of the (original) end wall. An annotation, likely to be attributable to Cotter, on one of the figures in the park’s copy of Campbell’s 1964 report,⁸⁷ indicates that a brick floor was found 3 ft. below grade in the (original) north corner of the gun shed. Campbell documented two superimposed brick pavements, and a relatively deep drain covered with stone slabs, within the area of the addition to the northeast end of the gun shed. The original northwestern walls of the gun shed and the store house coincided with the original boundary of the fort, and the northwest side of the 10 ft. space between the two buildings was found to have been in-filled with a brick wall, presumably in 1816-17 when the boundary wall was built. Campbell found evidence of a segment of the boundary wall southwest of the gun shed,⁸⁸ but its intersection with the gun shed’s foundation was not preserved, possibly due to the later construction at this end of the building of the stairs to the upper half-story, depicted in ca. 1860-65 illustrations and by the 1873 building plan.

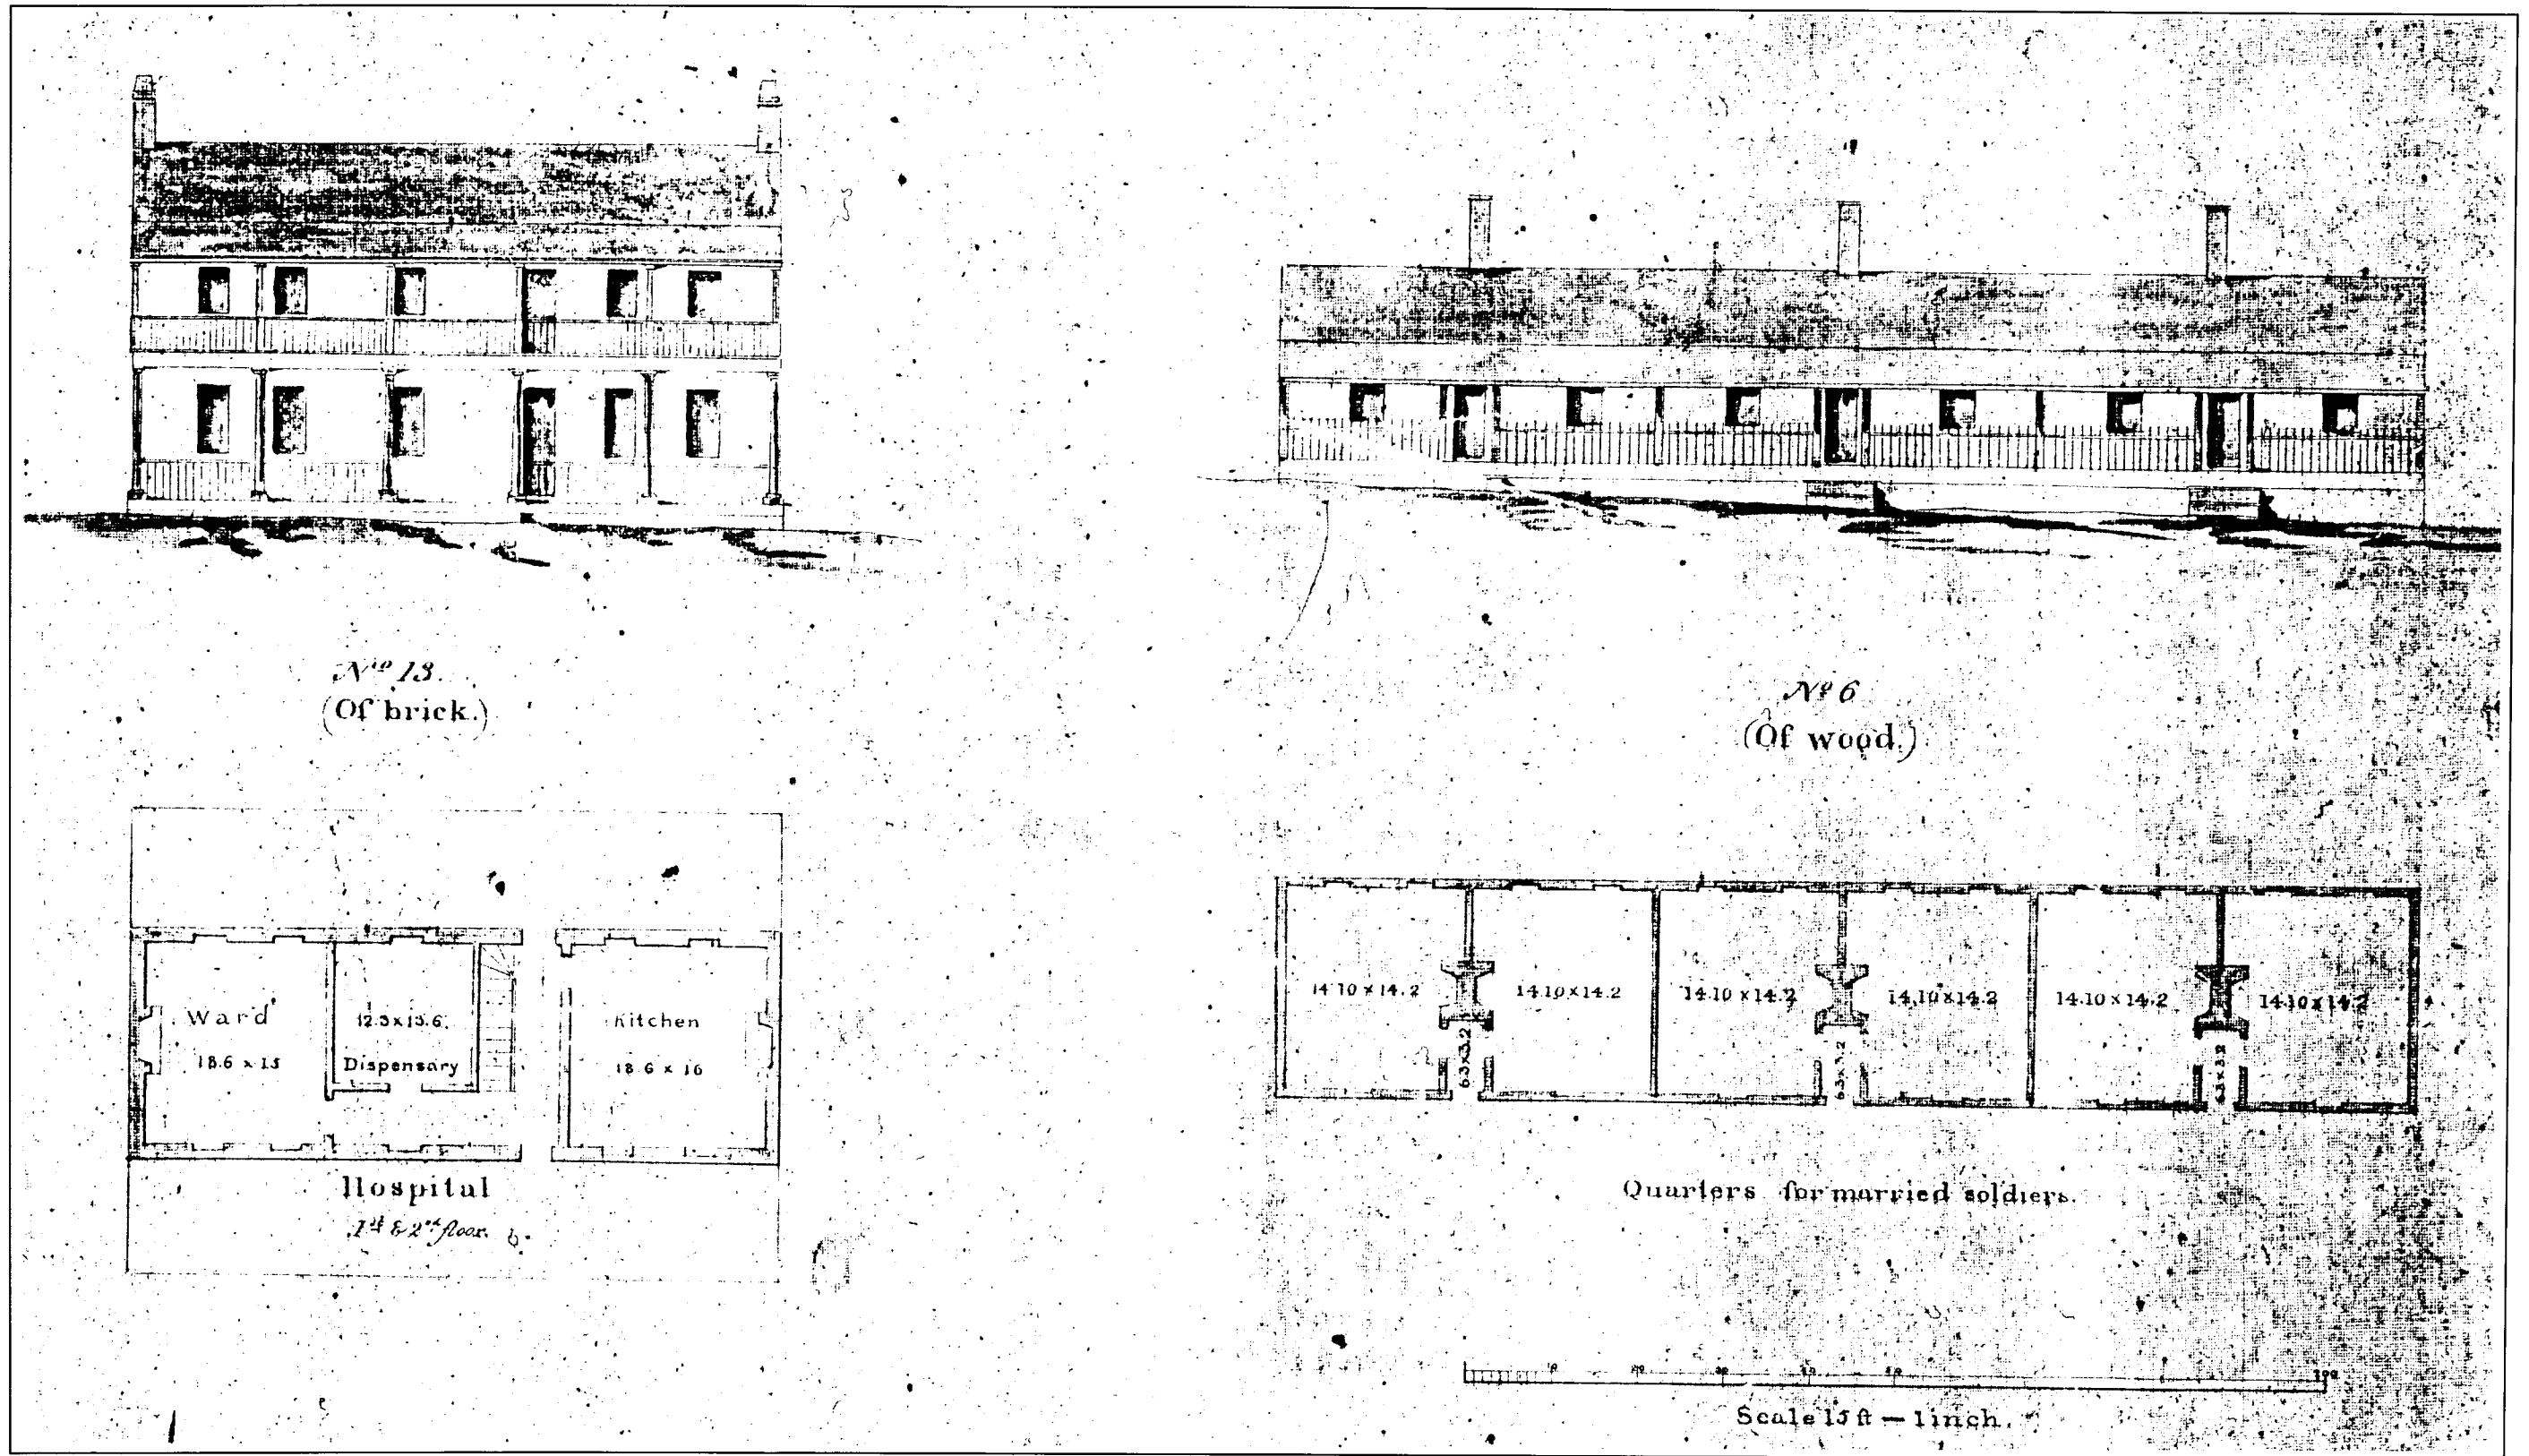
Figure 50. Detail of Lt. Thomas I. Lee's *Fort McHenry*, 1834, showing plans and elevations of the hospital and the married soldiers' quarters.

Lee's 1834 plan of the fort, which includes as details plans and elevations of several buildings, the hospital among them, provides the most complete and accurate image available of the 1813-1840 hospital (Figure 50). The original building, and the core of the later building, was about 57 ft. long by 20 ft. wide. The building had been modified in 1829, by the addition of 10 ft. deep porches along both the its southeast and its northwest sides, supported on six columns spaced about 11 ft. apart.⁹⁵ There were fireplaces at both ends of the structure, a 10 ft. by 20 ft. ancillary structure (kitchen?) attached to its northeast end, and two interior partition walls, 16 ft. northeast of the southwest end and 18 ft. southwest of the northeast end. The doorways on both sides were about 21 ft. southwest of the building's northeast end, but the porch railing and steps shown in the southeast elevation indicate that access onto the porches, 1.5 ft. to 2.5 ft. above grade, was at their center. The first floor was occupied by a ward, a small dispensary, a kitchen, and an L-shaped combination hallway and stair hall. There were presumably wards on the second floor as well, and perhaps the post surgeon's office and quarters.

The structure was presumably built soon after the preparation of the 1819 plan. Construction prior to 1829 is suggested by remnants of brick pavement discovered adjacent to the structure in 1975; the porch along the quarters' southeast side depicted on the 1834 plan (Figure 50) would have covered the pavement, possibly indicating that the 1829 porch, like others built that year, was added to an already existing building. During the Civil War, if not earlier, the structure became officers' quarters, and on an 1864 plan it was keyed as being 'temporary.' The structure was removed in

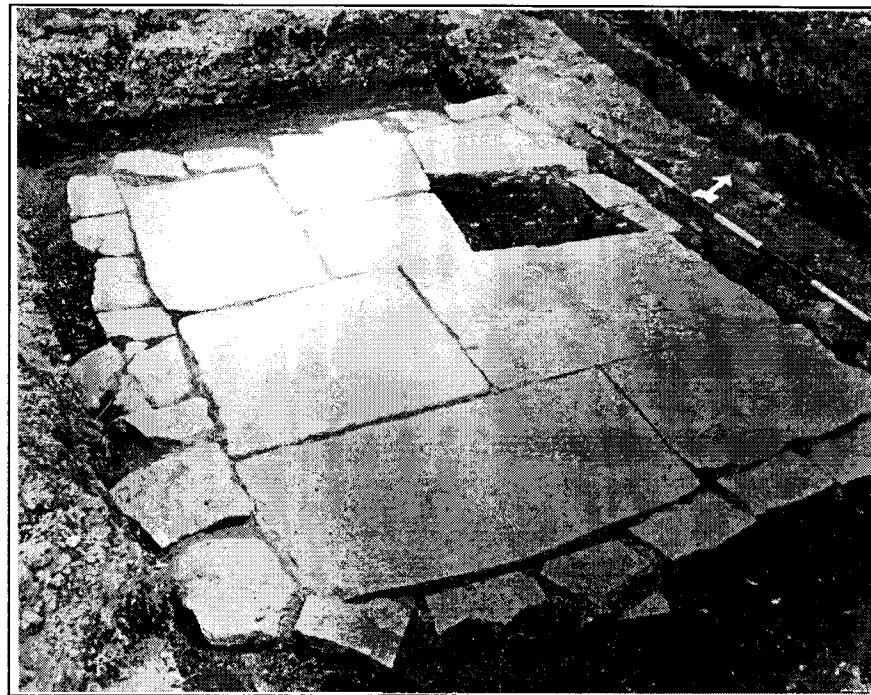
Figure 51. Remnants of possible ca. 1795-98 magazine or bombproof, viewed from the southeast, 1958.

Abutting the interior side of the boundary wall's footing, about 50-60 ft. northeast of the salient of bastion 2, Smith discovered a small rectangular area paved with stone slabs; surrounding the pavement was a roughly dressed fieldstone edging or footing (Figure 51).¹⁰⁶ Other than suggesting a likely 1795-1836 period of construction for this feature, Smith offered no interpretation of it. Smith also encountered the concrete footings of one of the hospital structures (building no. 54, which served as officers' quarters), and the cellar and foundation of the 1790s-1836 tavern, discussed below. An 1803 U.S. one-cent coin and two Civil War period artifacts were discovered at or near the stone slab feature, but their association with it was uncertain. Lacking evidence, one may speculate that the feature derives from a 1794-97 bombproof or magazine. In 1794 Rivardi suggested that a bombproof or magazine could be incorporated into one of the bastion of a horn work which he recommended be built on the land side of the earthen star redoubt; he described the bastion's location as "the driest [sic] place of the whole point."¹⁰⁷ The location of the feature is, in fact, very nearly the highest ground of the entire site. Except for a drainage ditch on the 1834 plan,¹⁰⁸ there are no structures depicted at this location on any of the early plans of Fort McHenry. If the feature had indeed been associated with the 1794-97 period, the structure it represents was most likely removed during the 1798-1803 construction of the existing fort.
