Signal Shunting Performance Related to Application of Wayside-Based Top of Rail Friction Control Materials

SUMMARY

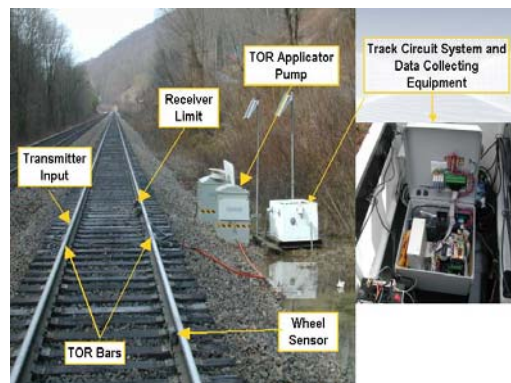
Figure 1. Signal Shunt Monitoring Site and Key Features

During the past year, NS has implemented 14 wayside-based TOR application systems over a section of double track east of Bluefield, WV. Although each track is capable of and receives bi-directional traffic, most westbound traffic, which consists primarily of empty coal unit trains, is routed on Track 2. Studies have shown that loss of shunt is more common with light axle loads where films can create a high resistance to, or even destroy, the electrical path between the rail and wheel. Figure 2 is a view looking westward of the overall shunt monitoring site and key features.
