Performing Onboard Diagnostic System Checks as Part of a Vehicle Inspection and Maintenance Program

David Sosnowski
Edward Gardetto
Transportation and Regional Programs Division
Office of Transportation and Air Quality
U.S. Environmental Protection Agency

June 2001

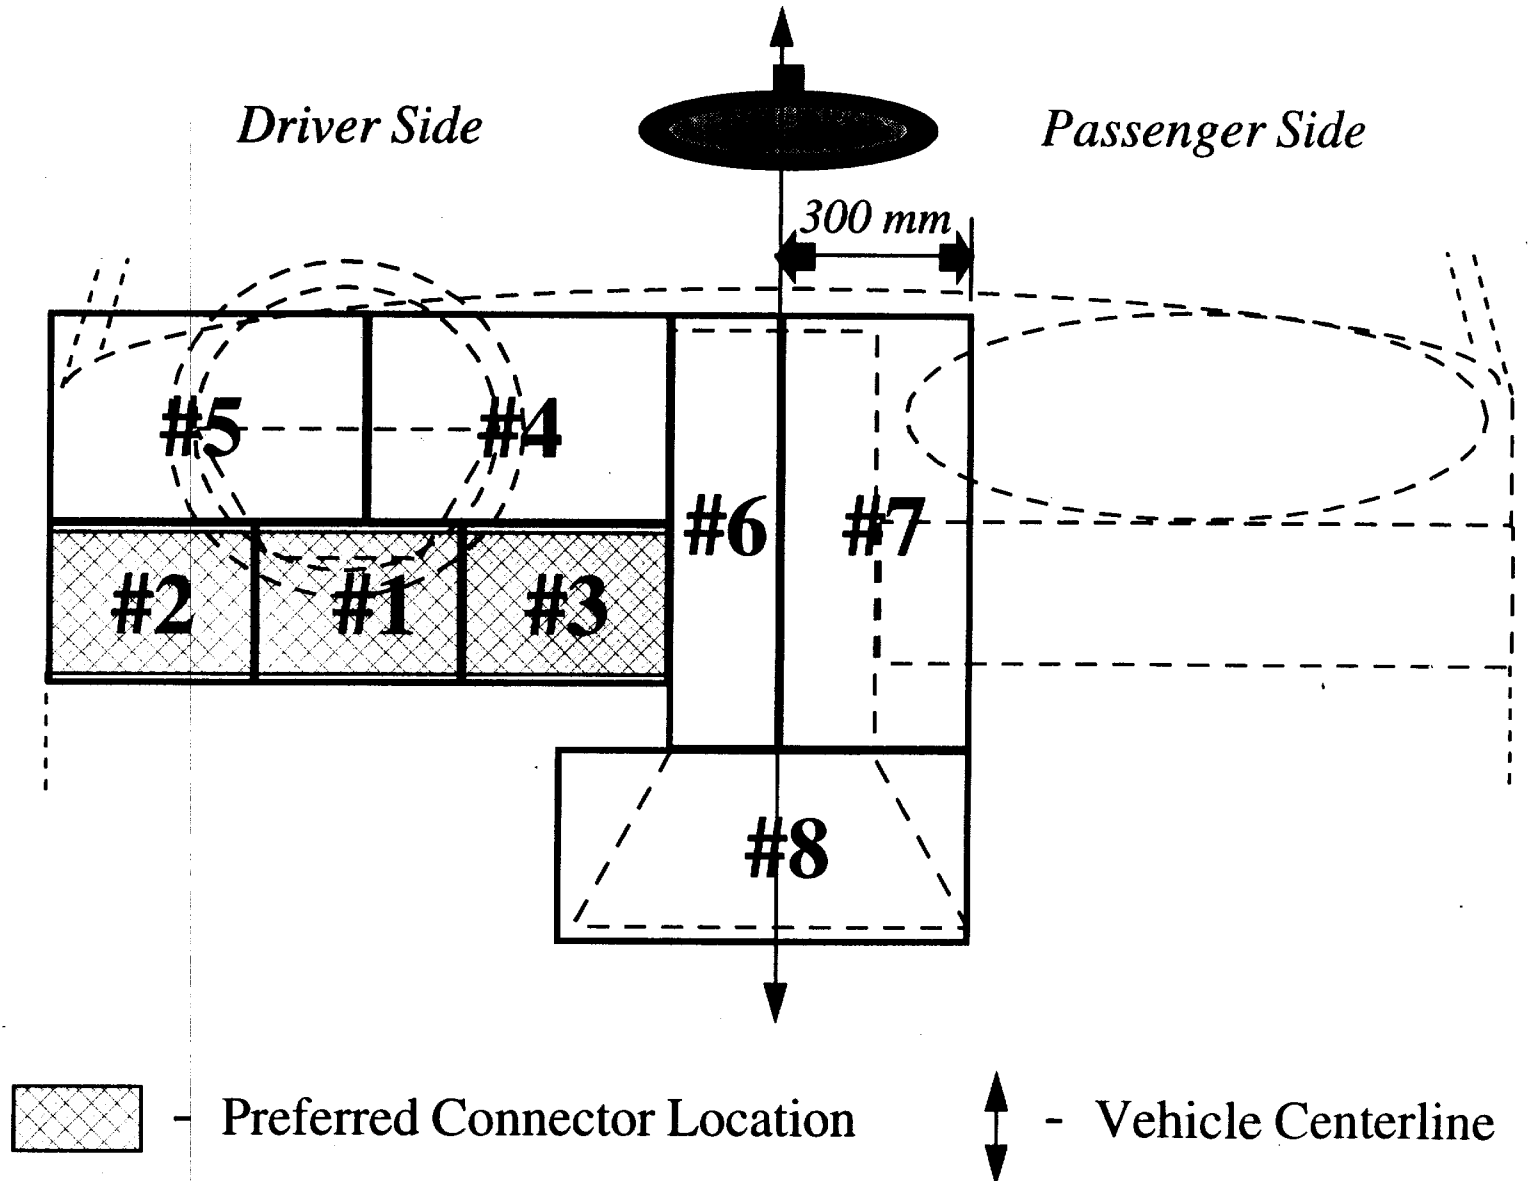
Diagnostic Link Connector Mapping Diagram

Diagnostic Link Connector (DLC) Mapping Diagram Explanation

The mapping diagram of DLC locations contains a divided instrument panel (IP) with numbered areas. Each numbered area represents specific sections of the IP where manufacturers may have located DLCs. This document briefly clarifies the numbered locations on the mapping diagram. Areas 1-3 fall within the preferred DLC location while the remaining areas, 4-8, fall into the allowable DLC location according to EPA requirements. Areas 4-8 require that manufacturers label the vehicle in the preferred location to notify parties of the alternate connector location.
