Best Practices for Road Weather Management

Florida DOT Motorist Warning System

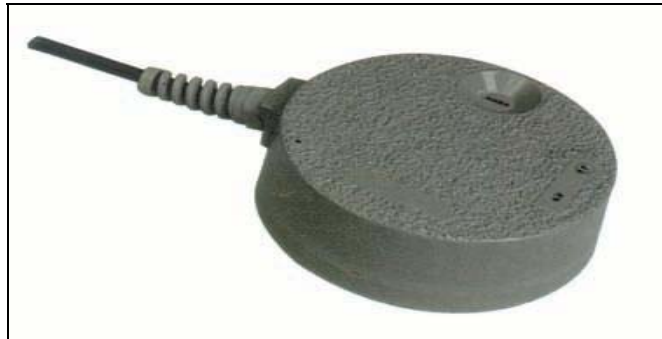
Florida DOT Pavement Sensor

System Components: As shown in the figure, a sensor embedded in the road surface was used to monitor pavement condition (i.e., dry or wet). On a pole adjacent to the ramp, a microwave vehicle detector was installed to record traffic volume and vehicle speed, and a precipitation sensor was mounted to verify rainfall events. A pole-mounted enclosure housed a remote processing unit (RPU), which was hard-wired to flashing beacons atop static speed limit signs. A dedicated telephone line was also connected to the RPU to facilitate data retrieval from an Internet server in the turnpike operations center located in Pompano Beach.

The DOT erected a 25-foot (7.6-meter) equipment mounting pole 8 feet (2.4 meters) from the edge of the travel lane, installed flashing beacons on two existing ramp signs, and arranged power and telephone service connections. The pole was installed approximately 180 feet (55 meters) in advance of the speed limit signs. The vendor furnished and installed field sensors, the RPU, and the Internet server. The pavement sensor was installed at the lowest elevation point of the ramp.
