U.S. Department  
Of Transportation

**Federal Railroad  
Administration**

RR06-03  
March 2006

## Video System for Joint Bar Inspection

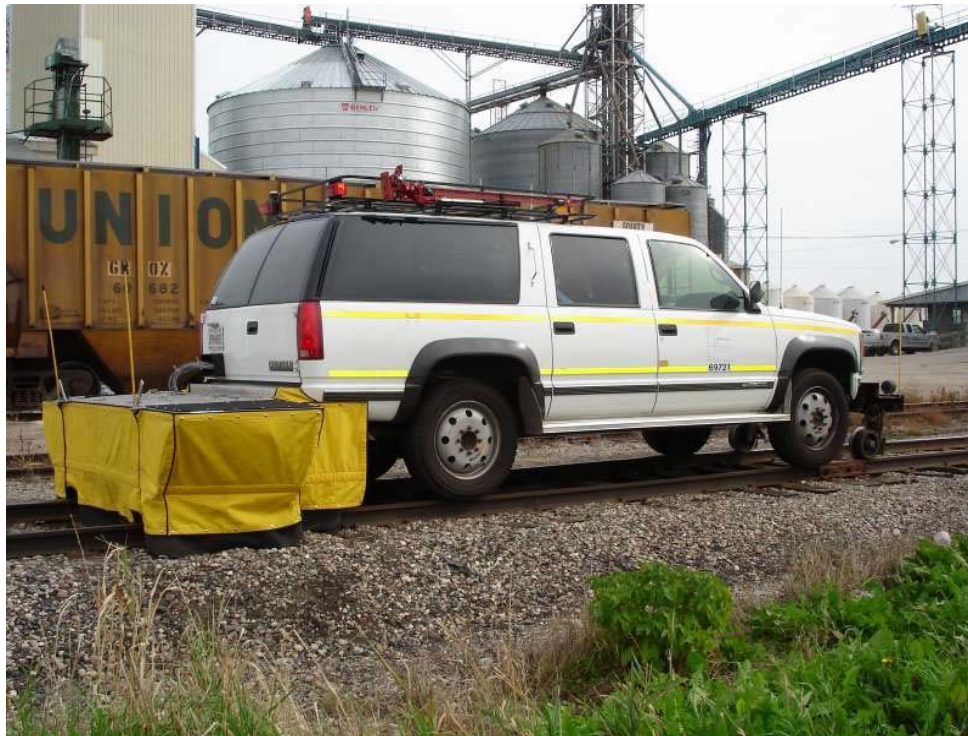
*Figure 1. Joint Bar Inspection System is fully deployed and ready for testing.*

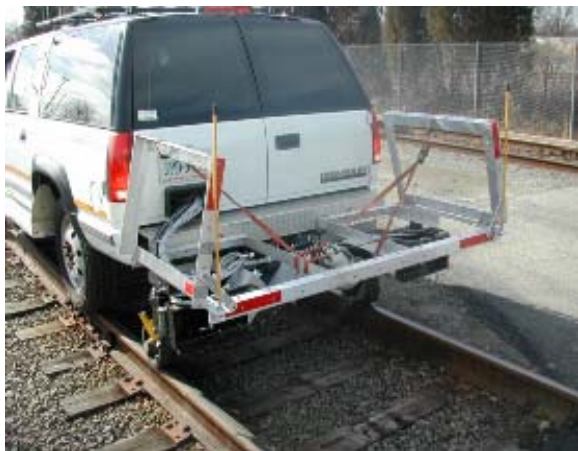
**Figure 2.** Side sections of instrumentation beam are folded for traveling on highway.

Broken joint bars have been identified as one of the significant causes of main line derailments in the United States. Currently, railroad maintenance personnel visually inspect joint bars during regular track inspection. The quality of this inspection, which is usually performed from a hi-railer, is questionable. Visual inspection of joint bars on foot provides good results; however, inspection on foot is a very slow and labor-intensive process. FRA, supported by ENSCO, Inc., developed and tested an automated video inspection system of joint bars, which operates from a moving vehicle (Figure 2).

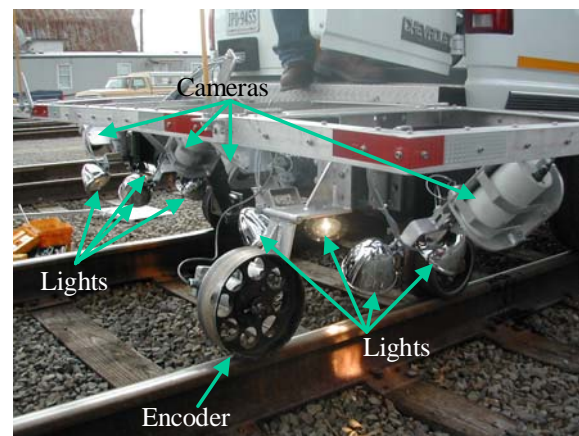
**Figure 3.** Joint bar inspection system mounted to the rear of the Hi-Railer.

railer, either on an instrumentation beam suspended from the hi-railer body (cameras, lights) or on hi-railer gear (laser sensors, encoder). Figure 3 shows the mounted cameras, lights, and encoder.

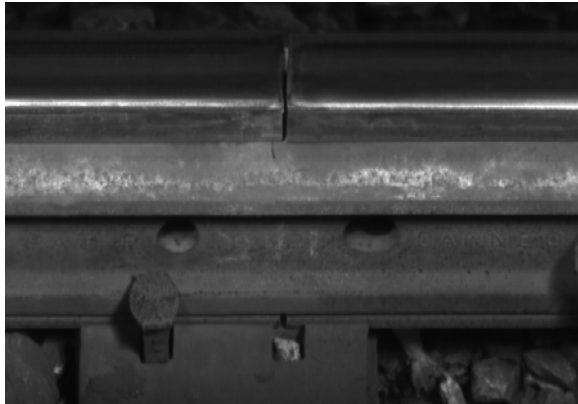
**Figure 4. Small center crack detected by joint bar inspection system.**

inspected joint bars, the software detected 60 joint bars (or 0.2 percent) as potential cracks. Based on visual analysis of the images, three cracked joint bars were confirmed and reported to the railroad (Figure 4).
