## ***ADA Access to Passenger Vessels: Finding Safety Equivalence Solutions for Weathertight Doors with Coamings***

### ***Phase 2: A Risk Management Approach to Reconfiguration Design Solutions***

March 2005

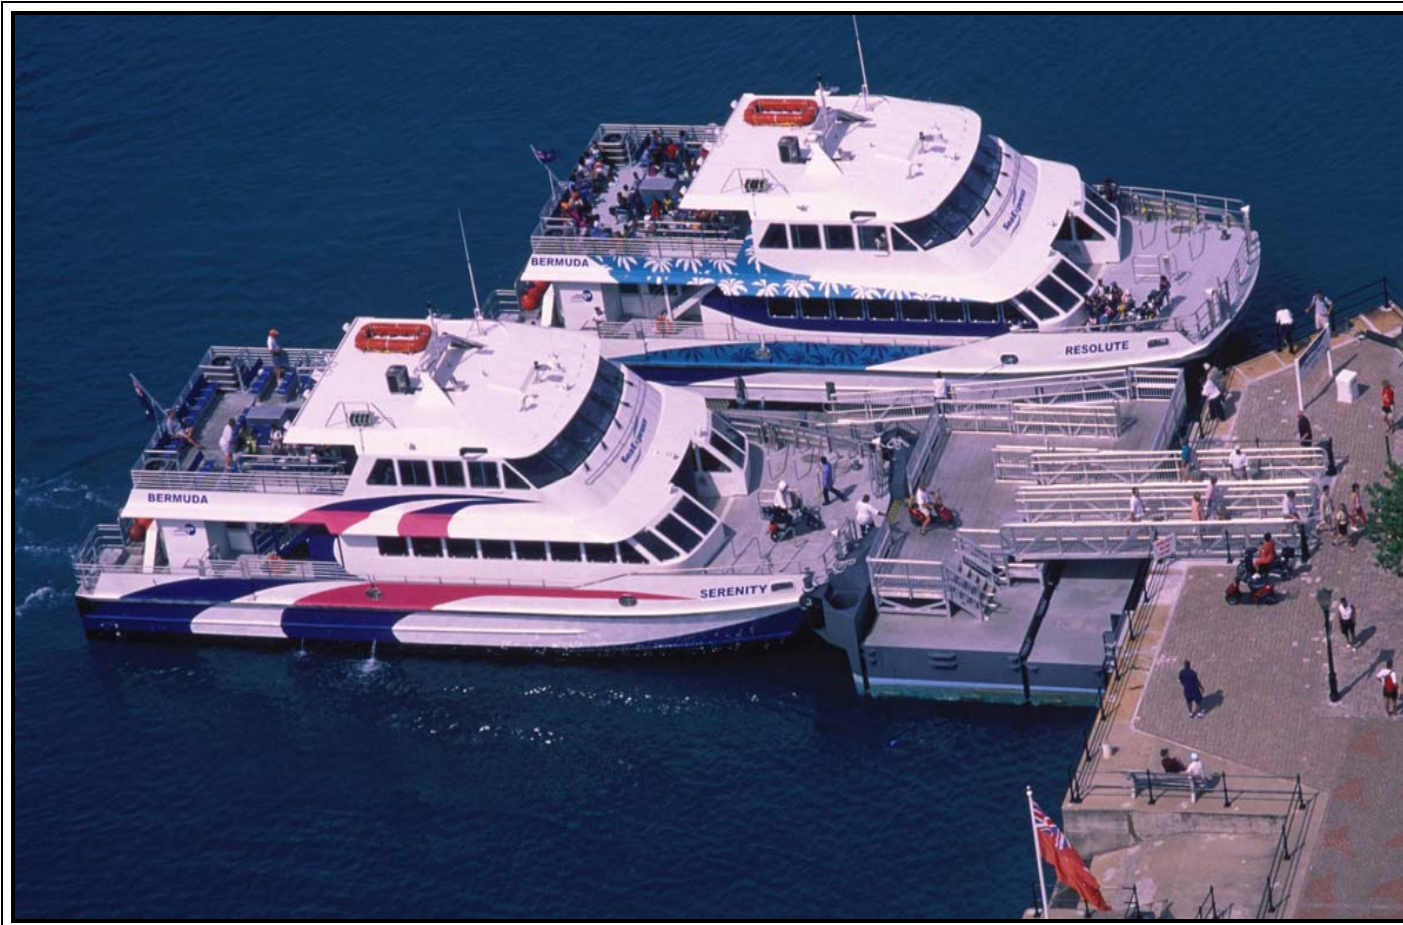
**Figure 2. Gladding-Hearn INCAT Design boats 331 and 332 at dock.**

**NOTE:** These boats are not identical to the design chosen for this example and shown in Figure 1. The photograph shows how bow doors and bow loading reconfigure the design (boat at bottom of photograph) of the passenger cabin. The configuration of the side loader (at top) has different doors into aft area of the passenger cabin, which are not part of the configuration for this example, as shown in Figure 1.

- Embarkation access may be via the bow to the forward deckhouse doors, or via bulwark gates near the stern to the aft deckhouse doors. Figure 2 shows GH-ICD boats of similar, but not identical, design to the 35-meter boat considered herein, one each with the bow and stern embarkation access points.
