The Hayward fault

OVERVIEW OF FIELD TRIP

SECTION I: THE HAYWARD FAULT AT UC-BERKELEY

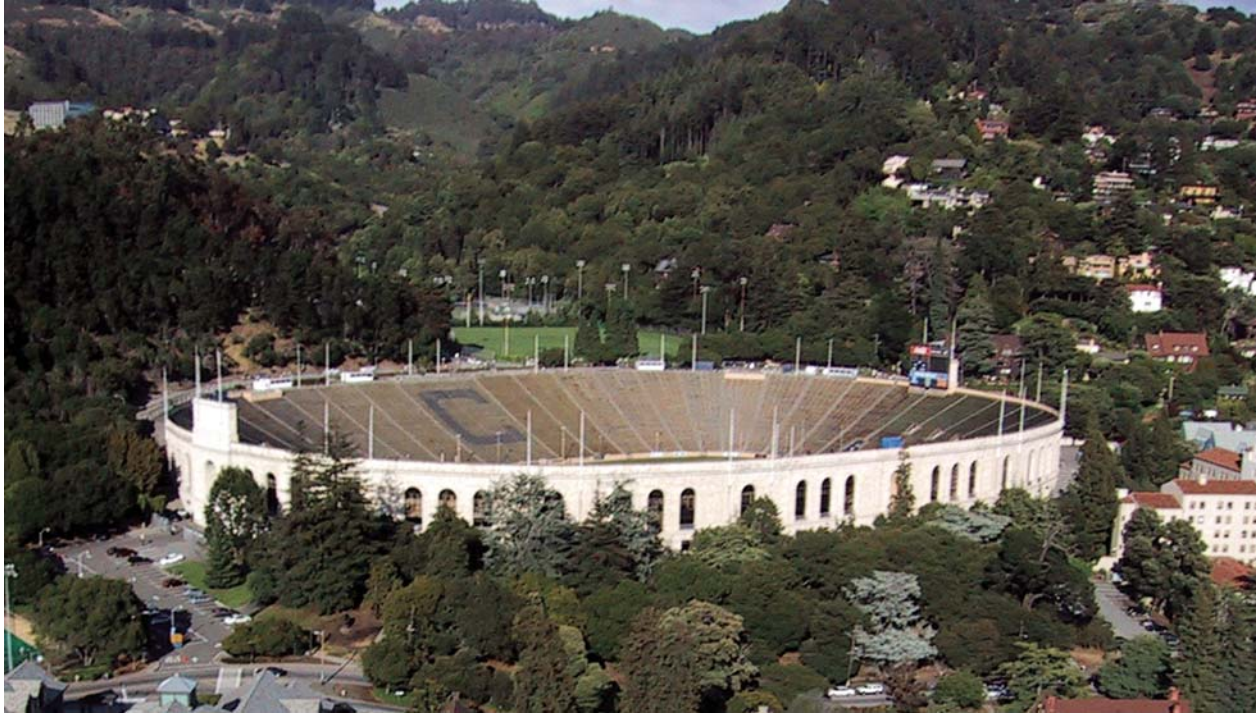
Figure 4. Memorial Stadium on the University of California–Berkeley campus. Kite photograph by Charles Beuton, University of California–Berkeley.

Memorial Stadium (Fig. 4) was built in 1923 as a tribute to World War I heroes. It sits directly astride the creeping trace of the Hayward fault, at the base of Strawberry Canyon where Strawberry Creek exits the Berkeley Hills. The university is currently developing plans to renovate the stadium, including improvements to mitigate fault rupture hazard to the structure.

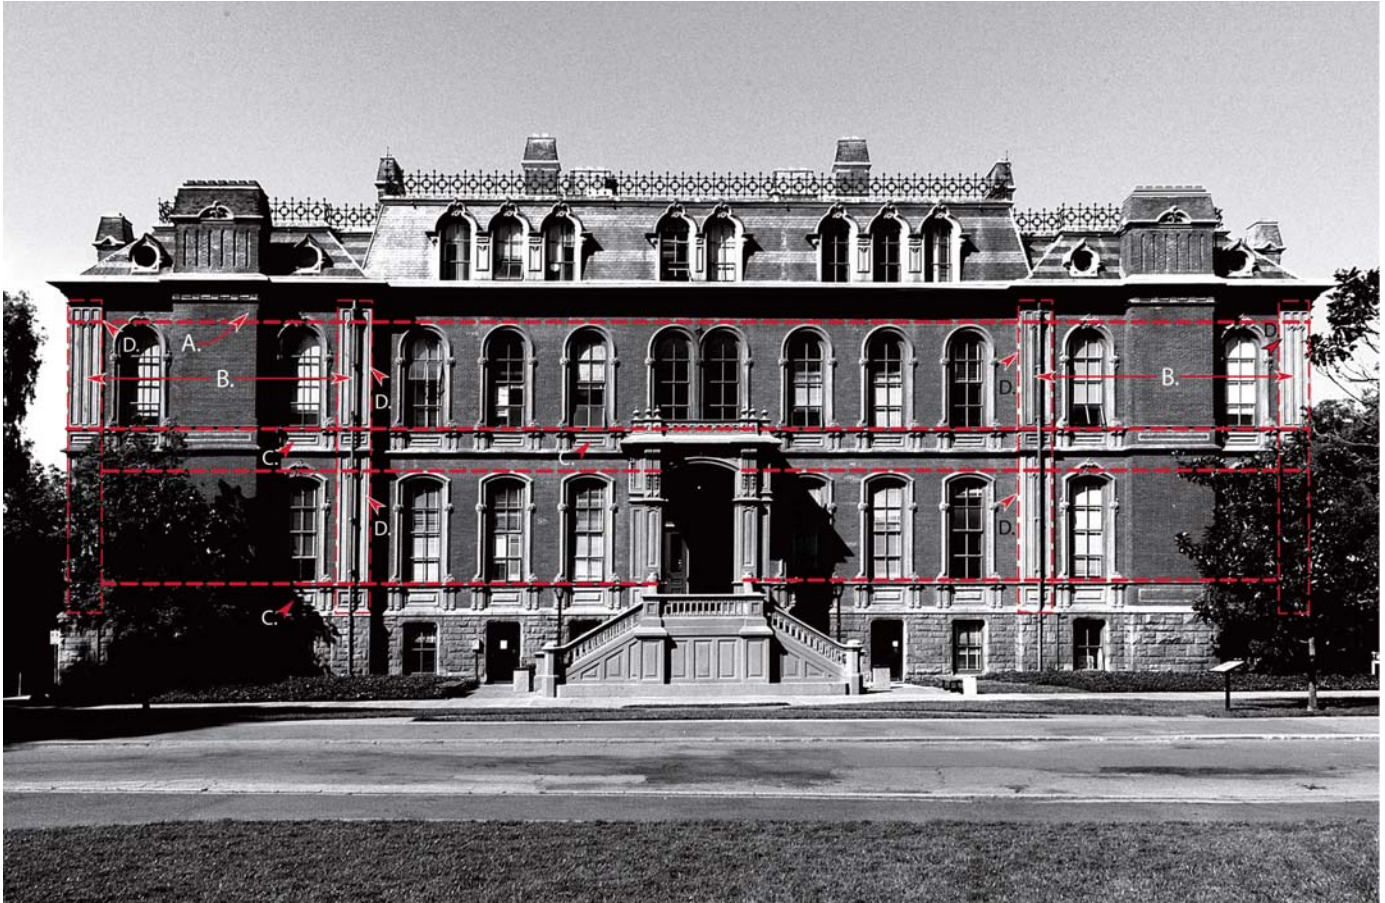
Figure 9. South Hall, 1873. Diagram of reinforcement in South Hall. A—bond iron courses through masonry; B—iron pilasters held in place by bond iron; C—the position of floor anchors in masonry; D—the position of internal iron girders.

South Hall (Fig. 9), the oldest building on campus, was initially designed to be earthquake-resistant in 1870 because the university regents had seen building failures in San Francisco in the earthquakes of 1865 and 1868. The regents understood that wood buildings resisted seismic forces more effectively than brick masonry, and they considered having South Hall constructed of wood. The problem with wood is that it burns and is less monumental than brick. So they decided on brick, but they stipulated that the new building had to be earthquake-resistant.

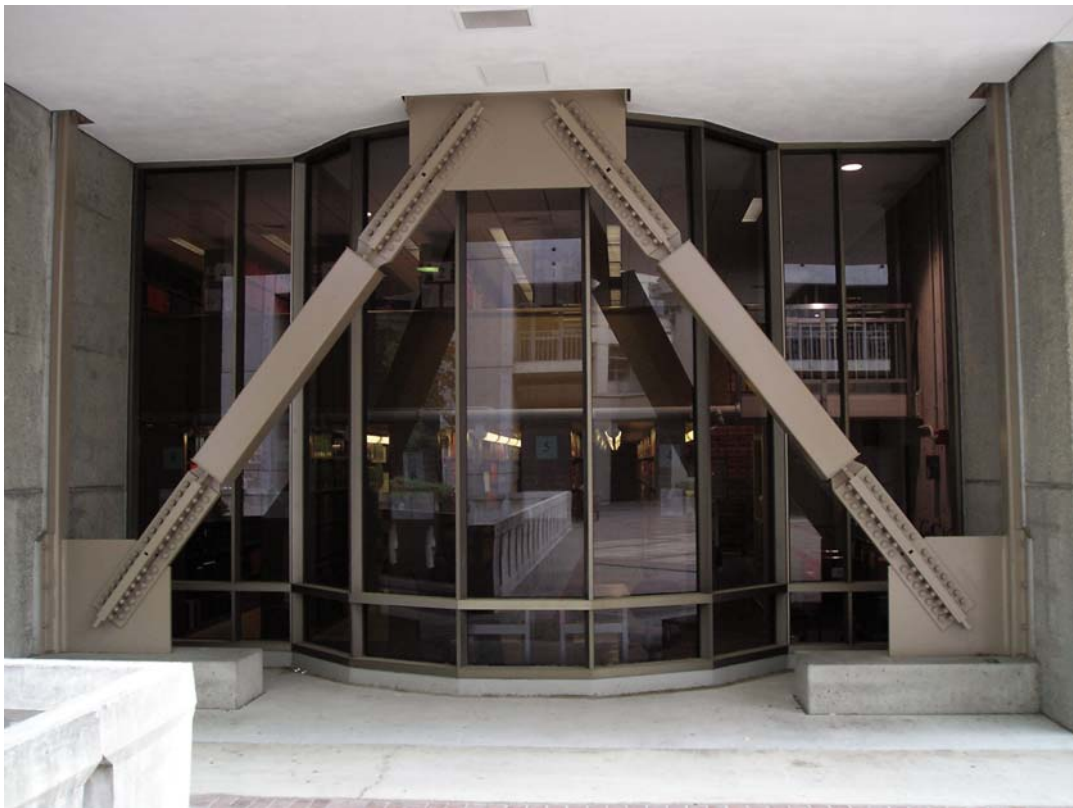
Figure 14. Hildebrand Hall: unbonded braces.

Anshen and Allen and Forell/Elsesser investigated numerous retrofit strategies for Hildebrand Hall and finally decided to use unbonded braces, which were a very new and promising addition to anti-seismic technology. You can see these braces on the plaza floor of the building (Fig. 14). Unbonded braces work in a simple and elegant manner. In a traditional steel cross brace, lateral forces are resisted axially by each cross-member. An applied lateral force will stretch one cross-member in tension and shorten the other in compression. Unbonded braces are made of both steel—which is strong in tension—and concrete—which is strong in compression, enabling the braces to exhibit nearly identical properties in both tension and compression. In addition to the braces, new concrete shear walls, providing lateral support, were added to the two lowest stories, and on the east and west side a portion of the shear walls extend up to the roof. The walls around the stair cores were strengthened and reinforcement was

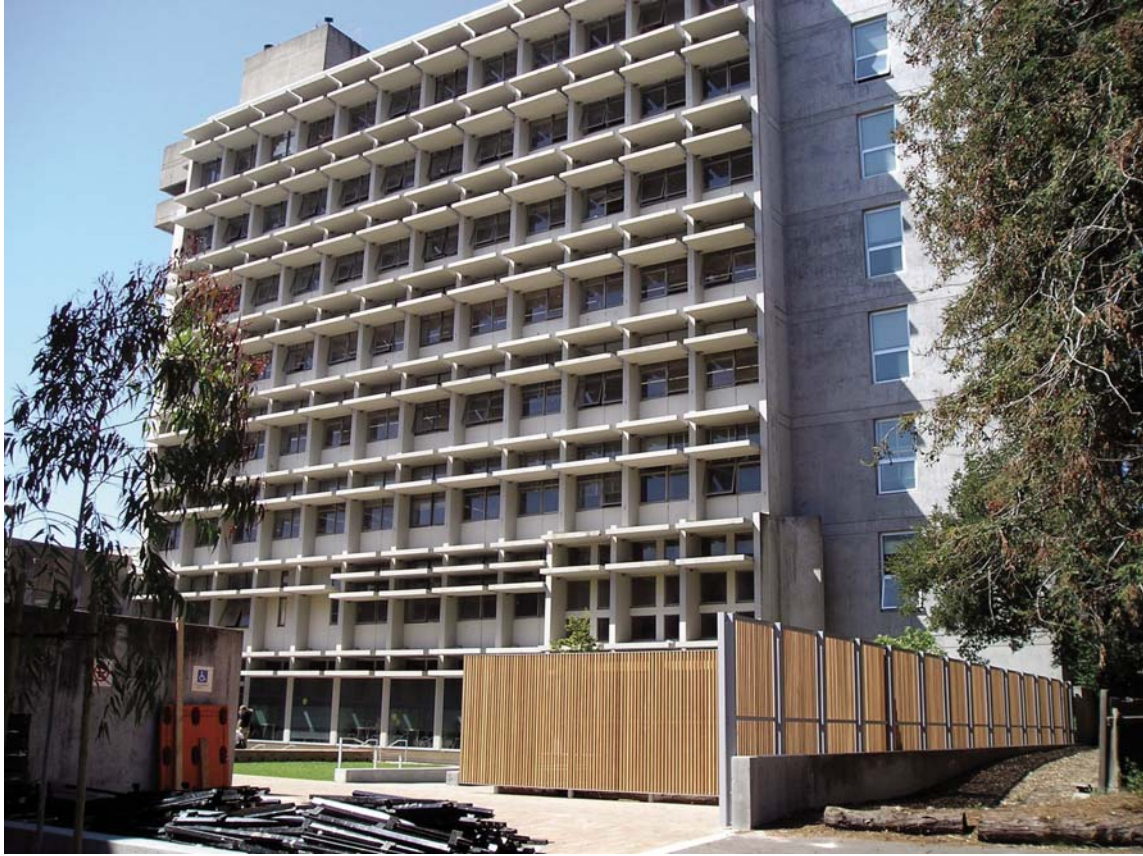
Figure 20. Wurster Hall Tower from the courtyard looking north.

Walk up to Wurster Hall and walk through and up the stairs to the courtyard. Look over to the tower for the most obvious retrofits (Fig. 20).

The project committee selected a design that involved adding a tube-like structure on the east of the tower and installing more continuous shearwalls on the west side of the tower, essentially creating two tubes. These tubes would brace the tower and provide lateral support. The tube scheme also included adding new shear walls and foundations to help resist lateral forces, minimizing potential displacement of the tower. Collector beams in the diaphragm were designed to tie the new

shear walls together with the existing structure, and two new foundations supported by drilled piers were added under the tubes. One tube, to the east, is clearly visible from the courtyard. Walk back into the building and peer in a few offices: notice the steel columns. To strengthen the fin columns, steel columns were added on the interior of the façade to transfer the vertical loads.

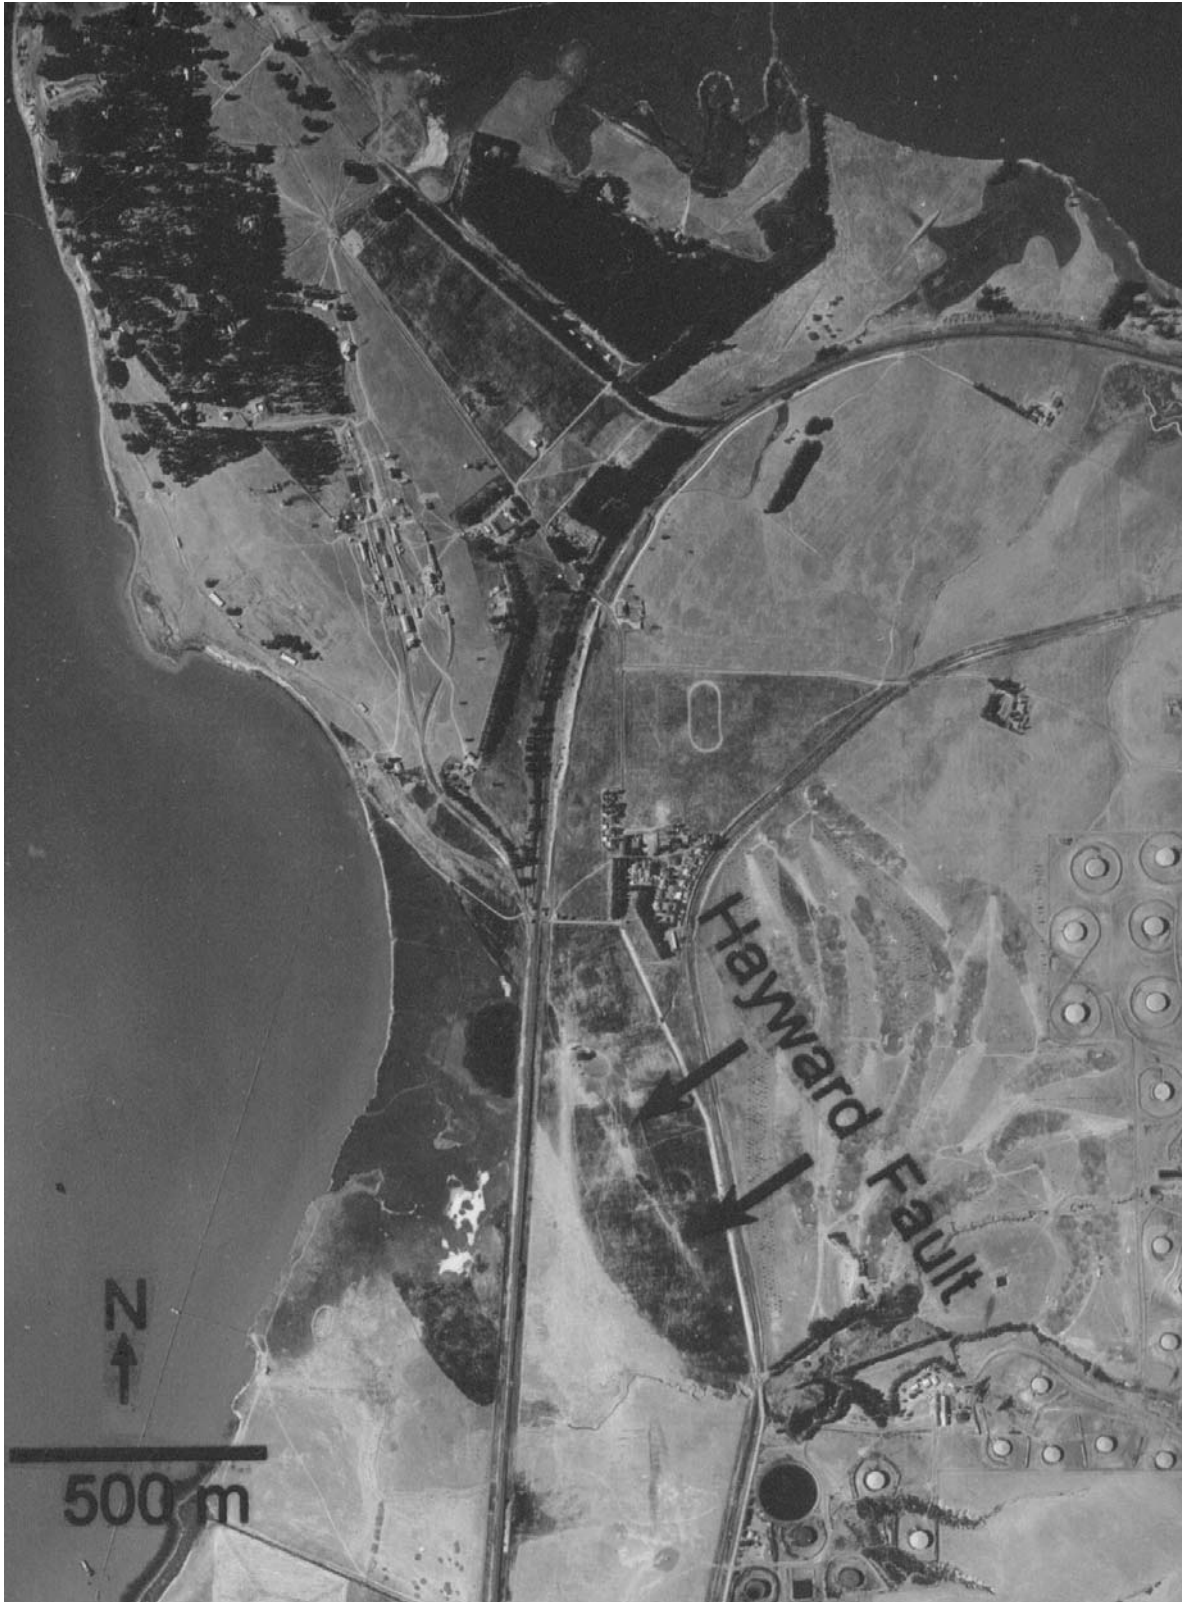
Figure 22. 1939 aerial photo showing the white linear feature that marks the location of the Hayward fault through what became Parchester Village in 1950. The white streak is the result of cultivation and erosion of an “E” soil horizon, which formed as a result of the water barrier produced by the fault. Most of the buildings seen here have been removed from the park.

Borchardt, and Lisowski, 1991), the Hayward fault crosses the southern boundary of the park (Fig. 23). The fault is delineated here by a small SW-facing scarp associated with a prominent white linear feature on 1939 air photos (Fig. 22). A series of benchmarks placed perpendicular to the fault by the USGS in 1968 underwent \sim 2.5' (65 mm) of aseismic displacement between 1968 and 1980 (5.3 mm/yr; Harsh and Burford, 1982). A real-time creep station was installed across the fault in 1996, yielding steady creep measurements of 4.8 mm/yr in a 50-ft-wide (15-m) zone from 1996 to 2004 (Bilham, 2005).

The strong linear feature on 1939 aerial photos (Fig. 22) was shown during seismic trenching to be a light gray “E” hori-

zon (a soil horizon depleted of organic matter and iron oxides) formed in response to the water barrier formed by the fault (compare Figs. 25 and 26) (Borchardt, 1988a). The shallow water table helped to preserve spectacular slickensides at the 13-ft (4-m) depth (Fig. 27). The area is still nearly level today because vertical slip along the fault diminishes as it steps over to the Rodgers Creek fault to the northwest.

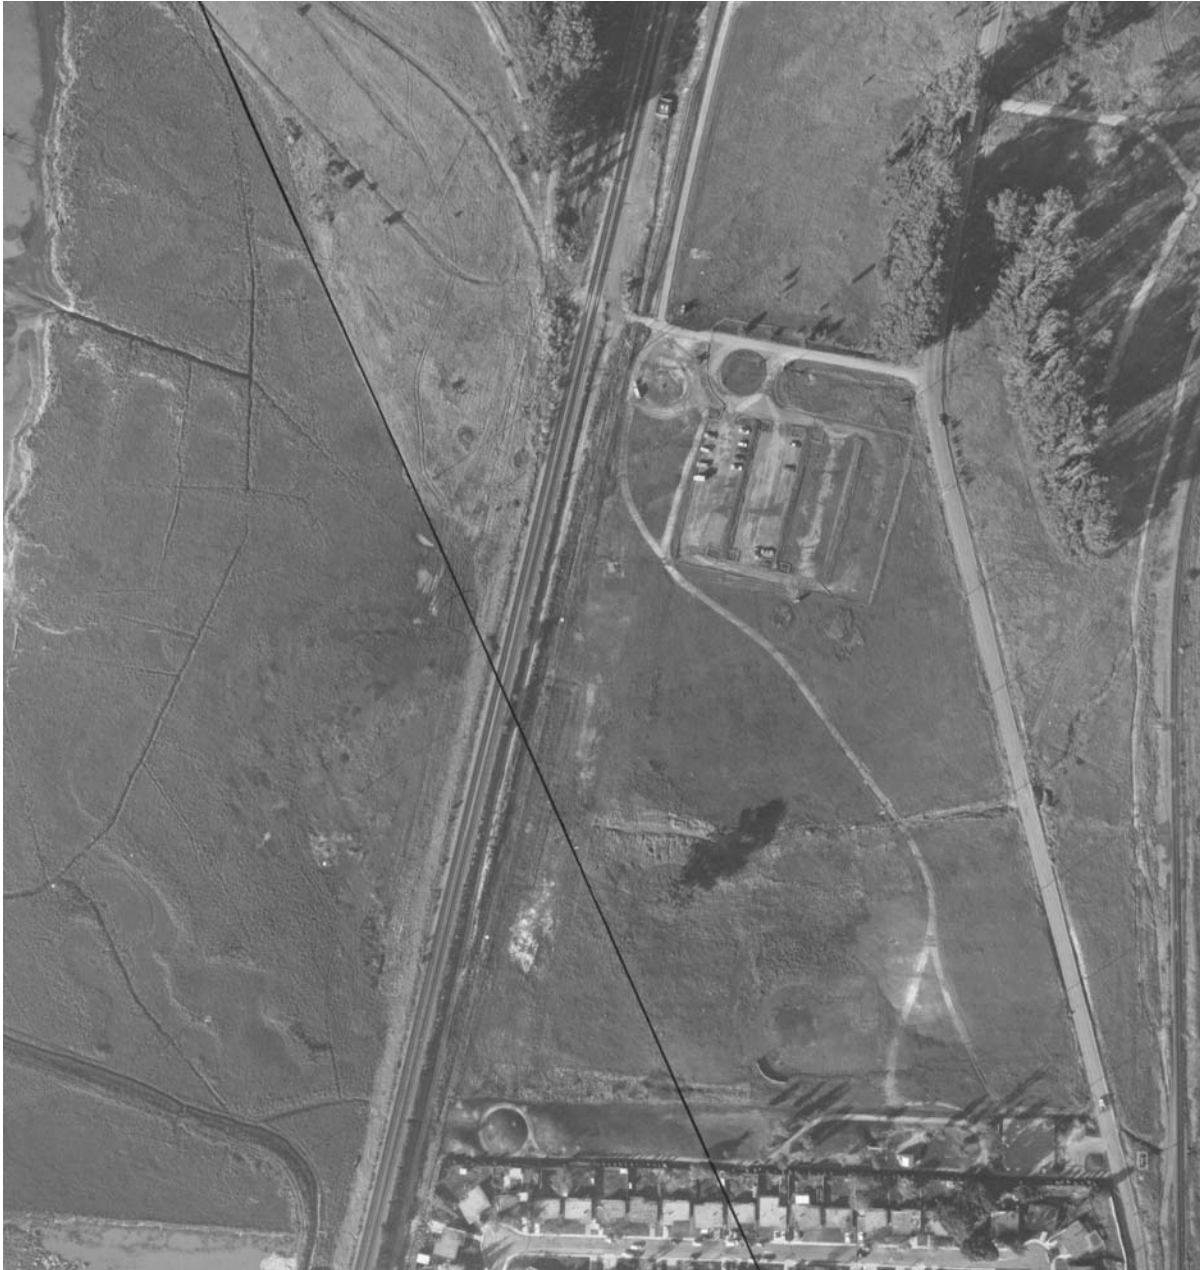
Figure 23. 1978 aerial photo of the Hayward fault as it passes through Parchester Village, offsets two pipelines and the Union Pacific railroad tracks, and then forms the linear scarp along the tidal marsh.

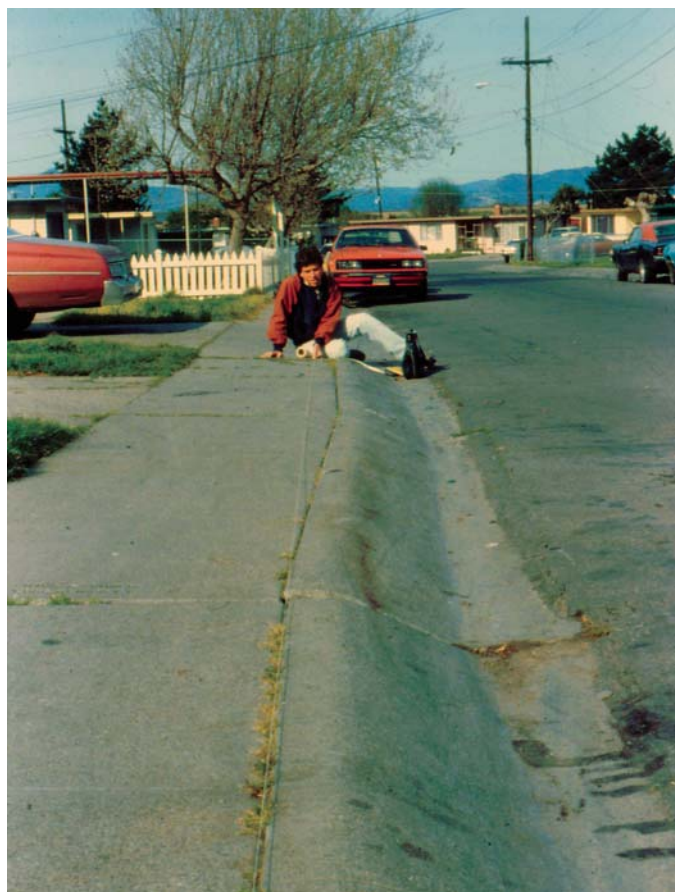
Figure 24. Right-lateral curb offset at 704 Phanor Drive due to aseismic slip in Parchester Village that was 150 mm (6 inches) by 21 March 1985. More precise techniques found 214 mm of offset in a wider span of the northwestern curb on Banks Drive in 1988 (Lienkaemper et al., 1991). By now, the offset should be about twice as much as shown here. Gene Kelley, Colorado State University, for scale.

After bisecting several houses, streets, and curbs (Fig. 24) in Parchester Village at 5.6 mm/yr since 1950 (Lienkaemper,

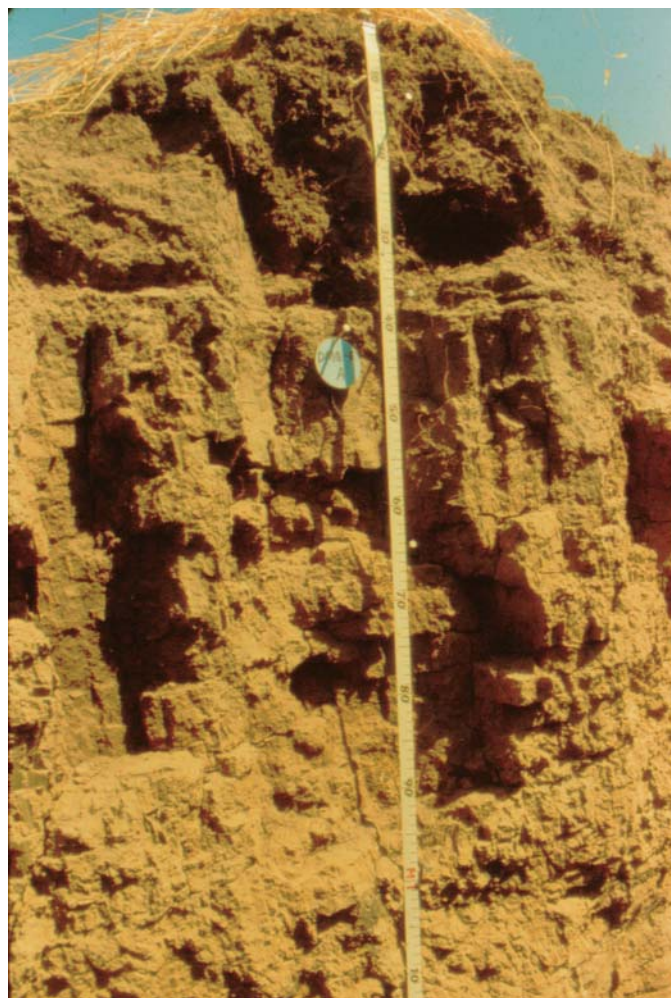
Figure 25. Moderately strong soil developed on the SW side of the Hayward fault in Trench DMG-E (Borchardt, 1988a).

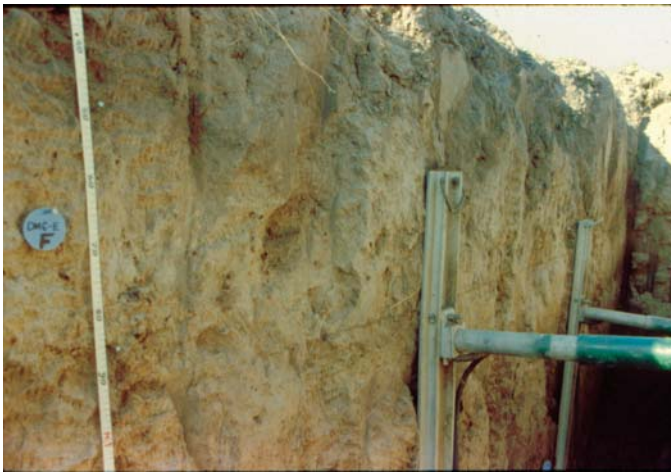
Figure 26. Light gray “E” horizon developed on the NE side of the Hayward fault in Trench DMG-E, a few meters from the soil profile in Figure 25 (Borchardt, 1988a).

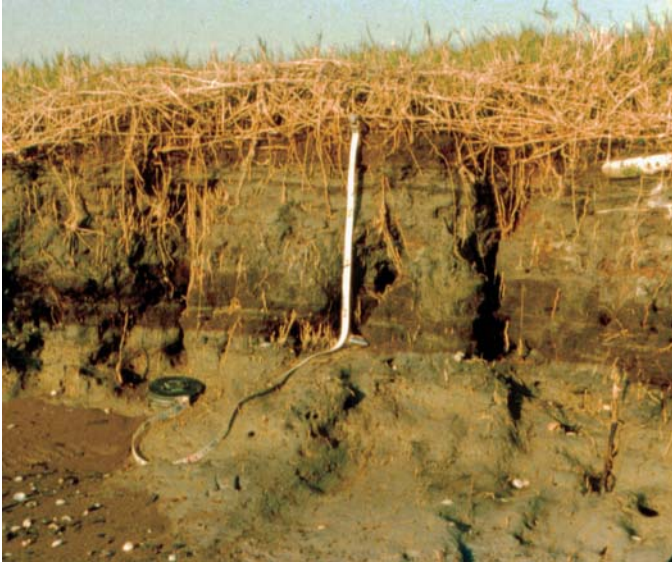
Figure 30. Bay mud cliff showing the younger bay mud and the pervasive sedimentary peat at the base that was dated at 1300 calendar years old.

A 1300-yr-old black sedimentary peat containing sand-size flakes of vermiculite (flakes of weathered biotite mica sometimes mistaken for gold in Sierra streams) lies buried in the tidal marsh southwest of the fault (Figs. 29 and 30). Examination of the salt marsh cliff and probings throughout the marsh revealed that the base of this distinctive peat layer exists at depths between 14” and 30” (36 and 75 cm) and that it varies in thickness from 4” to 11” (10–27 cm). Its depth and age are what would be expected in a crustally stable part of the world such as Micronesia (Bloom, 1970). Global sea level rise has been ~0.4 mm/yr during the past 4000 years, but measurements at the

Modern plant remains of the type found in the dated peat layer may be seen here mixed with vermiculite particles at the edge of the mud flat (Fig. 30). At low tide, the peat layer is exposed within the bay mud deposits along the full length of the salt marsh cliff. Bay mud is of mixed clay mineralogy and normally contains only clay and silt. Sand, if any, is brought in locally from nearby upland drainages.

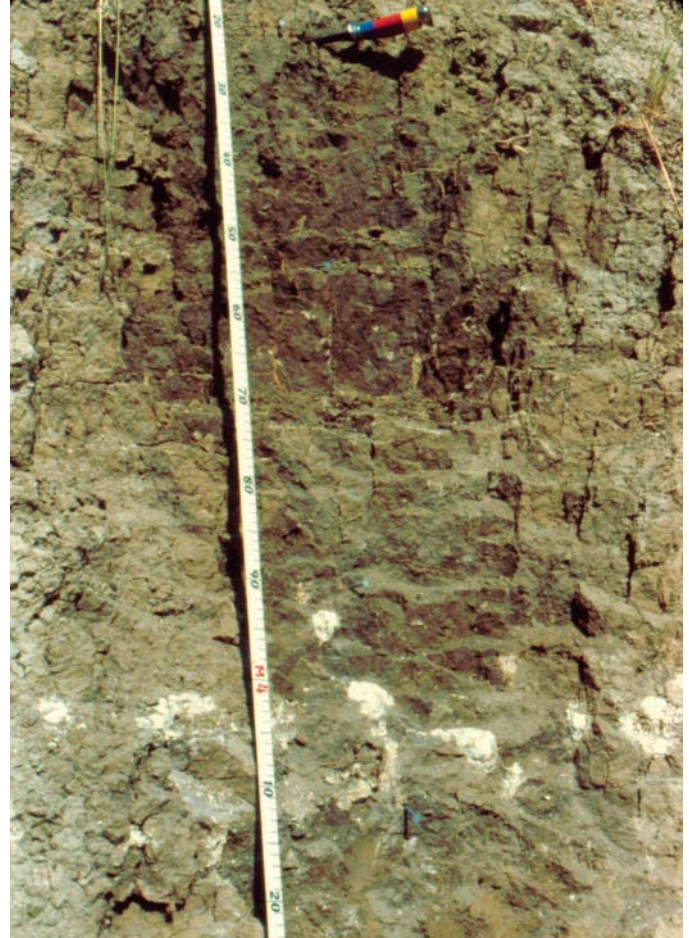
Figure 31. Paleosol (fossil soil) at the base of soil profile P2 at Point Pinole Regional Shoreline. The white nodules are calcium carbonate dated at 26,000 yr old (Borchardt et al., 1988; Borchardt and Seelig, 1991).

This paleosol (fossil soil) section, like most of the others along the shoreline, was exposed as a result of erosion produced by rising sea level in San Pablo Bay (Figs. 31 and 32). Note that the young trees at the shoreline are being rapidly undermined.

The development in the lower paleosol here is particularly striking (Fig. 31). This paleosol has a 35"-thick (88-cm) B horizon with strong blocky structure and clay films that extend into the BC horizon (a transitional soil horizon less weathered than the B horizon) for at least another 18" (45 cm). At a depth of 131–140" (333–355 cm), the base of the paleosol contains moderately dense, 2"-diameter (5-cm) calcite (calcium carbonate) nodules. The mechanism by which these nodules could form in soils and paleosols of the Bay Area is not well understood. In California, most calcareous soil horizons are found in the semiarid and arid regions. Calcium carbonate nodules, however, have been reported in borings in east-west cross sections across the southern San Francisco Bay. ²³⁰Th–²³⁴U analysis of two of these nodules resulted in an age of 26,000 yr. This was confirmed by a ¹⁴C date of 21,000 yr B.P. (yr B.P. of 1950), coral-corrected to 26,000 calendar years. The modern

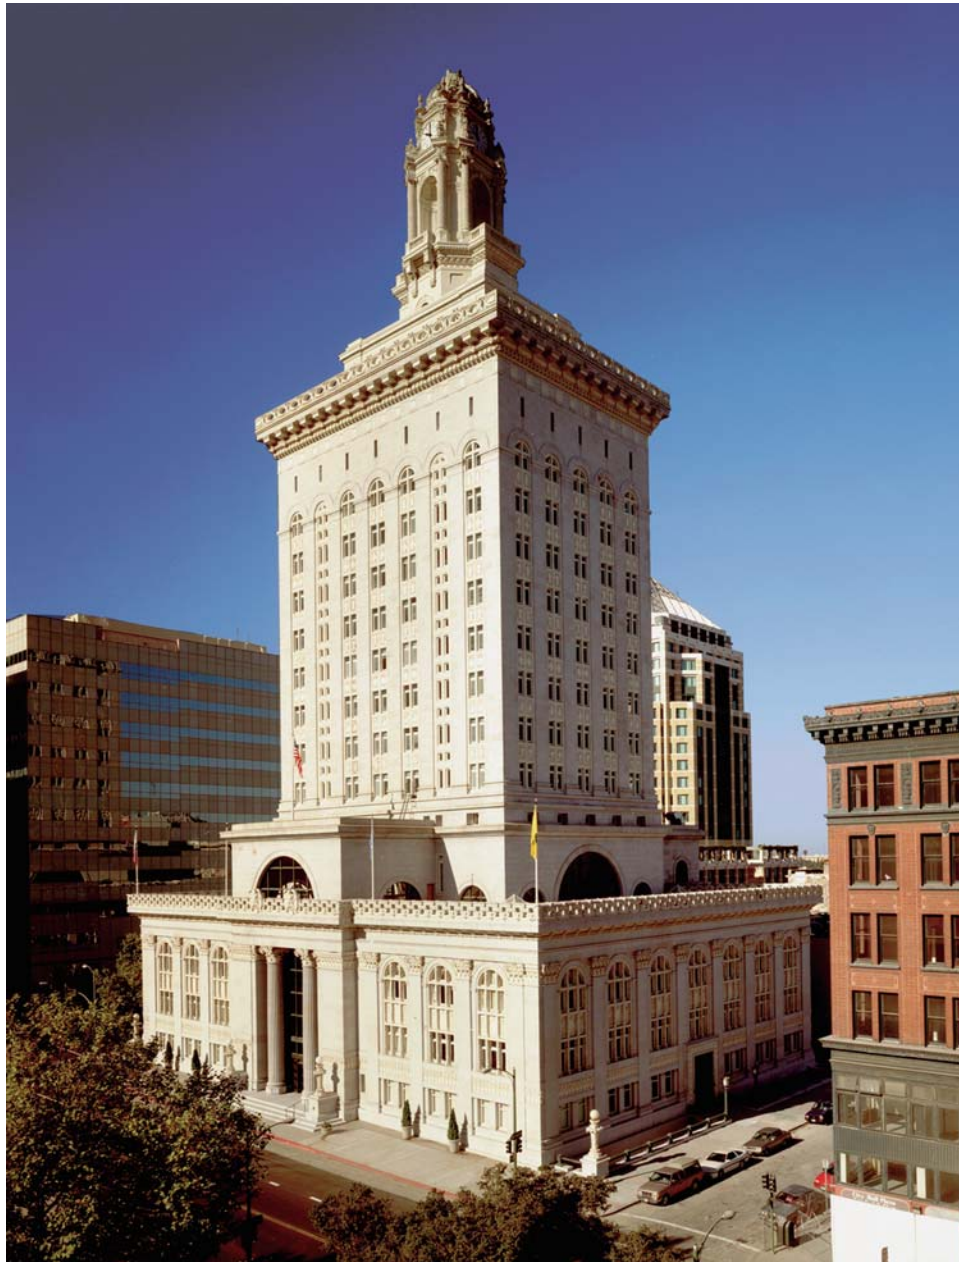
Figure 38. Photograph of Oakland City Hall (from Steiner and Elsesser, 2004).

tower, and a 2-story clock tower base that supports a 91-ft ornamental clock tower (Fig. 38). The total height of the building is 324 feet, and the total square footage is 153,000 sq. ft. The structural system is a riveted steel frame with unreinforced masonry perimeter in-fill walls clad with granite veneer and terra cotta ornamentation (DIS Inc., 2005).

The Oakland City Hall (Fig. 38) suffered significant damage in the October 1989 Loma Prieta earthquake, forcing the city to move all operations out of the building. The city hired a project team, headed by VBN Architects, to undertake a detailed feasibility study to quantify the building's lateral capacity and to examine alternative repair and strengthening schemes. The decision to install a seismic base isolation system as the most cost-effective solution was reached after eight alternative repair systems were compared and analyzed. A significant factor in the selection of base isolation as the most cost-effective approach was the limited strength of the building as constructed. To minimize the amount of new construction, the existing structure was given credit for the strength it exhibited during the Loma Prieta earthquake. This performance-based approach required less strengthening than conventional, code-based design, which ignores the existing capacity of the building.

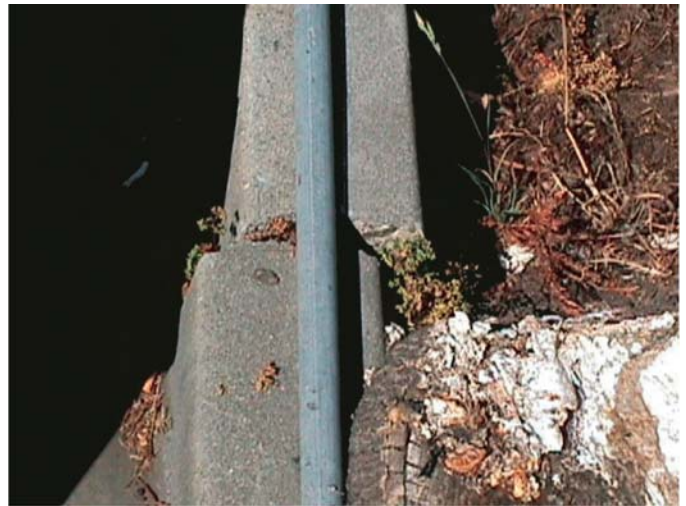
Figure 45. Photograph of evidence of right lateral creep on the mapped active strand of the Hayward fault. This offset curb is in the parking lot between A and B streets in downtown Hayward.

From City Hall, walk northwest along Mission Blvd, parallel to the creeping strand. Note that there is a little hill to the east. In addition to sliding right, the Hayward fault is also pushing its east side up ~0.5–1 mm/yr (Gilmore, 1992; Kelson and Simpson, 1995; Lienkaemper and Borchardt, 1996). Half a block past B Street, turn right into the City of Hayward parking lot. Here look for evidence of the creeping strand on the pavement, curbs, and nearby buildings (Fig. 45).

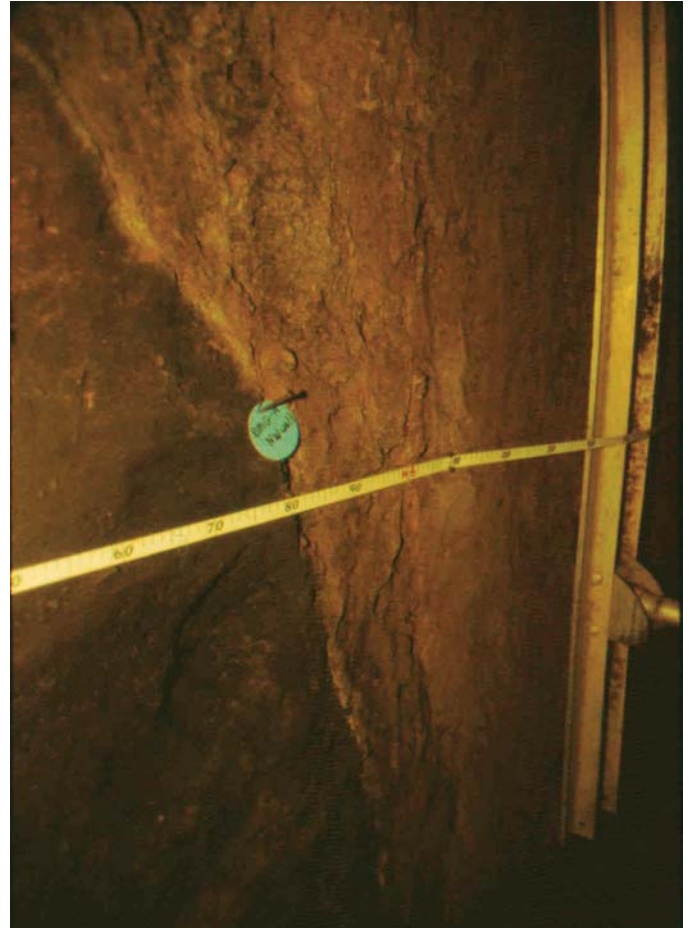
Figure 49. (*this and following page*) (A) Photograph of the Hayward fault exposure in a trench opened in 1987 on City of Fremont property (photo courtesy of San Jose Mercury News). The fault is a sharp boundary between fine-grained gray silt and light-colored sandy gravels.

This fault trench exhibit in Fremont's Central Park (Fig. 48) consists of an open pit that exposes the Hayward fault in a locality where the steep fault ruptured in 1868 and is easily observed in the different types of sediment (Fig. 49). The Fig. 49 photo comes from a trench located where the exhibit is today, ~150 feet north of the front of the former library (now the teen center). The public can observe the fault from the ground surface as well as walk down into the pit for a closer look. Visitors can also see where slow and constant creep along the fault is
