## Stream and floodplain restoration in a riparian ecosystem disturbed by placer mining

Kenneth F. Karle <sup>a,\*</sup>, Roseann V. Densmore <sup>b</sup>

Techniques for the hydrologic restoration of placer-mined streams and floodplains were developed in Denali National Park and Preserve Alaska, USA. The hydrologic study focused on a design of stream and floodplain geometry using hydraulic capacity and shear stress equations. Slope and sinuosity values were based on regional relationships. Design requirements include a channel capacity for a 1.5-year (bankfull) discharge and a floodplain capacity for a 1.5- to 100-year discharge. Concern for potential damage to the project from annual flooding before natural revegetation occurs led to development of alder (*Alnus crispa*) brush bars to dissipate floodwater energy and encourage sediment deposition. The brush bars, constructed of alder bundles tied together and anchored laterally adjacent to the channel, were installed on the floodplain in several configurations to test their effectiveness. A moderate flood near the end of the two-year construction phase of the project provided data on channel design, stability, floodplain erosion,

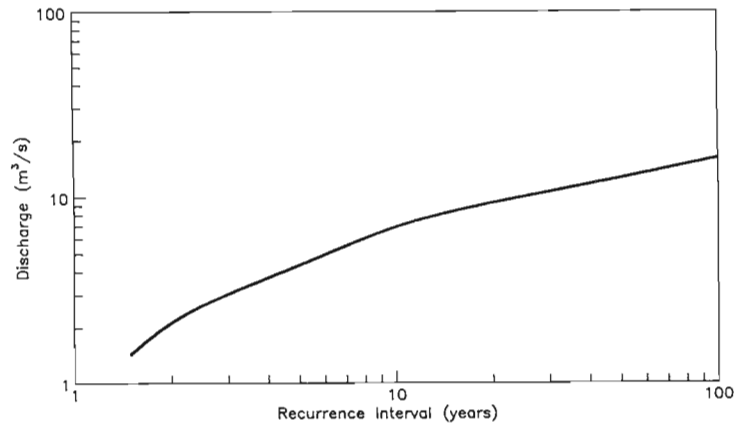
Fig. 2. Flood frequency curve for Glen Creek study area.

The design process began with the estimation of design flood flows from regional multiple-regression estimations (Lamke, 1979; Kane and Janowicz, 1988; see Fig. 2). The estimated bankfull discharge was  $1.44 \text{ m}^3/\text{s}$ ; however, a slightly larger value was used for the design flow as a factor of safety.

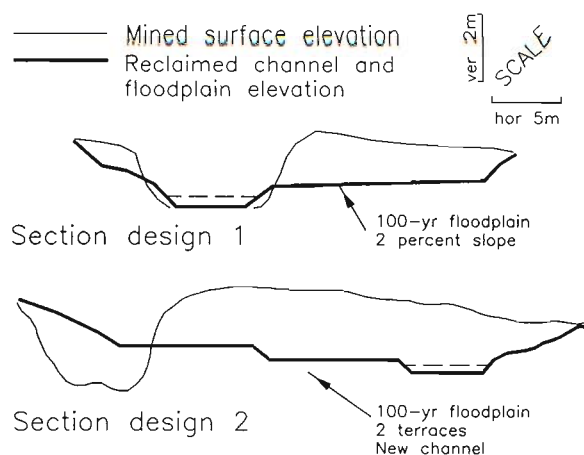
Fig. 3. Typical cross-section designs. The channel is designed to carry bankfull discharge (1.5-year flood). Two floodplain configurations (single 2% slope and 2-terrace) were designed to carry the 100-year flood.

Once the design parameters were established and surveyed, earthwork took place along two reaches of Glen Creek, including a 425-m reach in 1991 (upper study area) and an adjacent 975-m reach in 1992 (lower study area). To achieve the design goal of a functioning channel and floodplain, two types of earthwork configurations were constructed along the test reaches. Most of the work involved recontouring artificially raised floodplains to a lower elevation, using a shallow slope to restore natural floodplain processes and leaving the existing channel undisturbed except for minor bank modifications (Section design 1, upper study area, Fig. 3). In one area, an entirely new channel of 150 m long was designed and

repositioned in the valley center, away from the valley wall where it was previously located (Section design 2, lower study area, Fig. 3). Additionally, the floodplains along this reach were constructed with two terrace levels instead of a single slope.

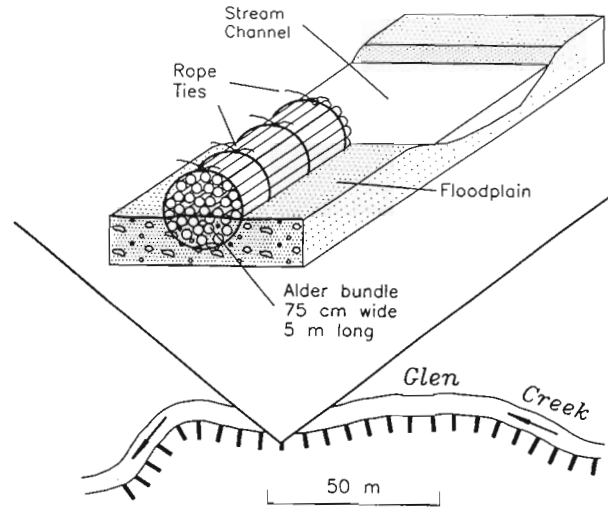
Fig. 4. Brush bar pattern, with one channel width spacing, along left bank of new channel reach in lower study area. Inset shows typical installation of alder bundle, adjacent to channel and anchored to floodplain.

To meet these requirements, a series of alder brush bars were installed on various locations along the study reaches. Designed to slow flood water velocity and encourage sediment deposition, these were bundles of cut alder, approximately 50 to 75 cm in diameter and 4 to 5 m in length. The bundles were installed by first digging a trench into the floodplain perpendicular to the channel. Several rope lengths were placed across the open trench, the lower half of each bundle was set into the trench, the trench was then backfilled, the top half of the bundle was added and the ropes were tied around the bundle to anchor the bundle in place (see Fig. 4). In 1991, two groups of brush bars were installed on the upper reach. The bars were spaced three channel widths apart, with four bars in the first group and 22 bars in the second group. Bars in the first group included one 4- to 5-m-long feltleaf willow branch buried in the lower half of the bundle and five willow cuttings planted into the downstream side of the bundle. For the 1992 project, two groups of brush bars were installed on the lower reach, with the spacing at one channel width apart. One group contained eight bars and the second group, installed along the left bank of the new channel construction, contained 25 bars.

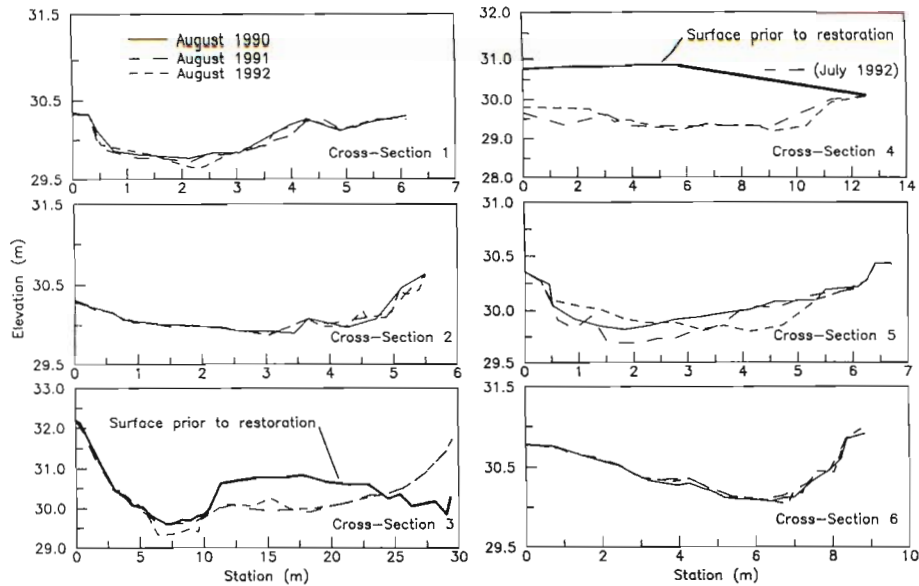
Fig. 5. Cross-section surveys along Glen and Spruce Creeks, from 1990 through 1992.

The passage of the August 5, 1992 flood event caused several significant changes to the channels in these areas. Severe bank erosion, channel widening and lateral migration of the channel were noted in both study areas. In the lower area along the new channel segment, enough erosion and lateral movement of this reach occurred to result in a slope decrease of almost 5%, with a corresponding increase in channel sinuosity. The erosion took place along the right bank, which was unprotected by alder brush bars (Cross-section 4, Fig. 5). Cross-section 3 in Fig. 5 also shows channel changes in the upper study area, which suffered bed and bank erosion and channel widening.

Floodwater cut behind only the first few brush bars in each group on the lower reach, where the bars were only one stream width apart. Substantial amounts of sediment were deposited on the floodplain where water did not run behind the bars. Cross-section 4 in Fig. 5 shows substantial deposition on the left bank (where the bars were located). Fig. 6 depicts the average deposition of material adjacent to brush bars installed along the new channel section.

In mined reaches where no active floodplain or channel restoration took place, bed and bank instability was apparent, with significant channel movement during the first two years of monitoring (Cross-section 5, Fig. 5). The two control reaches in upper Glen and Spruce Creeks remained relatively stable during this same period (Cross-sections 1 and 6, Fig. 5).

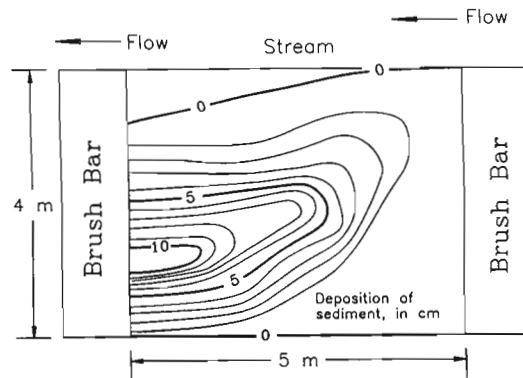
Fig. 6. Typical sediment deposition depths, in cm, for brush bars spaced one channel width apart along new channel reach.
