### Citizens Coordinating Council Meeting Silver Lake Pilot Study Results

December 5, 2007 Pittsfield, Massachusetts

### Silver Lake CCC Meeting Summary

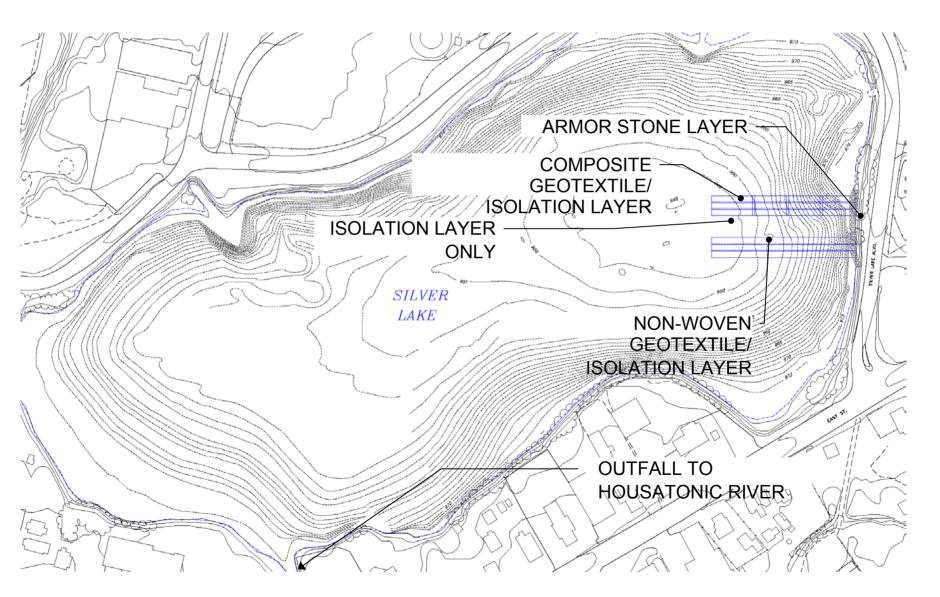
# **Pilot Study Location and Components**

One acre study area split into contiguous cells with three cap configurations

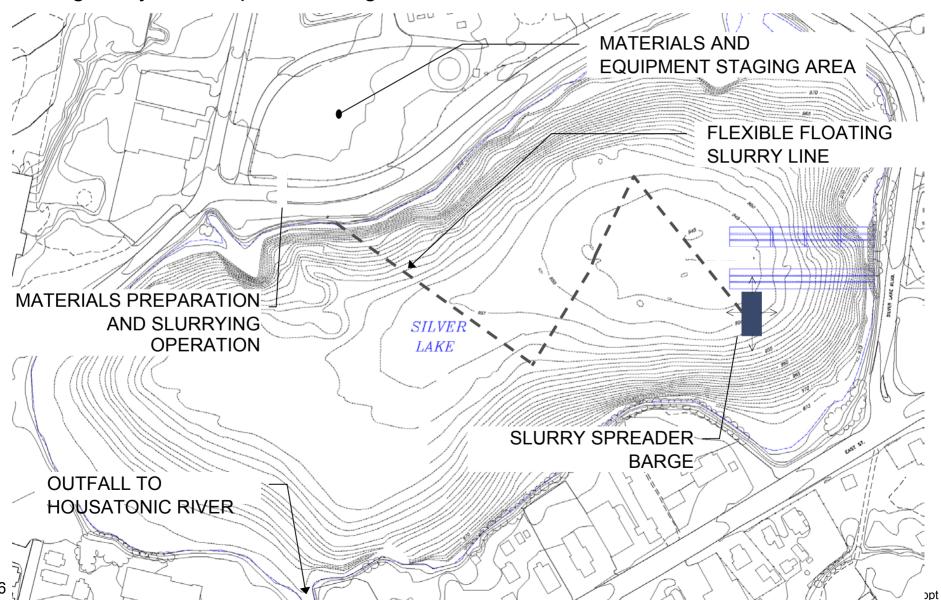
# **Pilot Study Operations**

Isolation layer materials slurried on shore w/ lake water, and pumped via floating slurry line to spreader barge

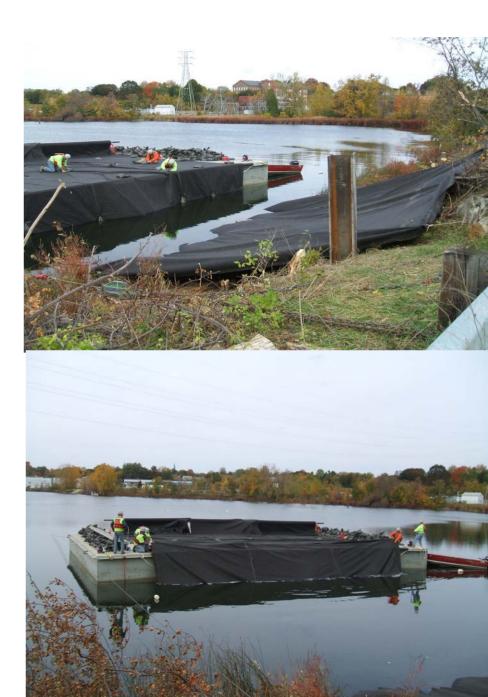
# **Geofabric Placement**

- Non-woven geotextile and geocomposite fabrics installed from barge
  - adjacent full length rolls sewn together and loaded onto barge mounted rollers
  - anchored to shore and barge moved away from shore
  - sand bags and rebar used to weight fabric and secure to lake bottom

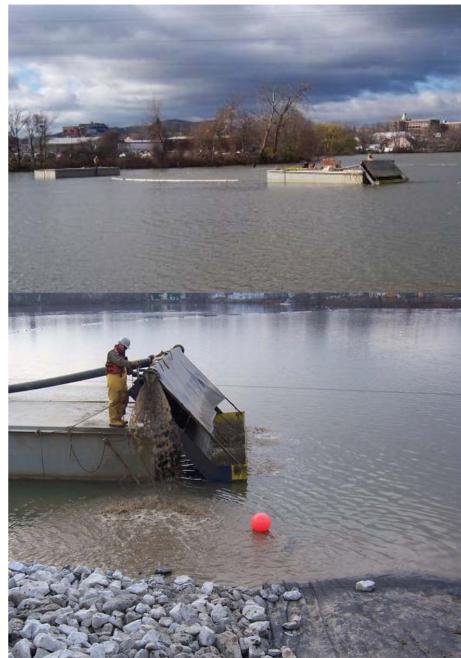
### **Isolation Layer Material Placement**

- Spreader-box distributes slurried isolation layer material over 20-ft span
- Barge speed and slurry delivery rate monitored/adjusted to achieve approximate 1-inch lifts
- Placement rate later increased for 2to 3-inch/day trials
- Side discharge used in near shore areas (approx. 2- to 4-ft water depths)

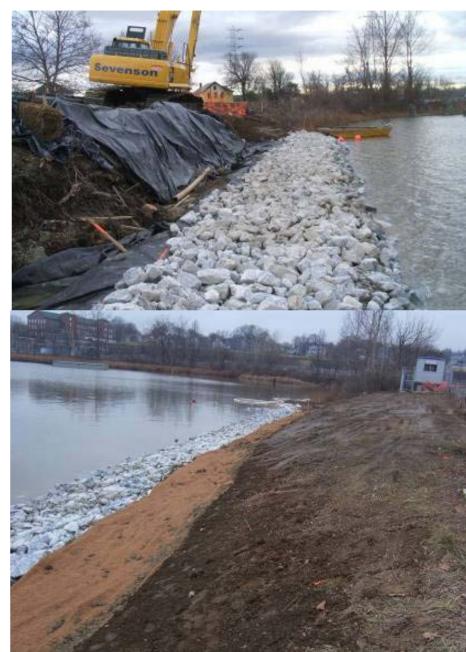
# **Cap Construction Along Bank**

- Bank soils excavated in anticipation of finished cap elevations
- Isolation layer and armor layer placed
- Armor stone layer extends to elevations approximately 2.5 ft above and below the apparent mean water line
- Gravel habitat layer placed on top of armor below water surface
- Remaining bank areas graded and seeded/mulched

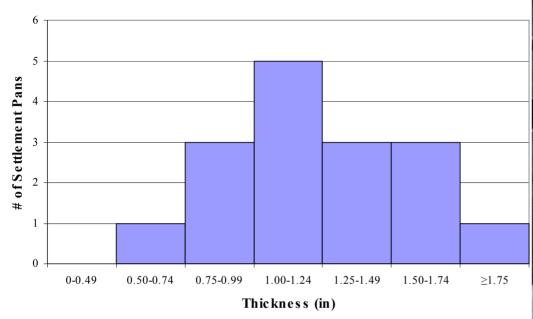
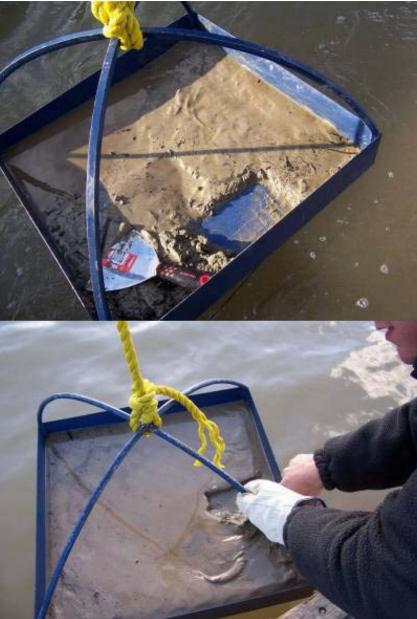
### **Collection Pan Data**

- Collection pans placed in path of barge travel to represent thickness of one 1inch/day "pass"
- Data suggests success in placement of approximate 1-inch lifts

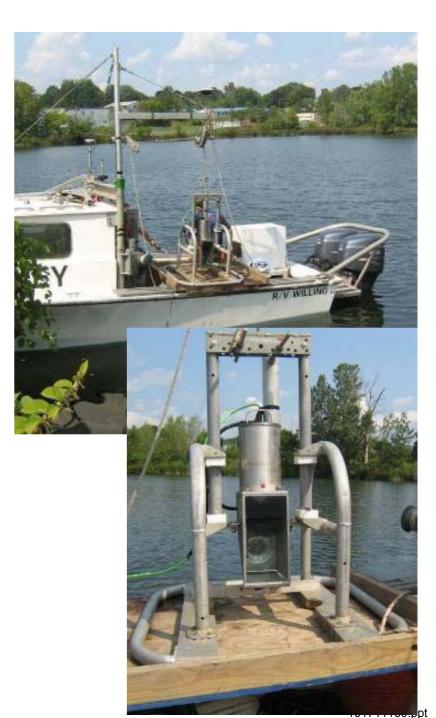
# **Sediment Profile Imaging**

Collected prior to and at approximate midway point of cap placement (after 7 lifts)

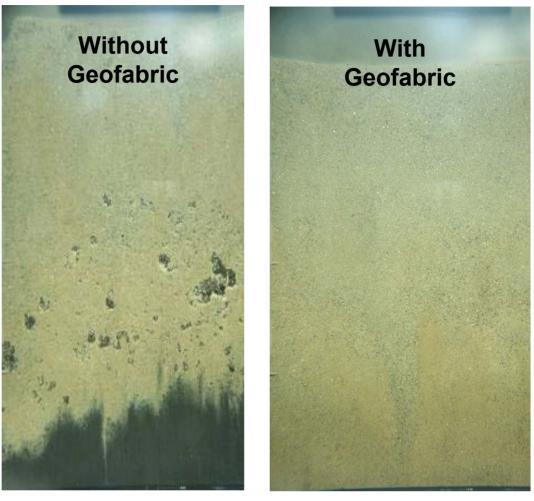
## **During-Construction SPI**

- Isolation layer materials appear fairly homogenous
- Mixing appears limited to the first inch of isolation layer materials in nongeofabric areas

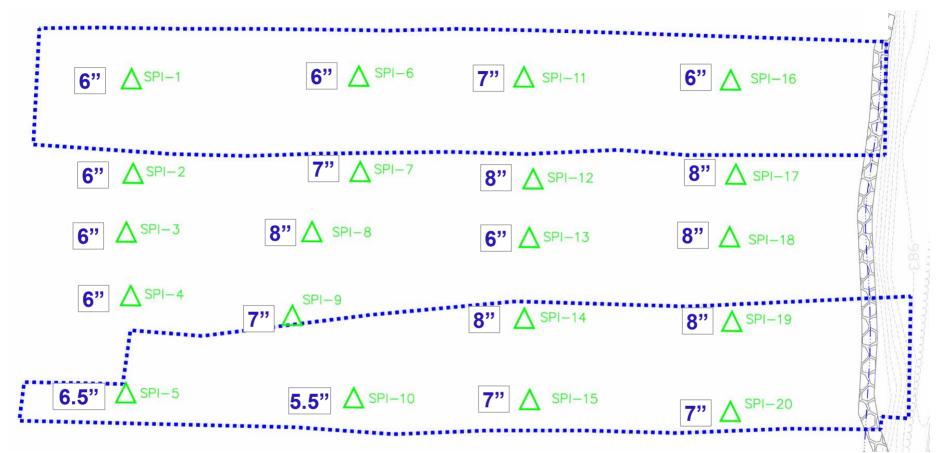
### **SPI Based Cap Thickness Estimate**

- SPI images collected at 20 locations
  - suggests achievement of cap thickness goals at mid-point of construction (after 7 lifts)

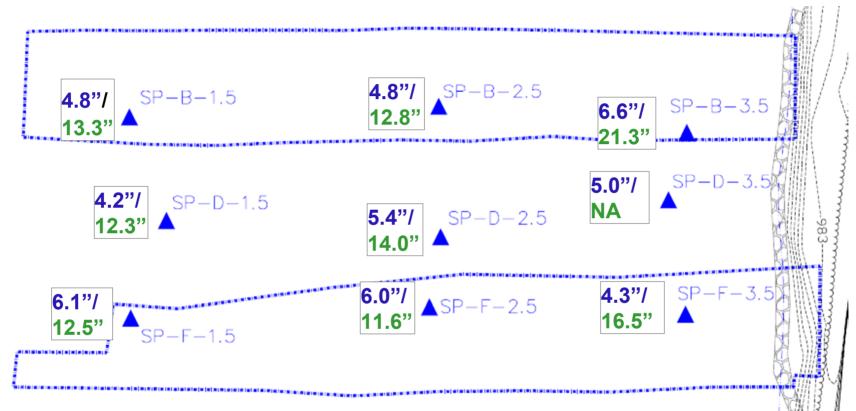
### Cap Thickness Probing Results at Settlement Plates

- 9 physical settlement plate locations probed by divers to confirm cap thickness and placement rates at interim/immediately after events
- Cap material well distributed using thin lift placement technique

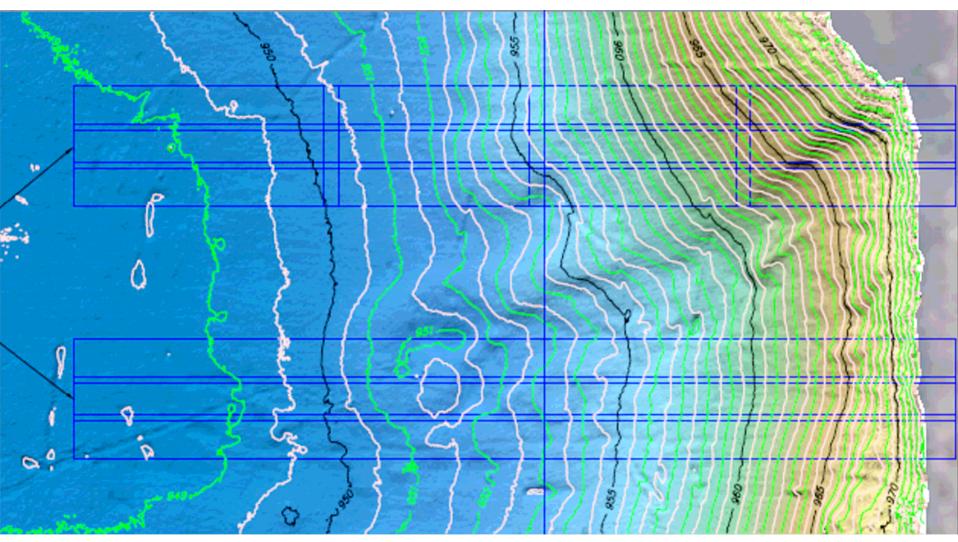
### **Bathymetric Surveying**

• Performed prior to; immediately after; and 6-months after construction for comparative purposes

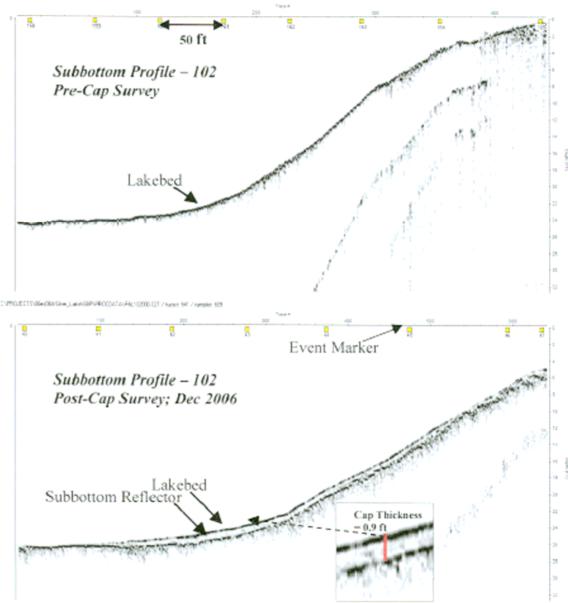
### **Post-Construction Sub-Bottom Profile**

- Acoustic survey capable of identifying unique layers and material interfaces
- Images provide visual information related to cap surface consistency/relief
- Suggests no apparent difference in performance related to presence/ absence of geofabric

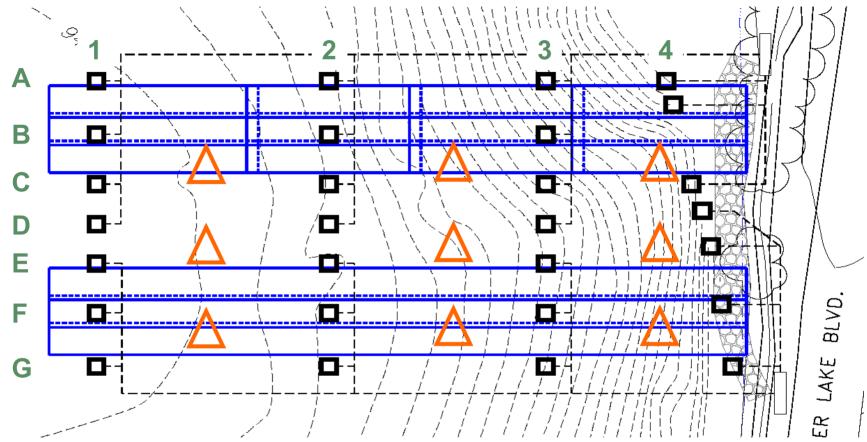
### **Geophysical/Consolidation Monitoring**

- 28 individual vibrating wire settlement cells and 9 physical settlement plates installed on top of sediment (above geofabric)
- Monitored during and after construction to assess sediment response (i.e., consolidation) to cap placement

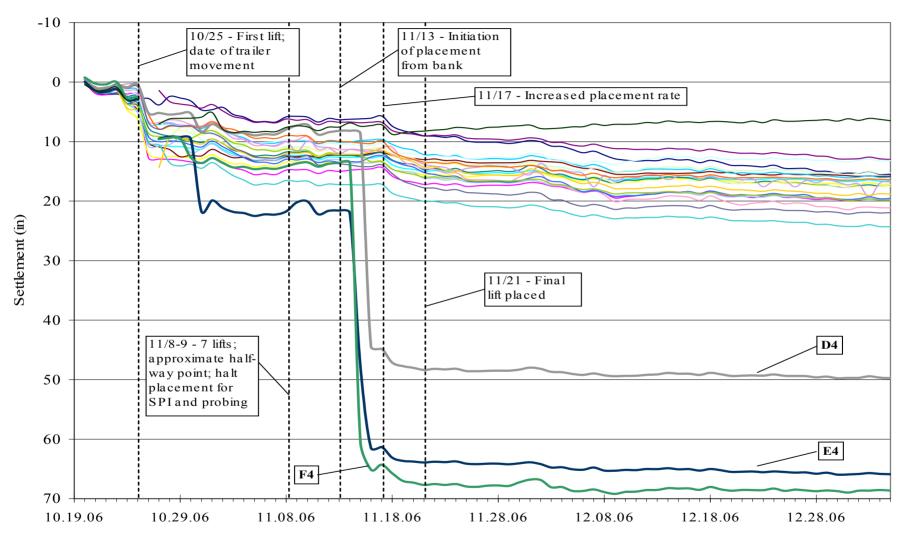
### **Vibrating Wire Settlement Cells**

- Confirms general patterns of settlement as indicated by bathymetric mapping and conventional survey at physical settlement plates
- Provided insight into sediment response to initial shoreline capping approach
- 20 No apparent difference related to presence/absence of geofabric

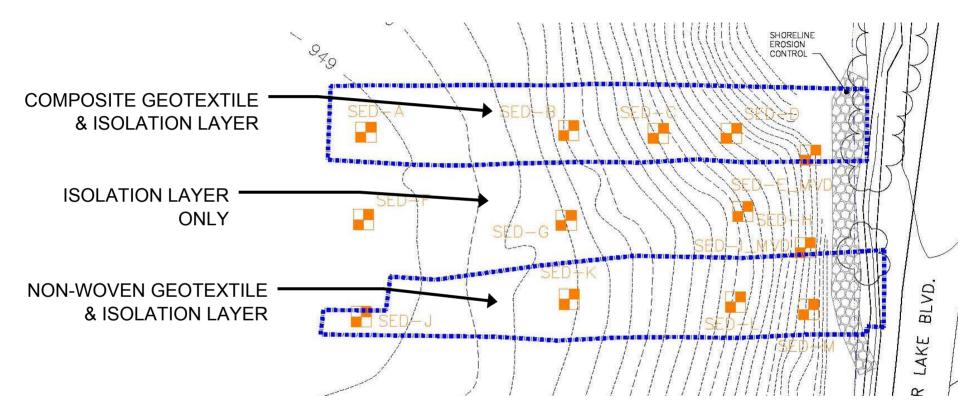
### Cap Coring and Sample Collection Program

- Performed immediately after, and 6 months after construction
- Cores visually observed to evaluate cap thickness and extent of mixing
- Cap materials analyzed for PCBs and TOC

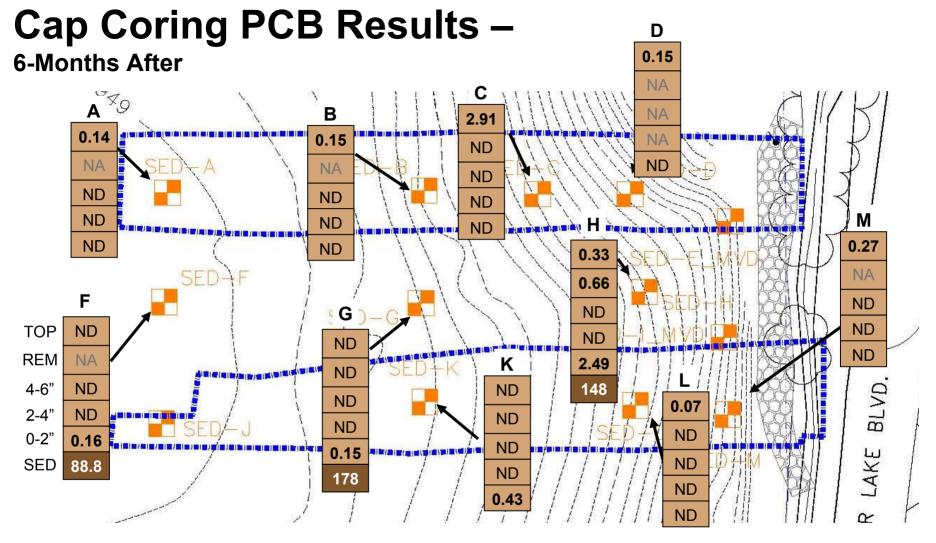
- 43 of 55 total samples contained no detectable PCBs
- 9 of 13 cores have no detectable PCBs below the surface increment
- Excluding TOP and 0-2" sample intervals, only one core has a detection in the remaining interior intervals

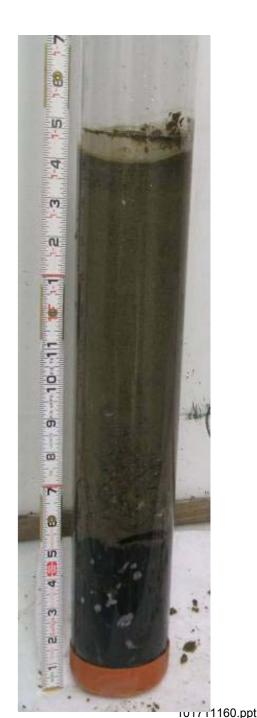
# **Cap Coring TOC Results**

0.58%	ТОР	
0.51%	REMAINDER	
0.47%	4- to 6-inch	
0.44%	2- to 4-inch	
0.44%	0- to 2-inch

• Dry isolation layer material samples precharacterized for TOC:

– Average: 1.1%

- Sedimentation pans collected outside study area:
  - -Average TOC ~ 4.0%
- Depth weighted average TOC ~ 0.5 %

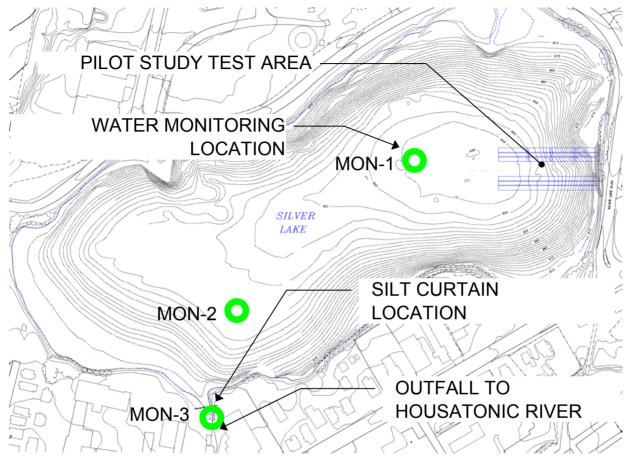
### Water Quality Monitoring Program

- Weekly collection at all three locations (PCBs, TSS)
- Continuous turbidity monitoring performed
- Turbidity >50 NTU at MON-2 or MON-3 triggered sample collection at all three locations (PCB, TSS)

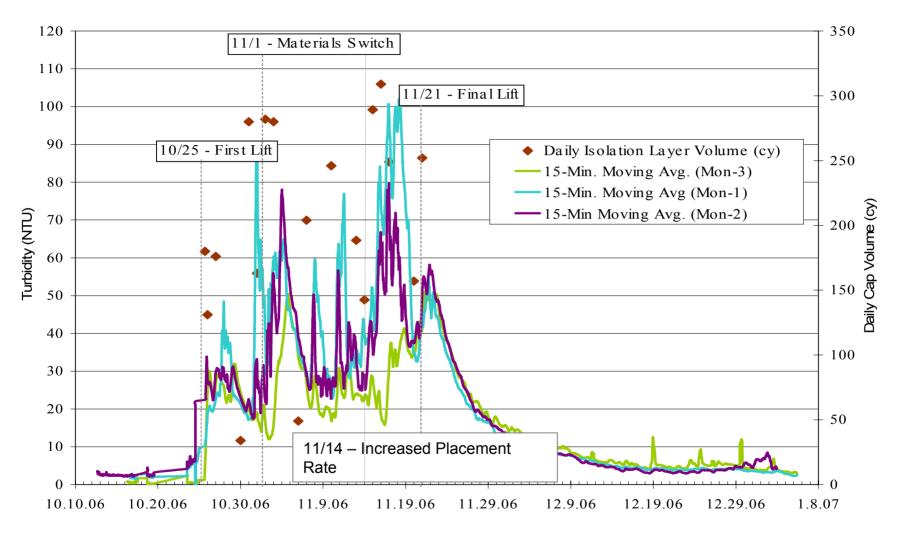
# **Turbidity Results**

- Few exceedances of 50 NTUs observed at outfall location
- Turbidity appears to approach pre-construction levels within 1 month of completion of placement activities

- Assess potential for water quality impacts during cap placement
  - Short-term increased turbidity observations related to isolation layer placement
  - No increase in surface water PCB concentrations observed

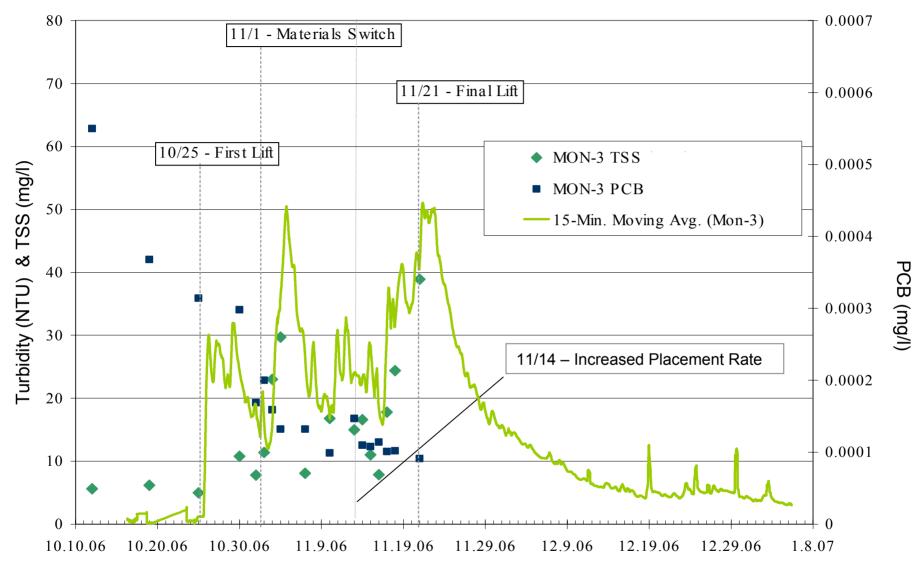
### Surface Water PCB, TSS Results

• PCBs concentrations in surface water were lower during the pilot study than PCB concentrations found before the study.
