**Environmental Restoration
Five-Year Review Report**

**Second Five-Year Review Report
For
Bonneville Power Administration
Ross Complex
Vancouver, Washington**

August 2004

**PREPARED BY:
Bonneville Power Administration
Vancouver, Washington**

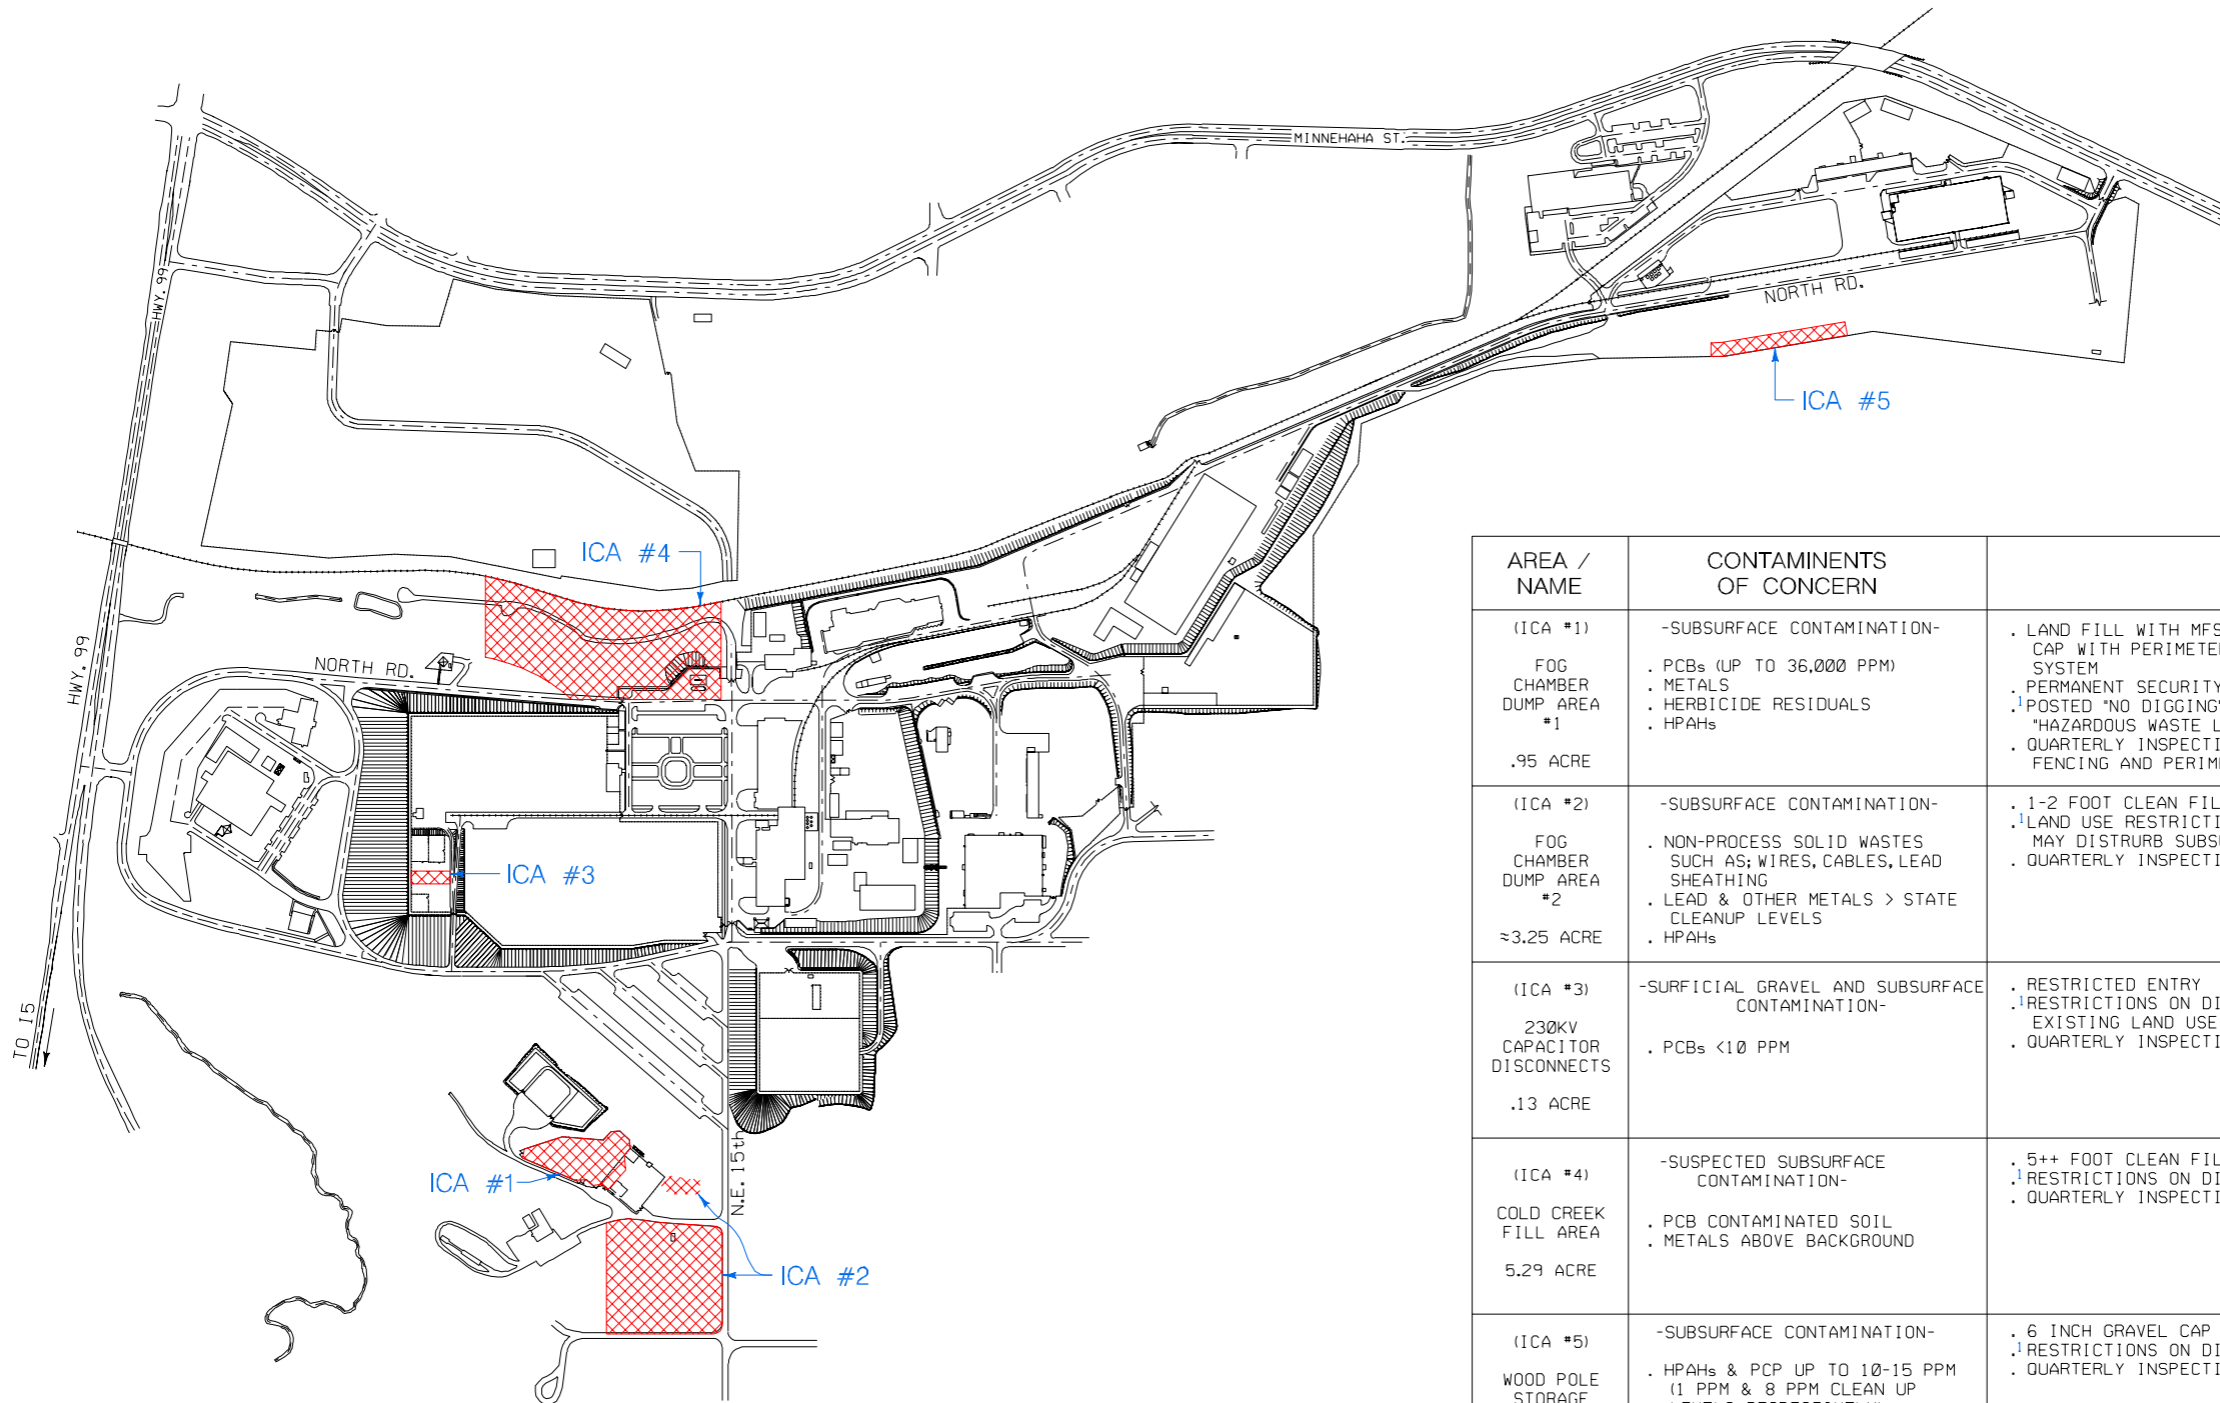
Attachment 1
Map of Ross Complex I/C sites

AREA / NAME	CONTAMINANTS OF CONCERN	CONTROL MEASURES	SEE FIG#
(ICA #1) FOG CHAMBER DUMP AREA #1 .95 ACRE	-SUBSURFACE CONTAMINATION- <ul style="list-style-type: none"> PCBs (UP TO 36,000 PPM) METALS HERBICIDE RESIDUALS HPAHs 	<ul style="list-style-type: none"> LAND FILL WITH MFS (IMPERVIOUS) ENGINEERED CAP WITH PERIMETER DRAINAGE COLLECTION SYSTEM PERMANENT SECURITY FENCE AROUND AREA POSTED "NO DIGGING" INSIDE OF FENCE, "HAZARDOUS WASTE LANDFILL" OUTSIDE FENCE QUARTERLY INSPECTIONS OF CAP, PERIMETER FENCING AND PERIMETER DRAINAGE CLEANOUTS 	FIG #1
(ICA #2) FOG CHAMBER DUMP AREA #2 ≈3.25 ACRE	-SUBSURFACE CONTAMINATION- <ul style="list-style-type: none"> NON-PROCESS SOLID WASTES SUCH AS; WIRES, CABLES, LEAD SHEATHING LEAD & OTHER METALS > STATE CLEANUP LEVELS HPAHs 	<ul style="list-style-type: none"> 1-2 FOOT CLEAN FILL MATERIAL COVER LAND USE RESTRICTIONS ON ACTIVITIES WHICH MAY DISTURB SUBSURFACE CONTAMINATION QUARTERLY INSPECTIONS 	FIG #1

(ICA #3) 230KV CAPACITOR DISCONNECTS .13 ACRE	-SURFICIAL GRAVEL AND SUBSURFACE CONTAMINATION- <ul style="list-style-type: none"> PCBs <10 PPM 	<ul style="list-style-type: none"> RESTRICTED ENTRY RESTRICTIONS ON DIGGING AND NO CHANGE IN EXISTING LAND USE QUARTERLY INSPECTIONS 	FIG #2
(ICA #4) COLD CREEK FILL AREA 5.29 ACRE	-SUSPECTED SUBSURFACE CONTAMINATION- <ul style="list-style-type: none"> PCB CONTAMINATED SOIL METALS ABOVE BACKGROUND 	<ul style="list-style-type: none"> 5++ FOOT CLEAN FILL CAP RESTRICTIONS ON DIGGING QUARTERLY INSPECTIONS 	FIG #3
(ICA #5) WOOD POLE STORAGE AREA, EAST .47 ACRE	-SUBSURFACE CONTAMINATION- <ul style="list-style-type: none"> HPAHs & PCP UP TO 10-15 PPM (1 PPM & 8 PPM CLEAN UP LEVELS RESPECTIVELY) 	<ul style="list-style-type: none"> 6 INCH GRAVEL CAP RESTRICTIONS ON DIGGING & LAND USE QUARTERLY INSPECTIONS 	FIG #4
