# McCurdy Road Stress-Laminated Timber Bridge

## A Viable Option for Short-Span Design

James A. Kainz, Forest Products Laboratory, USDA Forest Service  
Charles A. Hill, Richland County, Ohio

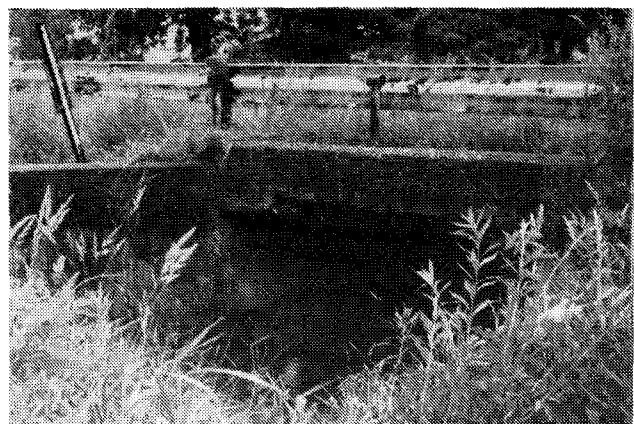
Figure 2—Original McCurdy Road crossing in 1986.

The McCurdy Road timber bridge is located in the southeastern part of Richland County, Ohio, approximately 0.4 km (0.25 mile) south of State Highway 97 on McCurdy Road (Fig. 1). This bridge spans a branch of the Babble Brook, which is a tributary of the Mohican River. The original crossing was a concrete box culvert built in the late 1930s (Fig. 2). After many years of use, this culvert was severely deteriorated, resulting in exposed steel and crumbling concrete. The bridge was posted with a 5.4-tonne (6-ton) load limit that restricted the crossing of heavy vehicles, which included fire equipment. Emergencies south of the bridge required a 9.7- to 12.9-km (6- to 8-mile) detour via Ashland County, which is located east of Richland County. In addition to the load restrictions, the cost of structure maintenance had increased beyond efficient means to maintain minimum traffic. Under the Ohio Department of Transportation (ODOT) condition grading system, this bridge was rated code 2 in 1993 (ODOT 1995). A code two designation is one step away from structure closure. (Code 1 represents structure closure.) Therefore, the McCurdy Road bridge was readied for replacement.

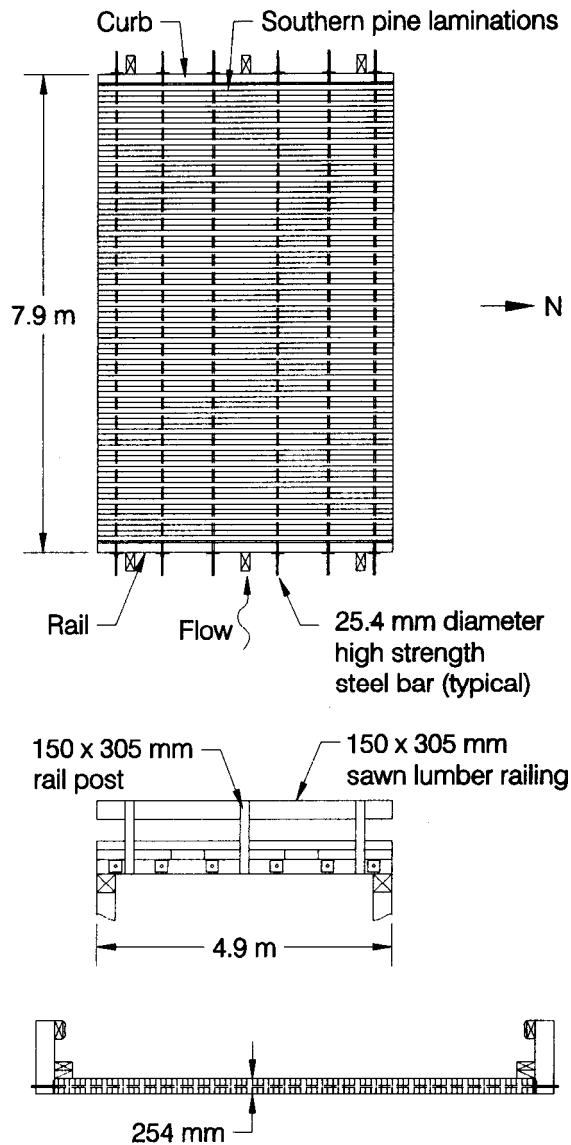
Figure 3—Design configuration of the McCurdy Road bridge.

The design geometry of the McCurdy Road bridge provided for a single-span, simply supported structure, 4.9 m (16 ft) long, 7.9 m (26 ft) wide, and 254 mm (10 in.) deep (Fig. 3). The stress-laminated deck consists of full-length, 51-mm (nominal 2-in.) Southern Pine lumber. Butt joints were not necessary in this deck because of the relatively short span.

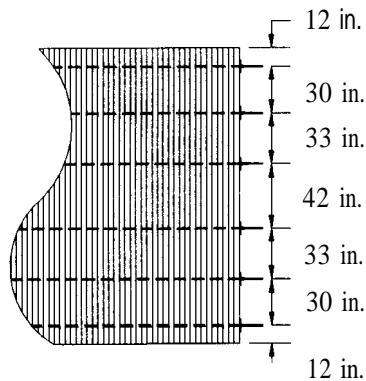
Figure 4—Stressing bar spacing on the McCurdy Road bridge.

The stressing system consisted of six high strength steel bars, which were inserted through predrilled holes at the center of the laminations. The design specified the use of 25.4-mm- (1-in.-) diameter threaded and galvanized steel bars with an ultimate tensile strength of 1,030 MPa (150,000 lb/in<sup>2</sup>), which meets the requirements of ASTM A722 (ASTM 1988). The bars were not uniformly spaced along the face of the deck (Fig. 4). The non-uniform bar spacing creates uneven interlaminar compression along the length of the deck. Interlaminar compression ranged from 1,020 kPa (148 lb/in<sup>2</sup>) at the deck ends to 737 kPa (107 lb/in<sup>2</sup>) at the center of the deck, based on a design force in the bars of 178 kN (40,000 lb). Usually, 690 kPa (100 lb/in<sup>2</sup>) is

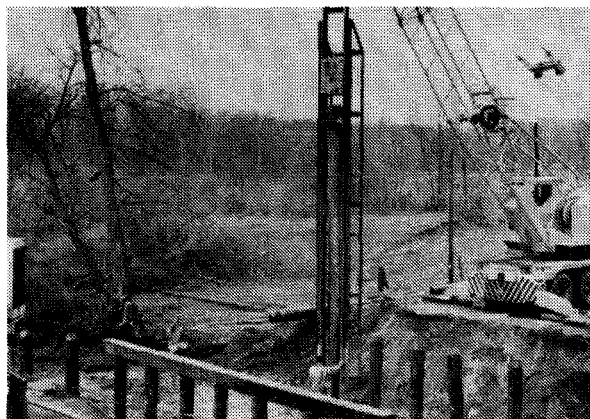
Figure 5–Abutment construction.

**Abutment Construction**– Abutment construction started by driving twenty-two 30-cm (12-in.) Southern Pine timber piles (Fig. 5). The pile configuration included seven piles per abutment and two in each wing wall. The end pile on each abutment was used to support the inboard end of the wing wall, thereby eliminating the need for one pile on each wall.

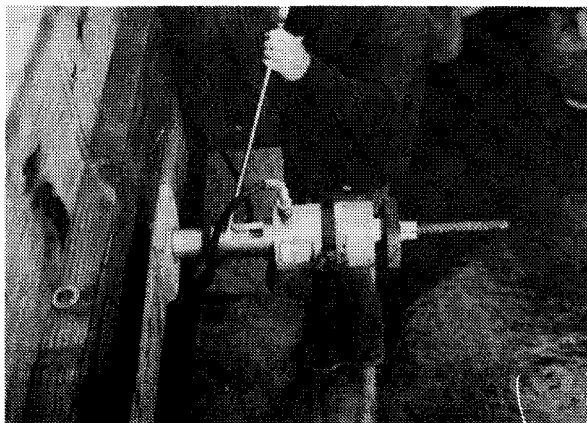
**Figure 6—Stress laminating the deck with a single hydraulic jack.**

Bar stressing for the McCurdy Road bridge consisted of four full-design bar tensionings over 5 days. Initially, the bars were slightly tensioned to bring the laminations in uniform contact. Each bar was then stressed to 178 kN (40,000 lb) using a single hydraulic jack (Fig. 6). One day after the first stressing, the bars

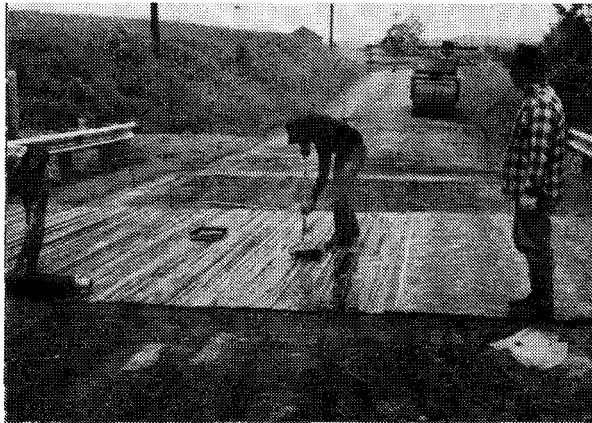
**Figure 7—Application of waterproof membrane.**

Richland County specifies a two-phase process using bituminous construction fabrics and 40 mm (1.5 in.) of hot-applied asphalt concrete pavement. Current practice is the use of Chase-Royston 10 AN Easy Pave ER<sup>1</sup> membrane glued to the deck using a solvent material designed for this purpose (Fig. 7). The application of the hot asphalt melts the bituminous material, creating a positive bond between the deck and the wearing surface.

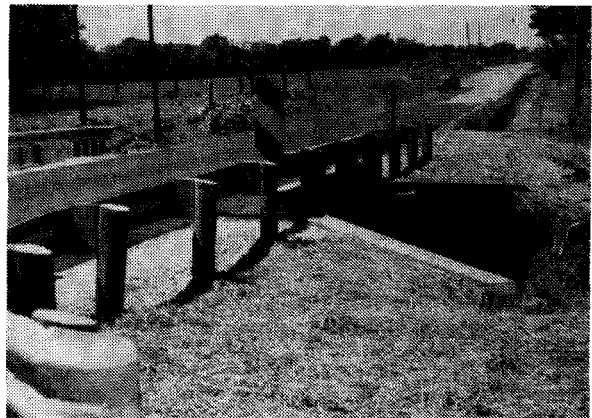
**Figure 6—Completed McCurdy Road bridge.**

After the wearing surface was applied, the bridge was opened for traffic. The completed bridge is shown in Figure 8.
