Class of 2004

Year in Review

Editor's Note:
All mishap rates are per 100,000 flying hours. FY04 flying hours in charts are forecast for September.

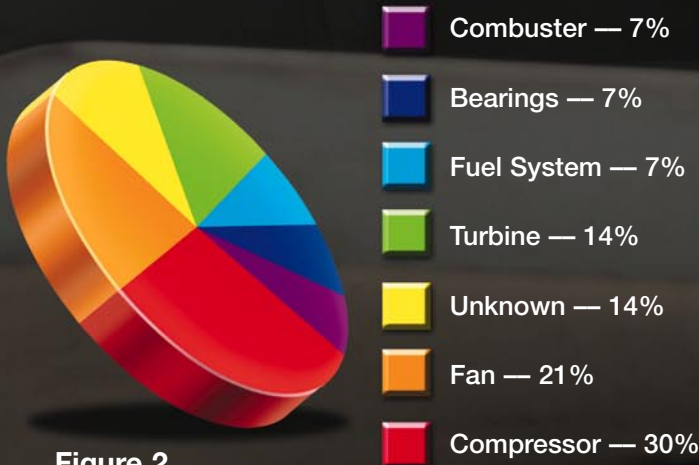
In an effort to explain this increase, let's look at which sections of the engine were the worst offenders. Figure 2 graphically displays the percentage breakdown of the 14 FY04 engine-related Class A mishaps. Surprisingly, one can quickly see that the "cold" sections of the engine (compressor and fan) caused half of the Class A mishaps. This bucks the historical trend of the turbine section being the major component driver of engine-related Class A mishaps. The increase from FY03 to FY04 can be explained by these two sections alone, since all other categories remained essentially constant in absolute numbers. As described earlier, both destroyed aircraft were a result of compressor stalls. The three fan-related mishaps consisted of two in-flight fan blade failures on a C-5 and a KC-10 and one test cell *domestic* object damage mishap in which a forward balance ring of an F119 engine was ingested. Risk mitigation by operators and vigilant use of inspection techniques by the maintenance community is our best front-line defense against these mishap drivers. We'll look at these mishaps in more detail later.

FY04 Engine-Related Class A Mishaps By Engine Section

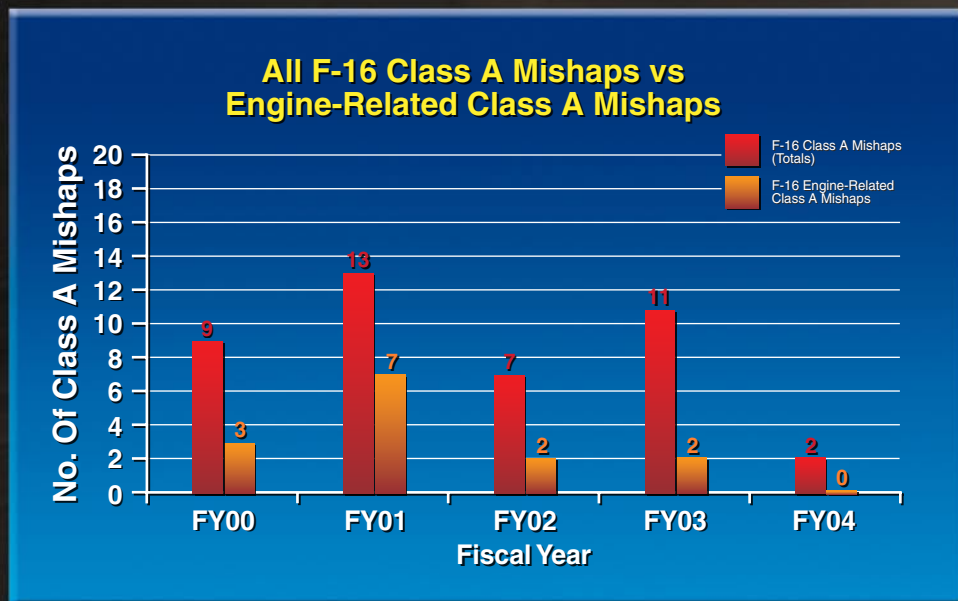
Table 1 shows the F-16 engine-related destroyed aircraft and rates for the last three fiscal years by engine model. Note the two columns of zeros under the FY04 heading. Figure 4 compares engine-related Class A mishaps to all other Class A mishaps for the F-16. This is the first time in the history of the F-16 we've seen a zero on this chart! This superb accomplishment is the highest compliment that can be paid to the many organizations and their people who make these machines fly. Congratulations to the Oklahoma City Air Logistic Center (OC-ALC), the Propulsion Product Group Manager, General Electric Aircraft Engines, Pratt & Whitney, flight crews, and, of course, our maintainers, who should all be proud of their contributions to the safety of this airframe. In the past year, combat operations and other flying commitments have continued to keep the hours high for our rapidly aging aircraft, which
