# **Best Management Practices Implementation Monitoring Trip Report**

Skipping Cow Timber Sale Roads Contract, Zarembo Island, Wrangell Ranger District Road 52033 (4.22 miles of new construction, MP 0.595 to 4.379) Road 6594 (1.39 miles of new construction, MP 6.36 to 7.759) 30 September 2006

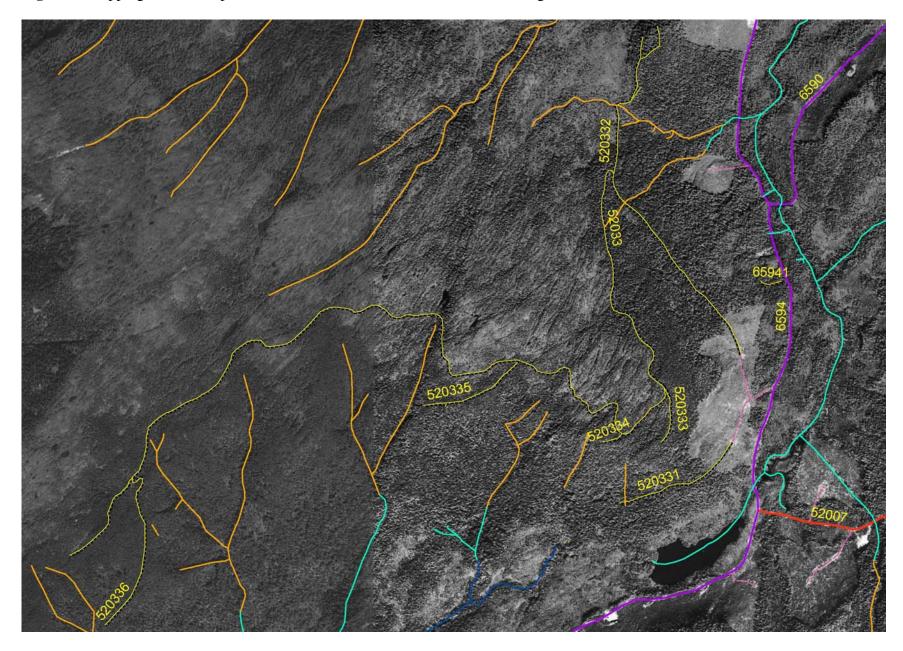
Figure 1. Skipping Cow Orthophoto of Class I and II streams, roads, and existing units

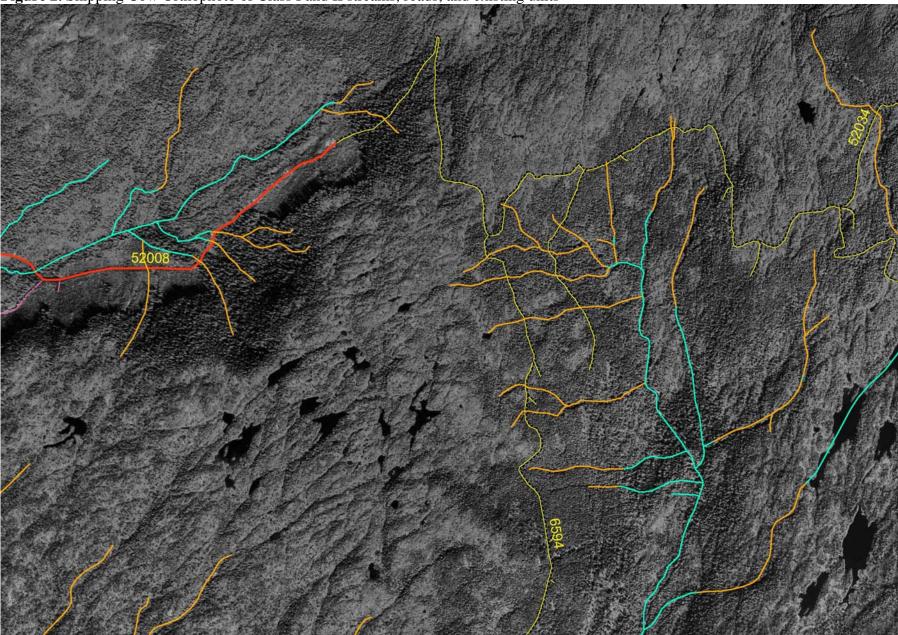
Figure 2. Skipping Cow Orthophoto of Class I and II streams, roads, and existing units
