DESIGN AND PERFORMANCE ISSUES RELATING TO RETAIL COMMERCIAL FACILITIES

7.1 INTRODUCTION

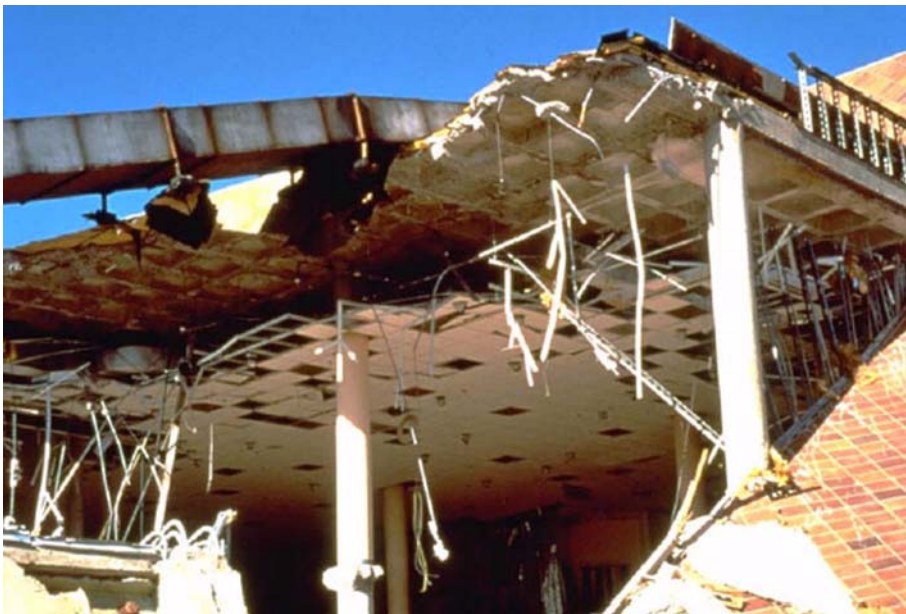
Figure 7-1 Severe damage to a department store severely shaken by the 1994 Northridge earthquake. Shear failure between the waffle slabs and columns caused the collapse of several floors. (photo courtesy of the Earthquake Engineering Research Institute.)

In the Northridge earthquake of 1994 near Los Angeles, a large regional shopping mall with 1.5 million sq.ft. of retail space suffered severe damage and was closed for 18 months. Some 200 mall stores were closed and six department stores under independent ownership received varying amounts of damage. One department store suffered a partial collapse, and was demolished and replaced (Figure 7-1). The
