8.1 INTRODUCTION

8.3 PERFORMANCE OF LIGHT MANUFACTURING FACILITIES IN PAST EARTHQUAKES

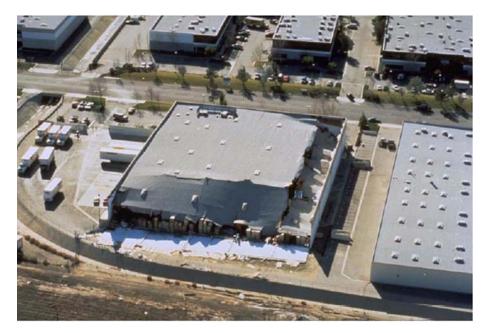
Figure 8-1 Roof and wall collapse of tilt-up building during the 1994
Northridge earthquake. (Photo courtesy of the Earthquake Engineering Research Institute)

Starting in the late 1950s larger light manufacturing buildings have been predominantly tilt-up structures, particularly in California. In seismic regions the perimeter precast walls were used as shear walls and roof structures were generally glued-laminated beams and plywood diaphragms. In the 1964 Alaska earthquake and the 1971 San Fernando (Los Angeles) event, performance of these buildings was poor, with considerable damage being sustained. The most common type of failure was to the wall/diaphragm anchors, but large out-of-plane movement of the panels, out-of-plane bending cracks in pilasters at mezzanine levels, and roof separations were all encountered and many roof collapses occurred. Due to the relatively large size of these buildings roof collapses were localized, rarely extending beyond one or two bays, and the buildings were sparsely occupied, so casualties were few. (Figure 8-1)

Following the 1971 San Fernando earthquake code changes were introduced, with the result that subsequent performance was improved. During the 1994 Northridge earthquake near Los Angeles, there were a number of failures of tilt-up structures and there were some collapsed wall panels along the sides of buildings resulting in partial roof collapse.
