Chapter 5 Construction Guidance

5.1 Embankment Conduits

5.2 Drainpipes and Filters

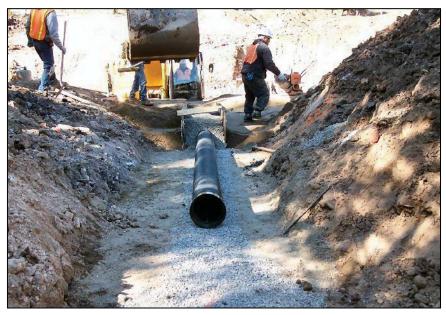
Figure 67.-Trapezoidal side slopes used in drainpipe construction.

The following steps describe a common method for installation of drainpipe in a trapezoidal trench. Figure 67 shows a drainpipe being properly installed. Other methods have also been successfully used, but are not discussed in this manual. This installation method is for a two stage filter/drain system:

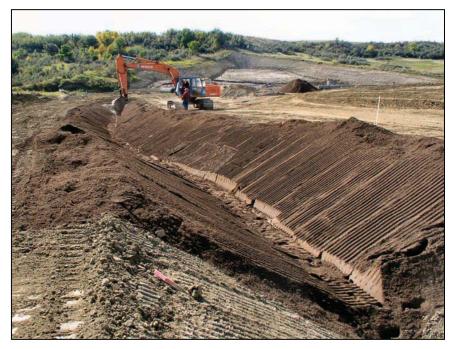
Figure 77.—Initial filter placement in a trapezoidal trench.

Figures 77, 78, and 79 show examples of filter and drain material placement around a drainpipe.

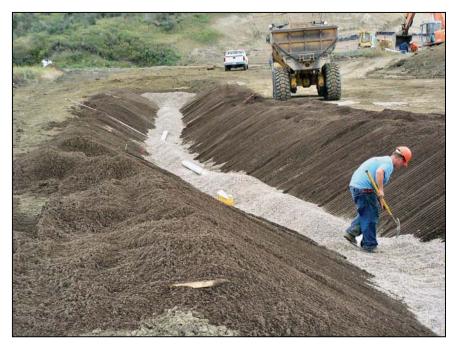
Figure 78.-Drain material being placed over a drainpipe.

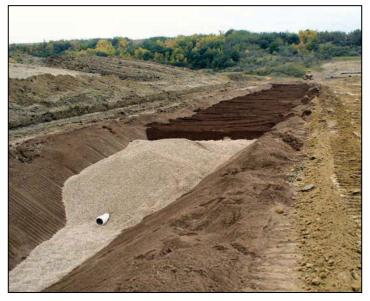
Figure 79.-Filter material being placed over drain material.

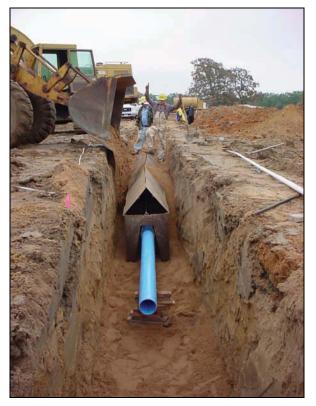
Figure 80.—A trench box or "doghouse" has been used to place material around drainpipes in vertically sided trenches in low hazard potential dams. Vertically sided trenches should not be used in significant and high hazard potential dam construction.

Placing material around plastic drainpipes can lead to damage and poor drainage when installed incorrectly. Manufacturers' literature typically describes how to install pipe in vertically sided trenches (often using a trench box such as the "doghouse" shown in figure 80). However, vertically sided trenches should not be used for drainpipe construction in significant and high hazard potential dams; a trapezoidal section is preferred. Low hazard potential dams often utilize vertically sided trenches. Pipe installed in vertical trenches encounters arching that occurs in the fill above the pipe. This arching reduces load not only on the pipe, but also in the adjacent and overlying fill. Since arching is less likely to develop in a trapezoidal trench and load on the pipe is greater, pipe installation and backfill are critical in order to offer haunch support to the pipe so its maximum strength can be developed.

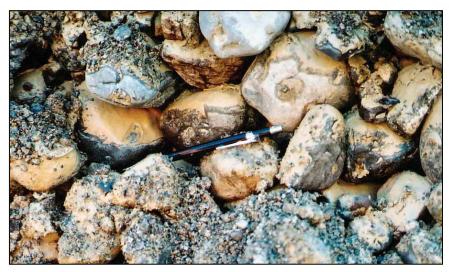
Figure 81.—Naturally occurring segregated soil. During deposition, the gravel sizes were segregated from the sand sizes. Poor construction practices can lead to similar segregation. The deposit is a broadly graded mixture of silt, sand, and gravel and is internally unstable. Note that silt has eroded into the gravel sizes and coated the particles.

Segregation during processing and placement is a common problem. Segregation may result in overly coarse filter/drain materials in contact with adjacent finer materials, which negates the effect of the filter. Incompatibility at the interface materials is the result. Many designers consider that segregation control during construction is the most important aspect of constructing a filter/drain. Segregation can have a significant bearing on the ultimate performance of the embankment dam. Figure 81 shows naturally occurring segregation.

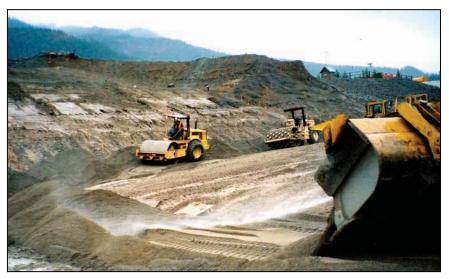
Figure 82.—Water being added to filter immediately preceding compaction. Note that this placement is occurring during a heavy rain, and wetting of the filter must continue.

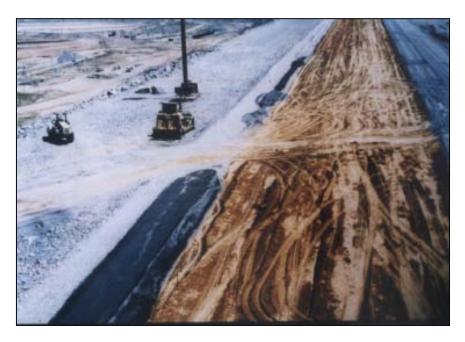
Figure 84.—Roadway crossing over a filter. Photo courtesy of ASDSO (Hammer, 2003).

To avoid contamination of filter/drain zones with excess fines during construction, several techniques should be used. The zone should be maintained higher than the surrounding fill surface, and the fill should be placed to maintain drainage of surface water (and sediments) away from the filter/drain zones. This will prevent the flow of muddy water into the filter or drain. Traffic should be well controlled, with crossings limited to prepared roadways which will be removed entirely prior to placing of additional filter/drain materials (figures 84 and 85). Crossings should be

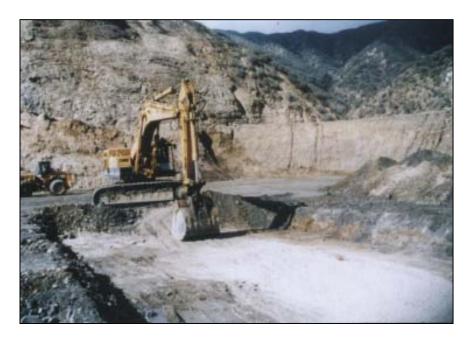
Figure 85.—Contaminated materials being excavated beneath a roadway crossing over a filter. Photo courtesy of ASDSO (Hammer, 2003).

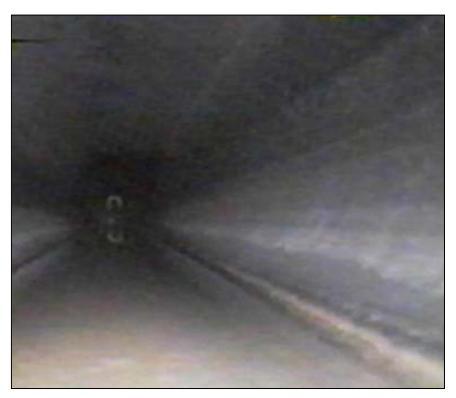
Figure 87.—Looking upstream toward the control gate in an HDPE sliplined outlet works conduit using CCTV inspection equipment.

Figures 86 and 87 show examples of CCTV inspection of an HDPE sliplined outlet works conduit. Figure 88 shows CCTV inspection of a white HDPE pipe. Manufacturers are moving away from white HDPE pipe and are using gray or black pipe to provide better viewing of the interior of the pipe. Inspections have found that white reflected too much light, and gray or black provides a better picture.

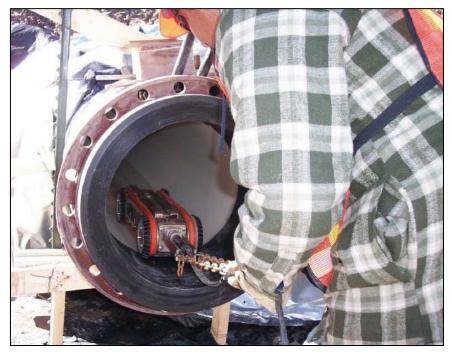
Figure 88.—CCTV inspection of a newly installed slipliner for an outlet works renovation.

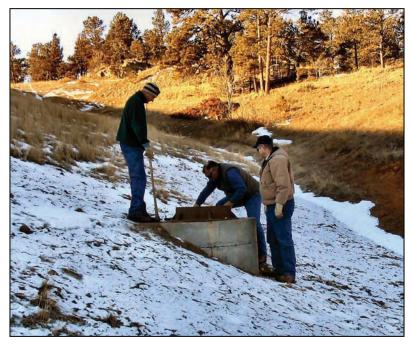
Figure 89.—Inspection well provides access to the drainpipe for CCTV inspection.

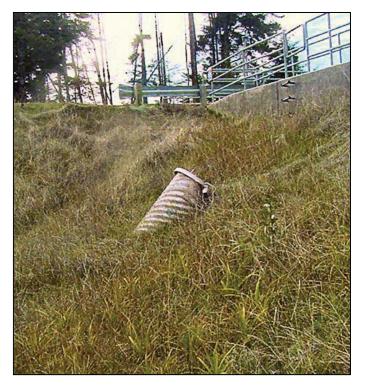
Figure 90.—Cleanout provides access to the drainpipe for CCTV inspection.

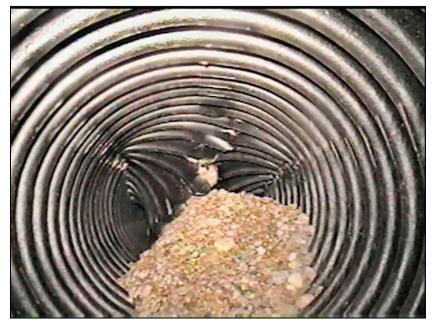
Figure 92.—Single wall corrugated HDPE drainpipe experiencing failure due to buckling.

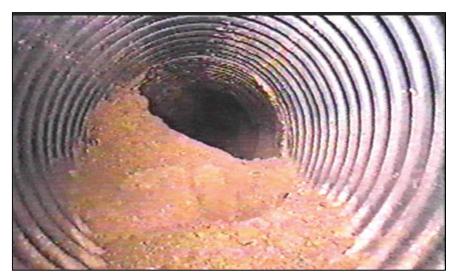
Figure 93.—This HDPE drainpipe has experienced joint separation allowing backfill materials to enter the drainpipe.

The primary cause of pipe failure is not always known. Reasons for failure could be singular or a combination of events. Failures observed are not indicative of all plastic pipe installations, but do assist in the understanding of drain reliability issues. The Bureau of Reclamation has been performing CCTV inspection of drainpipes as part of their dam safety program since about 1999. In performing these inspections a database has been developed to track the problems found within various types of drainpipe materials (Cooper, 2005). The results of these inspections show that early installations of single wall corrugated HDPE drainpipe sinspected. Shape deformation ranged from minor to extensive. Figure 92 shows a single wall corrugated HDPE drainpipes inspected. Joint offsets and separations ranged from minor to extensive. Figure 93 shows a single wall corrugated HDPE drainpipe inspected an extensive separation and has allowed materials surrounding the drainpipe to enter through the separated joint.

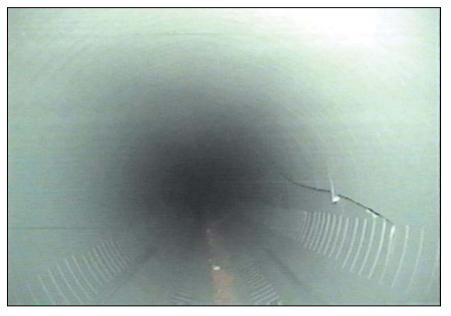
Figure 94.—Slotted PVC pipe used for toe drain has experienced longitudinal cracking. The cracking occurred during construction.

HDPE is not the only type of plastic pipe that has experienced problems. Figures 94 and 95 show examples of PVC drainpipe that have failed. These pipes were damaged during construction.

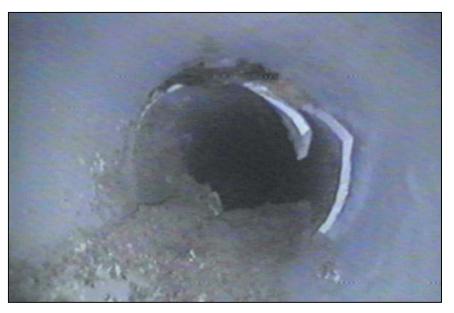
Figure 95.—PVC pipe used for toe drain has experienced transverse cracking. The cracking occurred during construction.

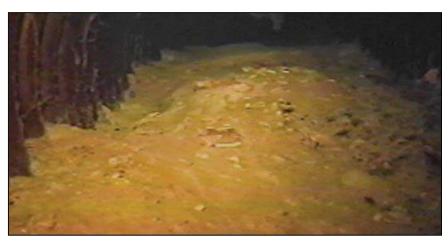
Figure 99.-Sediment deposit on the invert of a HDPE drainpipe.

Sediments are often encountered during a CCTV inspection (figure 99). Sediments may be transported by seepage flowing within the drainpipe and could be an indication of internal erosion occurring within the dam or foundation. Sampling and petrographic examination of the sediments may be required to assist in evaluating evidence of internal erosion.

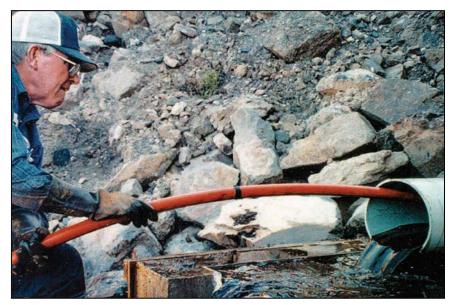
Figure 100.—Operator water jetting a drainpipe.

Cleaning of drain systems is not yet routine (figure 100). Most drains have never been cleaned, and based on their performance, cleaning may not always be justified. CCTV inspection should precede any cleaning attempt, to ensure that cleaning will not degrade existing conditions. The proper method of cleaning a drainpipe varies according to the conditions within the pipe and the structural integrity of the pipe. Commercially available water-jet cleaning is most often used that utilizes highpressure water spray from a nozzle. The orientation of individual jets on the nozzle of the cleaner can also be varied, depending on site conditions. In some cases, low pressure/high volume flow is best suited for sediment removal and high pressure/low volume flow is best suited for root or mineral encrustation removal. Sometimes both methods may be required at a particular site. The condition of the pipe is paramount for any cleaning attempted, and this may actually govern the cleaning method selected at a given site

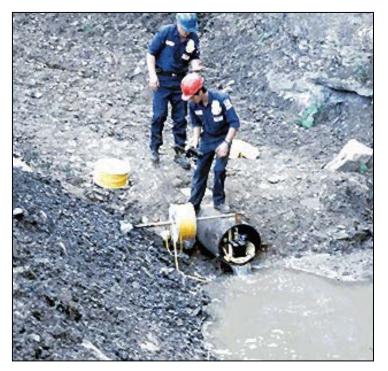
Figure 102.—Deflection monitoring of a decant pipe.

Designers have proposed fill heights in the range of 200 feet over plastic decant pipes in mine waste dams. Due to the limited experience with plastic pipe under high fills, and because of uncertainties in deflection analysis, such as appropriate E'values, the Mine Safety and Health Administration has generally only accepted designs for high fill heights contingent upon the mining company monitoring the pipe deflection at various amounts of cover and over time (figure 102). Based on the monitoring data, the value of E' is back-figured and an estimate is then made of the performance of the pipe under additional fill. Initial measurements are taken when the pipe is installed to establish baseline values. Subsequent deflection measurements start at a fill height where there is confidence that pipe performance will be adequate. Thereafter, the monitoring depends on how fast the fill level rises. Monitoring is done at predetermined increases in fill height and at predetermined time intervals, such as annually. Deflection monitoring has been accomplished by pulling devices, such as mechanical deflectometers (measures the vertical diameter of the pipe), sonar devices, and video cameras, through the pipe. Results of monitoring have shown, in some cases, that deflection was at or approaching the amount considered allowable (typically 7.5 percent). Once the allowable deflection is approached, or other signs of distress are evident, the decant pipe is replaced by another pipe. The new pipe is installed higher in the dam cross section, and the

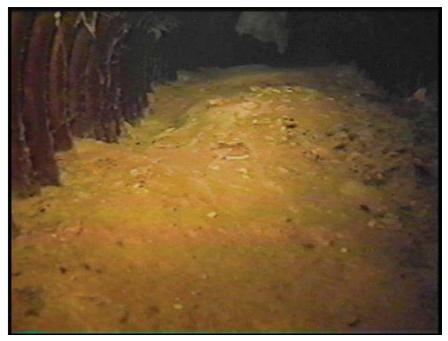
Figure B-2.—The typical amount of sediment deposition observed in toe drain during the November 2000 inspection.

In November of 2000, the Bureau of Reclamation performed a CCTV inspection of the toe drains at Davis Creek Dam as part of routine drain maintenance. Observations from the CCTV inspection showed areas of pipe buckling, other potentially damaged areas of pipe, and sediment deposition. Figure B-2 shows a typical amount of sediment deposition that was seen in the toe drain.

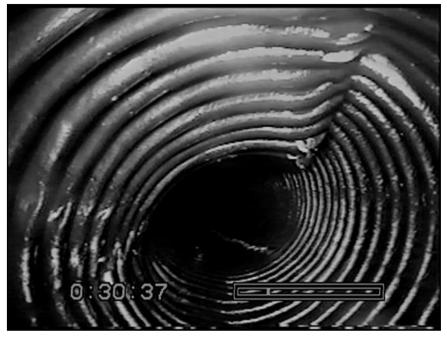
Figure B-3.—A buckled left toe drain pipe at approximately Sta. 23+25 stopped the camera-crawler. A cleaning removed fine materials from the pipe invert.

drain at Davis Creek was within the 12-inch-diameter pipe. The camera-crawler was inserted into the manhole at station 23+00, and proceeded downstream to station 19+46.91. The camera-crawler was then backed out and turned around in order to proceed upstream. The camera-crawler proceeded upstream to approximately station 23+25. Originally, it was intended to inspect the entire cleaned reach to station 26+00, but the camera-crawler was unable to proceed when it came across a section of buckled pipe that was previously reported during the 2000 inspection. Figure B-3 shows the results of drain cleaning and the pipe damage that halted the camera-crawler. This photograph was taken in the Davis Creek toe drain at approximately station 23+25. The fine materials previously seen on the pipe invert have been removed.

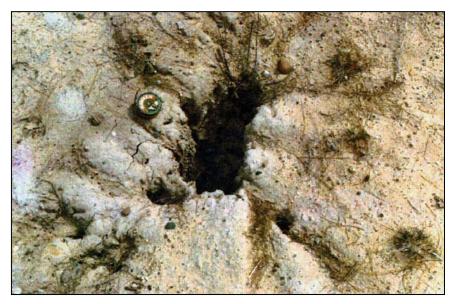
Figure B-4.—Subsurface fissure located at the downstream toe of the dam east of the outlet works. The subsurface soil had a very high moisture content.

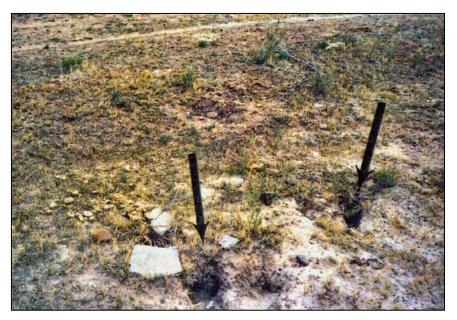
Figure B-5.—Erosional features typically associated with dispersive soils as seen at Ganado Dam. The common name for such features is "jughole."

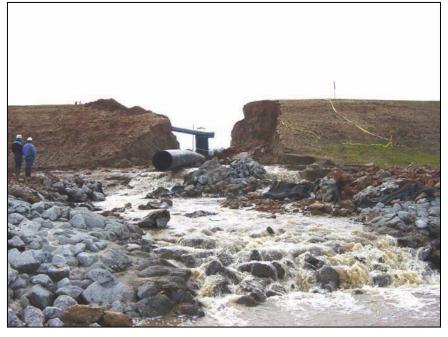
Figure B-8.—Looking upstream through the breach. Embankment was 18 feet high at breach.

The failure occurred 5 hours later (figures B-8, B-9, and B-10). Witnesses indicated that, just prior to the failure, they observed a stream of water, described as being about 10 inches in diameter, exiting at the downstream toe of the embankment adjacent to the spillway pipe. At the same time, a vortex was observed in the reservoir near the point where the pipe intersected the upstream slope. Failure of the embankment occurred approximately 20 minutes after the water flow was first observed. At the time of the failure, no water was flowing through the spillway pipe.

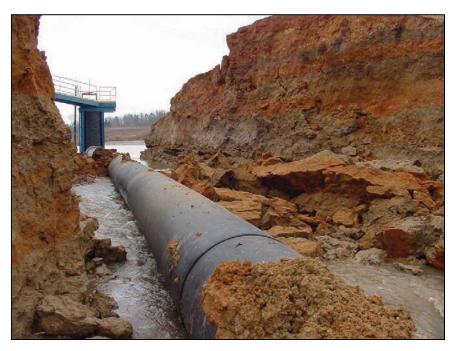
Figure B-9.—Breach showing 36-inch diameter HDPE pipe and riser.

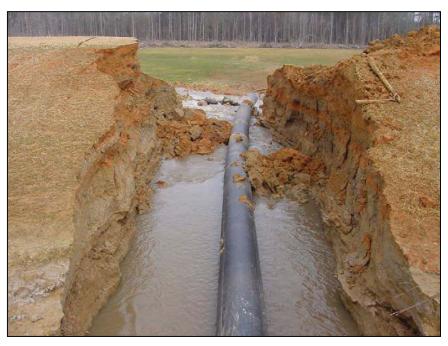
Figure B-10.—View looking downstream along the pipe. The breach was 26 feet wide.

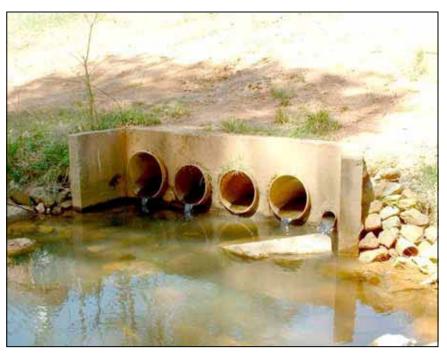
Figure B-12.—In the early 1990's the spillway capacity of the dam was increased by construction of a system of 5 PVC siphons embedded in concrete in a shallow trench through the dam.

In addition to widening the earthen emergency spillway, five PVC siphon pipes (ranging from 6 to 24-inches in diameter) were installed in a trench excavated through the crest of the embankment and terminating in a new wall at the toe of the dam (figure B-12). The design called for the pipes to be bedded in concrete. Control valves were installed in the siphons at the top of the dam, inside of manhole structures.

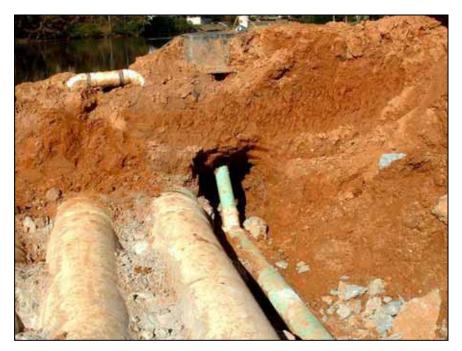
Figure B-13.—After about 10 years of operation, seepage was observed on the downstream slope of the dam in the vicinity of the siphons, and the overlying embankment material was excavated to expose the pipes to determine the source of the seepage.

The designer suspected that flow was occurring under the pipes and recommended exploratory "surgery" in an attempt to locate the source of the seepage. After removal of the backfill over the pipes (figure B-13), a small hole drilled through the concrete between the siphons (figure B-14) revealed no voids and additional excavation was required. After portions of the siphon pipes and concrete bedding were removed it was found that the original contractor had not achieved adequate placement of the concrete bedding, and there were extensive voids under the center of each siphon pipe. Constant flow through these voids had caused internal erosion of the underlying embankment soils.

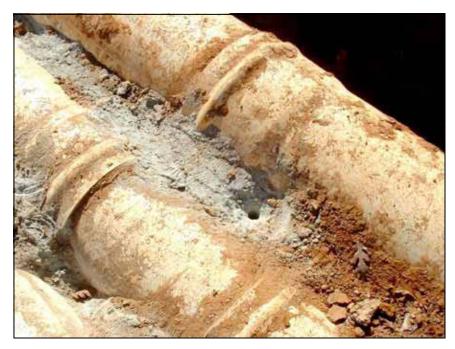
Figure B-14.—A small hole drilled through the concrete bedding between the siphons did not encounter voids under the concrete, even though the designer suspected that seepage was occurring directly under the pipes.

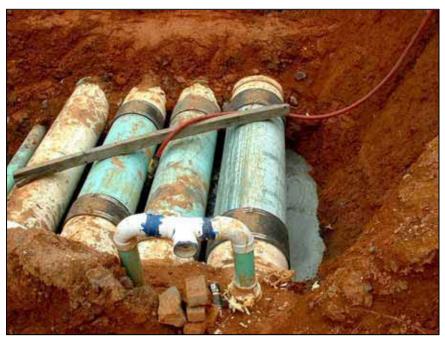
Figure B-15.—After removal of portions of the PVC siphons, it was determined that the original concrete bedding had been improperly placed, resulting in voids under the centers of the pipes. Portions of the siphons were replaced, and the bedding was replaced with a high slump concrete.

These sections of the siphons were replaced with new PVC pipe and the bedding was replaced with a higher slump concrete than was used originally (figure B-15).

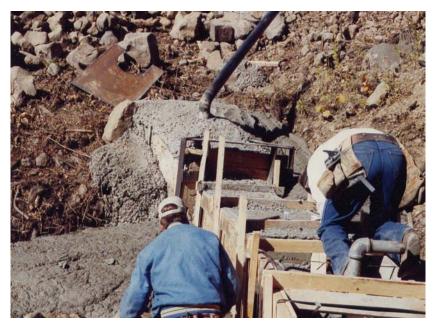
Figure B-16.—Looking upstream towards toe of dam: View of old box conduit and new downstream concrete encasement, during grout operation. Grout pipe is shown in top of photo.

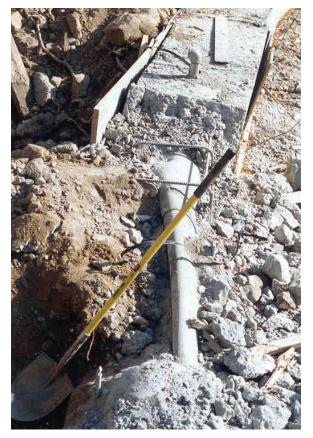
Figure B-17.—Looking downstream from toe of dam after excavation of collapsed portion of HDPE pipe (located in original box conduit, upstream of new concrete encasement).

Calculations completed after the failure (figure B-17) showed that the HDPE pipe's resistance to external hydraulic pressures was much lower than the grouting pressures that were used. Due to the location of the grout pipe, high grout pressures were necessary to push the grout upstream.

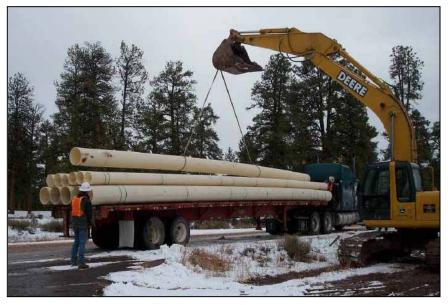
Figure B-23.—HDPE pipe being unloaded at the site using a John Deere 230LC excavator.

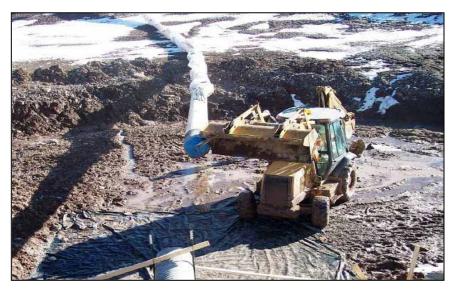
Figure B-24.—Guiding the 20-inch pipe into the upstream end of the CMP.

The excavator was used for guiding the 20-inch diameter pipe into the CMP at the upstream end of the conduit (figure B-24), while the backhoe pulled the pipe using a specially designed steel pulling head attached to the pipe pulled from the downstream end. The installation process was reversed for pulling the 14-inch diameter pipe into the 20-inch diameter pipe. After installation of both pipes, water from the reservoir was used to separately fill each pipe for hydrostatic pressure testing.
