III - HISTORY OF PROJECT

3-01 AUTHORIZATION

Hansen Dam was authorized by the Flood Control Act, approved 22 June 1936 (Public Law 738, 74th Congress) and extended and amended by subsequent Flood Control Acts of 1937, 1938, 1941, 1944, and 1946. The plan for construction, in accordance with the recommendations contained in the report dated 11 April 1940 by the Chief of Engineers, and submitted in House Document 838, 76th Congress, 3rd session, was authorized by the Flood Control Act, approved 18 August 1941.

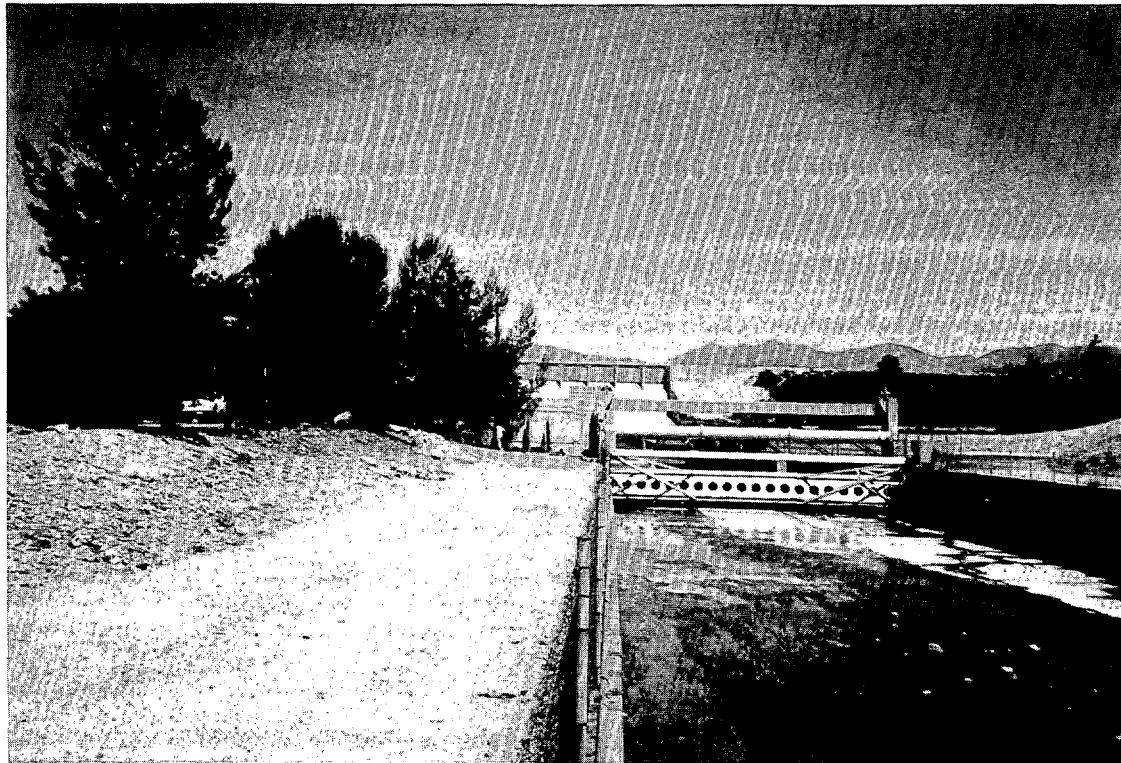
Figure 3-1. Hansen Spreading Grounds Diversion Structure.

into the spreading grounds. Photographs of the diversion structure and the spreading facility are shown in figures 3-1 and 3-2. pertinent information concerning Hansen Spreading Grounds is listed below:

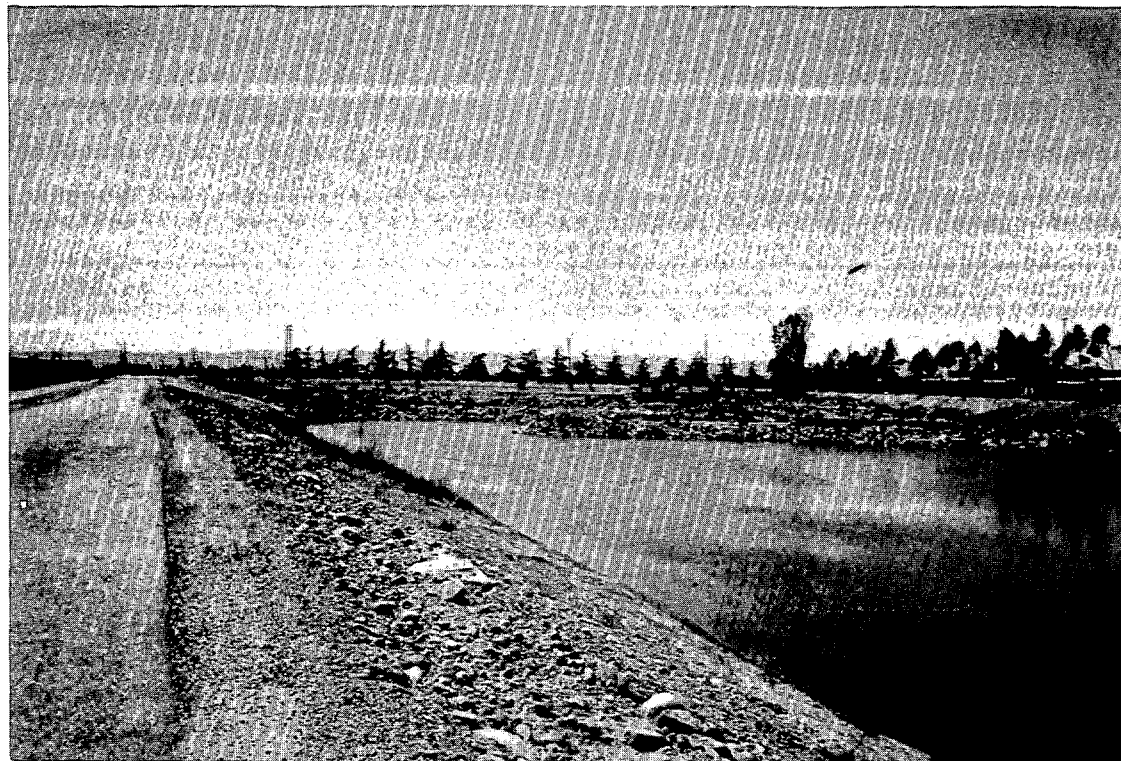
Figure 3-2. Hansen Spreading Grounds' Infiltration Pond.

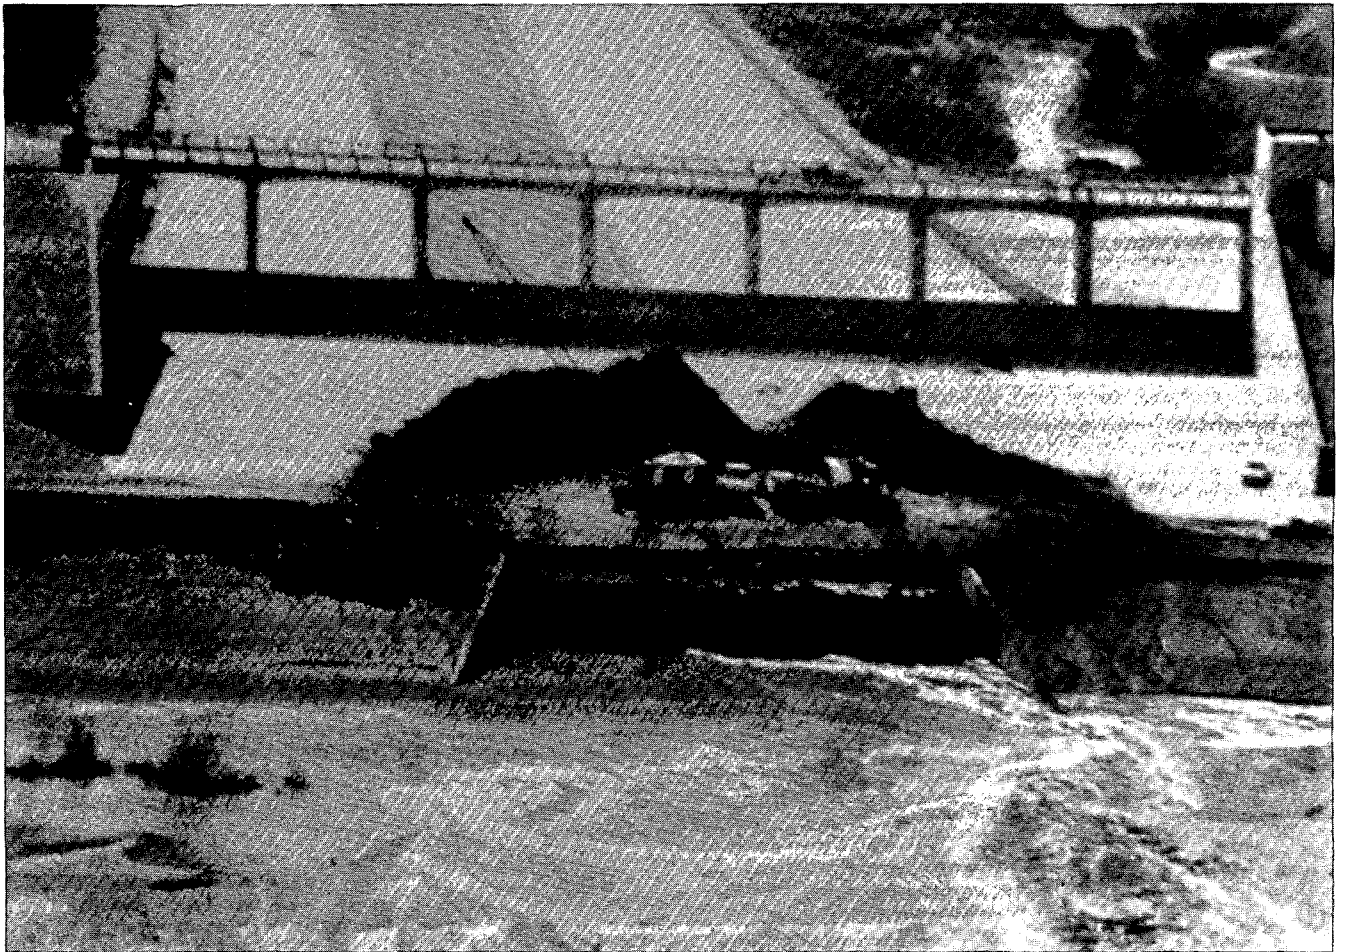
Figure 3-4. Debris at Hansen Dam after March 1, 1983 storm.

The March 1, 1983 flood again required use of a crane to remove debris from in front of the trash racks. Figure 3-4 shows debris being removed with cranes on March 4, 1983 after that storm.
