## II - DESCRIPTION OF PROJECT

### 2-03 PHYSICAL COMPONENTS

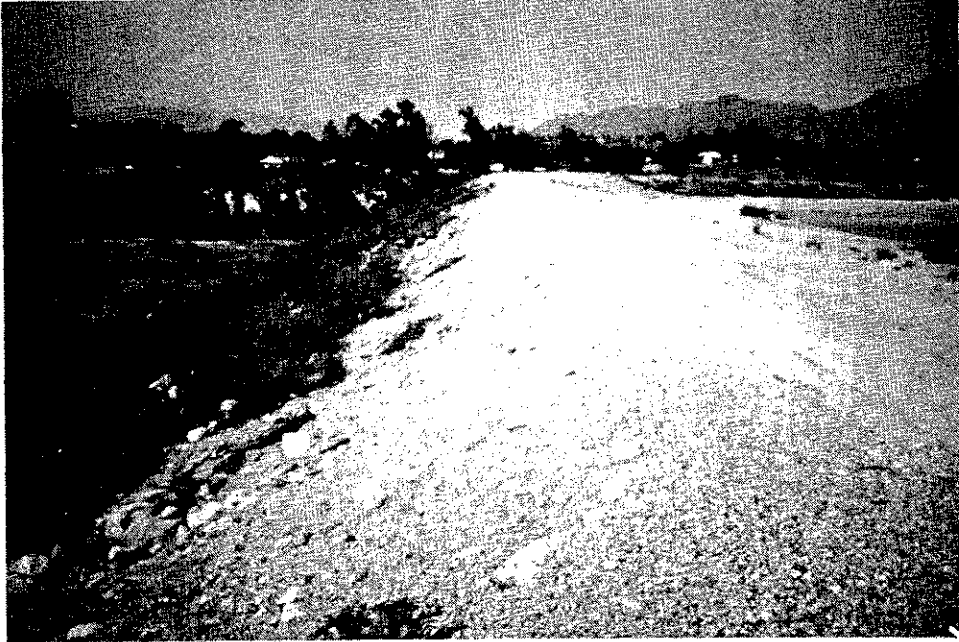
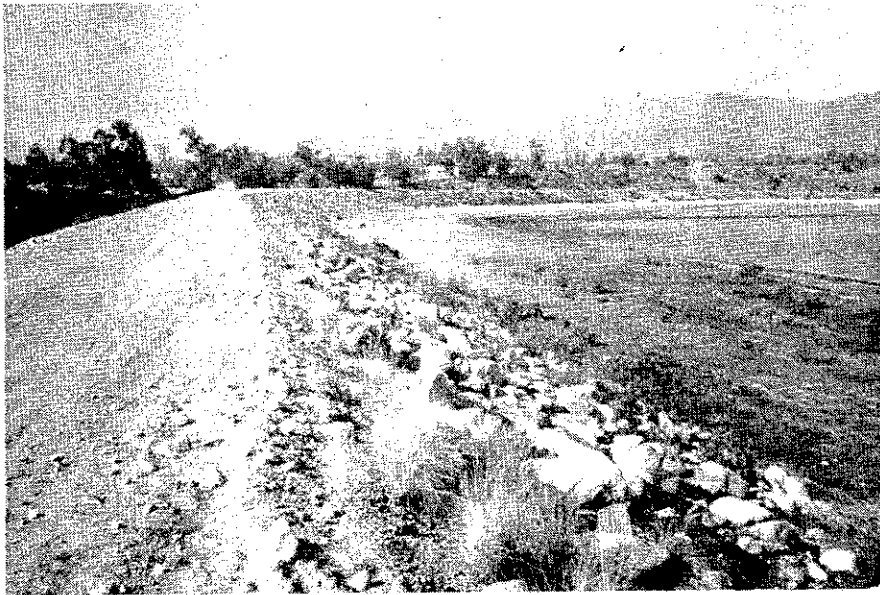
(a) Downstream Slope.

(b) Upstream Slope

Figure 2-1. Photographs of Lopez Dam Embankment.

a. Embankment. The earth-fill embankment has a crest length of approximately 1,300 feet and a maximum height of approximately 50 feet above the bed of Pacoima Wash. The crown width at the crest elevation of 1,298.9 is 20 feet. Upstream and downstream slopes of the embankment are 1 vertical on 2 horizontal throughout. The embankment has an impervious inner core with a crest width of 12 feet at elevation 1,292.8 with slopes of 1 vertical to 1 horizontal upstream and downstream. The upstream and downstream portions of the embankment are pervious zones constructed of material excavated from within the reservoir upstream of the dam and rock excavation from the spillway site. A three feet layer of loose rock on the upstream and downstream slopes of the embankment serves as protection against erosion. Information related to the embankment is shown on Plate 2-3. Photographs of the embankment are shown on Figure 2-1.

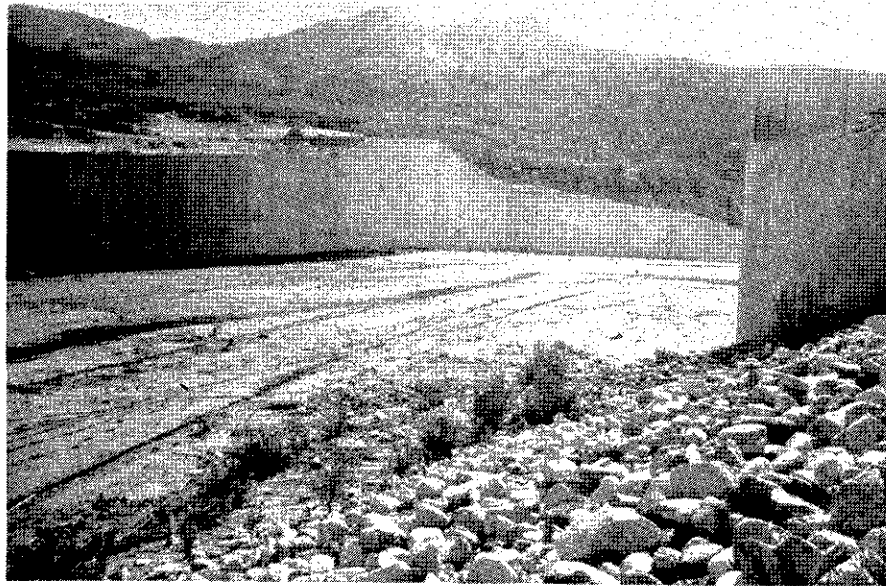
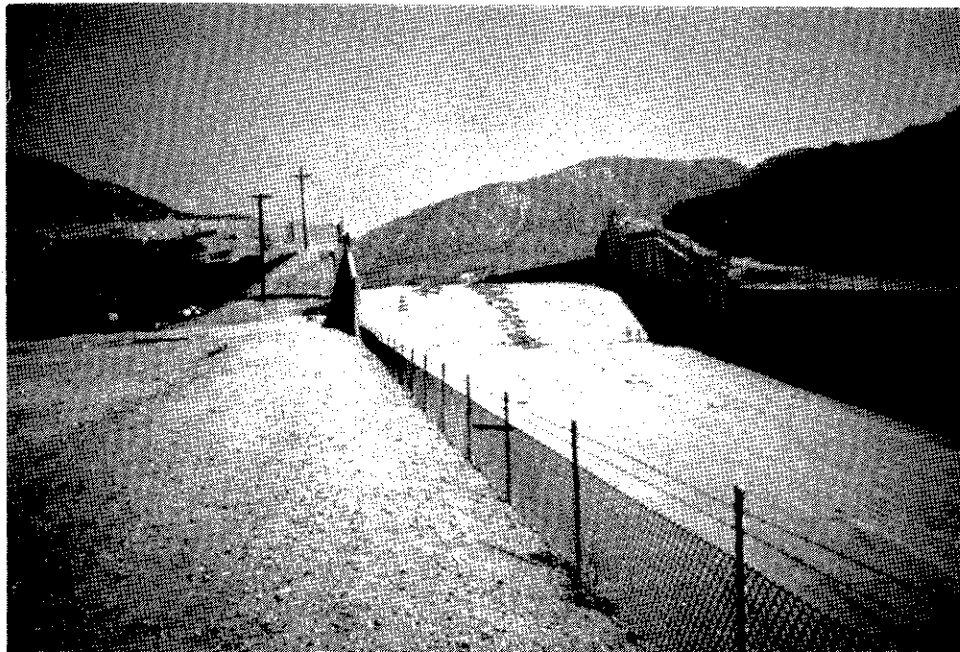
(a) Looking Downstream.

(b) Looking Upstream.

Figure 2-2. Photographs of Lopez Dam Spillway.

The upstream approach channel has a reinforced concrete invert and vertical walls diverging upstream from the crest (at the same rate as the downstream convergence) to a channel base width of 122.0 feet at the beginning of the invert. The vertical walls terminate in quadrant walls forming the spillway approach. The tops of these quadrant walls are at elevation 1,293.1. A concrete cutoff wall extending to a depth of 8 feet into rock is constructed beneath the approach channel invert slab at its upstream edge (station 9+10) and along the right side to station 10+10. Details, dimensions, and other information related to the spillway are shown on Plate 2-4 and Plate 2-5. Figure 2-2 shows photographs of the spillway.

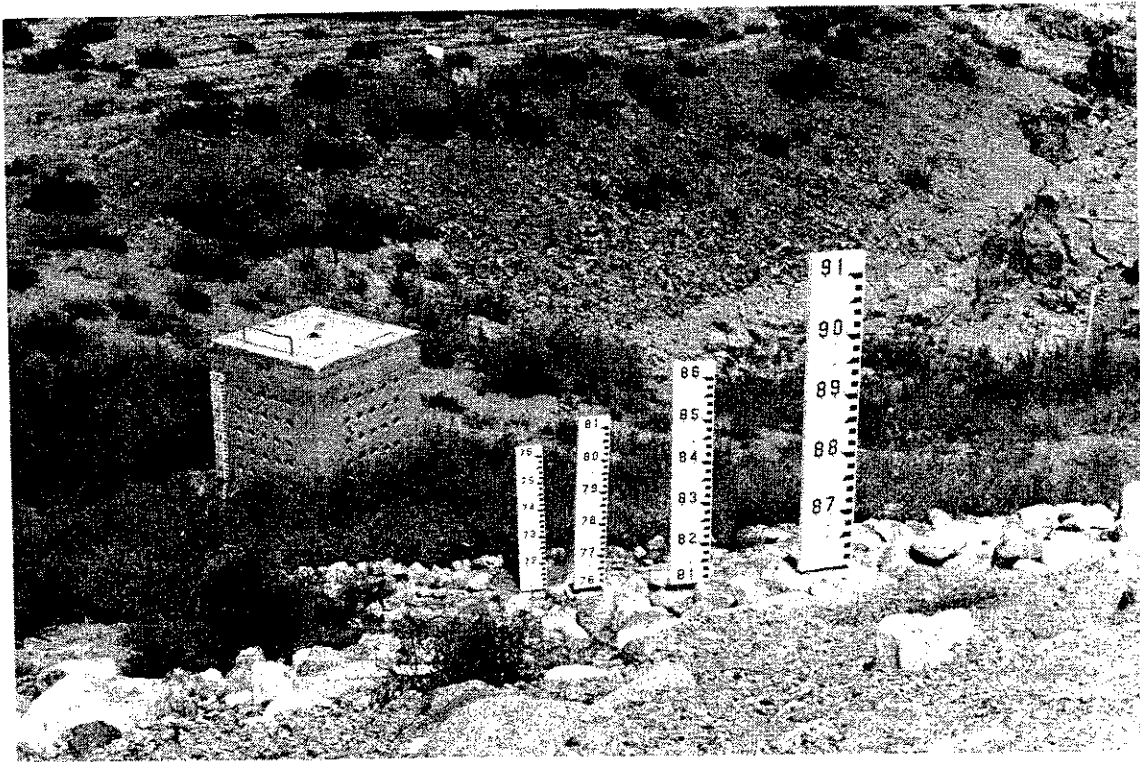
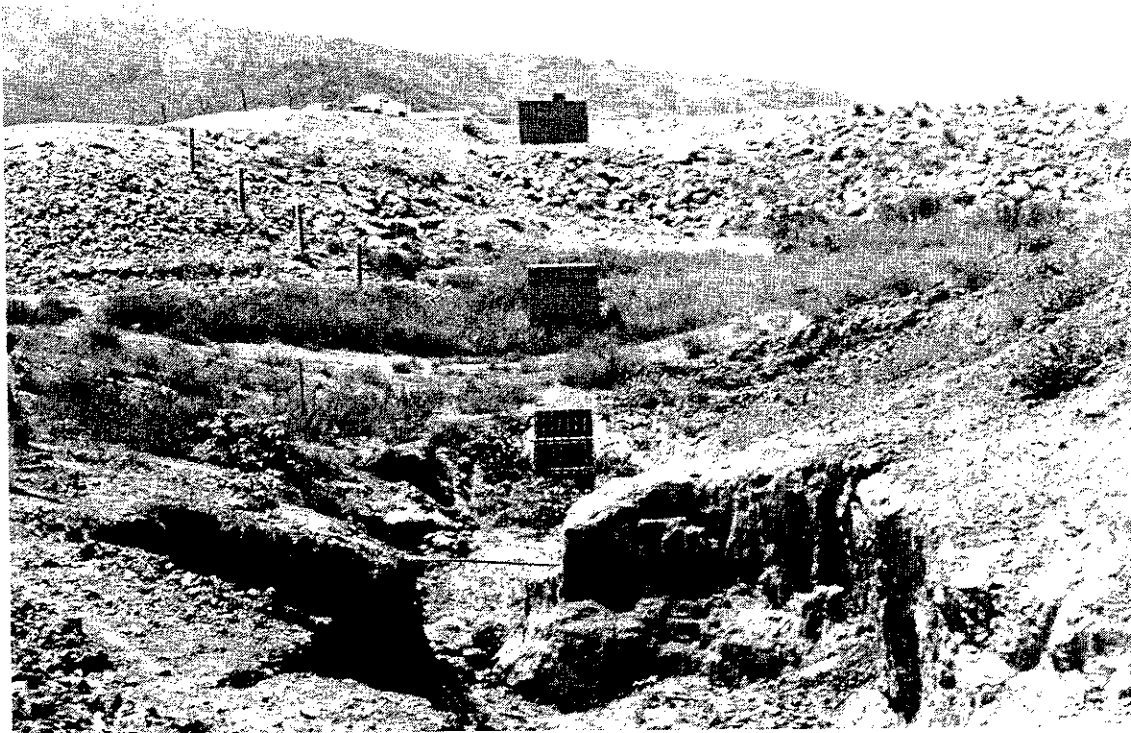
(a) Intake Tower.

(b) Low Level Inlet Structure.

Figure 2-3. Photographs of Lopez Dam Outlet.

The low level intake structure is equipped with removable steel grates spaced to permit the entry of water but to prevent the entry of trash and debris. The invert elevation of the low level intake is 1,253.9. The intake tower is a cast-in-place, reinforced concrete structure opening into the conduit. The tower is 5 feet square inside and extends to elevation 1,273.9 (one foot above spillway crest). It is perforated with 4-inch diameter formed openings which permits the pool to be drained down in the event the low level intake becomes inoperative. Photographs of the low level intake structure and the intake tower are shown in Figure 2-3, and Figure 2-4.

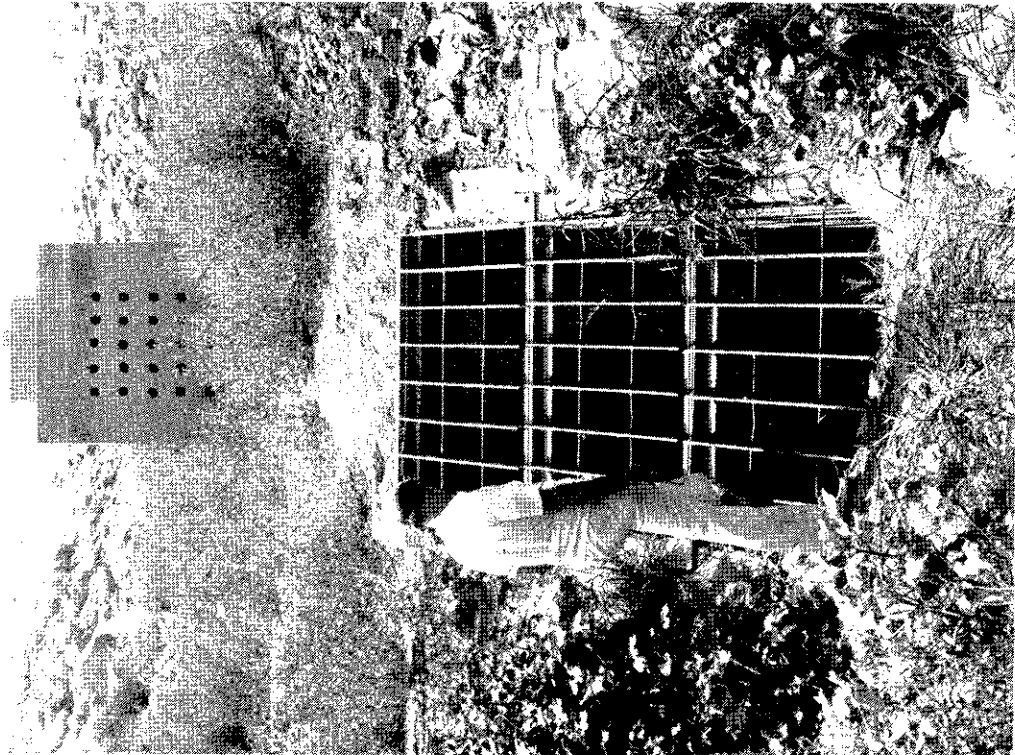
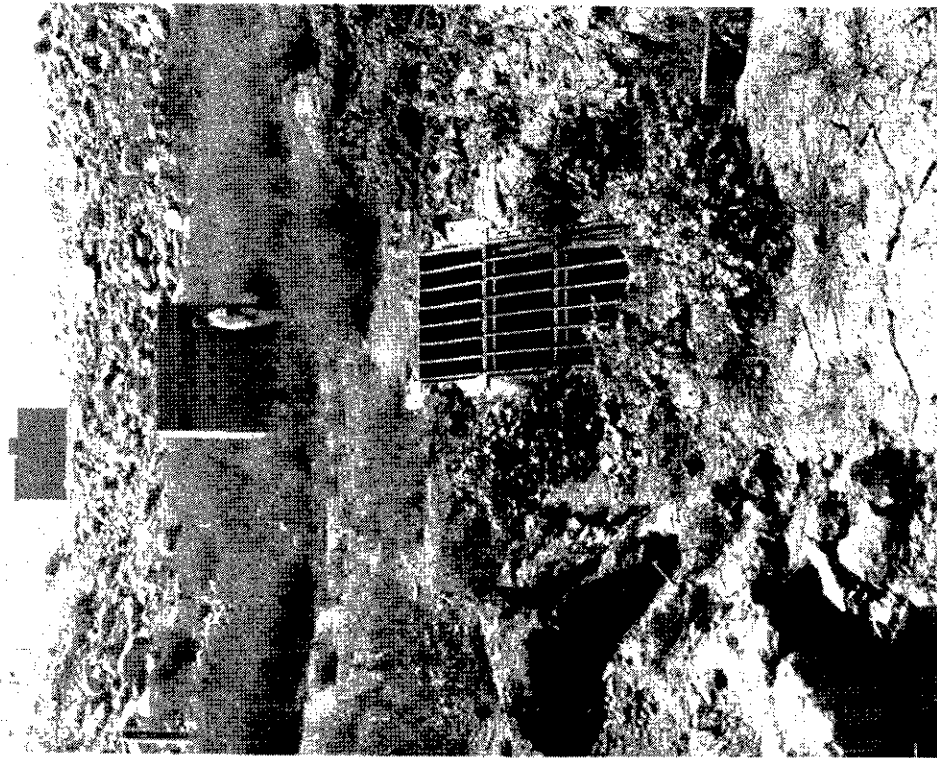
Figure 2.4. Photographs of Lopez Dam Intake Tower and Low Level Inlet Structure.

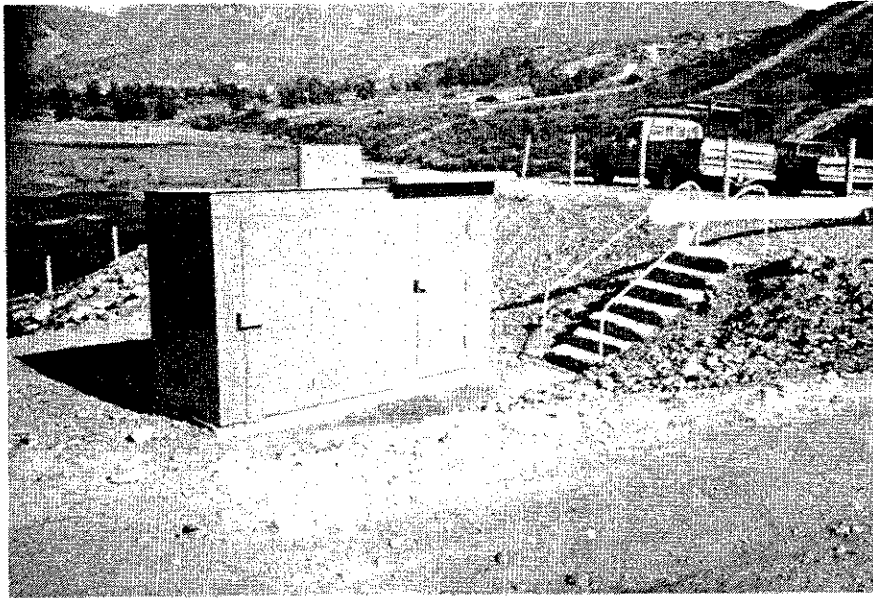
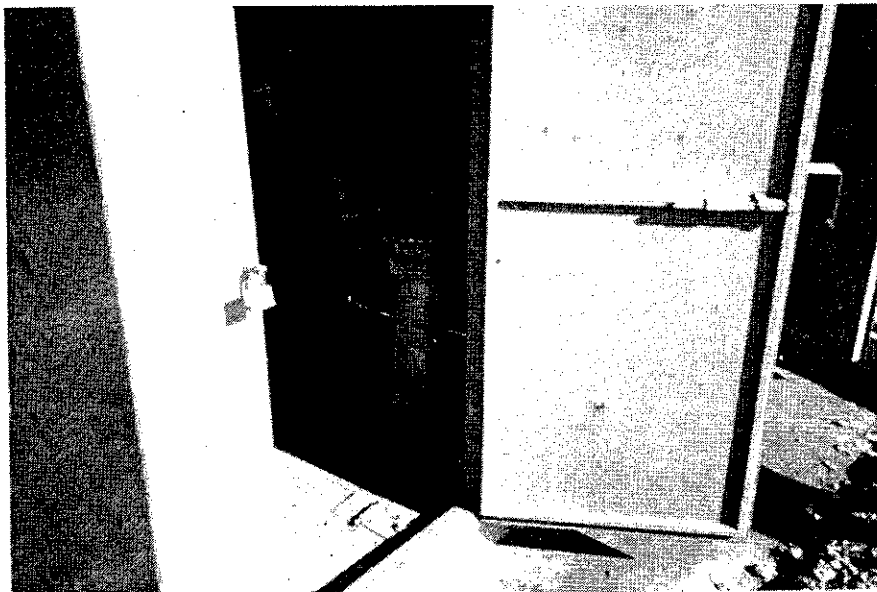
(a) Gate and Recorder Structure.

(b) Handrank Mechanism for Slide Gate.

Figure 2-5. Photographs of Lopez Dam Gate and Recorder Structure.

The gate well and float recorder well-structure consists of a 2-compartment, reinforced concrete shaft, 10.5 feet by 3 feet and 42 feet deep inside, located in the upstream embankment near the axis of the dam (at station 2+44). A concrete block and steel structure covers the recorder well shaft and houses the recording equipment. Photographs of the gate and recorder structure are shown in Figure 2-5. The recorder well is fed from an intake structure in the reservoir, near the pool drain intake, through a 6-inch diameter steel pipe, encased in concrete. The recorder well compartment is also connected with the gate chamber by a short length of 3-inch diameter cast iron pipe equipped with a gate valve. This connection permits flushing of the recorder well and permits the recorder well to be fed either from the reservoir intake or from the gate well when the 60-inch slide gate is closed.

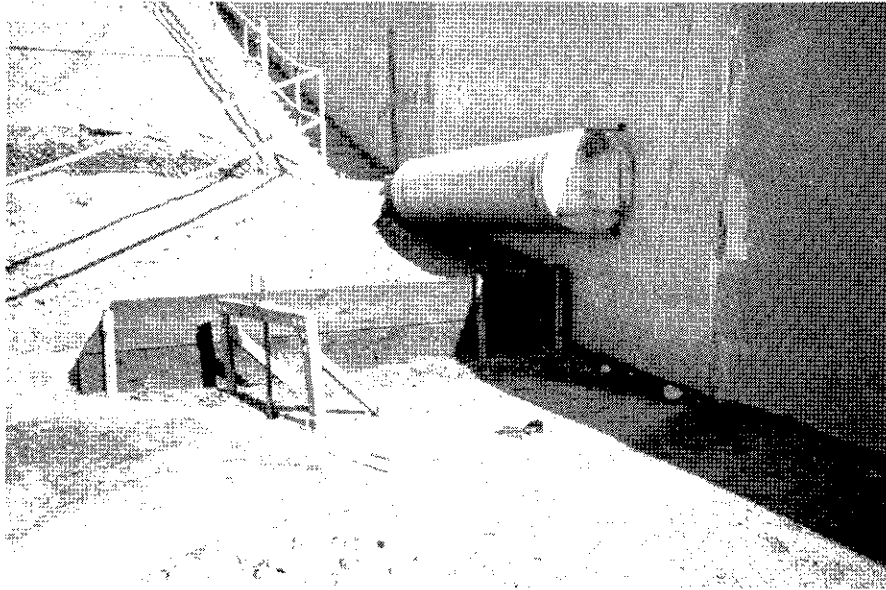
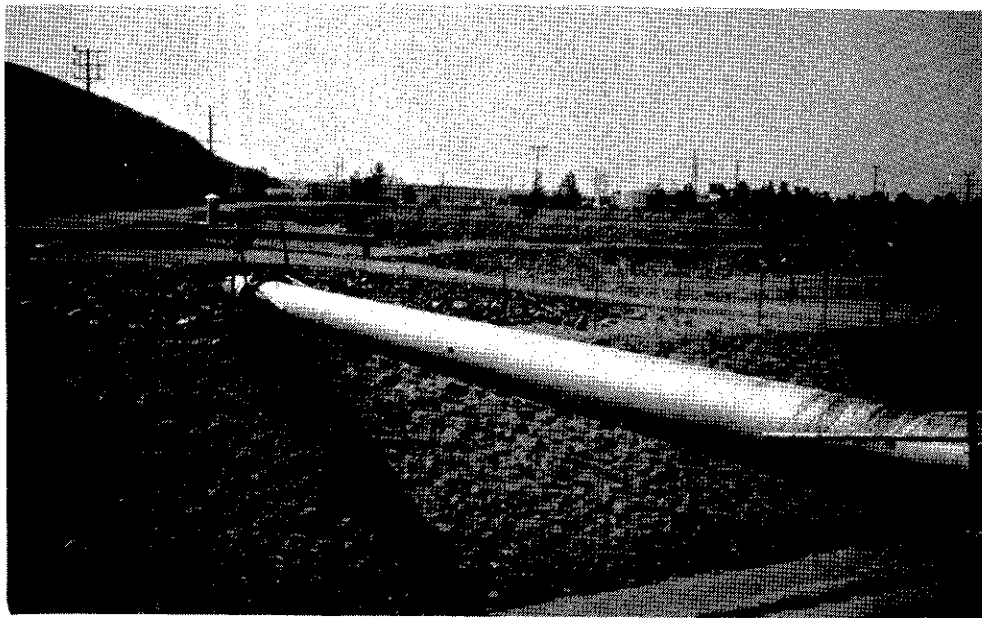
(a) Diversion Structure, Manhole.  
(The CMP is used to store equipment.)

(b) Spreading Facility.

Figure 2-6. Photographs of Lopez Spreading Grounds.

A diversion structure is located near the downstream end of the outlet pipe, immediately upstream of where the outlet pipe discharges into the spillway channel (see Plate 2-4). The diversion structure consists of a reinforced concrete box provided with slots for stop logs and a 30-inch diameter circular slide gate. The diversion structure was constructed with Lopez Dam in 1954 by the COE for the purpose of providing flows to the Lopez Spreading Grounds. The 30-inch gate remains closed and the stop logs are removed at all times except when spreading operations are in progress (Figure 2-6).
