**ASSESSMENT OF STEEL FLOOR PLATES INSTALLED ON
DIFFUSER GRATINGS TO FACILITATE PASSAGE OF ADULT
PACIFIC LAMPREY THROUGH FISH LADDERS**

**William T. Nagy
Fisheries Field Unit**

**U.S. Army Corps of Engineers, Portland District
Bonneville Lock and Dam
Cascade Locks, OR 97014
(541) 374 8801**

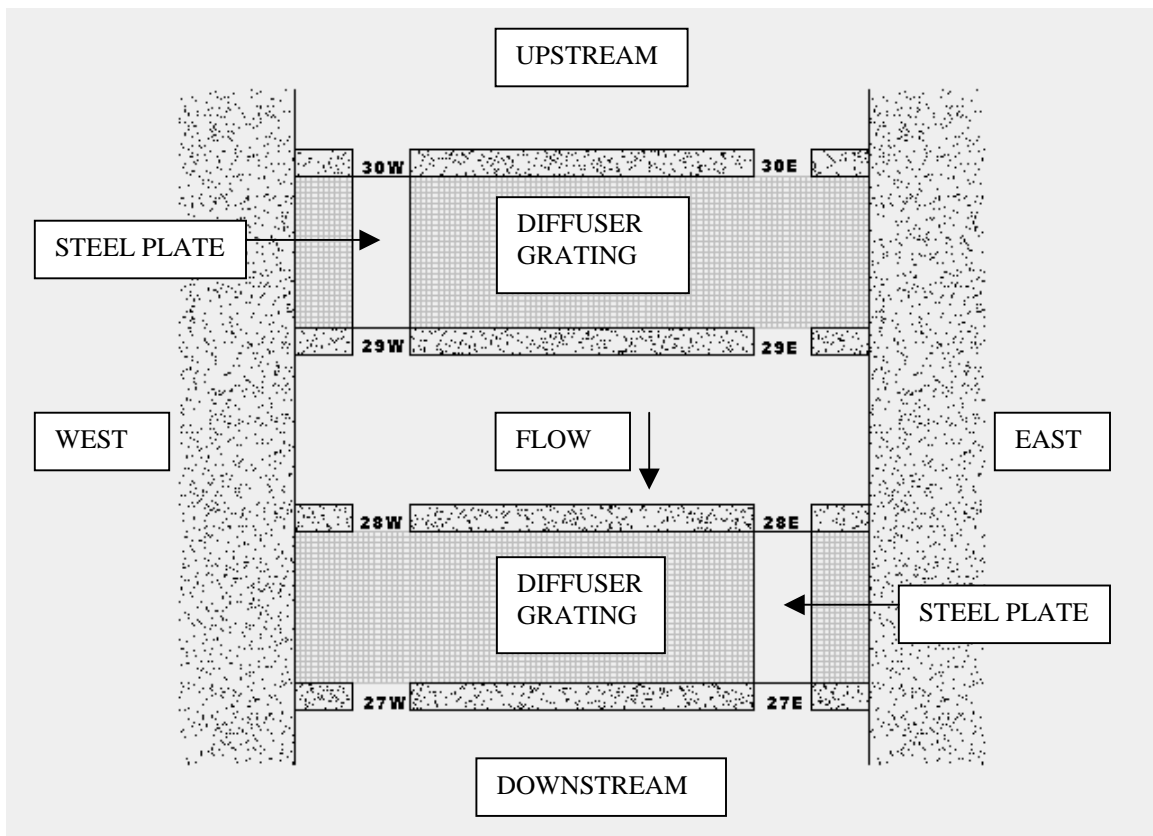
Figure 1. Schematic showing the location of steel plates over the diffuser gratings in the lower section of the Washington shore fish ladder at Bonneville Dam.

The study site for Objective 1 included the three pools at the lower part of the Washington shore ladder between weirs 27 and 30. The pools between weirs 27 and 28 and between weirs 29 and 30 are diffuser pools; the entire floor consists of diffuser gratings (Fig. 1). The floor of the pool between weirs 28 and 29 is concrete. Steel plates were installed in the two diffuser pools as indicated in the figure. The plates were 18 inches wide (same width as the orifices) and bridged the entire distance between weirs. Only one pair of orifices was bridged in each diffuser pool, the east orifices in the lower pool (27E to 28E) and the west orifices in the upper pool (29W to 30W). The other pair of orifices in each of the diffuser pools was intended as a control. The alternation between east and west was intended to lessen the effect of any east-west bias in lamprey passage.

1. If the steel plates were beneficial to lamprey passage, the presence of a steel plate on the downstream side of an orifice should result in increased up-counts at that orifice relative to the other orifice on the same weir. That is, up-counts at 28E on a particular date should be higher than the up-counts at 28W for the same date, and, likewise, up-counts at 30W should be higher than the corresponding up-counts at 30E (Fig. 1).
