The purpose of this letter is to inform you of the actions taken to address the Defense Nuclear Facilities Safety Board (DNFSB) staff observations of the electrical and instrument and control systems at the Hanford Plutonium Finishing Plant.

Electrical and Instrumentation and Control Systems

Corrective Action Plan

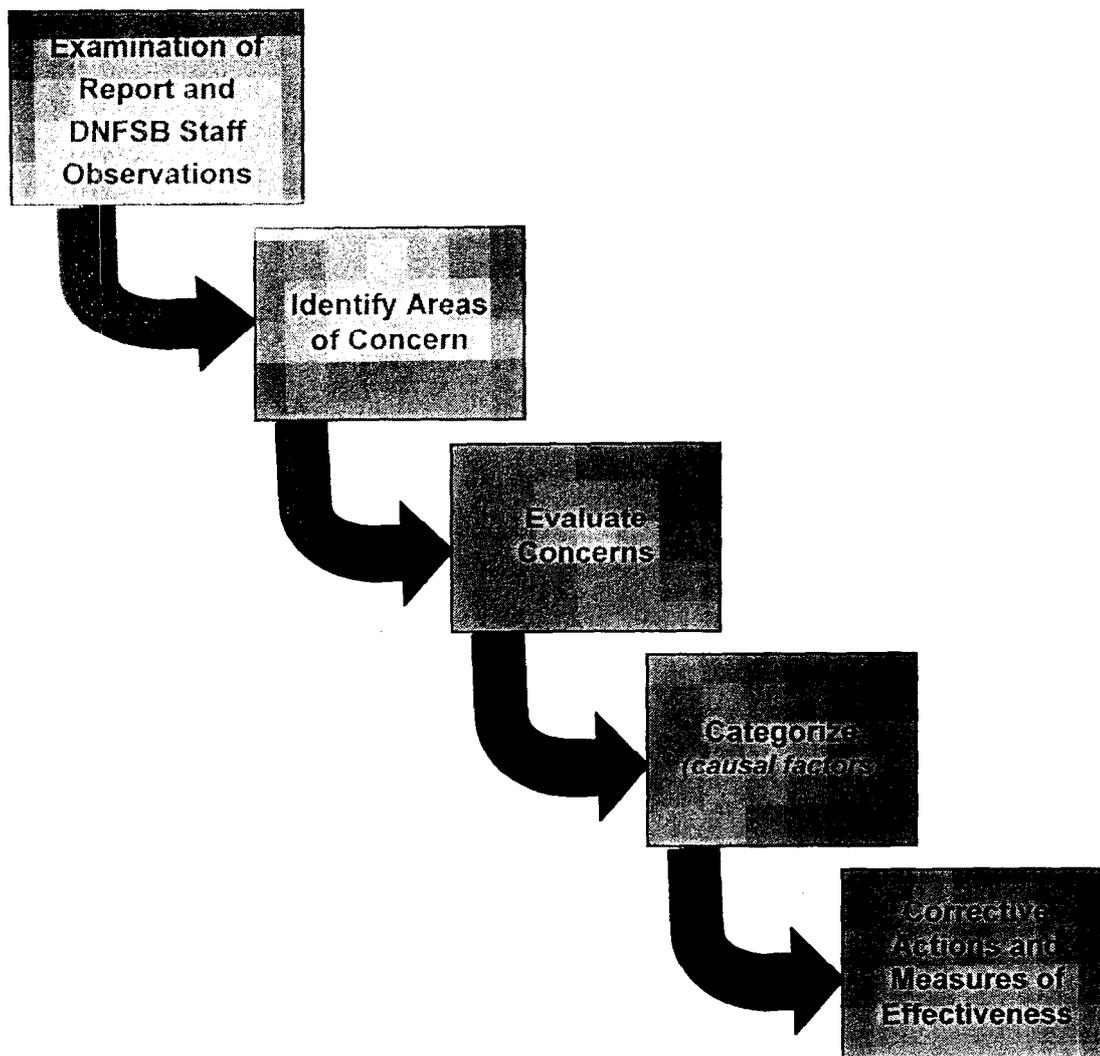
Figure 2-1. Corrective Action Methodology

The key process steps are illustrated in Figure 2-1. The CAP is provided in Section 8, *Corrective Action Plan*.
