Mitigation Case Studies

Clara Barton Hospital Shelter

Hoisington, Kansas

May 2004

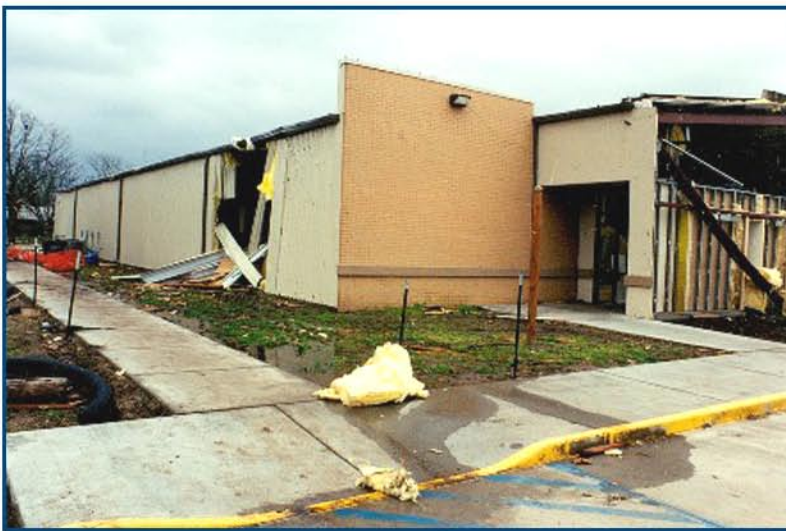
Severe damage to metal stud walls of the hospital's clinic building.

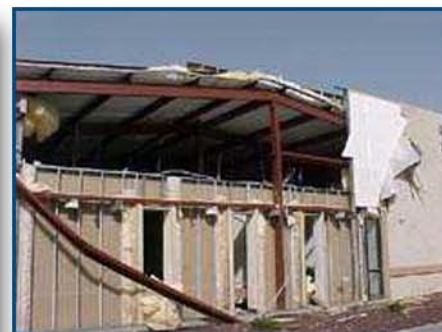
Rear view of damaged clinic building (left) and main hospital building (right).

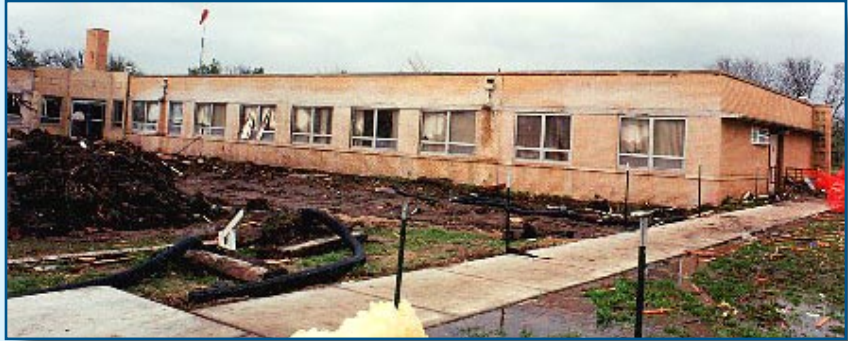
Front view of damaged hospital building.

The main hospital building survived the F4 tornado with broken windows and power loss. A new emergency generator, large enough to provide power for the entire building, was installed after the event because the existing generator served only some areas of the hospital. The protection and maintenance of these emergency generators is a critical issue. Emergency generators must be protected to the same level as the shelter occupants. The new generator for the hospital is located outside the building, mounted on a concrete slab that is adjacent to an exterior wall and provided with a lockable steel shell. To ensure its reliability during an emergency, the generator is tested every Monday by the hospital's maintenance staff.

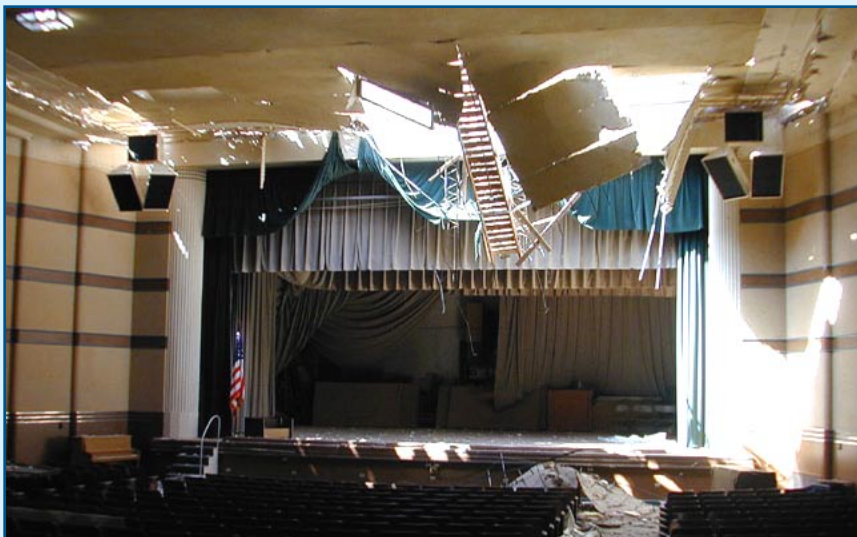
The tornado caused serious damage to Hoisington High School. Part of the roof structure was removed by the high winds.

Hoisington High School was another victim of the F4 tornado in April 2001. The building envelope was severely compromised in several places, rendering the building unfit for occupation for several weeks. The roof of the auditorium was torn away, the exterior wall of the art room was blown in, the technology building was damaged, and windows were smashed. Outside the school, parked buses were destroyed and the light poles for the football field were bent in half by the high winds. School had to be canceled until alternative arrangements for the students could be made.

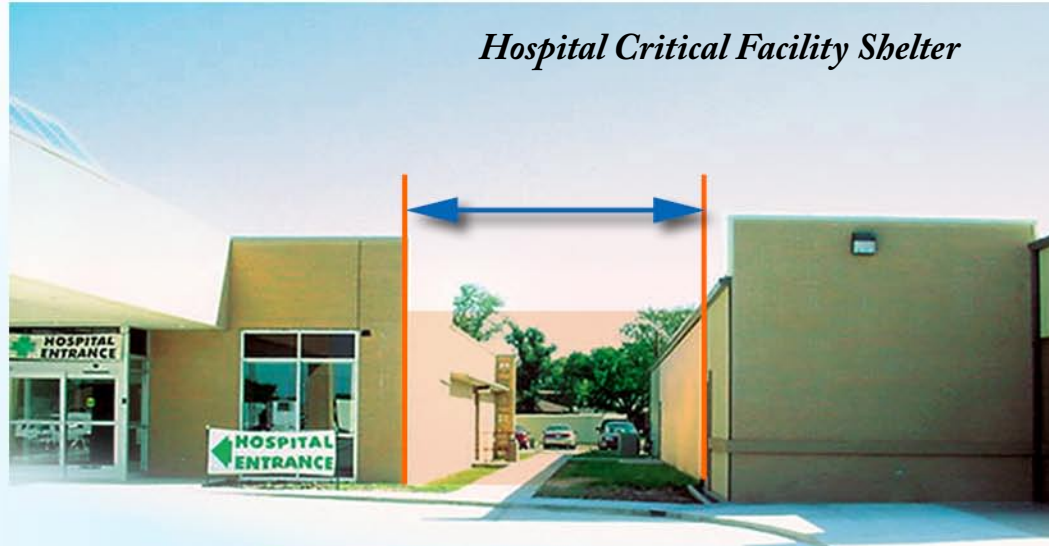
This photograph, taken before construction of the shelter, shows the area between the hospital building (left) and clinic building (right) where the shelter is now located

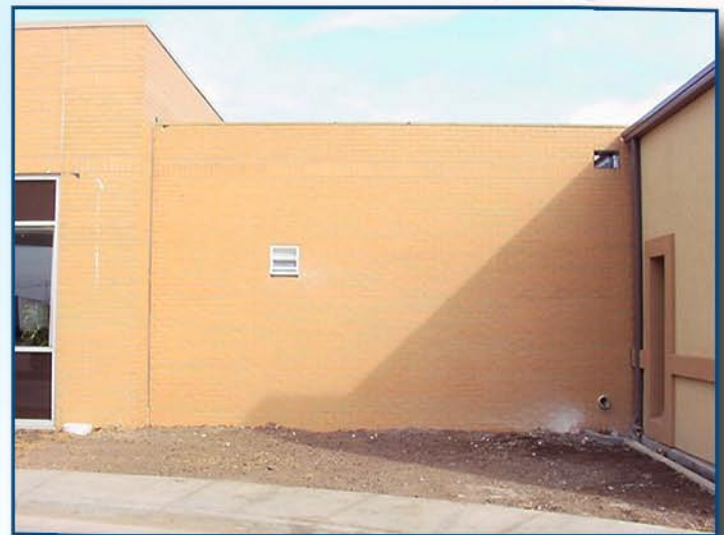
Shelter, as seen from the front, between hospital building (left) and clinic building (right).

The new shelter is located between the main hospital building and the clinic building to facilitate easy access from both areas. The shelter is connected to the two buildings with interior doors that meet the criteria presented in FEMA 361, *Design and Construction Guidance for Community Shelters*. The shelter has one exterior door (meets the FEMA 361 criteria) and no windows. The shelter has 1,026 square feet of finished area and is designed to accommodate 14 patients – assuming 6 are seated, 6 are in wheelchairs, and 2 are bedridden – and 30 standing staff members, with space for an additional 67 evacuees. The maximum number of occupants the shelter is designed to hold is 111. The shelter layout includes one large open area, two restrooms, a mechanical room, and a storage room. Typically, the open area is used for meetings and training classes.

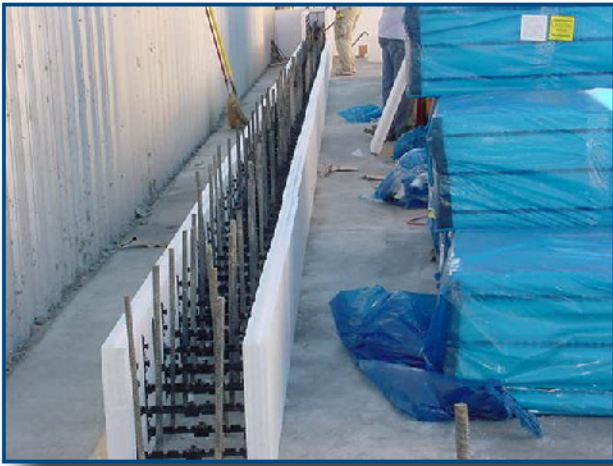
All perimeter walls were constructed with insulating concrete forms and reinforced with #5 bars spaced 8 inches on center to resist 250 mph wind speeds.

The wall system is Insulating Concrete Form (ICF) construction. This type of construction comprises 12-inch poured-in-place concrete, with polystyrene forms left in place, reinforced with #5 bars spaced at 8 inches on center (see cross-section of wall and roof on next page).

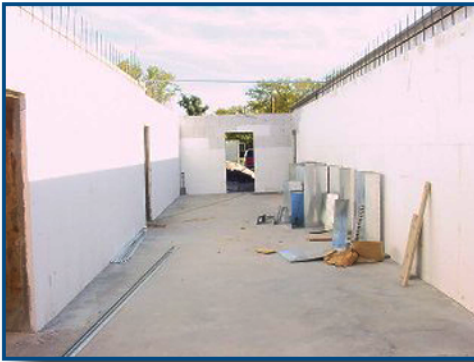
Interior of shelter, showing insulating concrete form perimeter walls.

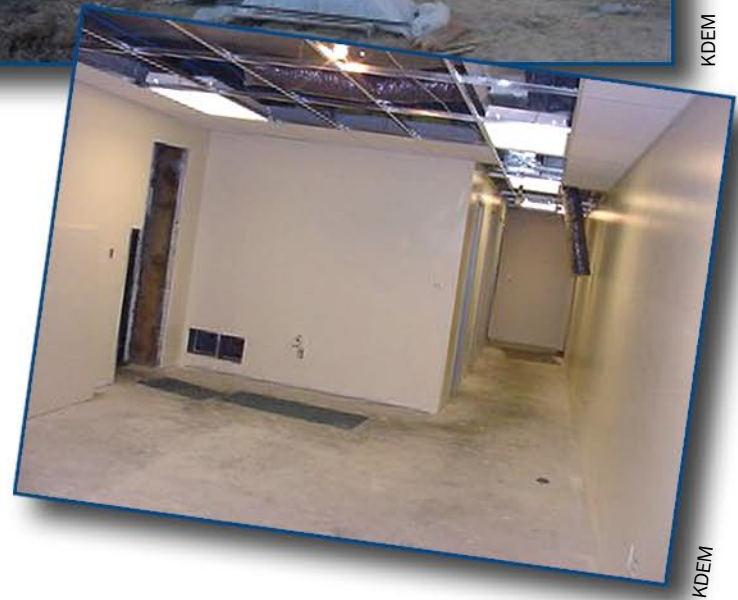
Construction of the reinforced ICF exterior wall at the rear of the shelter (top). Interior walls of shelter with gypsum board finish (bottom).

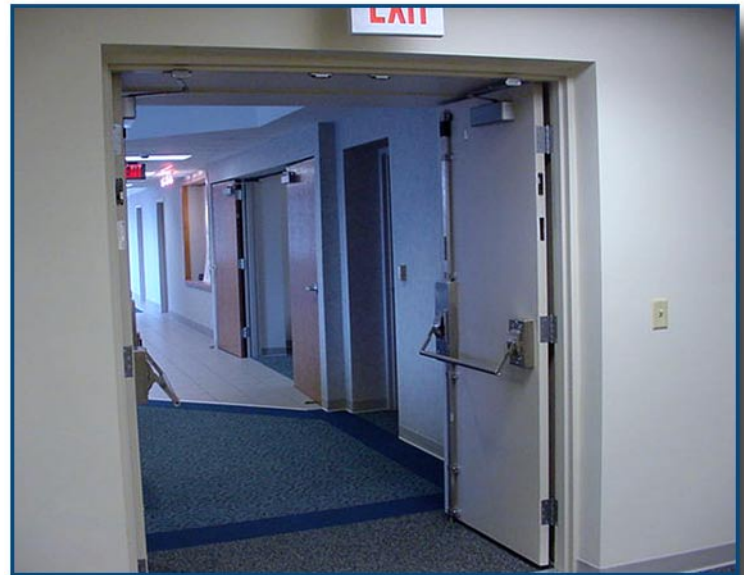
The double door without mullion allows hospital staff to move patients in rolling beds into the shelter.

Doors posed a particular problem in the design of this shelter. The architect needed to find double doors that met the criteria specified by FEMA 361. In addition, the hospital had a special need for double doors without a center mullion (center vertical support) that would allow rolling beds and medical equipment to be moved into the shelter area.

After checking with area suppliers to determine the storm protection door system most often used in the region, the architect selected doors manufactured by Steelcraft. At the time, Texas Tech University was testing Steelcraft's Paladin™ double-door model for compliance with FEMA 361. After Texas Tech completed the testing and verified that the Paladin™ double doors did meet FEMA 361 criteria, the doors were shipped to the hospital and installed.
