MERIAM HOUSE

Minute Man National Historical Park
Concord, Massachusetts

Historic Structure Report

Barbara A. Yocum, Architectural Conservator
Historic Architecture Program, Northeast Region
National Park Service
Lowell, Massachusetts

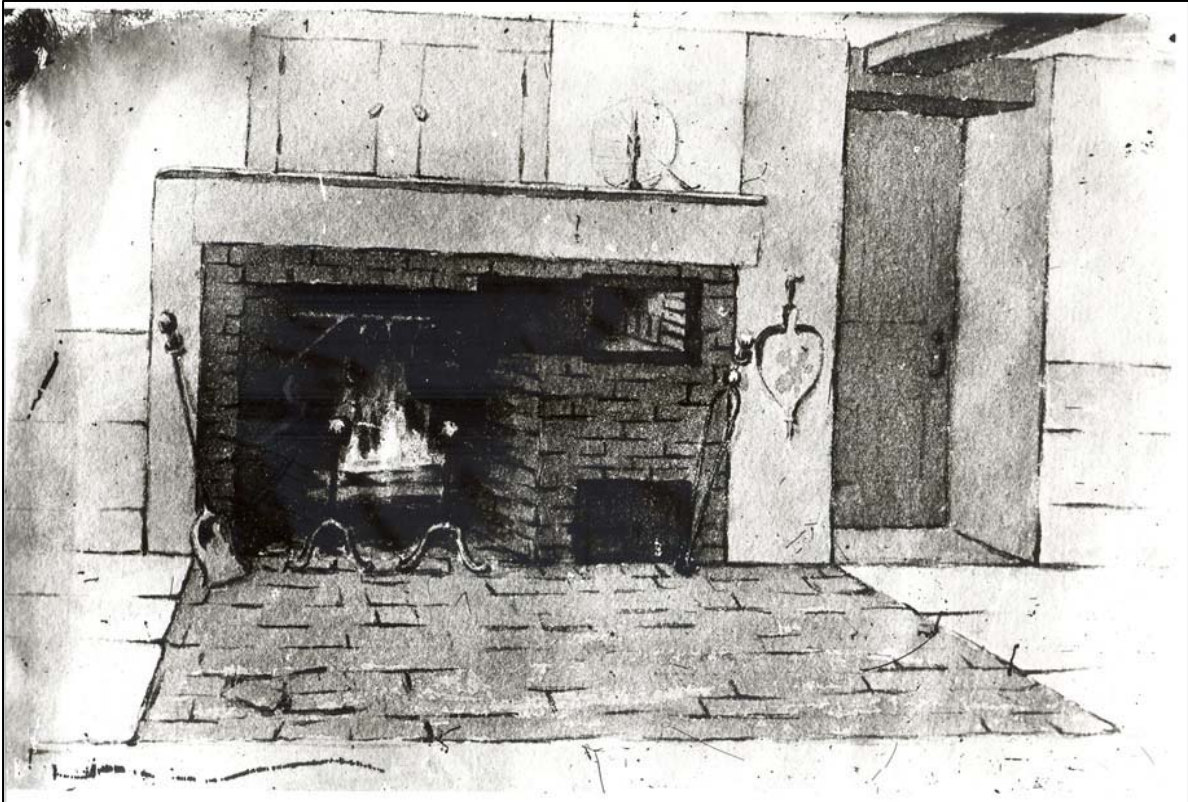
Figure 4. Photograph of sketch by Mary Wheeler (1846-1920), showing the Meriam House kitchen fireplace, circa 1865.

The only known early interior view of the Meriam House is a sketch of the kitchen fireplace wall entitled “Merriam Interior Kitchen” (fig. 4). The drawing was by artist Mary C. Wheeler (1846-1920), and was later photographed by Alfred Hosmer (1851-1903).¹⁰⁶ Mary Wheeler was a Concord native who attended the Concord public schools and the Abbott Academy in Andover. She taught in the Concord schools for two years, circa 1865-1866. The kitchen sketch is believed to have been made about this time, because Miss Wheeler later relocated to Providence, Rhode Island.¹⁰⁷

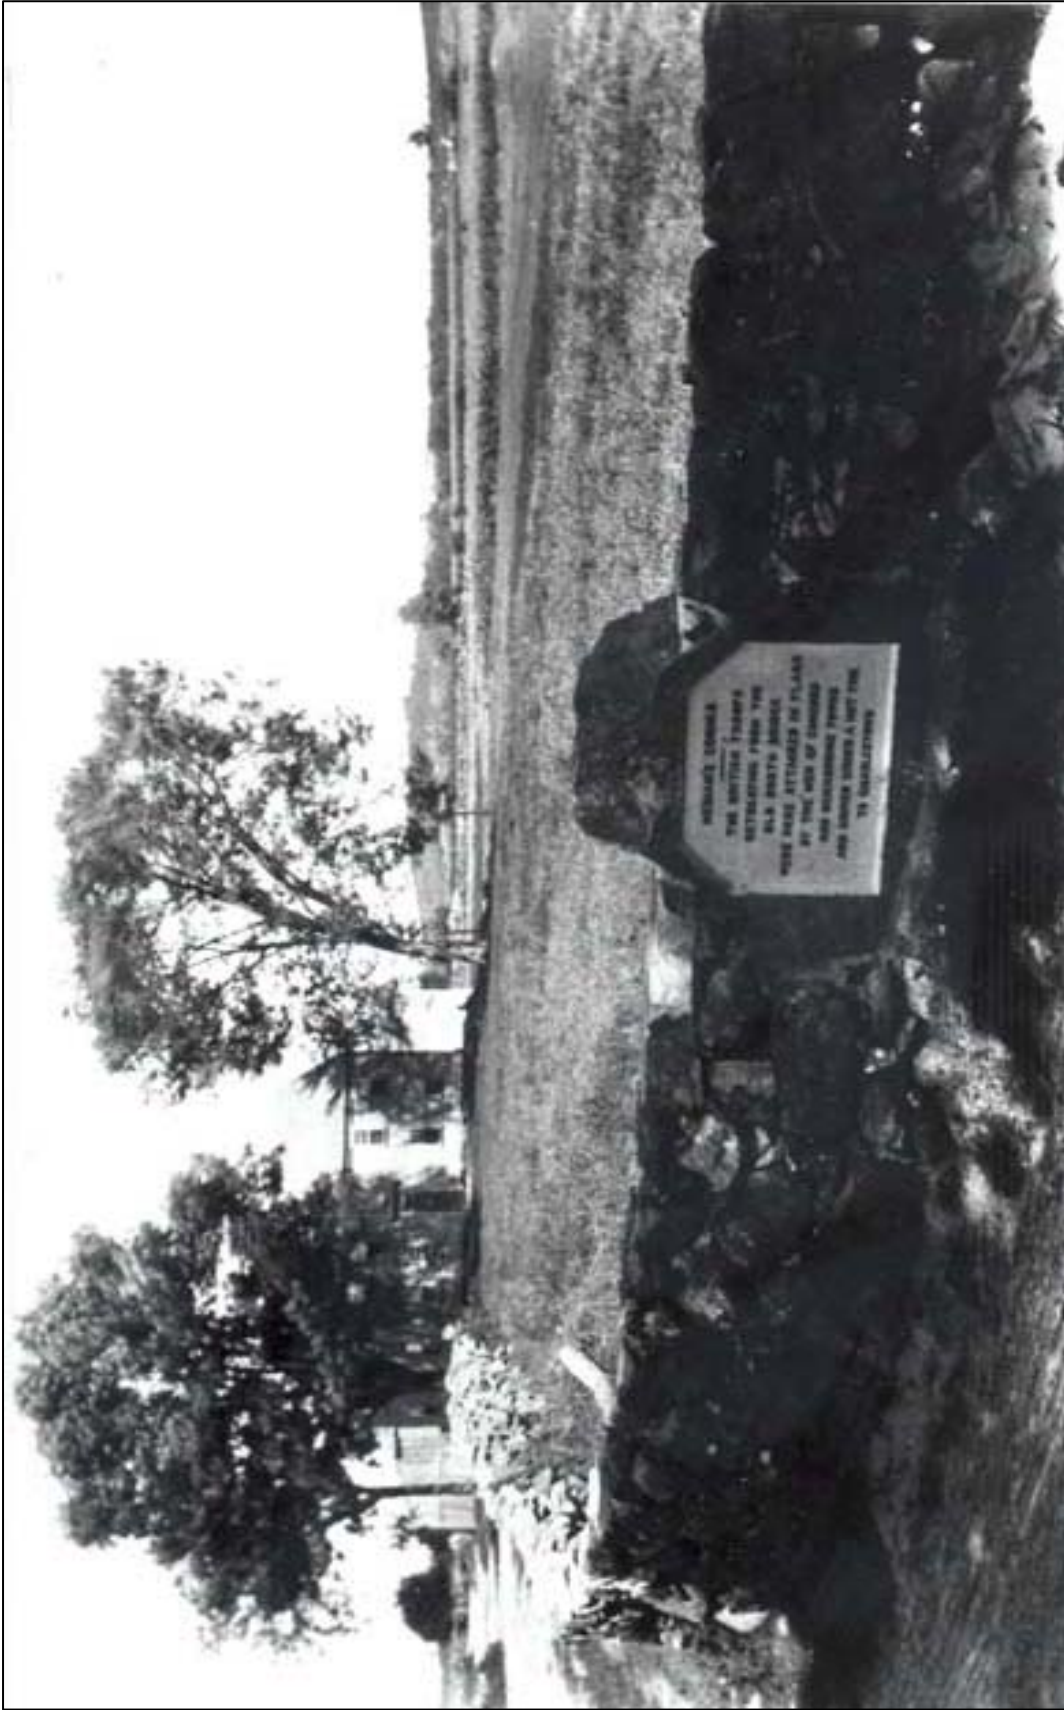
Figure 5. Earliest-known exterior view of the Meriam House, taken after the memorial stone was installed in 1885, and before the barn was demolished sometime between 1898 and 1899.

Assuming that this account is accurate, and that the Reading Company was traveling towards Concord on what is now Old Bedford Road, this would place the barn behind (on the north side of) the existing Meriam House. It was therefore most likely the barn of Nathan Meriam, who was then living in the Meriam House. The earliest photograph of the house (fig. 5) does in fact show what appears to be a barn in this location.⁵⁰

The barn, which was also divided into east and west sides, was on the same side of the road as the house. It was probably behind the house, based on an early photograph taken in the late 19th century that shows what appears to be a barn in this location (fig. 5). The barn was probably not new in 1805, because the widow Mary then had it repaired using shingles and nails; whether the shingles were used on the roof or walls is not known.⁷⁷ The description of the widow's third of the barn as being from the “easterly side of the west flowerway to the cell by said flowerway—and thro the Barn” has been interpreted by one researcher to mean “the entrance to the barn cellar was

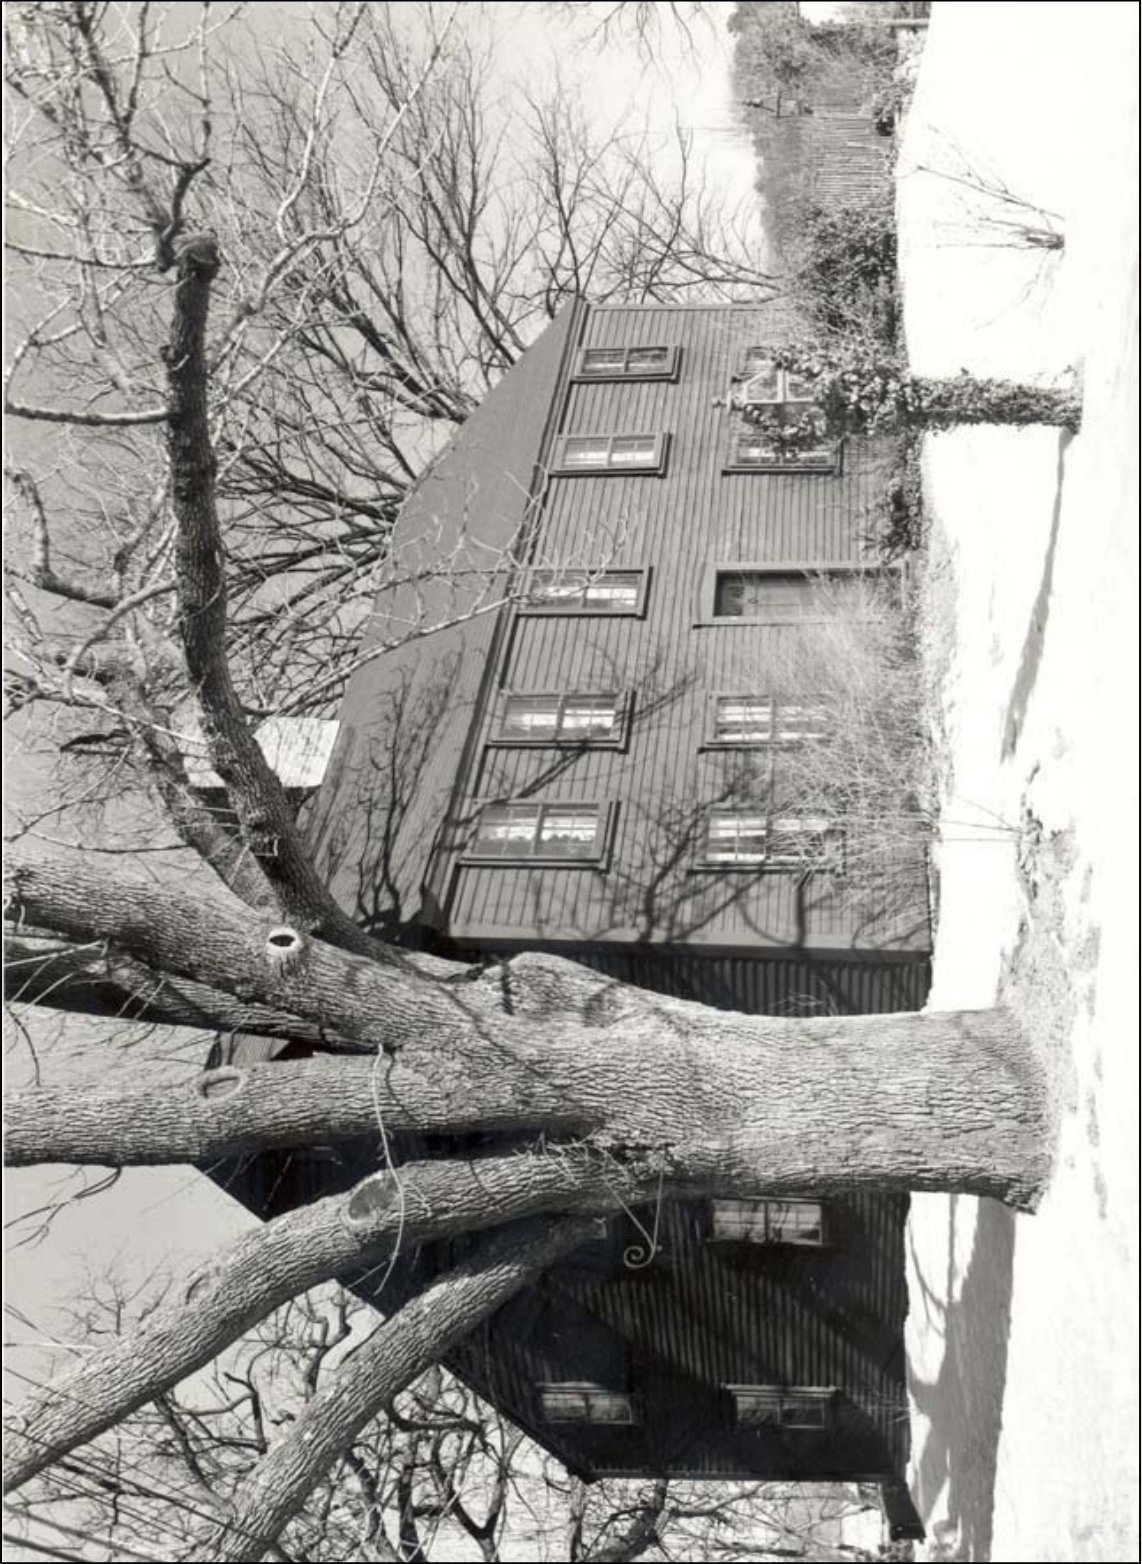
Figure 20. Meriam House exterior, view looking northeast, 1963.

The appearance of the circa-1743 chimney stack prior to the 1984 rebuilding can be deduced from photographic evidence. Figure 8 (circa 1899) indicates that the early chimney had a corbeled cap. Figure 17 (circa 1937) shows both the corbeled cap and what appears to be a drip course at the base of the stack. Figure 20 (1963) shows the stack to have been approximately five brick courses taller than it is today. (Interestingly, figure 20 does not show the drip course seen in figure 17.)

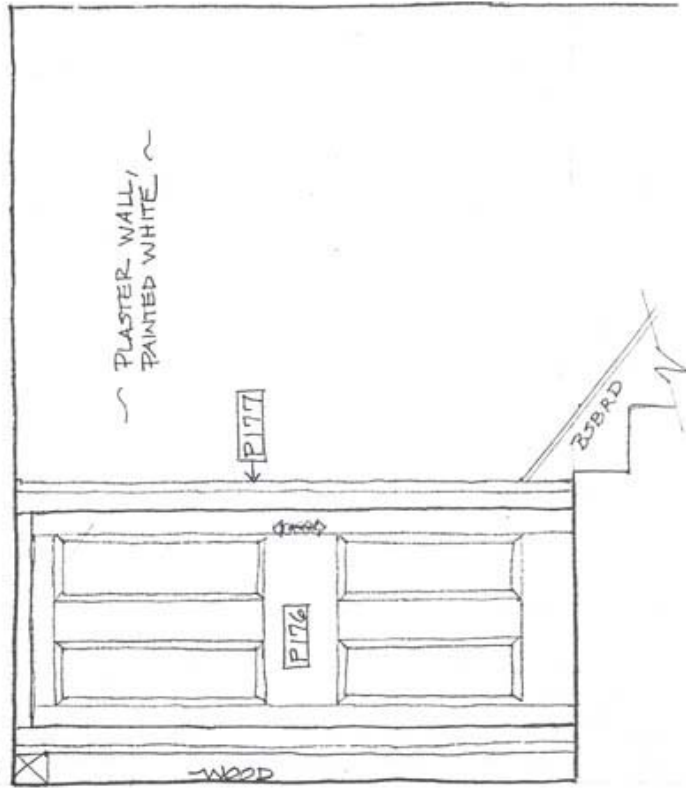
MIMA: MERIAM HS
RM 201, WEST WALL
SEPT. 7, 1998; B. Yocum
SCALE: 1/2" = 1'0"

DOOR: MORTISED, WITH NORFOLK LATCH ("NAVY" BACKPLATE) & X 2 HINGES (3-KNUCKLE 3 SCREWS/LEAF); PANELS ARE RAISED RM 201 SIDE, RECESSED-MOLDED RM 202 SIDE; DOOR MEASURES: 2' 5 3/4" W
6' 2 1/8" H
1" THK
APPEARS TO BE IN ORIG. LOCATION.

FINISHES:
PLASTER PTD WHITE;
WOODWORK PTD RED

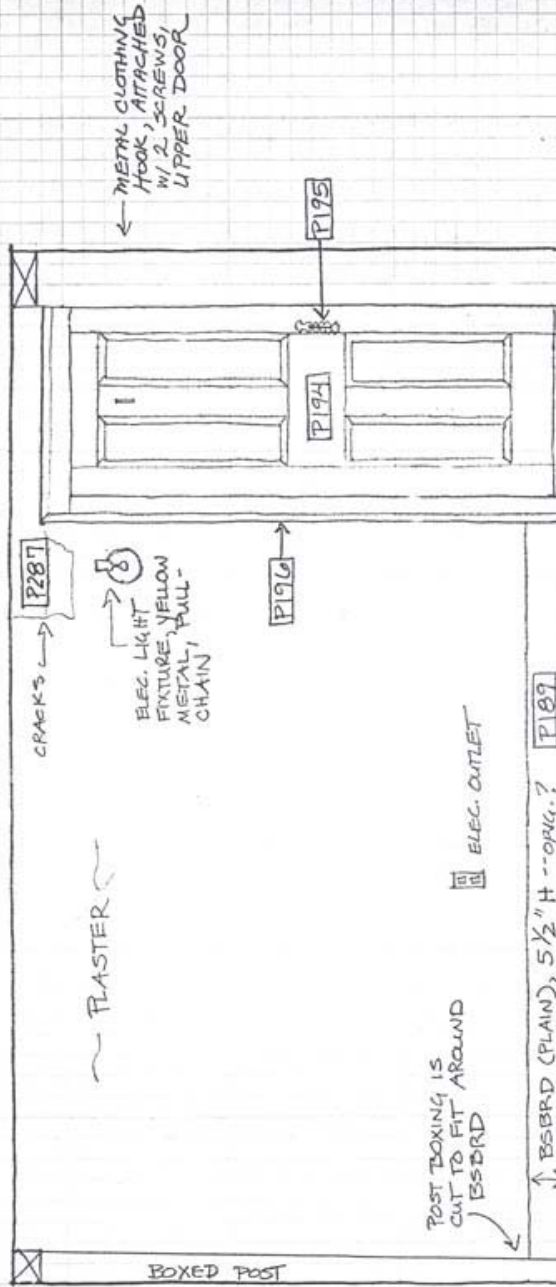
THM: MERIATH HS
 RM 202, NORTH WALL
 SEPT. 9, 1993; B. J. O'CONNOR
 SCALE: 1/2" = 1'0"

FINISHES:
 PLASTER WALL PTD.
 WHITE (SAND PAINT);
 WOODWORK PTD. BLACK

DOOR: OLD, OF MORTISED CONSTRUCTION;
 ARCHITRAVE IS ALSO OLD (= EAST
 DOORWAY). NORFOLK LATCH SAME
 STYLE AS @ EAST DOOR. DOOR
 HAS BEEN ENLARGED W/ 3/4" SHIM ON
 EAST SIDE. HINGES ALSO SAME
 AS @ EAST DOORWAY. RAISED
 PANELS, RM 202 SIDE; UNMOLDED
 RECESSED PANELS, RM 203 SIDE.
 DOOR MEASURES:
 2'4 1/2" W (W/SHIM) X
 5'11" H X
 1" THK

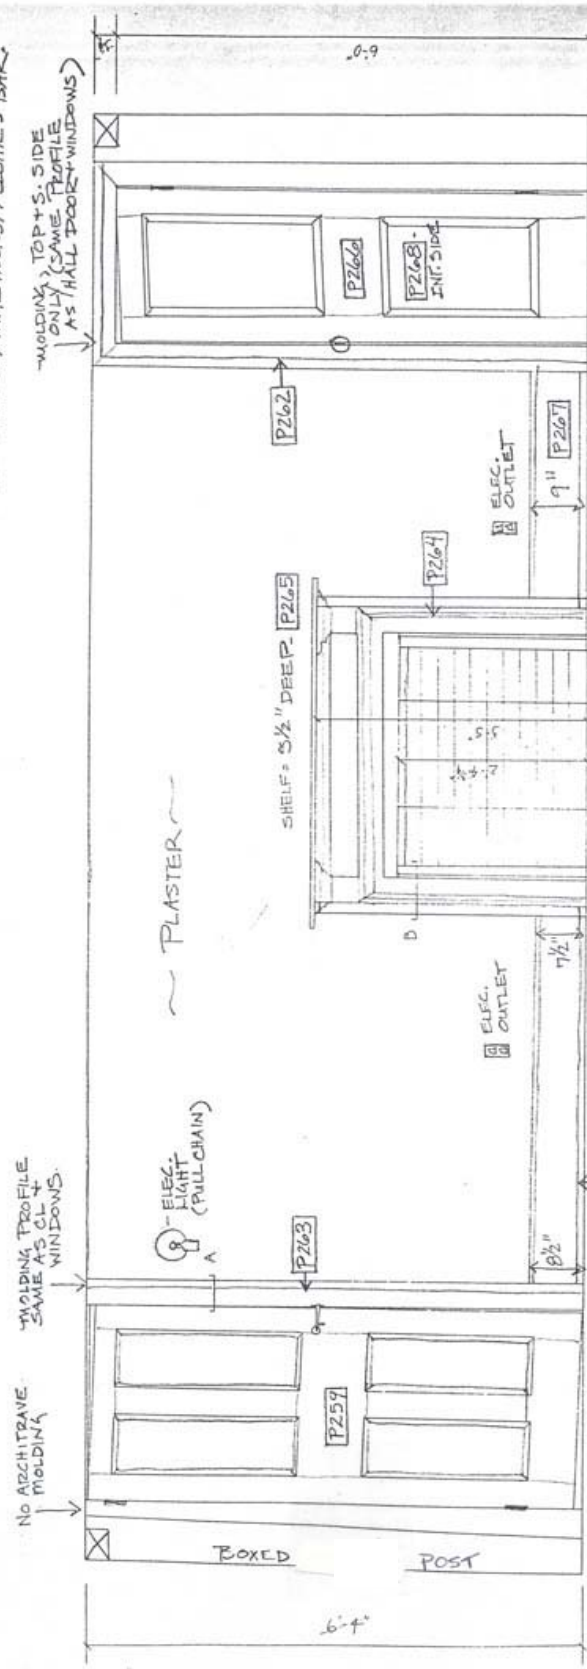
CLOSET DOOR: APPEARS TO BE IN
 ORIG. LOCATION. THORTISED,
 RAISED PANELS RM SIDE, RECESSED
 UNMOLDED PANELS CL SIDE; X 2
 3-KNUCKLE HINGES; 2" DIAM.
 (BEARS?) SWIVEL LATCH RM SIDE;
 DOOR MEASURES:
 1' 11" W X
 5' 10 7/8" H X
 1" THK
 THRESHOLD - 4" WIDE

FIREPLACE:
 MANTEL = RM 202;
 FIREBOX IS 1' 4" DEEP
 2' 9 1/2" W X 2' 2 1/2" H;
 FACE BRICKS PAINTED
 BLACK (2' 2" W)

RECESSED, MOLDED
 PANELS.
 THRESHOLD: 5 1/2" W (CRACKED)

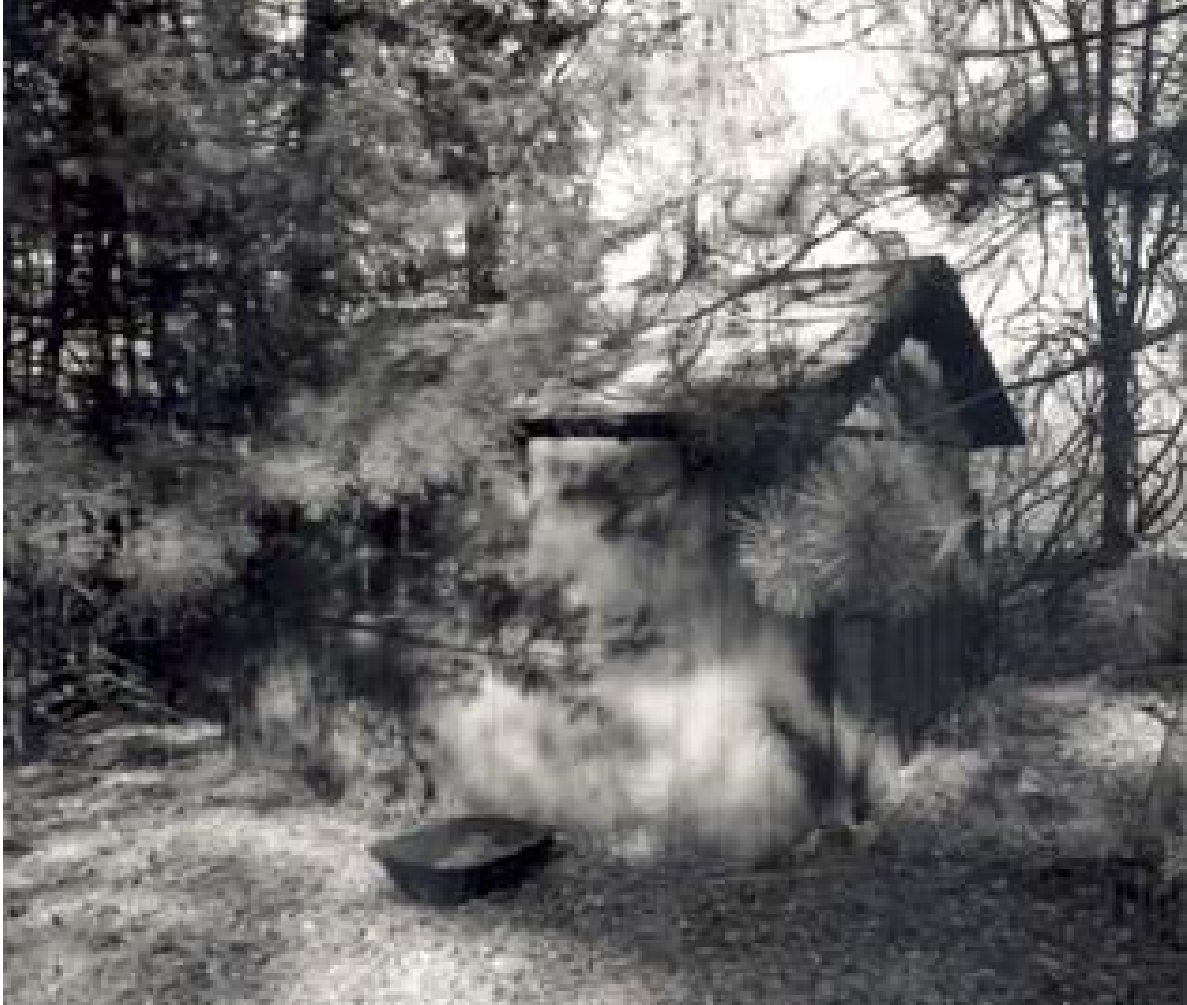
Figure 41. Garden Shed, view looking northwest, November 10, 1993.

The three small outbuildings on the site today were all built, or moved here, by the Ingrahams. The garden shed has been dated 1956; the tool house, 1960; and the cottage, sometime before 1969. All are suffering from deferred maintenance. Because the existing outbuildings are 20th-century structures in poor repair, it is recommended that they be removed from the site.

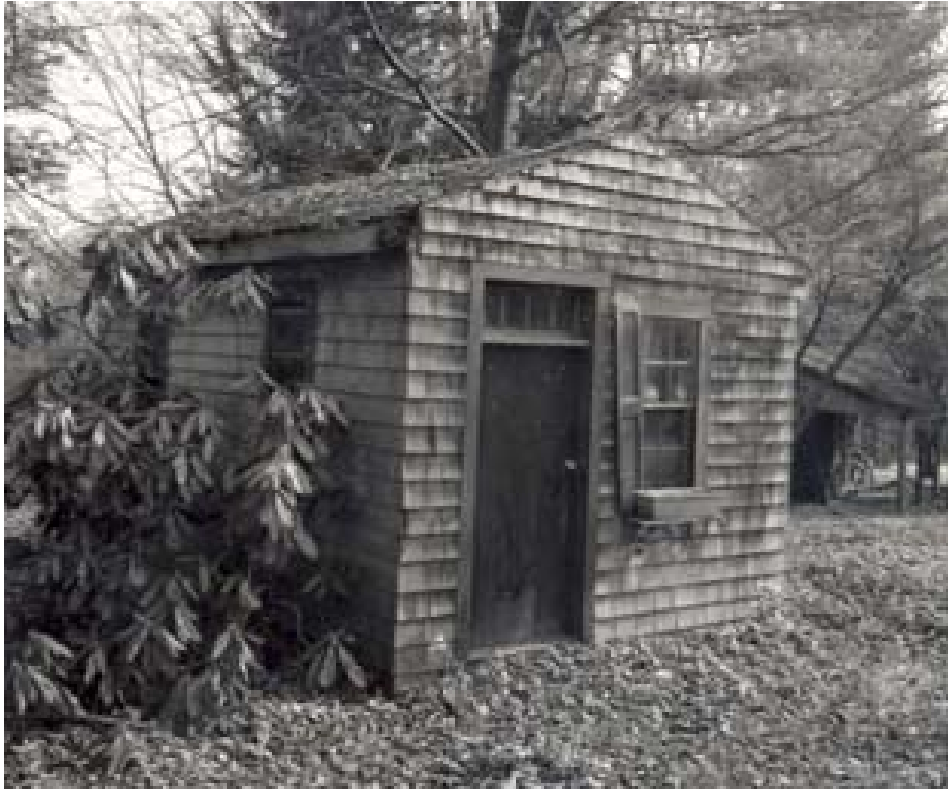
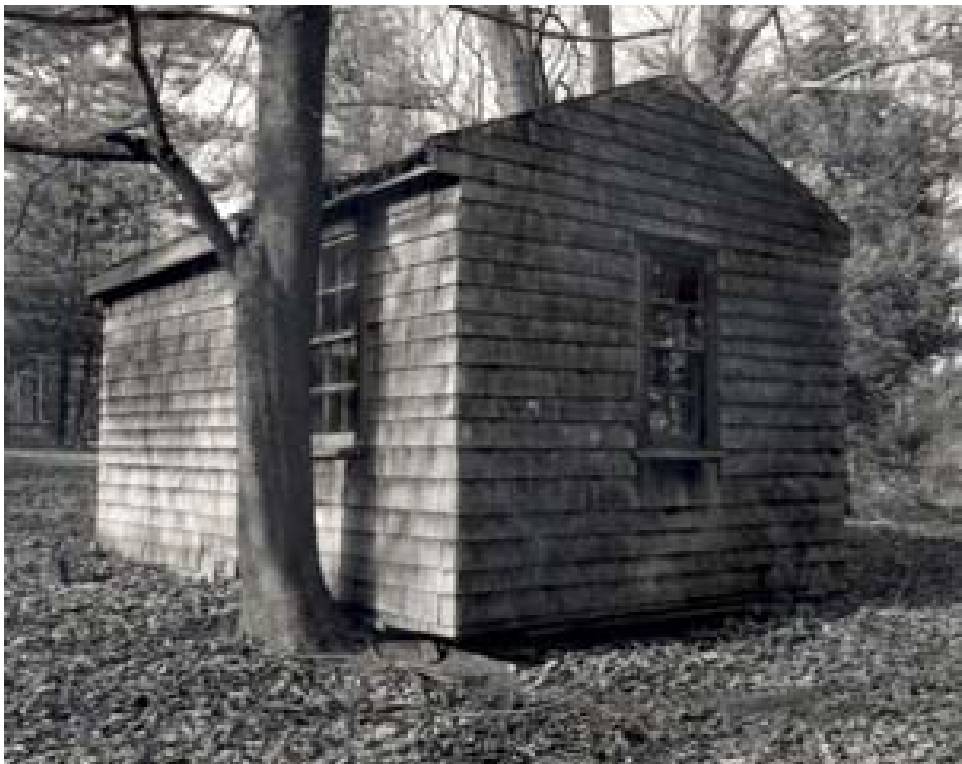
Figure 42. Tool House, views looking southeast and northwest, November 10, 1993.

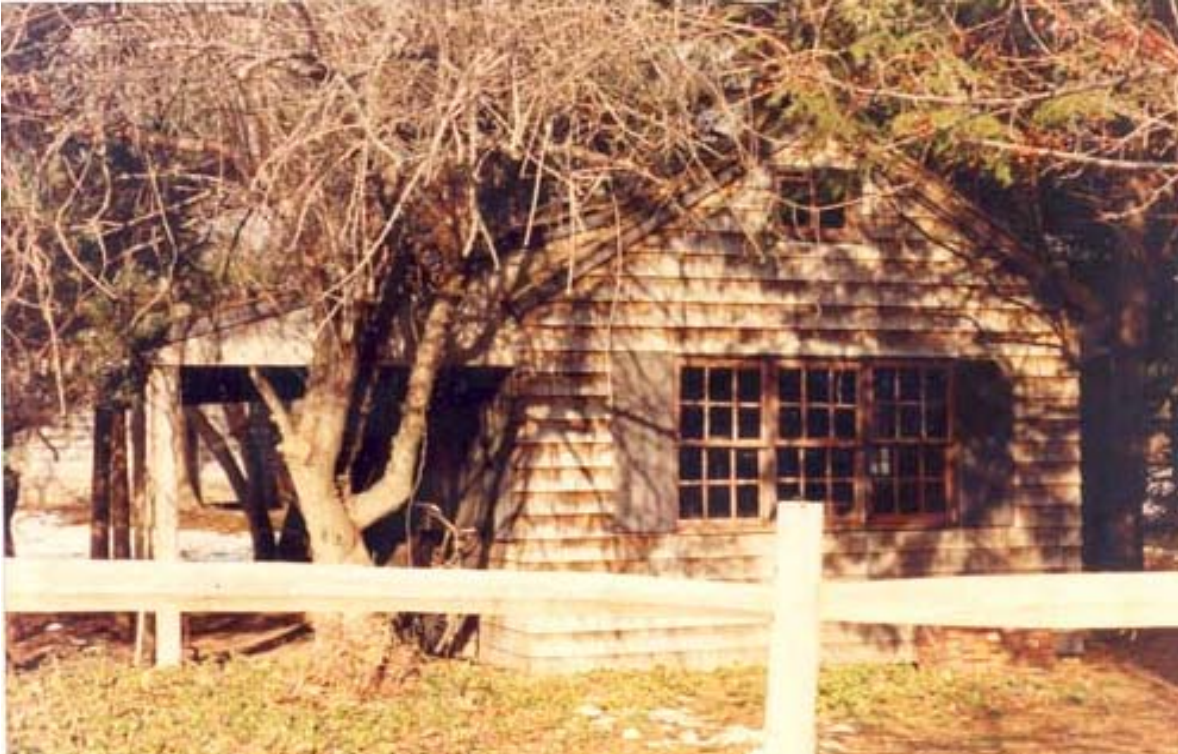
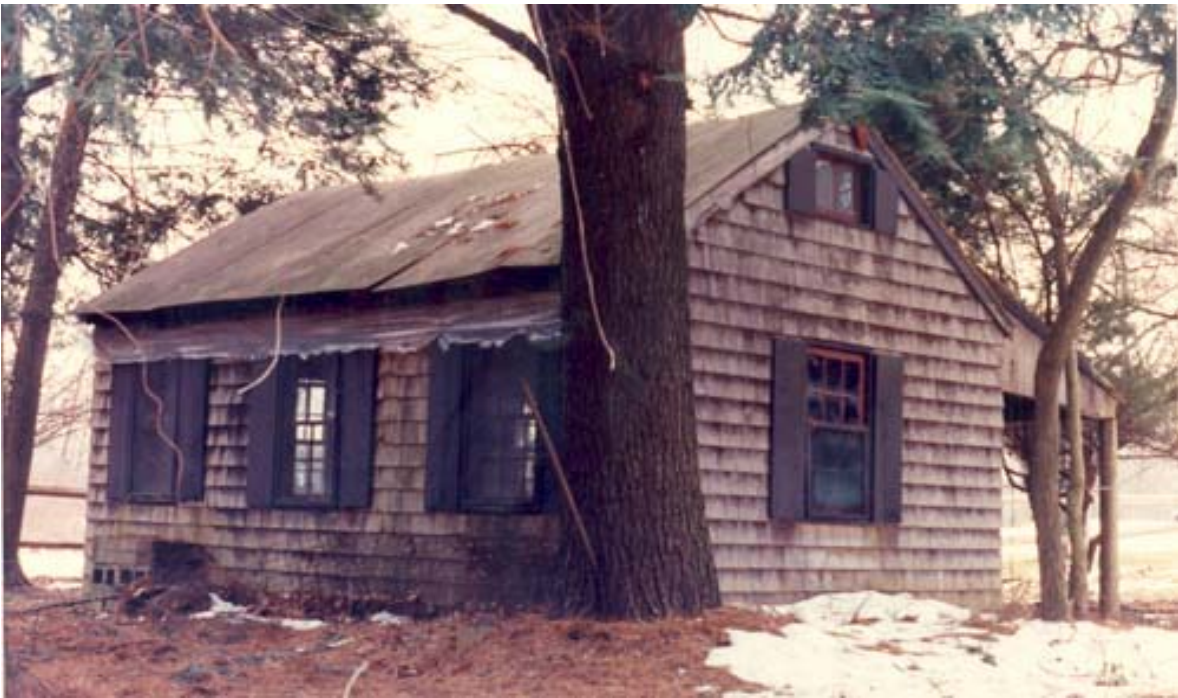
Figure 43. Cottage, views looking north and southwest, December 1992.
