Evaluation of Devices to Prevent Construction Equipment Backing Incidents

Todd M. Ruff

Spokane Research Laboratory, National Institute for Occupational Safety and Health,
Spokane, WA USA

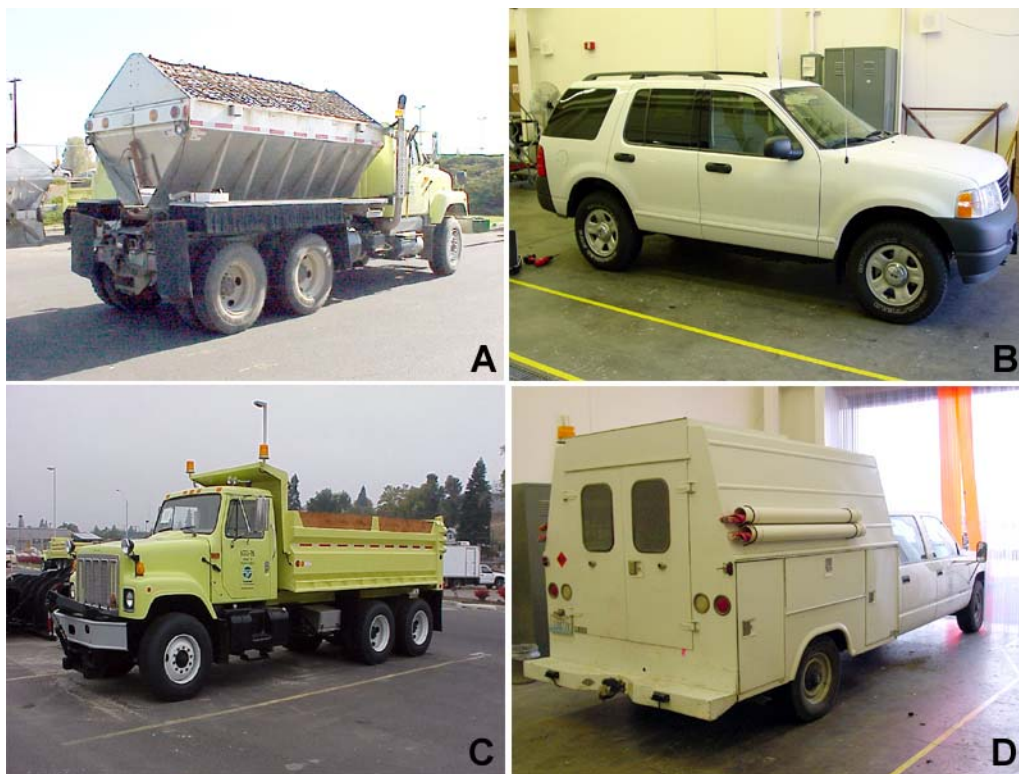
Figure 1.—WSDOT test vehicles. A, Sanding/plowing truck; B, sport utility vehicle; C, dump truck; D, pickup truck.

Test Results-Dump Truck: Tests were conducted on a tandem-axle dump truck (figure 1C). Several positions for the radar antenna were tried; the best results were obtained when the antenna was mounted on the hitch plate at a height of 89 cm (35 in) and slightly off-center (figure 3). The antenna could not be mounted closer to the center of the truck because the system may detect the hitch, causing false alarms, or be crushed when the truck is backed up to a trailer tongue. The alarm display was mounted on top of the dashboard in the cab.

Test Results-Sanding/Plow Truck: Tests of the radar system through the winter were conducted on a sanding truck (figure 1A) to determine the system’s effectiveness in harsh weather conditions. Radar mounting was the same as described above for the dump truck. Only driver interviews and a researcher’s direct observation were used to obtain feedback on the system’s operation.

A single sensor system (HS100) was mounted on the receiver hitch of the Ford Explorer (figure 1B) at a height of 50 cm (20 in) at the center of the vehicle. The alarm display was mounted in the rear cargo area of the cabin and near the upper right corner of the rear window. This was the recommended mounting position and allowed the driver to see the warning lights when looking over the right shoulder while reversing. Power for the system was taken from the reverse lights. The detection area for a person covered the width of the vehicle and extended to 2 m (6.6 ft) from the bumper in a rectangular shape.

On the pickup truck (figure 1D), a two-sensor system was tested (HS300). This vehicle was wider than the Ford Explorer and required two sensors for adequate detection. The sensors were mounted near the ends of the rear bumper at a height of 46 cm (18 in) and a spacing of 1 m (39 in), as shown in figure 14. The alarm display was mounted in the cab on the dashboard. The sensor configuration resulted in a detection area for a person that was similar to that in figure 13. It covered the width of the truck and extended 2.5 m (8.2 ft). Early in the tests the system generated false alarms when the truck was moved in reverse in a clear area on asphalt or gravel surfaces. The sensor mounting brackets were modified so the sensors had an upward angle of approximately 5 degrees. This eliminated false alarms on flat ground, but still allowed a 13 cm (5 in) high curb to be detected.

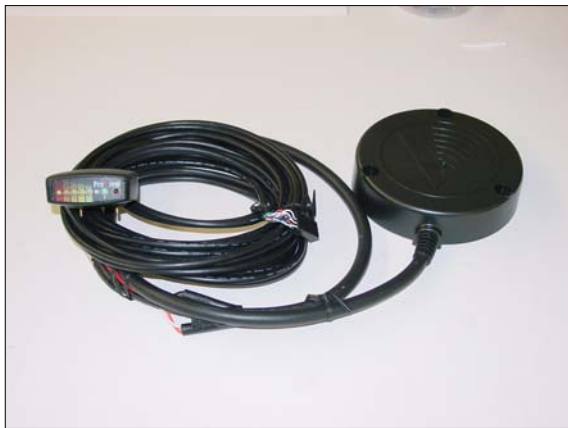
Figure 2.—Preco's Preview radar system

System Description: This radar system uses pulsed microwave signal techniques to detect an object in the radar beam. It consists of a radar antenna and processing electronics, an alarm display, and cables (figure 2). No motion of the object or vehicle is needed for detection. The alarm display indicates distance in 1-m increments using a series of LED's. An audible alarm that changes in frequency as the distance to an object changes is generated. The radar system is designed to monitor the rear blind area and is activated when the vehicle is in reverse. This model has no user-adjustable settings.

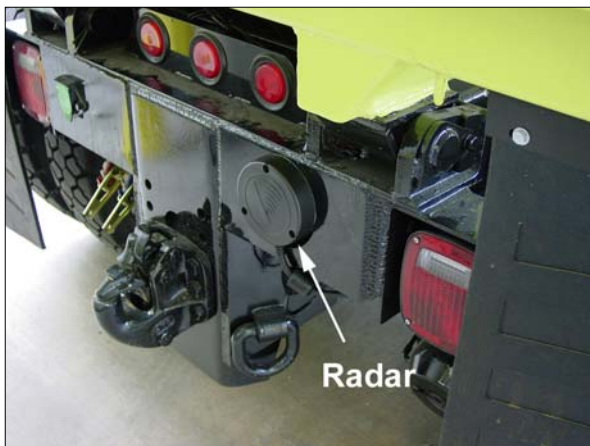
Figure 3.—Preview radar antenna mounted on hitch plate.

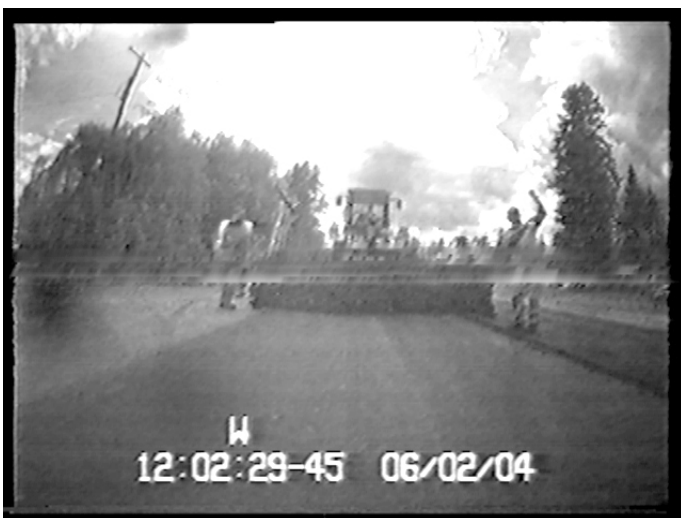
Figure 5.—Screen shot of video from rear camera view. Note that the “W” indicates a radar alarm.

Figure 5 shows an example of a video obtained from the camera and radar combination. Note that a “W” appears on screen whenever the radar system alarms. Since the radar detection zone is entirely contained within the camera’s field of view (FOV), any object that causes an alarm can be seen in the video. This allows researchers to determine when alarms occur and what causes them. In this case, the radar system correctly detected the nearby equipment and workers.

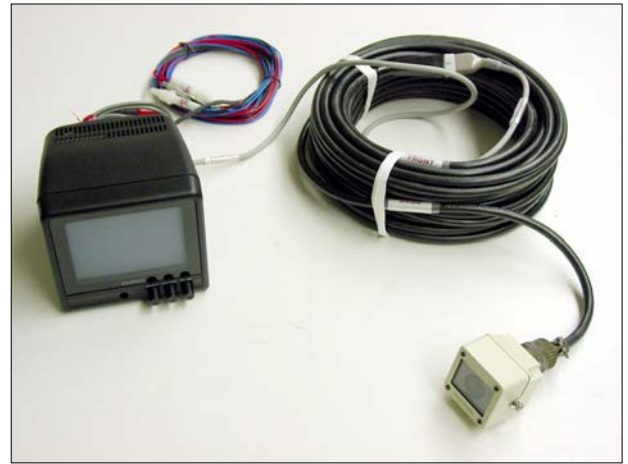
Figure 6.—Intec camera system

System Description: The Intec camera system consists of a small camera the size of a 5-cm (2-in) cube (model CVC210XL), an 11.4-cm (4.5-in) video monitor (model CVM450LPP), and cables (figure 6).

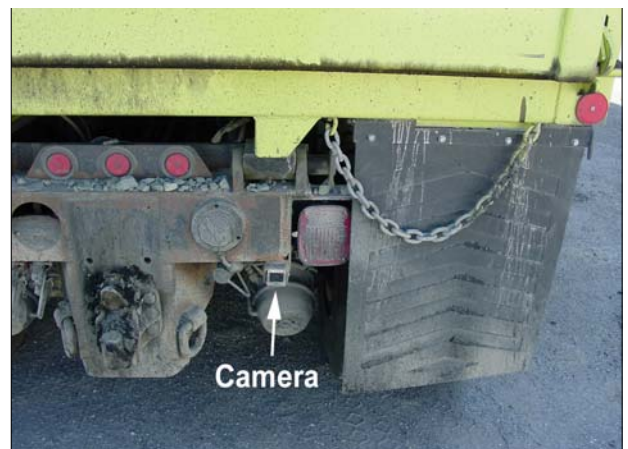
Figure 8.—Intec camera mounted near hitch.

Because the dump box is removed and replaced with a sand hopper, WSDOT and NIOSH researchers wanted to find a mounting position that would be undisturbed during the box switching process. An alternative camera mounting position near the hitch is shown in figure 8. This may not be an adequate position for all truck types, especially if the camera is in the path of material as it flows out of the tailgate or if the FOV is blocked by structures on the truck. The monitor was mounted in the cab on the center pedestal between the seats. This allowed the driver to check the monitor without too much head movement after checking the right side mirror. Other monitor positions are acceptable, and feedback from the driver is required to find the preferred position. Figure 9 shows the FOV of the camera with the view extending to the horizon.

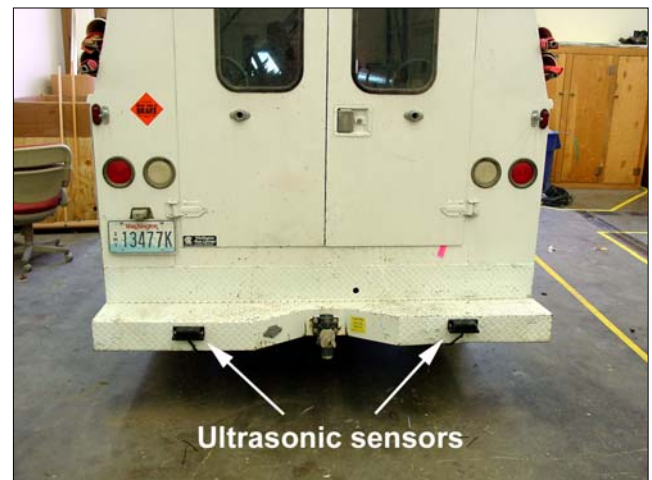
Figure 14.—Hindsight system sensors mounted on pickup.
