NOISE AND VIBRATION REDUCTION OF A VIBRATING SCREEN

David S. Yantek, NIOSH, Pittsburgh, PA

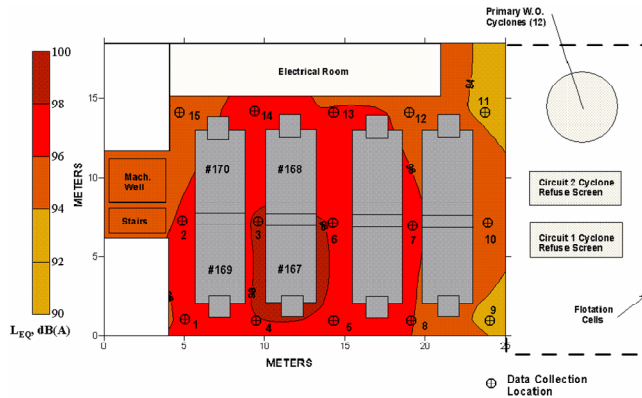
Figure 1. Contour plot of the A-weighted sound levels around a group of eight clean coal screens.

The consortium selected a coal preparation plant for the study based on its proximity to all of the involved researchers. In the selected plant, preliminary measurements were made in the area surrounding a group of eight horizontal vibrating screens used to process clean coal. These measurements indicated that the sound levels ranged from 94 to 98 dB(A) with the plant processing coal (see Figure 1) and from 89 to 97 dB(A) without the plant processing coal and the screens operating with vibration only. The sound levels decrease significantly with increasing distance from the screens, indicating that the

screens dominate the overall A-weighted sound level in this area of the preparation plant. In order to reduce the potential for overexposing preparation plant workers to noise, the collaborators agreed to test several commonly used engineering noise controls for vibrating screens. In addition, the collaborators initiated a research effort to rank the noise sources on one of the horizontal vibrating screens and to develop engineering noise controls to address the dominant noise sources.

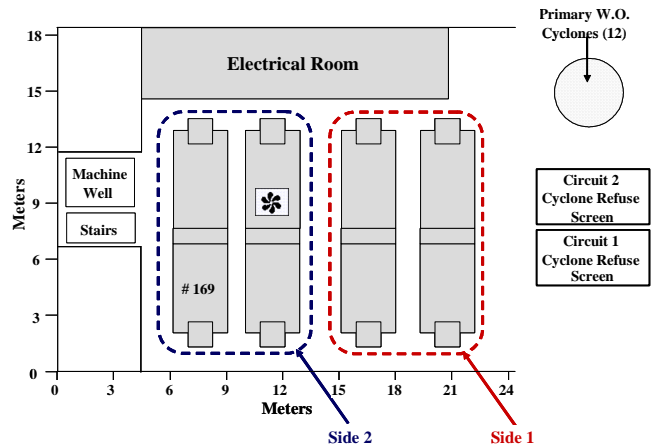
Figure 2. Overhead view of test area.

After the plant operation, test options, and available screens were discussed, a single 2.4 m x 4.9 m horizontal vibrating screen used to drain and rinse a 1 x 10 mesh cyclone clean coal product was selected as the test screen. The test screen, Screen #169, operates within a group of eight similar screens as shown in Figure 2. The plant is designed such that the eight screens are split into two groups of four screens, referred to as Side 1 and Side 2. The sound levels at any location within the test area are influenced by each of the eight screens. Ideally, the sound level around the test screen could be measured with only the test screen processing coal. However, the seven other screens cannot be turned off while processing coal on only the test screen. All of the screens from either Side 1 or Side 2 can be turned off while processing coal. In addition, one screen from Side 1 or Side 2 can be turned off while processing coal with the remaining screens. Therefore, without some means of reducing the contribution of the other screens to the sound level around the test screen, evaluating the sound levels due to the test screen and the noise reductions due to installing engineering controls would be impossible.

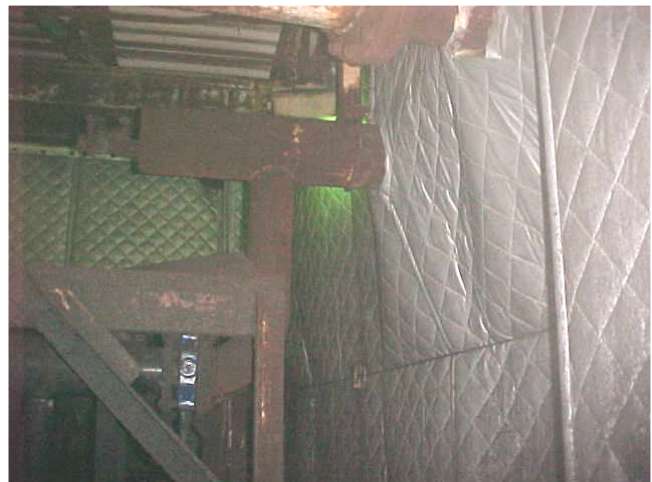
Figure 3. Barrier-absorber curtain between screen numbers 169 and 167 showing tight seal around piping.

In order to reduce the background sound levels around the test screen due to the nearby plant machinery, quilted barrier-absorbers consisting of two fiberglass layers with a loaded vinyl septum and covered in a nylon material were hung from the plant support beams around the test screen (see Figure 3). The barriers were attached to the support beams of the above floor with bolts through grommets. The barriers were sized such that they touched the floor when installed. The seams between individual barrier strips were sealed with Velcro, and gaps around pipe penetrations were kept to a minimum. The above steps were necessary to achieve the maximal reduction in the background noise near the test screen.

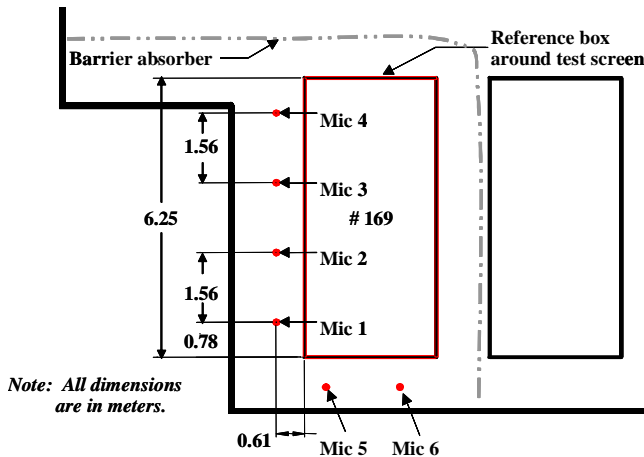
Figure 4. Overhead view of microphone positions around test screen (169) showing barrier-absorber curtain location.

Six microphones were positioned at a height of 1.5 meters and a distance of 0.6 meters from a reference box surrounding the test screen (see Figure 4). Four microphones were positioned along the left side of the test

screen with two microphones behind the feed chute. Due to the proximity of the barrier to the right side of the test screen, it was not possible to position microphones along the right side of the screen. Microphones could not be positioned at the discharge end of the screen between the test screen and Screen #170 due to the screen design. The data acquisition equipment was positioned in the corner of the building as shown in Figure 5.

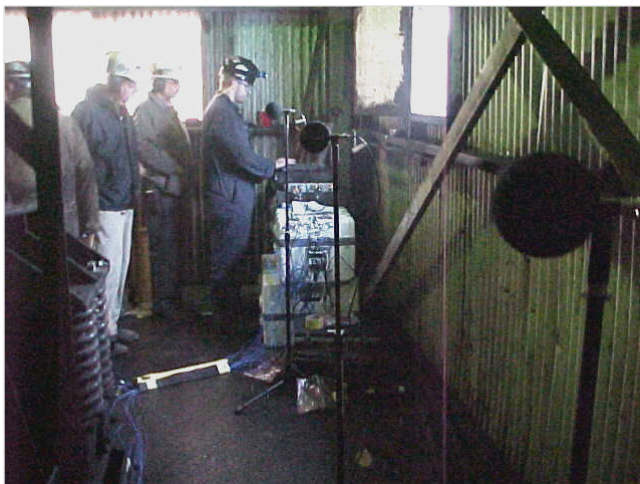
Figure 5. Data acquisition equipment location and microphones along left side of screen 169.

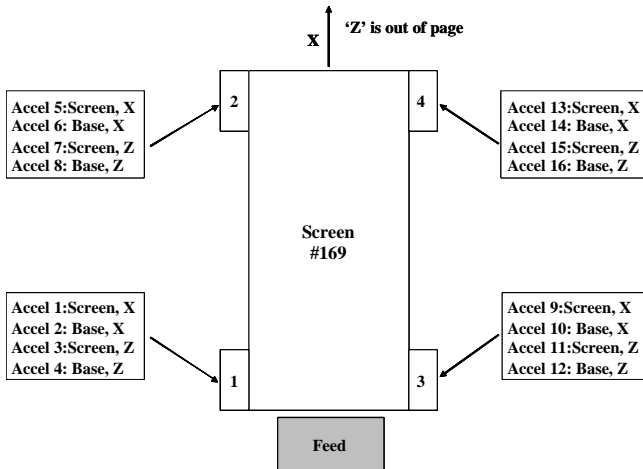
Figure 6. Accelerometer locations used during steel coil spring and rubber isolator testing.

After the barrier-absorber curtain was in place, sound level measurements were performed with new steel coil springs installed. To determine the effect of switching to rubber isolators on building vibration, accelerometers were attached to the screen at the steel coil spring locations on both the screen side and building side of the springs to measure accelerations in both the fore/aft (x) and vertical (z) directions as shown in Figure 6. Figure 7 shows the accelerometers at one mounting location with the steel coil springs (upper picture) and rubber isolators (lower picture).

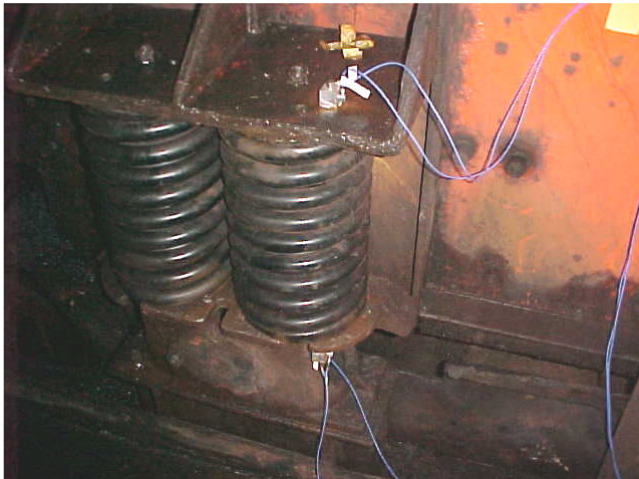
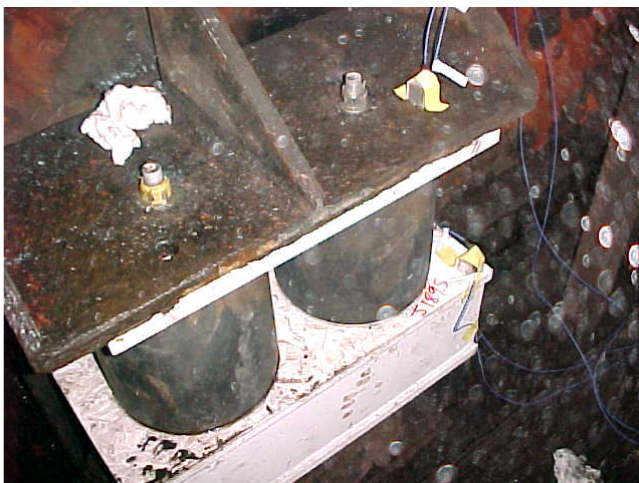
Figure 7. Accelerometers affixed to screen and base at isolator mount locations.

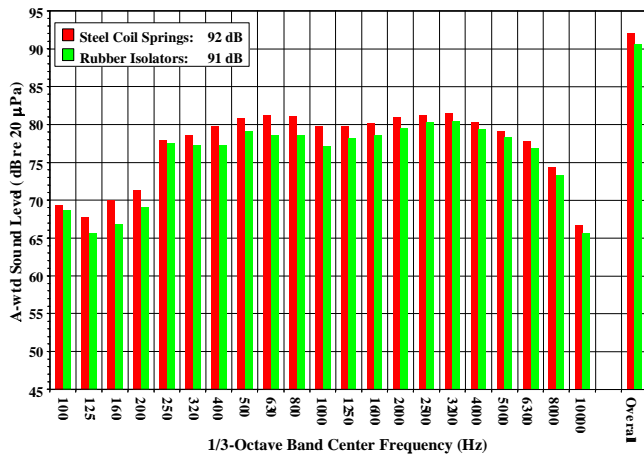
Figure 8. A-wtd 1/3-octave band sound levels for steel coil springs vs. rubber isolators, full operation.

Figures 8 and 9 show the background-noise-corrected A-weighted, 1/3-octave band sound levels due to the test screen for full operation and vibration only, respectively. The figures show that using rubber isolators reduced the overall sound level by 1 dB(A) for full operation and 2 dB(A) for vibration only operation. The figures show that small reductions occur throughout the 100 Hz to 10 kHz frequency range.

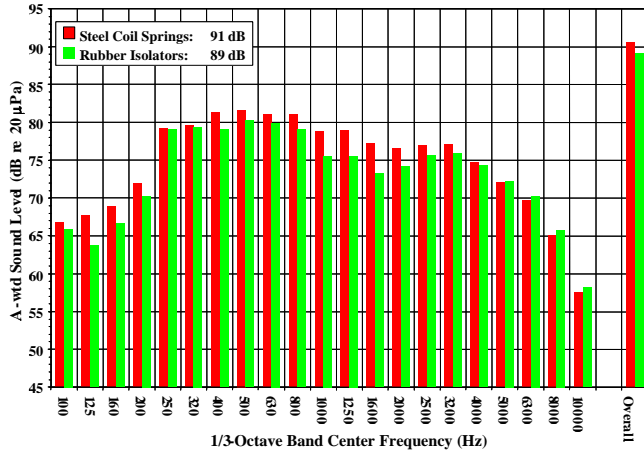
Figure 9. A-wtd 1/3-octave band sound levels for steel coil springs vs. rubber isolators, vibration only.

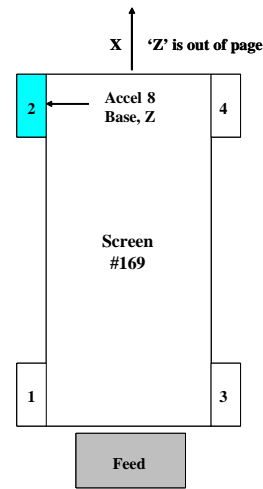
Figure 10. Location used to compare the acceleration time history with steel coil springs and rubber isolators.

To examine the vibration associated with noise radiation, the time waveform of the accelerometer signal on the building side of the mounting location highlighted in Figure 10 was compared for the steel coil springs and rubber isolators. Figure 11 shows the time waveform with the steel coil springs and with the rubber isolators. The

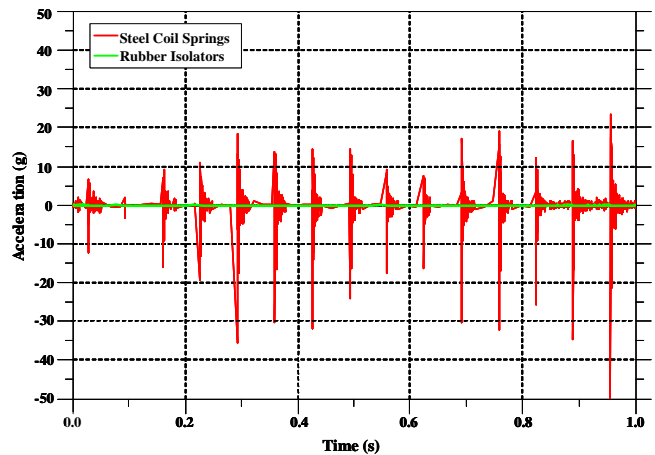
Figure 11. Acceleration in Z-direction at mount 2 with steel coil springs and rubber isolators.

figure shows that 15 impacts per second occurred with the steel coil springs. This impact rate corresponds with the rotation frequency of the vibration mechanisms. The impacts cause peak to peak high frequency vibrations on the order of 75 g at this location. Similar results were observed at the other mounting locations. The impacts could be due to contact between an inner and outer coil spring, a coil spring and its positioning disk, a friction check and the screen, or the screen and a fixed object such as a chute, pipe, or support structure. These impacts cause the screen and its support structure to vibrate and radiate noise. Therefore, these impacts must be eliminated to reduce screen noise in the most efficient manner.

Upon the re-installation of the steel coil springs, vibration measurements were taken at the spring mounting locations to determine the cause of the steel-on-steel impacts observed in the original data (refer to Figure 11). The steel-on-steel impacts were not observed at this time. It is possible that the original test data were influenced by an installation problem with the springs, which would increase the sound level around the screen. It is also possible that during the year that had passed any high spots on the gears in the rebuilt mechanisms had worn away resulting in smoother tooth engagement. In addition, with the rubber isolators, more vibration was transmitted to the building which could have increased the drive noise. Proper installation of the steel coil springs may have eliminated the steel-on-steel impacts and reduced the vibration transmitted to the building, thus decreasing the noise radiated by the screen and the building.

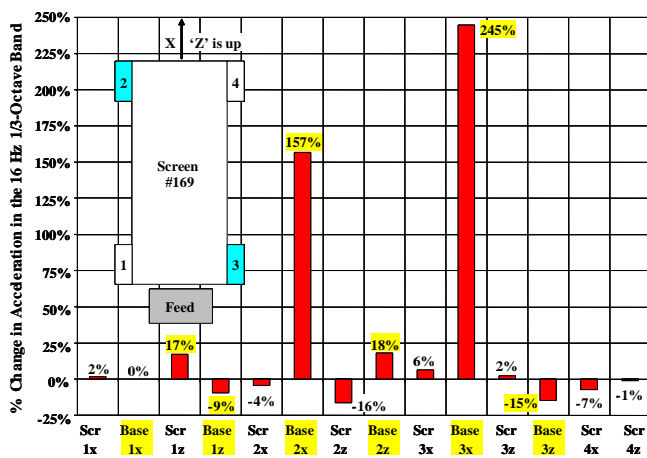
Figure 12. Percentage change in the acceleration in the 16 Hz 1/3-octave band due to replacing steel coil springs with rubber isolators.

rotation frequency. These low frequency vibrations can be a concern with respect to building vibration. Figure 12 shows the percentage change in the accelerations in the 16 Hz 1/3-octave band for the fore/aft (x) and vertical (z) directions on both the building (base) and screen side of each mount. The figure shows that the building vibration at the left mount on the discharge end and the right mount on the feed end of the screen increased substantially. Subjectively, an increase in the building vibration could be felt in the corner of the building where the acquisition equipment was located. The low frequency vibration with the rubber isolators was significantly higher than with the steel coil springs, even though the high frequency vibrations were lower with the rubber isolators.

The increase in building vibration is probably due to a difference between the system spring rates with the rubber isolators and the steel coil springs. With the steel coil springs, two sets of inner and outer springs are used at each mount at the discharge end whereas one inner and outer spring and a third spring are used at each mount on the feed end. However, with this arrangement, the product of the feed end spring rate with the distance from the feed end mounting location to the screen center of gravity is equal to the product of the discharge end screen rate with the distance from the discharge end mounting location to the screen center of gravity. In this case, the translational and rotational motions of the screen are decoupled so the screen motion is primarily translational in the direction of the force applied by the eccentric mechanisms.

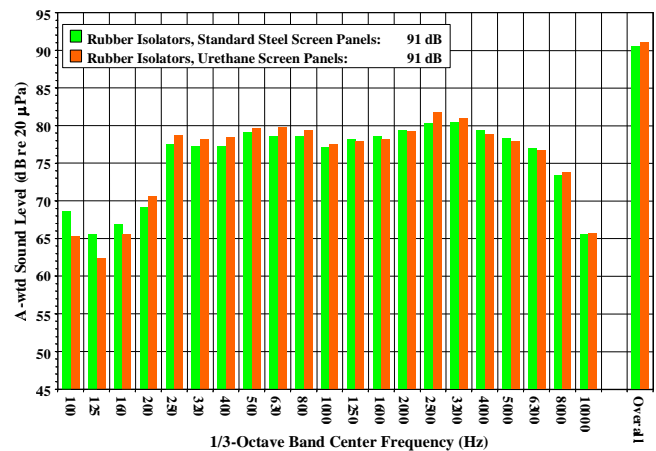
Figure 13. A-wtd 1/3-octave band sound levels for standard steel screen panels vs. urethane screen panels with rubber isolators, processing coal.

Following the tests with the rubber isolators, the steel screen panels were replaced with urethane screen panels. Sound level measurements were then performed with the screens processing coal. Figure 13 shows the background-noise-corrected A-weighted 1/3-octave band sound levels with the standard and urethane screen panels. A slight increase in sound level was observed. However, the increase was only a few tenths of a decibel, which is within measurement error. The figure indicates that the urethane screen panels did not reduce the sound level around the test screen in this case. These results are consistent with the findings of a 1977 report to the Bureau of Mines which states that particle size must ordinarily be greater than 12 mm diameter before coal impact noise exceeds 90 dB(A) near a screen (Rubin, 1997). Generally, coal flow noise is dominant in screens handling coarse coal, while noise due to the drive mechanism, which may be radiated by the screen body or mechanism housings, is the most significant noise source in screens handling finer coal (Ungar et al., 1976).

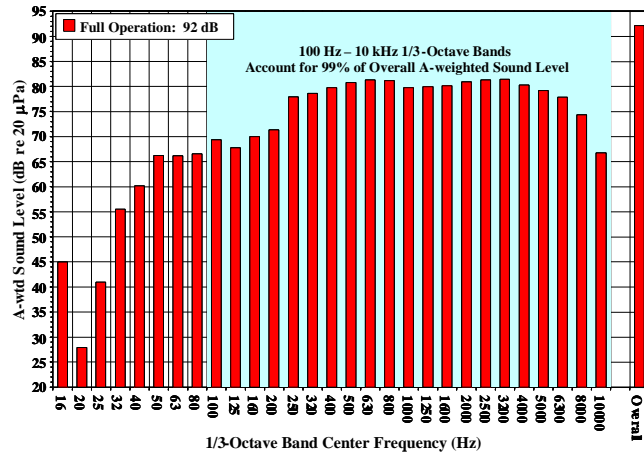
Figure 14. A-wtd 1/3-octave band sound levels for test screen while processing coal.

Figure 14 shows the A-weighted 1/3-octave band sound levels for the test screen with the steel coil springs and standard steel return deck while processing coal. The figure shows that the sound level in the 16 Hz 1/3-octave band, which contains the mechanism rotation frequency, is unimportant in terms of the overall A-weighted sound level. The 100 Hz through 10 kHz 1/3-octave bands, however, account for 99% of the overall A-weighted sound level under full operation. Therefore, emphasis was placed on this frequency range in determining the contributions of each noise source on the screen.

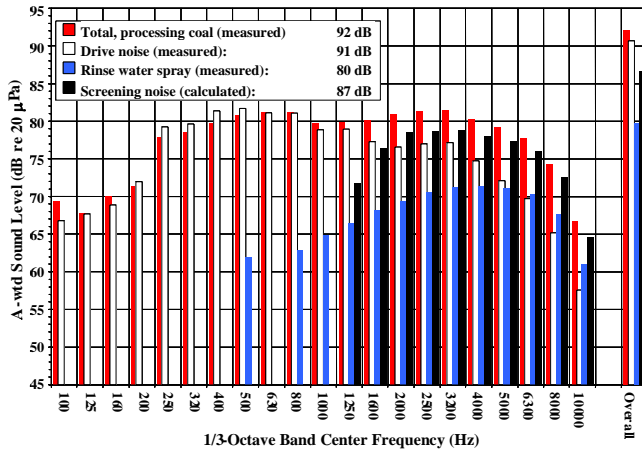
Figure 15. A-wtd 1/3-octave band sound levels for the total screen noise, drive noise, rinse water spray noise, and screening noise.

The A-weighted 1/3-octave band sound levels for the total screen noise, drive noise, rinse water spray noise, and screening noise are shown in Figure 15. The figure shows that drive noise is dominant in the 100 Hz through 1600 Hz 1/3-octave bands, whereas screening noise is dominant above the 1600 Hz 1/3-octave band. Therefore, the most effective approach to reduce the sound level around the screen would be to first address the drive noise in the 100 Hz through 1600 Hz 1/3-octave bands. Once the sound level due to drive noise is reduced to 87 dB(A), drive noise and screening noise would be equal contributors to the sound level around the screen during full operation. At this time, a decision would have to be made regarding which of these two noise sources would be most easily addressed to further reduce sound levels, if necessary.

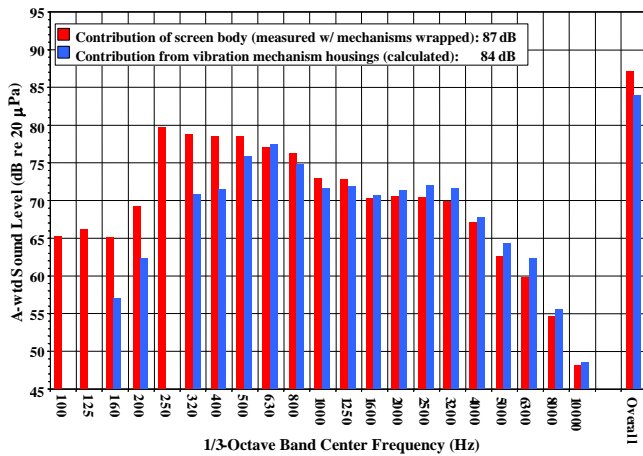
Figure 16. A-wtd 1/3-octave band sound levels for noise radiated by screen body and mechanism housings.

Figure 16 shows the A-weighted 1/3-octave band sound levels due to screen body and mechanism housing vibration. The sound levels due to screen body and mechanism housing vibration were found to be 87 dB(A) and 84 dB(A), respectively. Since a 3-dB difference in levels indicates a doubling of energy, screen side vibration can be said to have twice the significance of mechanism housing vibration in terms of drive noise. The spectra indicate that the noise radiated by the screen body is dominant in the 100 through 500 Hz 1/3-octave bands. The screen sides account for 83% of the sound energy for this band. In the 630 Hz through 1600 Hz 1/3-octave bands, the figure shows that the screen sides and mechanism housings generate similar sound levels with each contributing approximately 50% to the drive noise in this frequency range. In the 2 kHz through 10 kHz 1/3-octave bands, the sound levels due to mechanism housing vibration are higher than those associated with screen side vibration. Mechanism housing vibration accounts for 58% of the drive noise sound level in this frequency range.

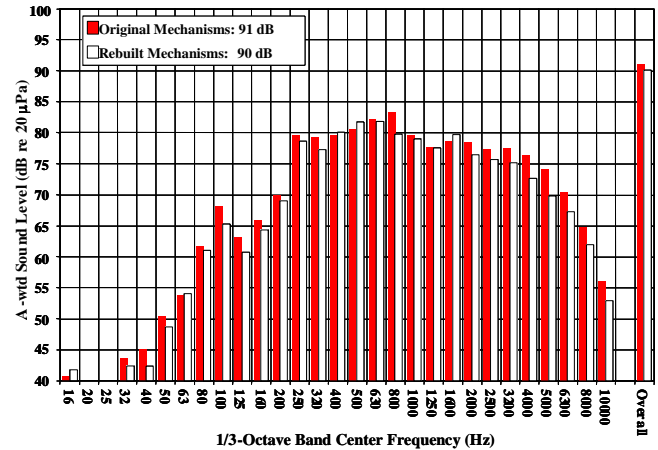
Figure 17. A-wtd 1/3-octave band sound levels for vibration only operation with original and rebuilt mechanisms.

Baseline sound levels were measured with the existing set of mechanisms, the rubber isolators, and the urethane screen panels installed on the test screen with the plant shut down and the test screen operating with vibration only. The mechanisms were then replaced with rebuilt mechanisms and the measurements were repeated. Figure 17 shows the 1/3-octave band sound levels with the original and rebuilt mechanisms. The figure indicates that installing the rebuilt mechanisms reduced the overall A-weighted sound level by 1 dB. According to the screen manufacturer and the coal company, installing rebuilt mechanisms costs

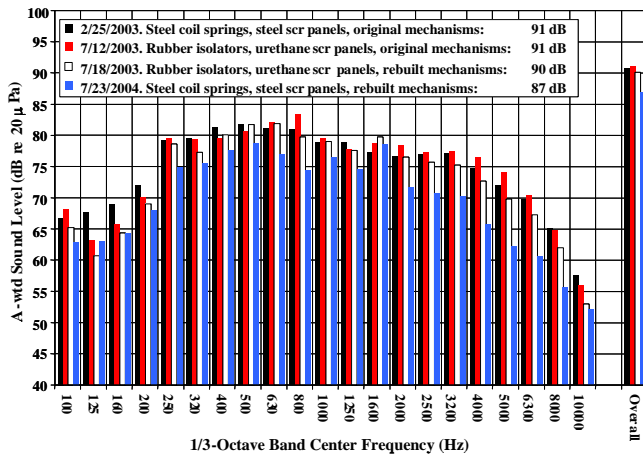
Figure 18. Comparison of sound levels with original or rebuilt mechanisms, steel coil springs or rubber isolators, and steel or urethane screen panels for several test dates.

Due to the increased building vibration with the rubber isolators, the mounts were switched back to the steel coil springs. In addition, the urethane screen panels were removed and standard steel screen panels were installed since the urethane screen panels did not reduce the sound levels and were prone to plugging. After approximately one year, a new set of measurements was performed to establish the baseline sound levels for the screen operating with vibration only with the steel coil springs and steel deck. The measurements were performed on a maintenance day with the plant shut down. At this time, an unexpected result was observed. The vibration only sound levels for the test screen with the steel coil springs and rebuilt mechanism decreased to 87 dB(A), a 4-dB reduction compared to the original measurements from February 25, 2003. Figure 18 shows a comparison of the vibration only sound levels with (1) steel coil springs, steel screen panels, and the original mechanisms, (2) rubber isolators, urethane screen panels, and the original mechanisms, (3) rubber isolators, urethane screen panels, and the rebuilt mechanisms, and (4) steel coil springs, steel screen panels, and the rebuilt mechanisms. The test dates for these data were February 25, 2003, July 12, 2003, July 18, 2003, and July 23, 2004, respectively.

The figure shows that the average sound level measured on February 25, 2003, with new coil springs, the steel return deck, and the original mechanisms was 91 dB(A). When testing was conducted within a 1-week period (July 12, 2003, and July 18, 2003) with the original versus rebuilt mechanisms with rubber isolators and urethane screen panels, the sound levels were 91 and 90 dB(A), respectively. However, after the steel coil springs replaced the rubber isolators and the steel screen panels replaced the urethane screen panels and one year had passed since the installation of the rebuilt mechanisms, the sound level for vibration only operation was 87 dB(A).

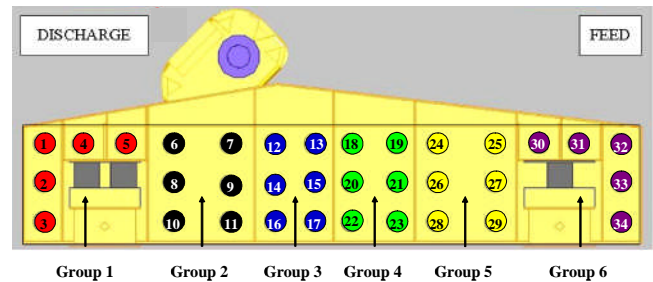
Figure 19. Approximate accelerometer locations used for vibration measurements on the left side of the screen.

Prior to constructing the damped side plates, a series of vibration measurements was performed on the left side of the screen to determine the relative vibration levels along the side of the screen. The goal was to determine if constrained layer damping was necessary on the entire side plate or if some areas, which had insignificant vibration levels, could be left untreated. The left side was divided into six areas and a group of accelerometers was attached to each area as shown in Figure 19.

The test screen was operated with vibration and without coal. Since noise radiation is directly related to the surface-averaged velocity, the resulting 1/3-octave band accelerations were integrated to yield vibratory velocities, and the surface-averaged A-weighted velocity levels for the six areas were calculated (see Figure 20). A-weighting was applied to the vibratory velocities to deemphasize low frequency vibration, which is not a significant contributor to the A-weighted sound level in this case. The figure shows that the velocity levels are highest in the 100 Hz through 400 Hz 1/3-octave bands for the Group 2 and Group 5 accelerometers. However, above the 500 Hz 1/3-octave band, the variation in vibration levels from group to group is generally less than 10 dB. Therefore, each area is a significant contributor to the drive noise radiated by the screen sides and should be treated.

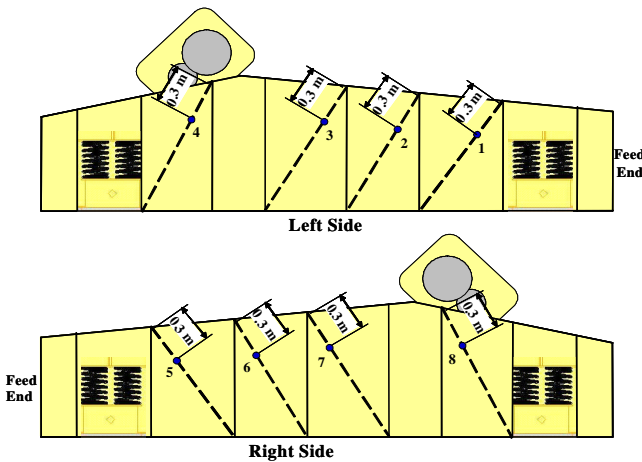
Constrained layer damped side plates were constructed by bonding a layer of viscoelastic damping material to new side plates using epoxy. A 1/8-inch-thick layer of steel was then attached to the viscoelastic material with epoxy to complete the construction. Mechanism covers were fabricated from a barrier-absorber material similar to the material used to exclude background noise from the test area during the initial tests. Prior to installing the damped side plates, baseline sound level measurements were taken during miner's vacation with the plant shut down and the test screen operating with vibration only. In addition, acceleration measurements were taken on the sides of the screen at the locations shown in Figure 21.

Figure 21. Accelerometer locations used to evaluate the effects of installing constrained layer damped side plates.

mechanism covers were then removed and the measurements were repeated. In addition, acceleration measurements were performed at the locations shown in Figure 21 for comparison with the baseline vibration measurements collected in July.

To evaluate the effects of the damping treatment on the screen side vibration, the average A-weighted vibration velocity levels for the left and right sides of the screen were calculated from the measured accelerations at the locations shown in Figure 21. Although the aforementioned problems with the screen installation would tend to increase the radiated noise, it was thought that the damping treatment would still reduce the screen side vibration. This is because both of the installation problems would tend to cause additional noise to be radiated from the building and from local areas more than from the screen sides. Figures 23 and 24 show the A-weighted 1/3-octave band vibration levels on the left and right sides of the screen, respectively. Figure 23 shows reductions in the A-weighted velocity levels on the left screen side ranging from 2 to 7 dB in the 200 Hz through 5 kHz 1/3-octave bands with the damped sides. For the right screen side, Figure 24 indicates reductions of 1 to 6 dB in the 200 Hz through 5 kHz 1/3-octave bands. In the 200 Hz through 630 Hz 1/3-octave bands, the A-weighted vibration levels were reduced by 3 dB on the left side and 4 dB on the right side. The A-weighted vibration levels in the 800 Hz through 5 kHz 1/3-octave bands were reduced by 6 dB on the left side and 3 dB on the right side. With these substantial reductions, the A-weighted sound levels should have been reduced by 3 dB or more. More research should be performed to evaluate the effects of mechanism covers and the damped sides on the radiated sound levels.

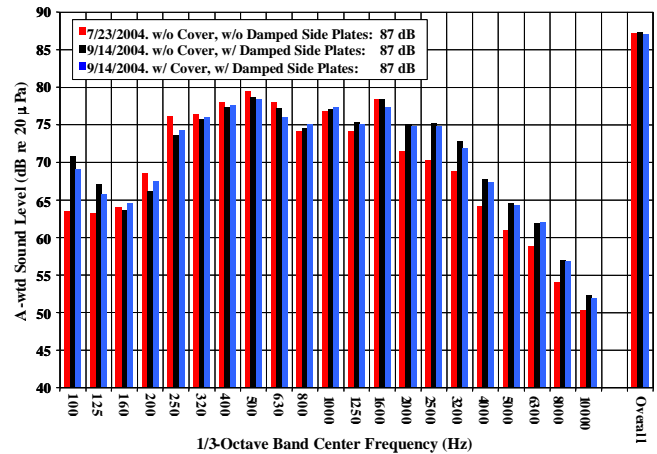
Figure 22 shows the A-weighted 1/3-octave band sound levels for baseline conditions and with the engineering noise controls installed. As the figure shows, neither the damped side plates alone nor the damped side plates and mechanism covers reduced the overall A-weighted sound level. It was expected that the sound level would be reduced by 3 dB or more. The figure shows that the sound levels in the 200 Hz through 630 Hz 1/3-octave bands were reduced by 1 to 2 dB with the damped side plates. With the damped sides and mechanism covers, the reductions in this band were again 1 to 2 dB. In the 800 Hz through 10 kHz 1/3-octave bands, the sound levels measured with the engineering controls installed increased from 83 dB(A) to 84 dB(A). Since it is unlikely that installing these noise controls would increase the sound levels in these bands, something must have changed with the vibrating screen during the period between baseline testing in July, 2004, and the testing with the noise controls in September, 2004.

Figure 22. A-wtd 1/3-octave band sound levels with vibration only operation for mechanism cover and damped side plate tests.

Further investigation of the screen revealed a possible cause for the increase in sound levels. One of the inner springs on the discharge end of the screen was broken when the damped side plates were installed. As a result, only three springs were installed on the right side of the discharge end when the damped side plates were installed. With three springs at this location, it is likely that the screen would undergo a pitching/rolling motion that could create steel-on-steel contact between the support springs or with

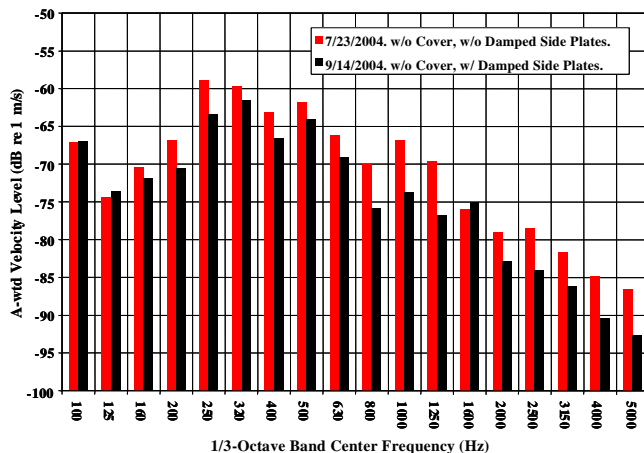
Figure 23. A-weighted average velocity on left side of the screen without and with damped sides.

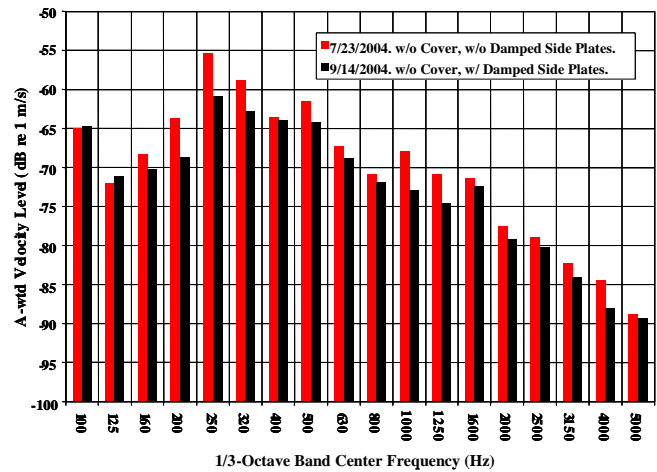
Figure 24. A-weighted average velocity on right side of the screen without and with damped sides.
