Subject: Interior Alterations to School Buildings to Accommodate New Uses

- Applicable Standards:
1. Compatible Use
 2. Retention of Historic Character
 5. Preservation of Distinctive Features, Finishes and Craftsmanship
 9. Compatible New Additions/Alterations

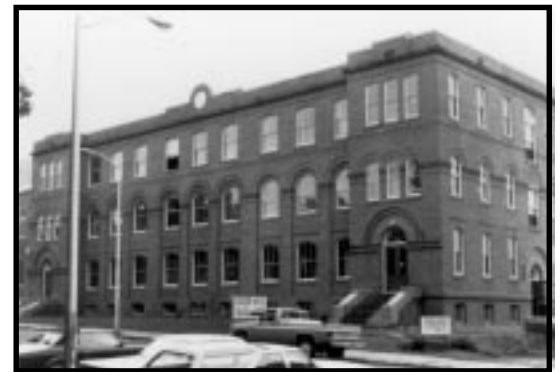
The school after rehabilitation. Windows, doors, and transoms were repaired. The building was not cleaned.

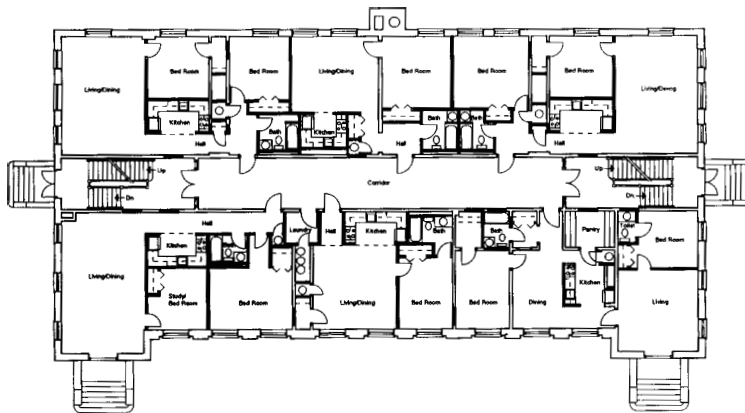
The plan after rehabilitation showing the successful insertion of approximately one unit per classroom.

A comparison of before and after photographs documents the sympathetic rehabilitation work. In the hallways, transoms were retained but infilled with fire-rated drywall on the classroom side, the coat hooks were removed, a sprinkler and fire safety system was installed, some doors were fixed in place, and carpeting was installed. Otherwise, the hallways were kept intact. Six apartments were created on each floor - three on each side of the corridors. With few exceptions, the plan was retained by inserting only one unit per classroom.

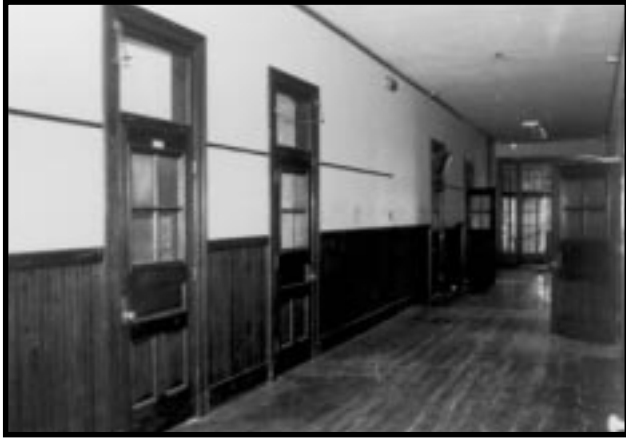
Second floor hallway prior to rehabilitation.

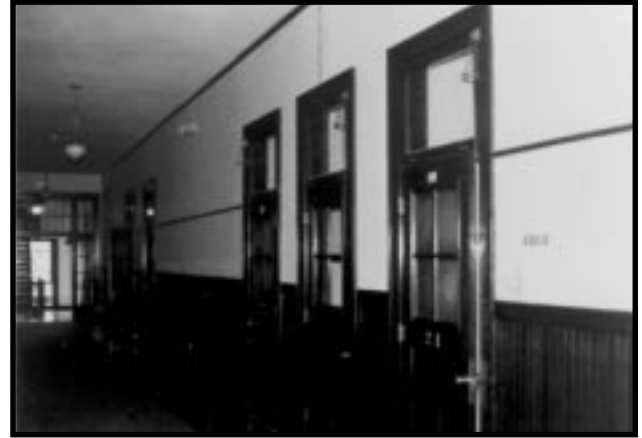
Second floor hallway after rehabilitation. Note retention of historic fabric.

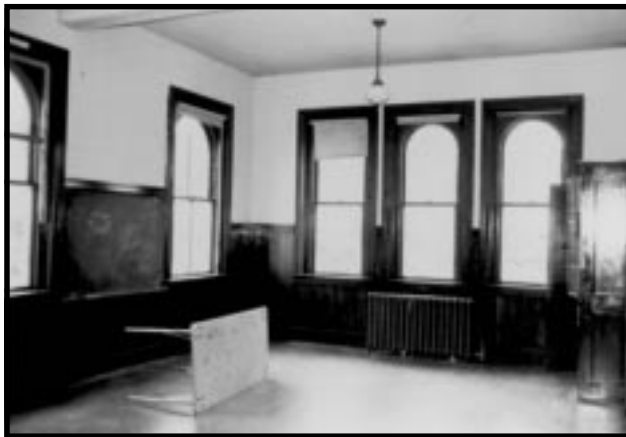
Second floor cloakroom, prior to rehabilitation.

Living rooms, dining rooms, and bedrooms were located against exterior walls and all trim was retained, as well as full-height ceilings (some of which are pressed metal). Kitchens, bathrooms and closets were located on interior walls or within former cloakrooms. Ceilings were dropped only in the utilitarian spaces to allow for mechanical and plumbing equipment. One laundry room per floor was inserted in the original ventilation stack. The existing staircases were retained intact.

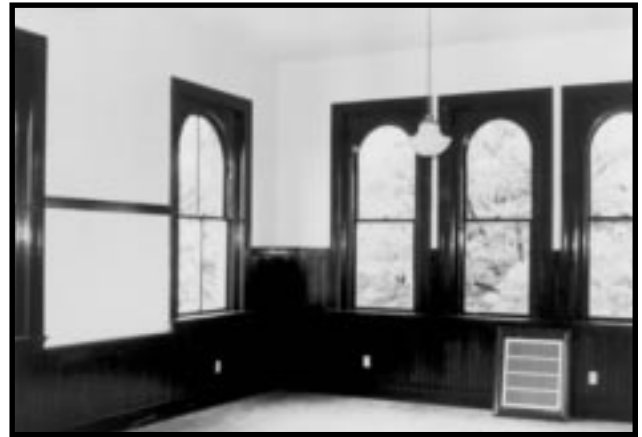
Second floor cloakroom, after rehabilitation. Register circulates heat and air conditioning.
