Subject: Adding Vehicular Entrances and Garage Doors to Historic Buildings

Applicable Standards: 2. Retention of Historic Character
9. Compatible New Additions/Alterations

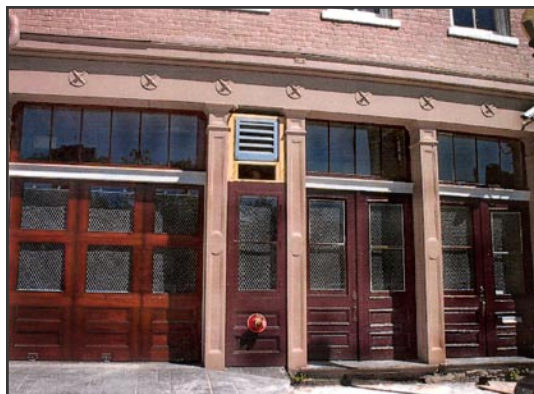
*Left and Upper Right:
The left bay was
enlarged to create a
vehicular opening
which is compatible
with the building's
historic character.*

The rehabilitation project proposed to return the upper floors to residential use. The first floor, which had little historic features or finishes remaining, was to be converted into an office in the front and parking in the rear. The rear of the building is a secondary elevation and using this portion for parking was determined to be compatible. Since no garage opening existed, the rear entrance had to be modified for vehicular access while retaining its historic character. One cast-iron pier was moved over several feet to create an opening wide enough for a car. Wood garage doors replicating the existing pedestrian doors were installed. Although moving the pier resulted in a slight change to the formerly symmetrical entrance, it did not negatively impact its historic character. The project met the Standards.

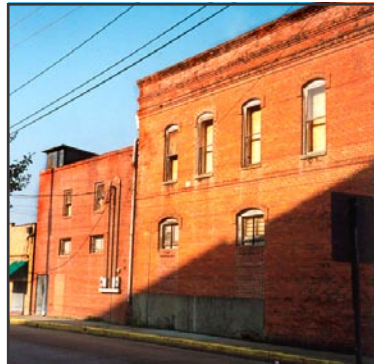
Left and Center: The front and side elevations of this building are shown here before rehabilitation.

Application 3 (*Compatible location/ Incompatible treatment*): This 1880s retail building, situated on a downtown corner, had been altered numerous times since its construction. The storefront had been remodeled and a rear addition had been constructed. The first floor of the building was to be rehabilitated for continued commercial use and the second floor for apartments. The rehabilitation included a compatible storefront design, and a proposal to cut a vehicular opening in the side wall of the non-historic addition so that the interior could be used for parking. Although the rear addition faces a street, it is a secondary elevation, and it was determined that adding a garage door in this location would not negatively impact the character of the historic building.

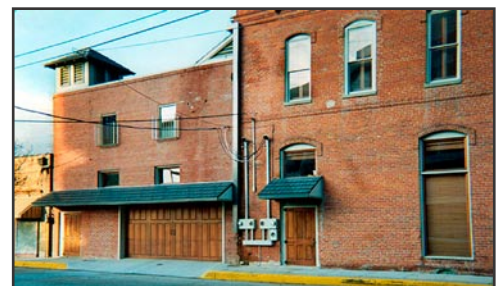
Right: The cumulative effect of the size, design and finish of the new garage door and the new pent roof overhang is a contemporary treatment that is incompatible with the historic character of the building.

Most treatments were completed as proposed. However, the new garage entrance differs from what had been proposed and approved. Two doors, varnished rather than painted as they would have been traditionally, are installed in a very large opening. A large pent-roof overhang which spans the entire length of the addition, extending from the garage to the back door, is also incompatible with the building's historic character. The garage entrance treatment did not meet the Standards and the project was denied certification.
