**ARCHEOLOGICAL INVESTIGATIONS AT THE
HARRIET DEAN HOUSE (11SG272),
LINCOLN HOME NATIONAL HISTORIC SITE,
SPRINGFIELD, ILLINOIS**

Midwest Archeological Center
Technical Report No. 93

U.S. Department of the Interior
National Park Service
Midwest Archeological Center
Lincoln, Nebraska

2005

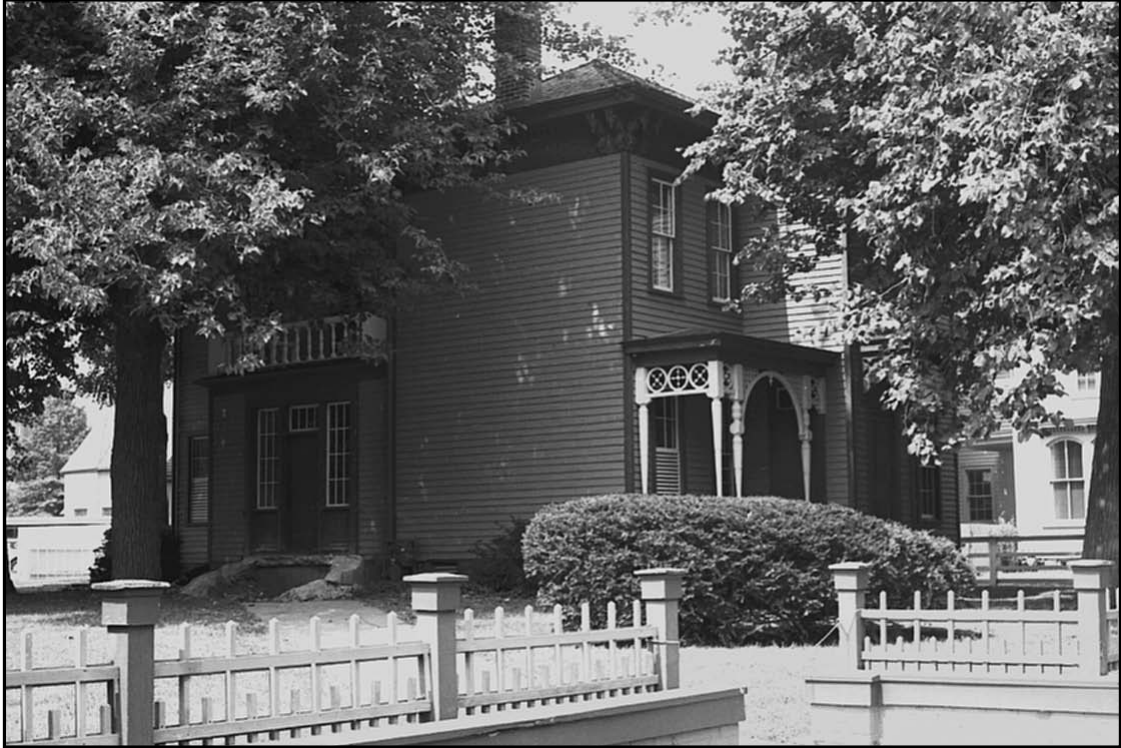
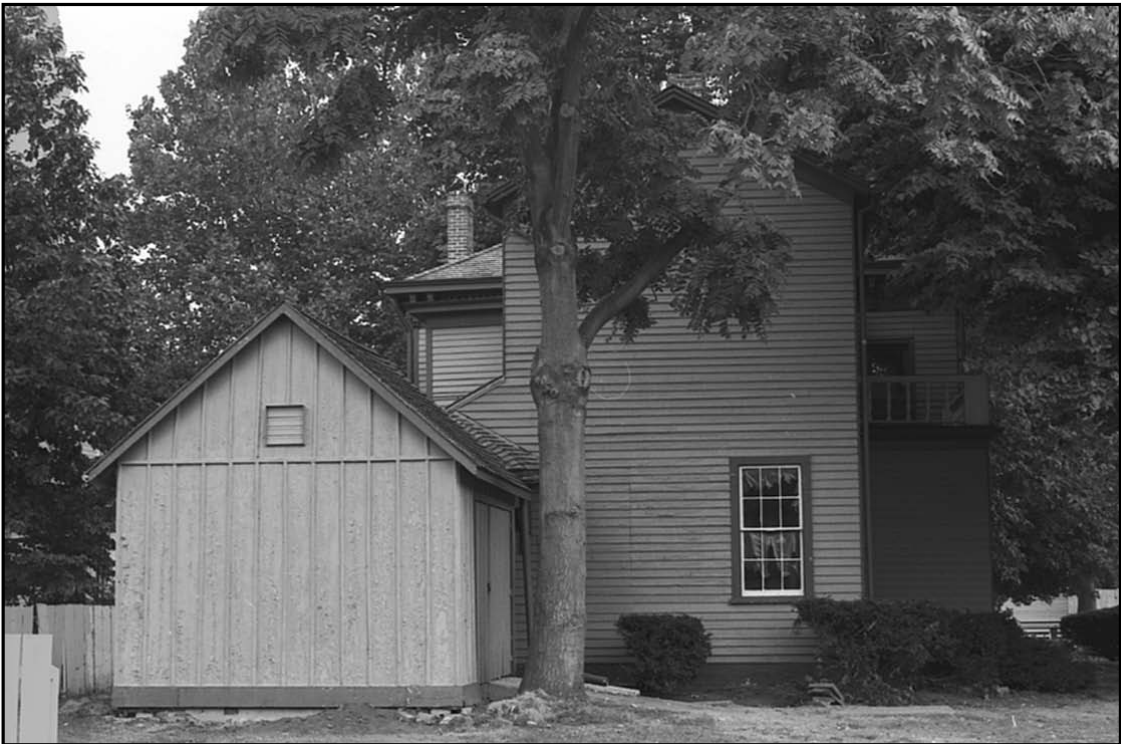
Figure 1. The Harriet Dean House as it appeared in 1991: viewed from the southeast (top) and viewed from the west (bottom).

The Harriet Dean House (Figure 1) is one of several 19th-century residential structures within the Springfield, Illinois, neighborhood that the National Park Service now administers as Lincoln Home National Historic Site. Soon after transfer of Abraham Lincoln's former residence from the State of Illinois to the Federal government, which occurred in 1972, the National Park Service began acquiring additional properties in the four-block area that surrounds the intersection of Eighth and Jackson streets where the Lincoln Home stands. Their purpose was to protect the Lincoln Home from encroachment of incompatible development and, ultimately, to return the surrounding neighborhood to a reasonable facsimile of its historic character by restoring the extant mid-19th-century structures to a semblance of their former appearance and reconstructing others. Deeded to the United States of America in 1978, the Dean House is located at 421 South 8th Street, across the street and a short distance northwest of the Lincoln Home, which stands on the northeast corner lot at the intersection of Eighth and Jackson (Figure 2). Immediately prior to NPS acquisition the structure served as a private museum and gift shop with two apartments on the second floor. It is designated Historic Structure 13 (HS-13) in Lincoln Home's List of Classified Structures.

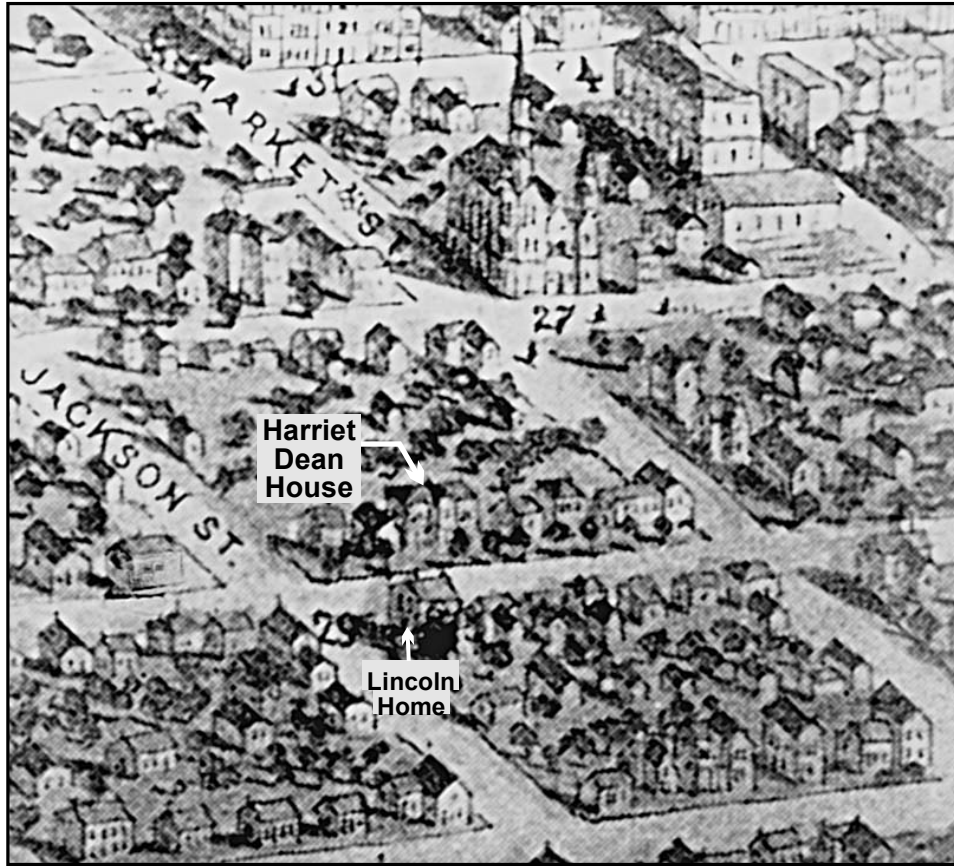
Figure 5. Annotated detail from *Springfield, Illinois; Drawn from Nature*, by A. Ruger, 1867. Bird's-eye panorama of a portion of Springfield showing the location of the Harriet Dean House.

Three "bird's-eye-view" or panoramic depictions of Springfield (Beck and Pauli 1870; Koch 1873; Ruger 1867) give a stylized perspective on this residential district over the next ten years (Figures 5-7). The 1867 drawing (Figure 5) is of fairly poor quality, but does show a two-story house on the Dean property, as well as an outbuilding on the alley that could be the same one depicted on the earlier plats. Beck and Pauli's (1870) depiction of three years later provides a much clearer sketch of the dwelling as it looked in 1870, but the alley area is obscured by the representation of several trees (Figure 6). The last in this series of panoramas (Koch 1873) gives by far the best view of the Dean House in essentially its modern form (Figure 7). In fact, the structure in that ca. 1873 depiction looks much as it did when the Dean House restoration project began more than 100 years later.

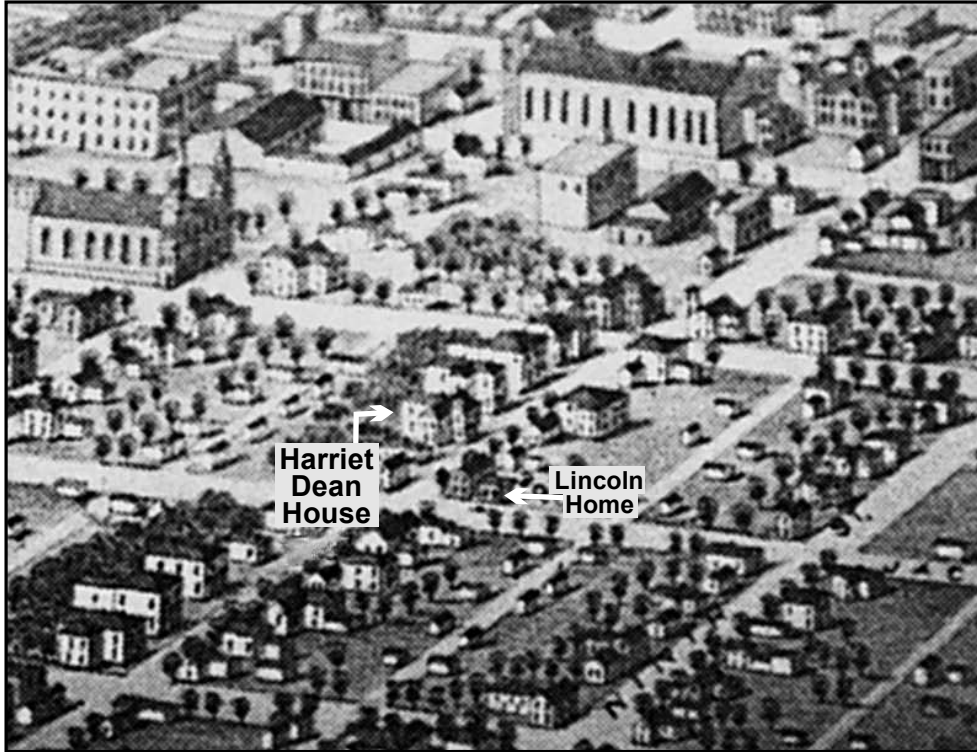
Figure 6. Annotated detail from *Map of Springfield, 1870*. Bird's-eye panorama of a portion of Springfield showing the location of the Harriet Dean House.

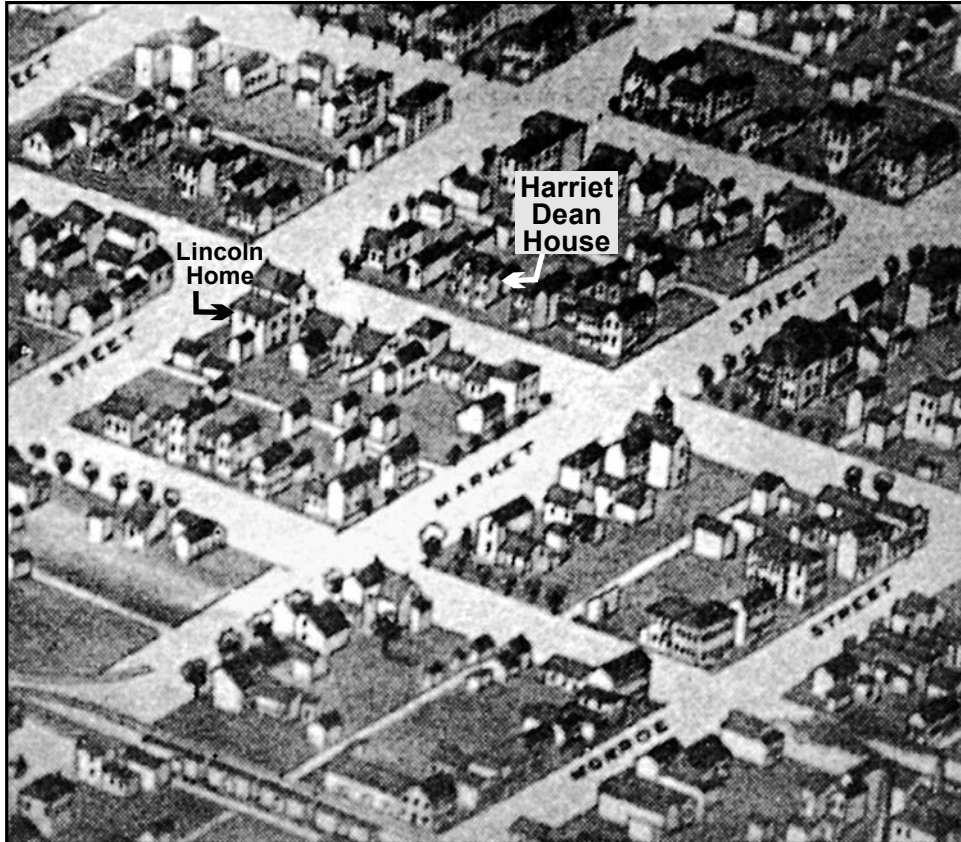
Figure 7. Annotated detail from *Bird's Eye View of Springfield, Illinois*, circa 1873, showing the location of the Harriet Dean House.

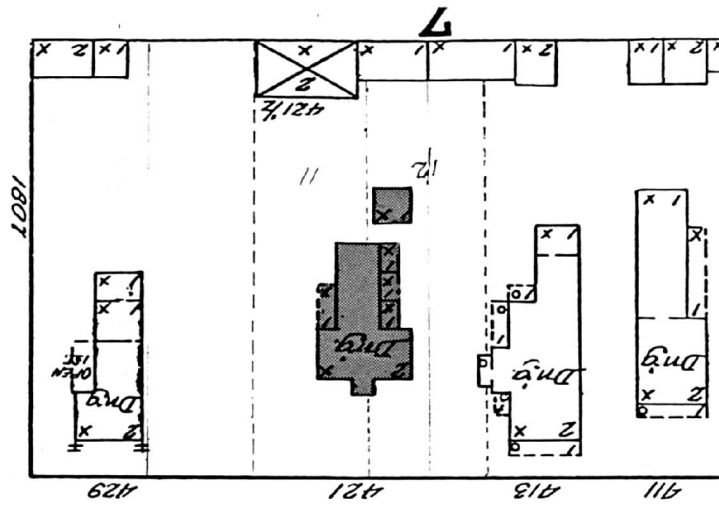
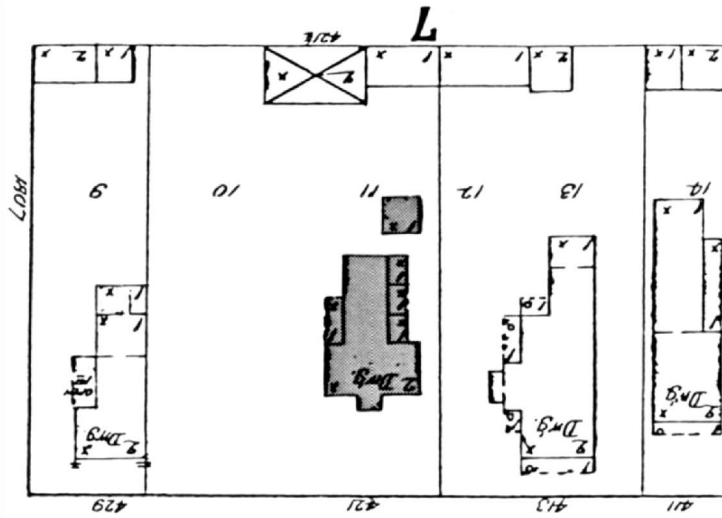
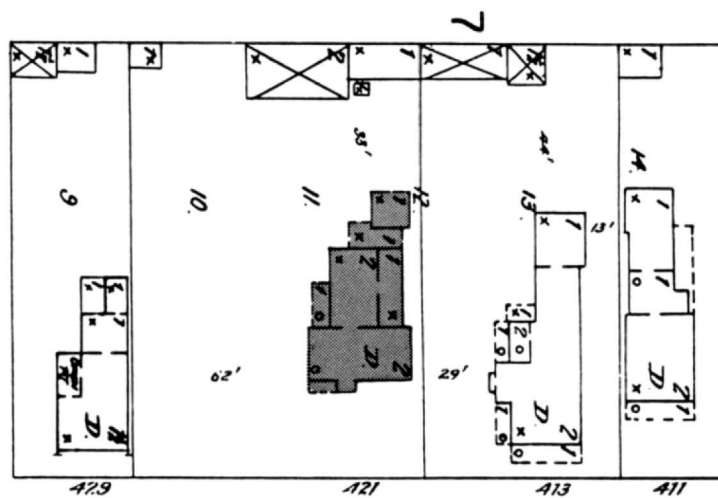
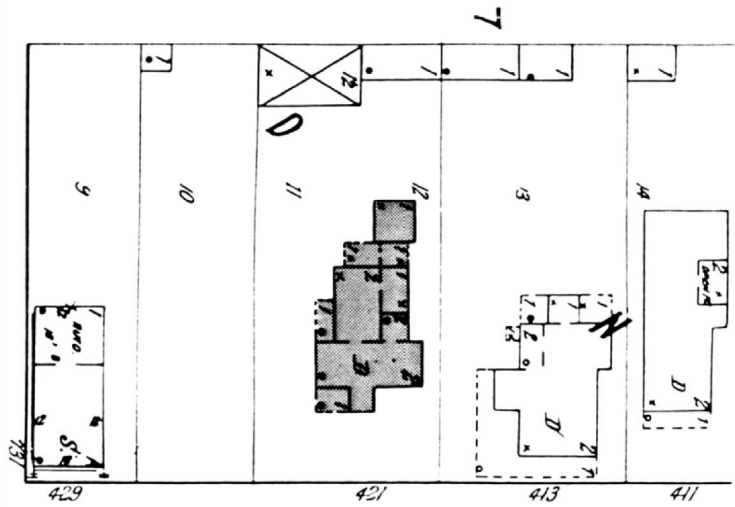
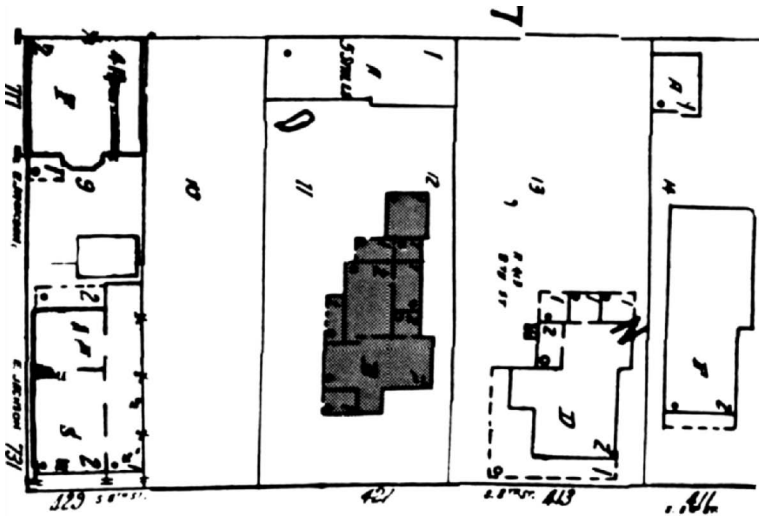
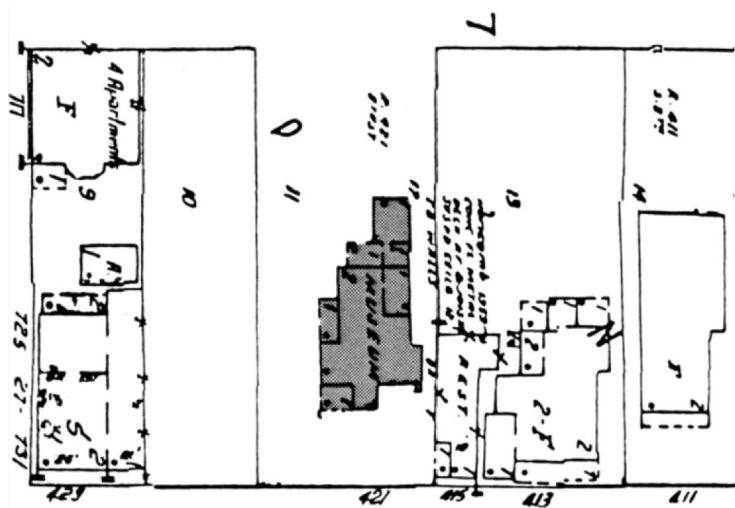
Figure 8. Six annotated details from Sanborn fire insurance maps (1884–1952), illustrating changes in the configuration of the Harriet Dean House and surrounding property (continued on following page).

The 1884 Sanborn map provides the first indication of several outbuildings known to have been associated with the Dean House (Figure 8). The most substantial of those structures is a two-story stable, as indicated by the Sanborn convention of a large “X” connecting its corners, at the rear of the property. Interestingly, it is also annotated with a street number (421 ½), making its association with the Dean House (No. 421) clear and suggesting perhaps that it was also used as living quarters. There is also what would appear to be a one-story shed immediately north of the stable or barn, and a smaller structure lies only a few feet from the rear of the house in the back yard. Given its size (approximately 14 ft square) and its close proximity to the residence, it is reasonable to speculate that the small outbuilding may have been used as a laundry shed, a summer kitchen, or a combination of both those specialized functions.

Note also that the original platted property lines between lots 10-11 and 11-12 are dashed on the 1884 Sanborn, consistent with the fact that lots 10 and 11, and the south half of 12, had been consolidated under a single owner by that time. A solid line separates Lot 12 into two parcels, indicating different ownership for the northern segment of Lot 12 and combination of it with Lot 13. Research into the Chain of Title for the Dean House found that George Hoffer camp purchased lots 11 and 12 (S 20 ft), on which stood the dwelling, on August 15, 1877, and added Lot 10 on March 22, 1880 (FWA 1990:2.10). The 1890 Sanborn map shows no obvious changes from the 1884 map with respect to the Dean property, but the dashed lines between lots 10-11 and 11-12 are no longer shown (Figure 8).

This is consistent with plan views of the Dean House appearing on Sanborn insurance maps published in 1896, 1917, 1941, and 1952 (Figure 8). The porch does not appear south of the Dean House vestibule on the 1884 and 1890 Sanborn maps of Springfield. Nevertheless, there does seem to be a small porch immediately left of the vestibule in a bird's-eye-view depiction of the Dean House in 1873 (Figure 7). It is not known why the small section of decking should be absent from the 1884 and 1890 Sanborn maps.

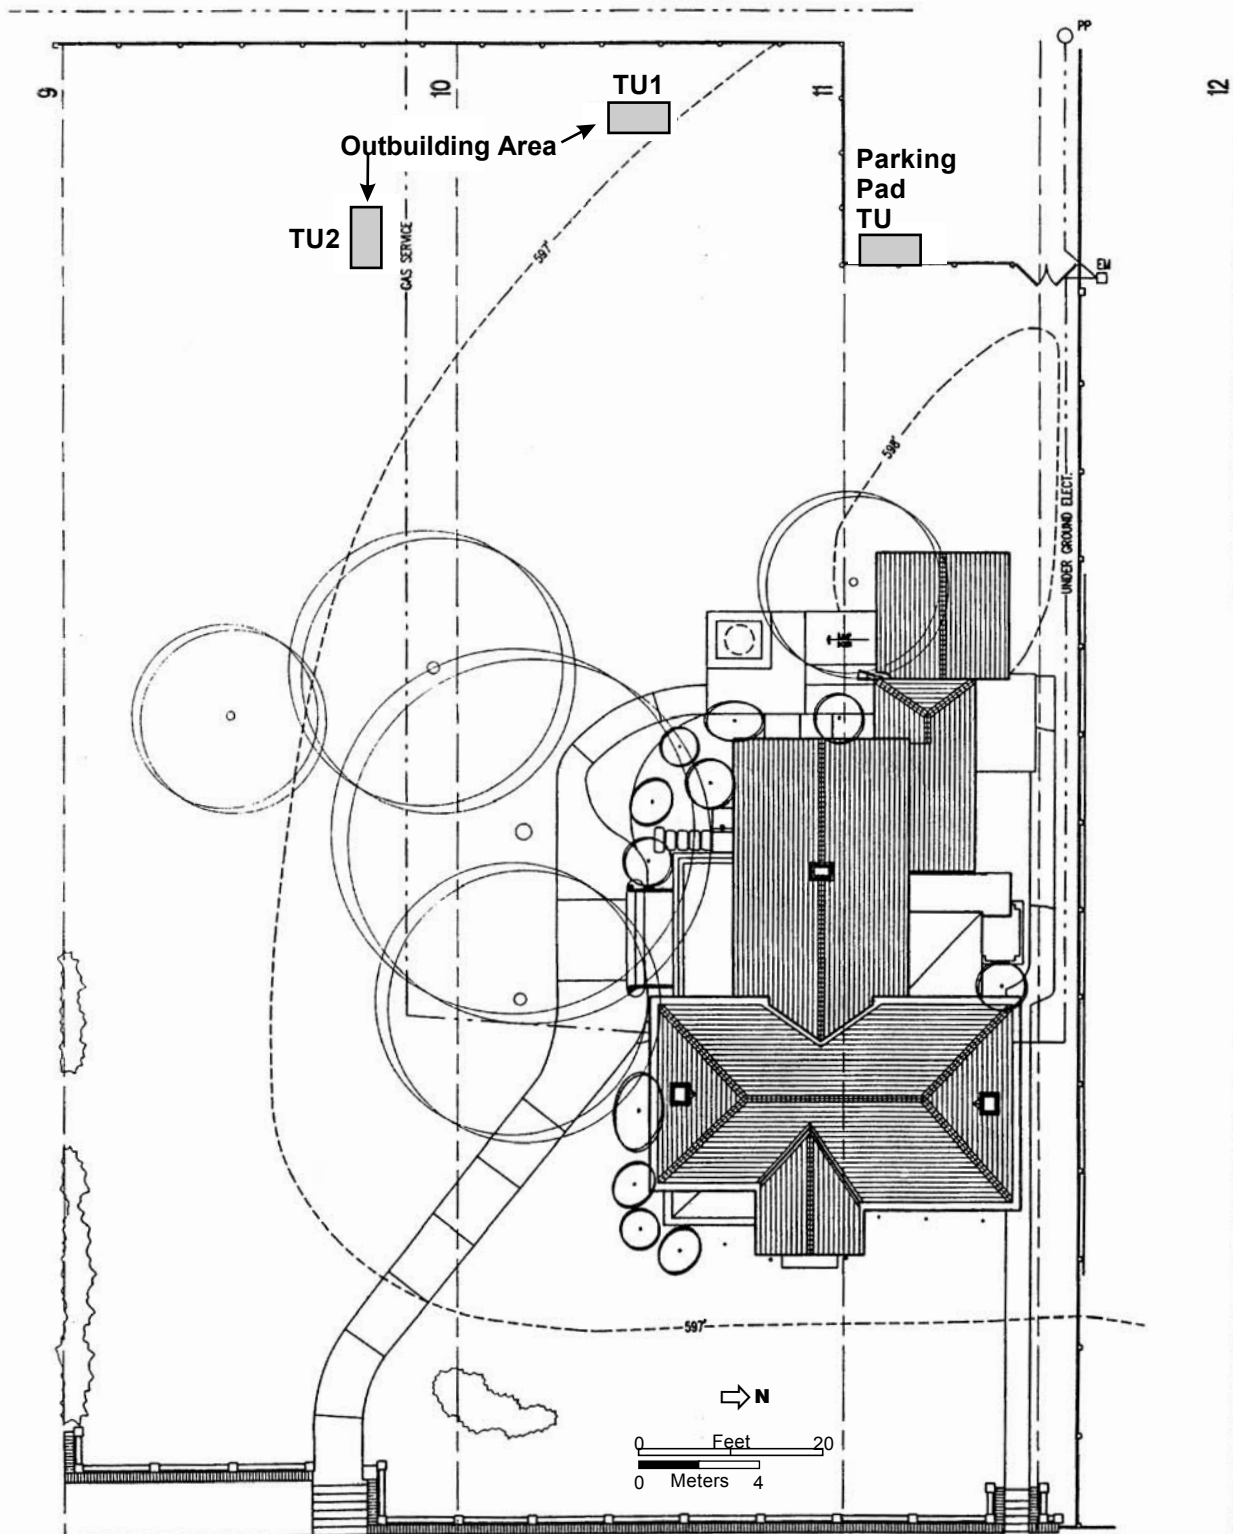
Figure 9. Harriet Dean House and lot showing the location of excavation units in the backyard.

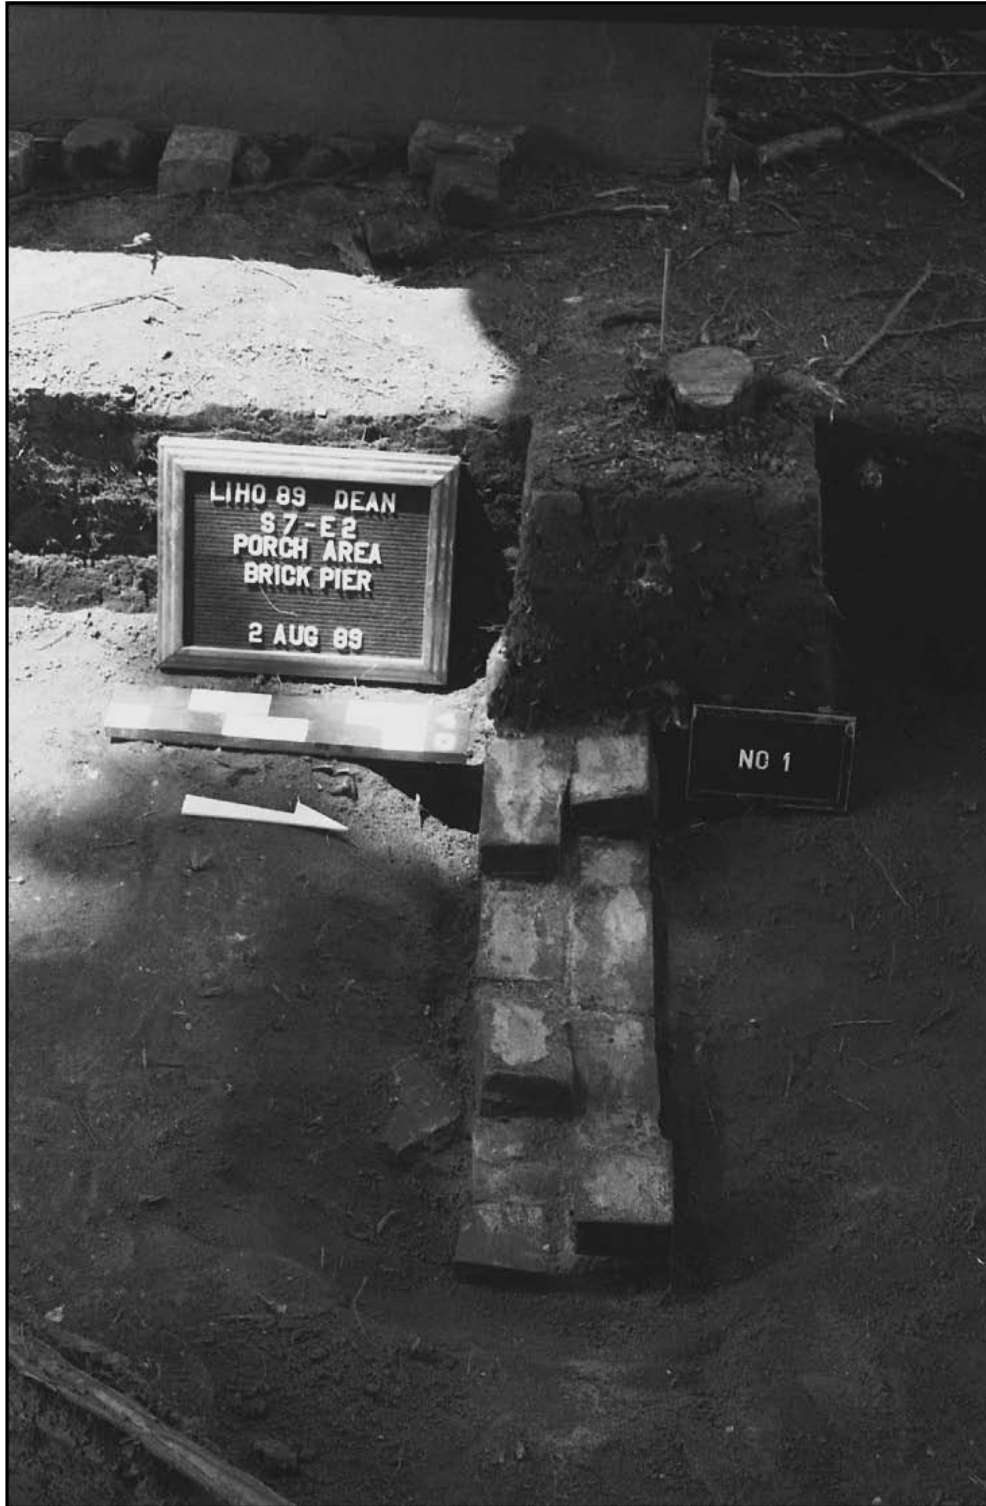
Figure 14. Front porch area and the north brick alignment, looking west toward the entry of the Harriet Dean House.

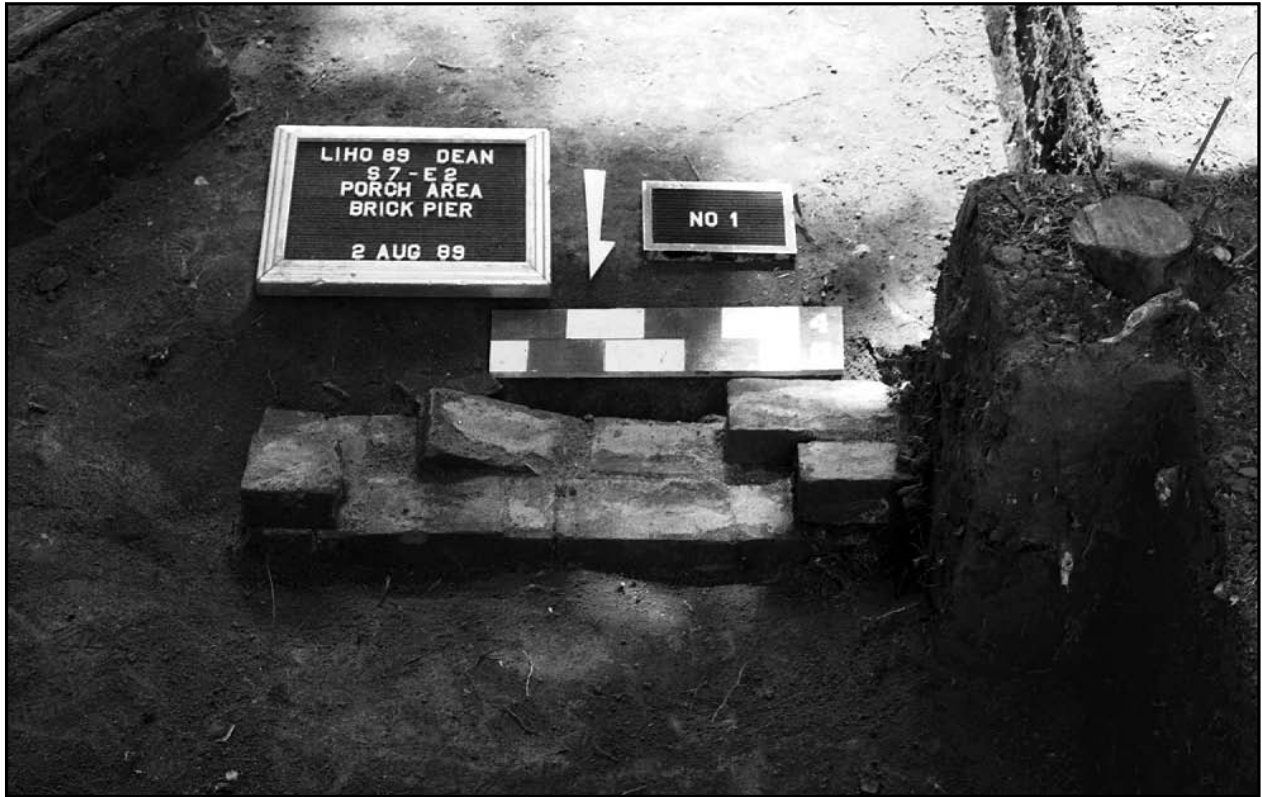
Figure 15. Front porch area and profile of the north brick alignment.

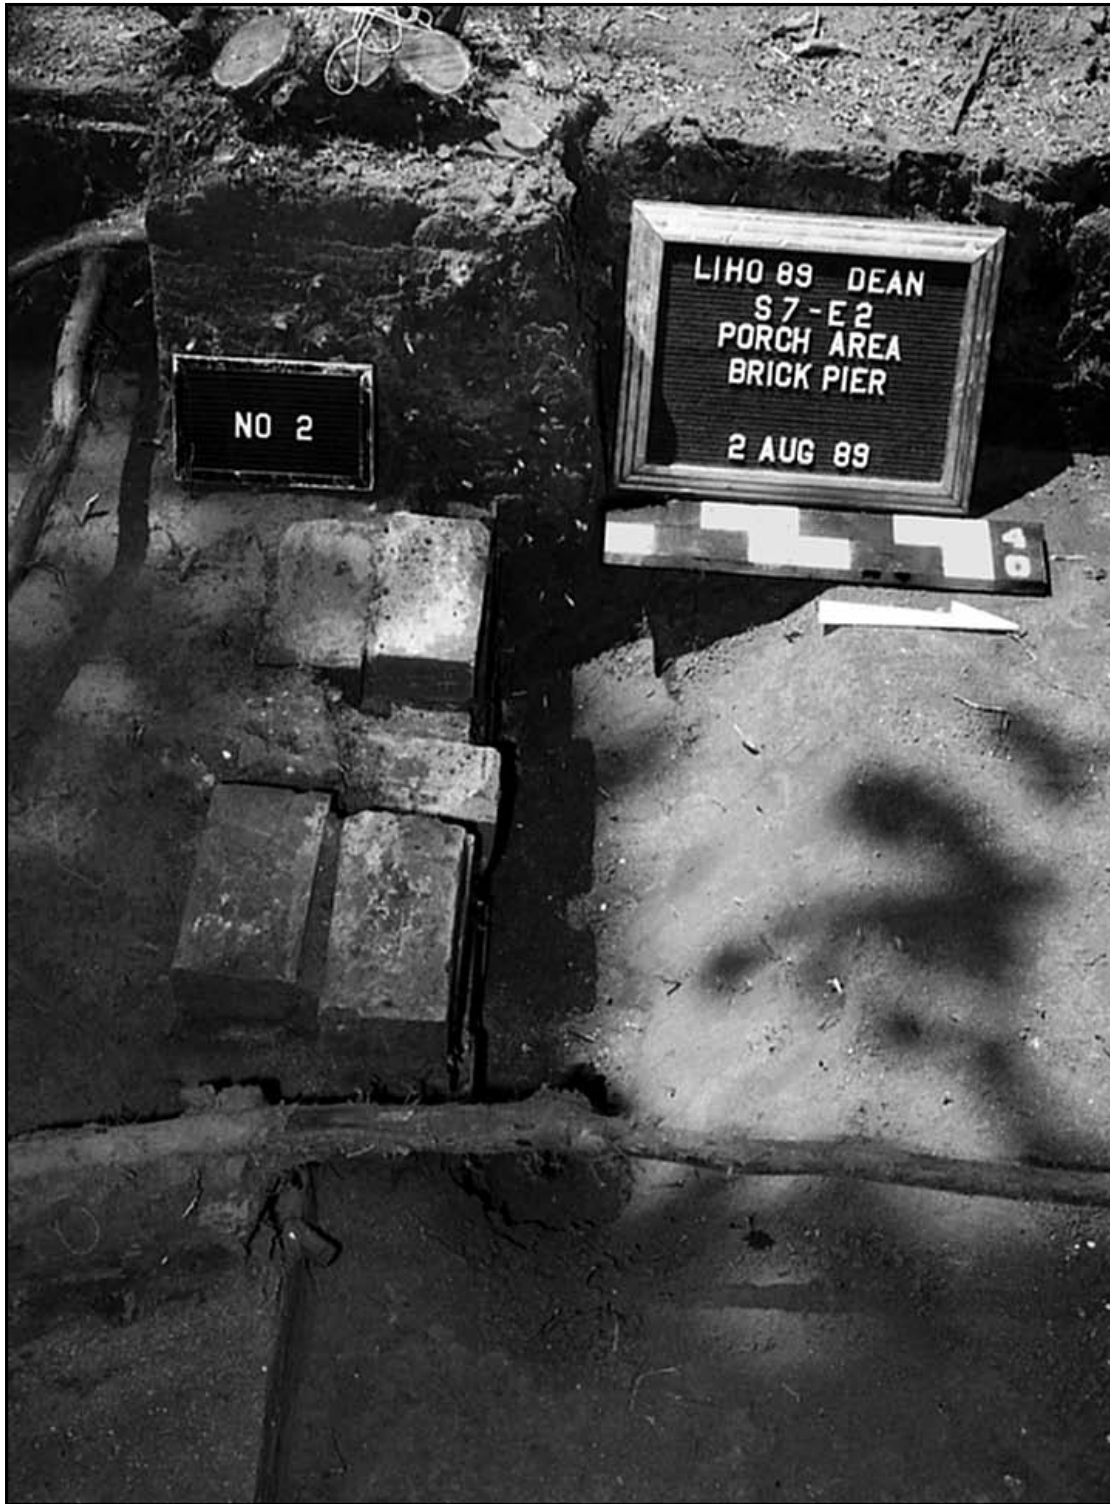
Figure 16. Front porch area and the south brick alignment, looking west toward the entry of the Harriet Dean House.

As many as six courses of brick were still present in the south (No. 2) alignment when that feature was exposed in 1989 (Figures 16 and 17). The uppermost course clearly was not the true top of the structure, however, since the superior surface of those bricks also exhibited residual mortar, indicating that at least one more course above that had been removed. It is also worth noting that the south element was covered by approximately 30 cm (12 in) of soil, and the north element, which had fewer surviving courses, averaged about 60 cm (24 in) below grade in 1989. Unfortunately, it could not be determined by examining the soil deposits if the grade present at the front of the Dean House in 1989 conformed to the grade when those structural elements were built. Excavations around many other houses in the neighborhood have consistently shown changes in grade dating from the time of original construction. This is generally attributed to the spreading of earth removed from the basement cavities across the ground surface, which eliminated the need to haul that material away, or from subsequent modifications in more recent times. Brick walkways associated with such neighborhood structures as the Julia Sprigg House and Henson Robinson House, for example, have been discovered at varying depths below their adjacent ground surfaces today.

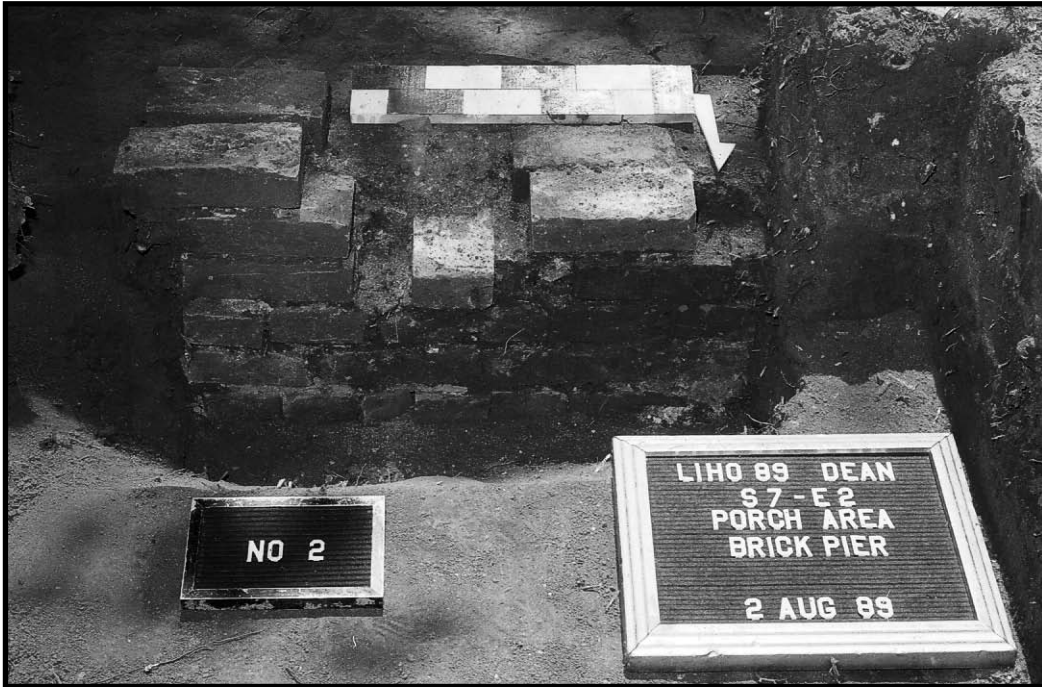
Figure 17. Front porch area and profile of south brick alignment.

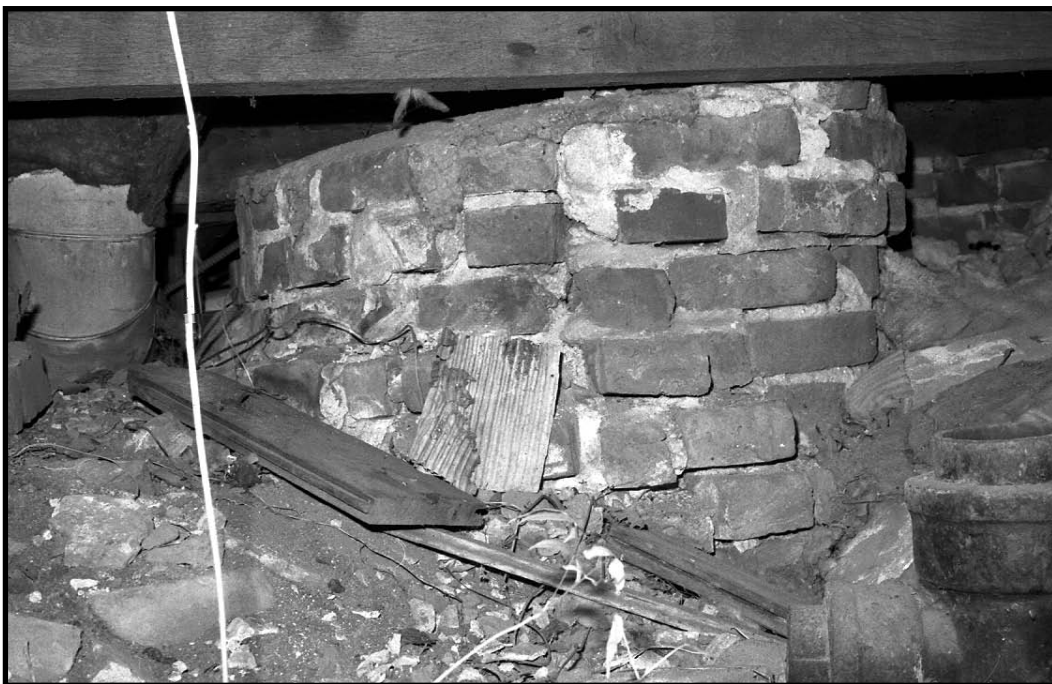
Figure 18. Cistern in Harriet Dean House crawl space.

During earlier field investigations at the Dean House, park staff had directed our attention to the presence of what was believed to be a large well or cistern beneath flooring in the northwest quarter of the building (Figure 18). That feature had apparently been rendered useless when the house was expanded over it. Access to the feature was not possible, however, until floorboards were pulled up as part of demolition activities inside the house. A concrete plug had been poured into the opening, which was removed by dismantling the brick collar after it was recorded. It soon became clear that the feature was an abandoned cistern, probably once associated with a former porch now enclosed as a room. The cistern cavity was empty, except for some silt in the bottom and a discarded light bulb of relatively modern manufacture. The bell-shaped reservoir measured approximately 10 ft (ca. 3 m) in diameter with the floor about 10 ft below the oculus.
