Effect of drilled holes on the bending strength of large dimension Douglas-fir lumber

R.H. Falk*
D. DeVisser*
G.R. Plume
K.J. Fridley*

Forest Prod. J. 53(5):55-60.

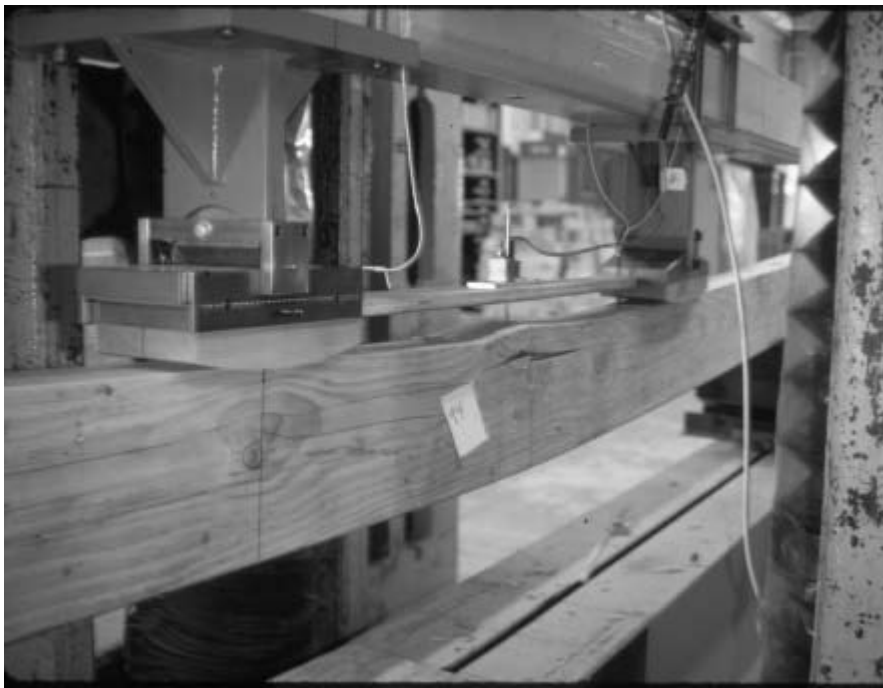
Figure 7. — Test configuration and hole layout for group I beams.

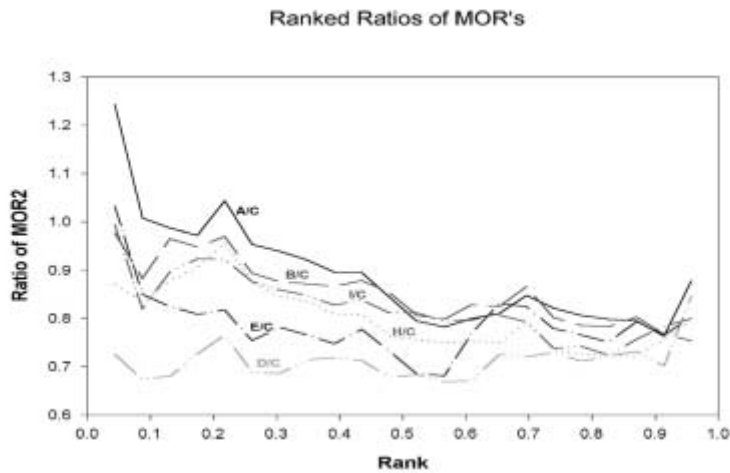
Figure 10. — Ranked ratios of MOR values.

The MOR values of each group were ranked to determine how the whole distribution compared to the control group (Fig. 10). To generate Figure 10, the MOR values of each group were ranked highest to lowest. The MOR of each group (ranked 1 to 22) was divided by the group C MOR values (ranked 1 to 22). As shown in Figure 10, all ratios of ranked MOR values that were less than 1.00 indicate lumber with strengths lower than that of the control. Overall, this figure indicates that with the exception of a few specimens at the lower end of the distributions, all specimens with holes were weaker than the control group of the same rank (in the worst case, strength was about 70% that of the control).
