EFFECT OF DAMAGE ON THE GRADE YIELD OF RECYCLED LUMBER

ROBERT H. FALK[†]
DON DEVISSER[†]
STANDEN COOK
DALE STANSBURY

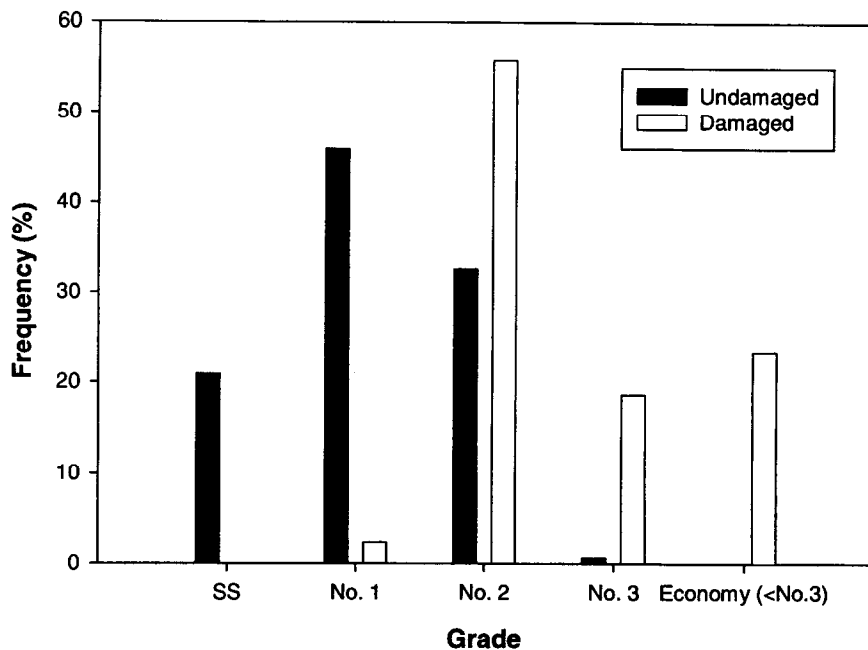
Figure 3. – Grade reduction as a result of damage, 2 by 8's, all forms of damage.

Figures 1 through **4** show the reduction in grade as a result of damage in 2 by 4's, 2 by 6's, 2 by 8's, and 2 by 10's, respectively. For all forms of damage (Types I, II, III), the figures indicate 1) the grades of lumber (as graded, including damage) and 2) the grades of lumber if no damage existed (undamaged). As expected, for all sizes of lumber, when damage exists, the grade was reduced.

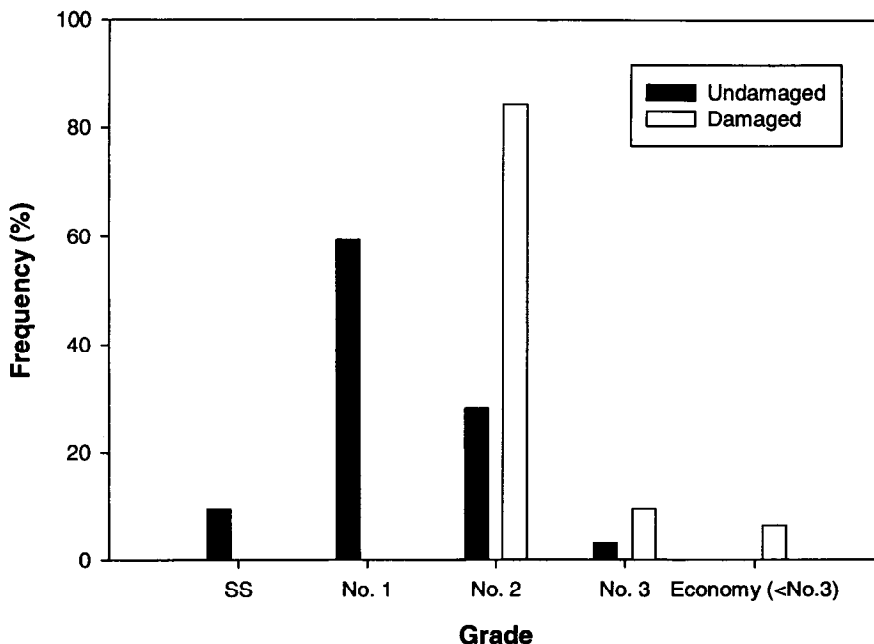
Figure 4. – Grade reduction as a result of damage, 2 by 10's, all forms of damage.

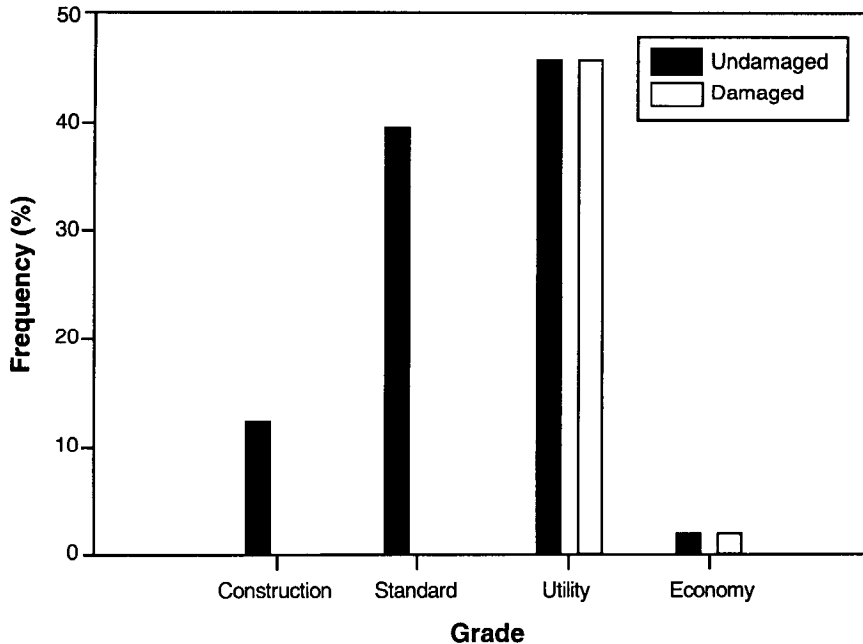
Figure 5. – Grade reduction as a result of damage, 2 by 4's, deconstruction damage only.

Figures 5 through **8** indicate the effect of only deconstruction damage (Type III) on the grades of lumber evaluated.

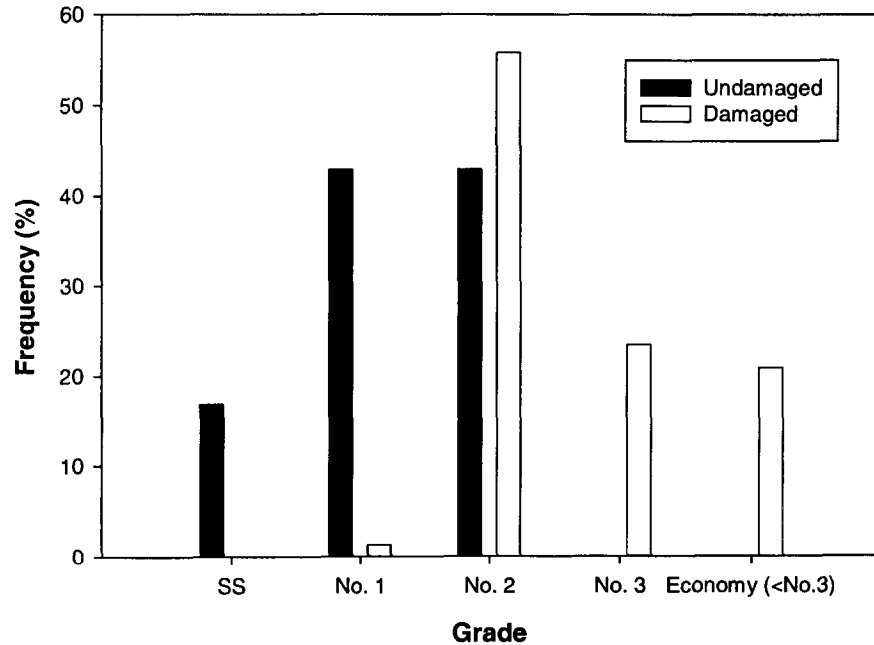
Figure 7. – Grade reduction as a result of damage, 2 by 8's, deconstruction damage only.

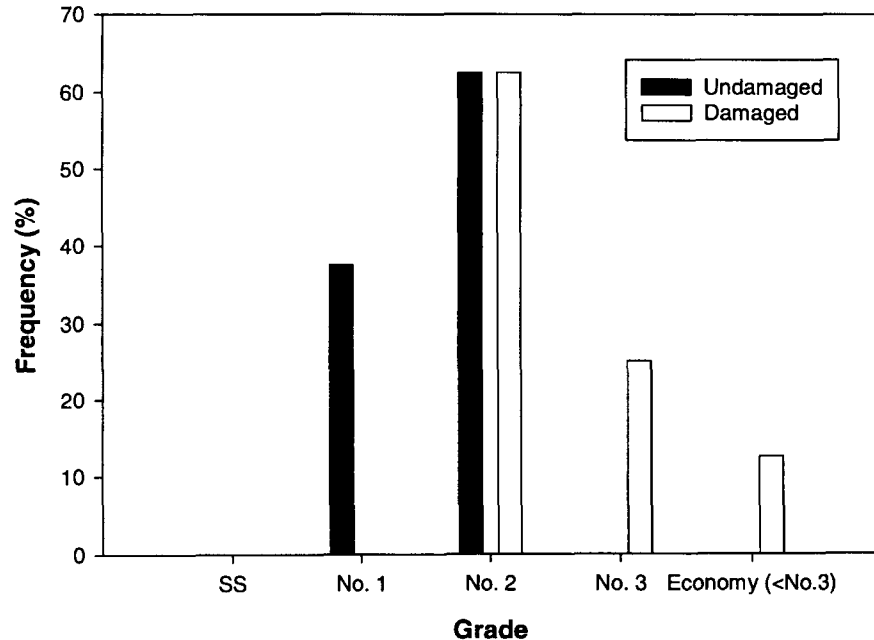
Figure 8. – Grade reduction as a result of damage, 2 by 10's, deconstruction damage only.
