## Wind House II – Deterioration Effect on Structure Resistance to High Winds

Wind House II, to be constructed on Park Service property near the Florida panhandle coast, will be the site of several studies to evaluate structure resistance to high-wind events. Deterioration of building components can negatively impact the capacity of a structure to withstand high winds. Therefore, the studies to be conducted by Mississippi State University (MSU) personnel will focus on areas of the structure where deterioration problems are known to exist, such as windows, pilings, and decks.

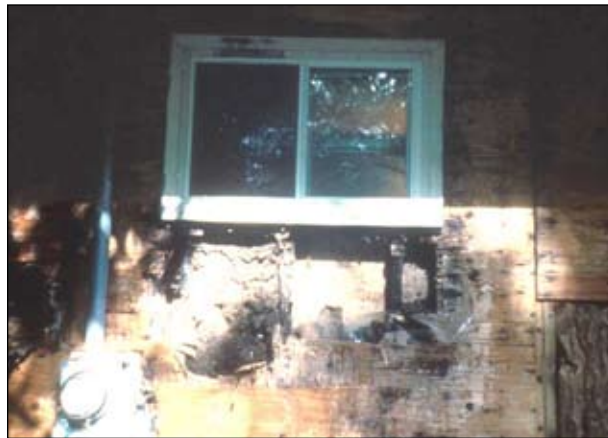
**Alternative methods of installation will be investigated to help avoid improper installation as seen above. Moisture intrusion can and will lead to decay in wood associated with windows.**

Moisture intrusion into walls that leads to decay is frequently associated with windows. Alternative methods of window installation will be investigated. Readings from moisture probes in the wall voids under windows will be one indication of the effectiveness of an installation procedure.

The infiltration of moisture into walls around windows will be measured by moisture probes (and perhaps CO<sub>2</sub> detectors) placed in wall voids under windows as well as visual inspection for signs of decay. Window installation procedures will focus on preventing wetting of framing near window openings. Techniques for minimizing the infiltration of salt water into piling will be evaluated by measuring the amount of pulp (loosening of fibers) on piling surfaces. Deck stabilization will be measured by the relative checking and splitting

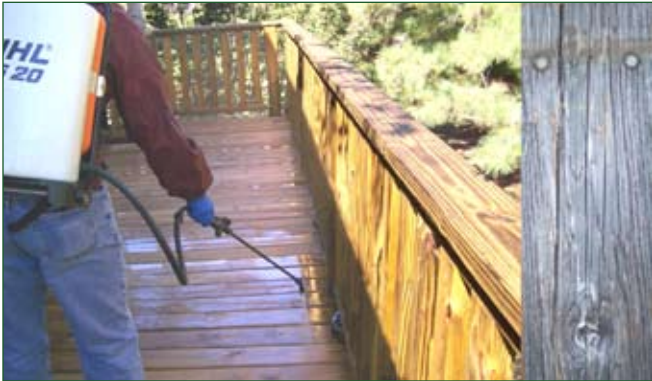
**Decking exposed to high intensity UV light and successive wetting and drying cycles check and split excessively leading to fastener corrosion (right) causing untimely replacement of decking surfaces. Evaluation of topically-applied deck treatments to slow this phenomenon will be evaluated.**

Deck boards exposed to high intensity ultraviolet (UV) light and successive wetting and drying cycles check and split excessively, and fasteners used in these deck boards corrode. In some cases, this has led to decks literally falling off the structure. Topically-applied deck treatments to stop this phenomenon will be evaluated.
