Research
Paper
FPL-RP-622

Durability of Hardboard Lap Siding

Determination of Performance Criteria

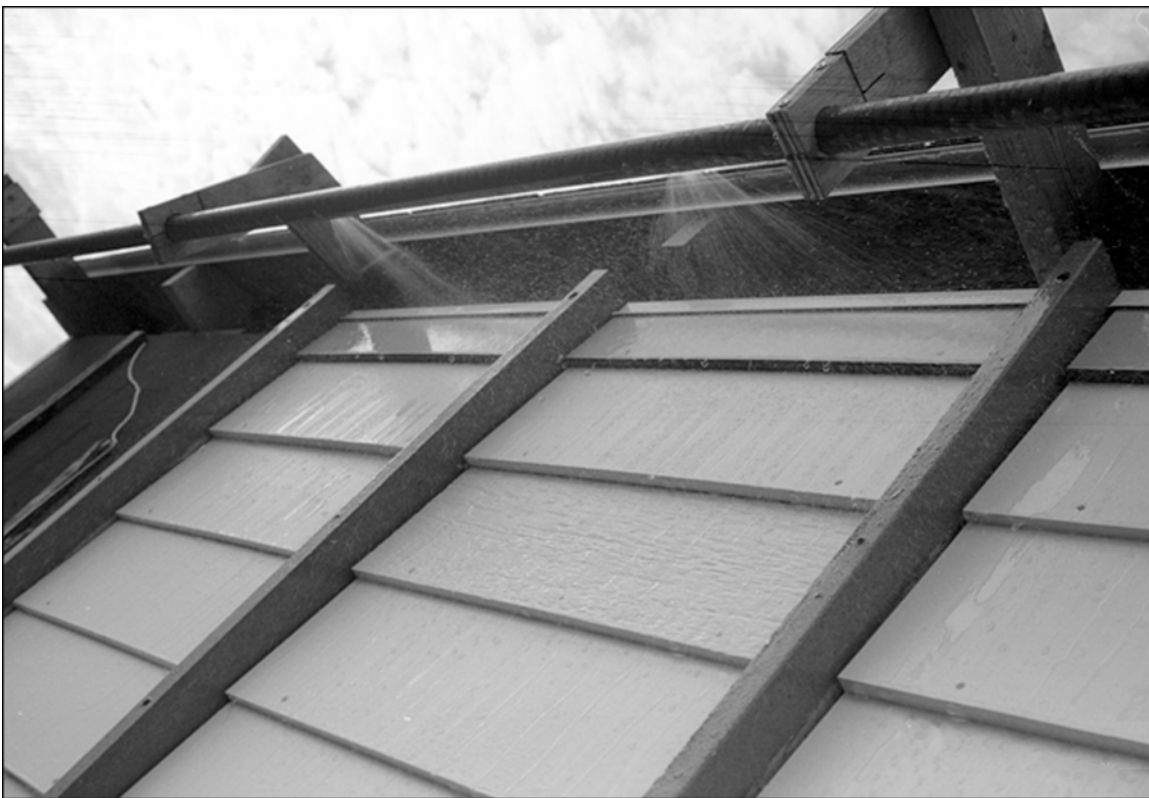
Figure 6—Spraying of the fences.

Each column of siding on the two test fences was individually sprayed for 1 h each day from May through late November. The spray was turned off during the winter. Spraying started mid-August 1997. The water spray hit above the top board and water ran down each column of siding. Column separators prevented water movement between columns. The water was drawn from a well on the test site. To verify that each column received comparable amounts of spray water, we measured the water spray rate of each spray nozzle in July 1997 and again in June 1998. We found that although the rate varied with water pressure, the average flow rate was about 0.23 gal/min (15 mL/s), with maximum variations between nozzles of about 10%. Each nozzle delivered a fan-shaped spray of water, with the long dimension of the fan oriented horizontally (Fig. 6). The spray was directed at a siding strip above the top board in each column. The spray fan could be deflected by wind but did not reach board ends, even under moderately windy conditions.

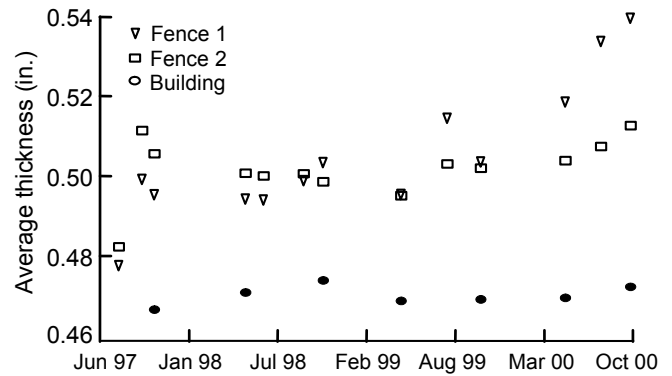
Figure 10—Average siding thickness as measured in place on the test fences and the building.

Figure 10 shows the average thickness of all boards as measured in-place on the two test fences and the test

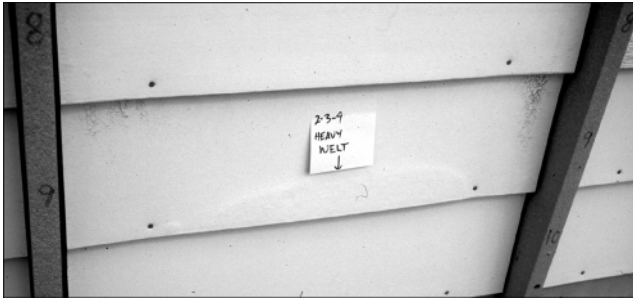
Figure 11—Example of edge welt on fence 2 (drip edges intact). Specimen was rated on August 25, 1999, as having a welt severity of 9.0 and a welt area of 21 in² (EWI = 21).

Welt is a term sometimes used in the hardboard siding industry to describe localized swelling along panel edges (Baldwin 1988). The swollen area projects beyond the normal panel surface plane, and the surface within the swollen area is irregular (that is, not flat) (Fig. 11). Some degree of fiber raising can be expected in welted areas.

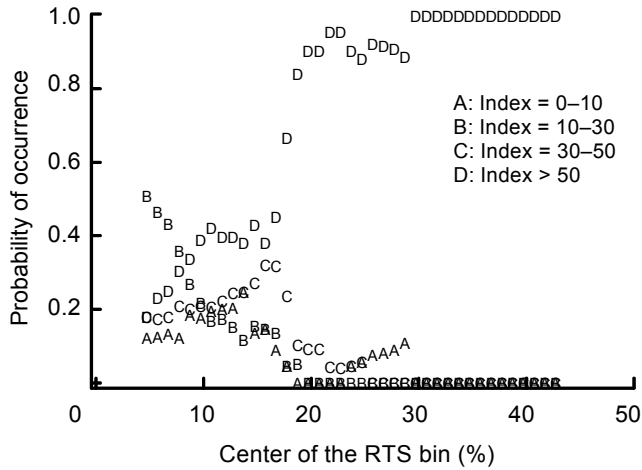
Figure 16—Edge welt index as a function of residual thickness swell (RTS), fence 1, all classes except OSB (class 9). Lower index means less welt.

Figures 16 to 18 show the probability of occurrence of various levels of edge welt as a function of RTS on fence 1 at final inspection. Figure 16 depicts data for all hardboard classes on fence 1. The frequency of an edge welt index of over 50 (category D) increases steadily between the 5% and 11% RTS bins (2% to 14% RTS), and steeply increases in the 18% and 19% RTS bins (15% to 22% RTS). The frequency of category C index value ($30 < I < 50$) steadily increases from the 13% to 18% RTS bins, where category D begins to predominate. The 30% RTS bin and the bins beyond ($RTS > 27\%$) contain only boards with a welt index over 50.

Severe wetting (category D) was less common on fence 2 than on fence 1 (Figs. 19 to 21 compared with Figs. 16 to 18); the painted drip edges on fence 2 evidently retarded the development of severe welts. Figures 19 to 21 more clearly show a decreasing frequency of boards with low welt index values as RTS increases. Figure 19 (all boards on fence 2) shows that the frequency of boards with the lowest edge welt index (category A, $I = 0$ to 10) steadily drops with RTS between the 5% and 14% RTS bins and then drops more rapidly in the 15% and 16% RTS bins. Higher edge welt index categories (C and D) begin to increase markedly at the 16% RTS bin. No strong correlation seems to exist at RTS levels beyond 25% except that the number of boards with an edge welt index between 30 and 50 (category C) gradually increases with RTS. When non-commercial boards are excluded from the analysis (Fig. 20), the same gradual drop in number of boards with the lowest index (A) occurs at lower RTS ratings, with a sharp drop at the 15% and 16% RTS bins. More severe edge welt categories (C and D) begin to increase at RTS over 17% (14% RTS bin).

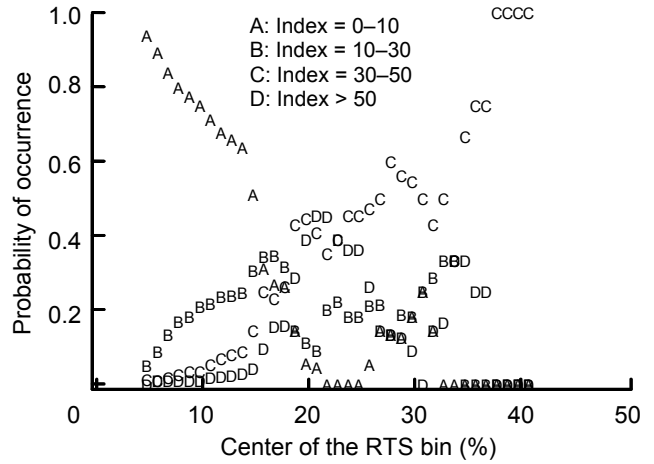
Figure 19—Edge welt index as a function of residual thickness swell (RTS), fence 2, all classes except OSB (class 9).

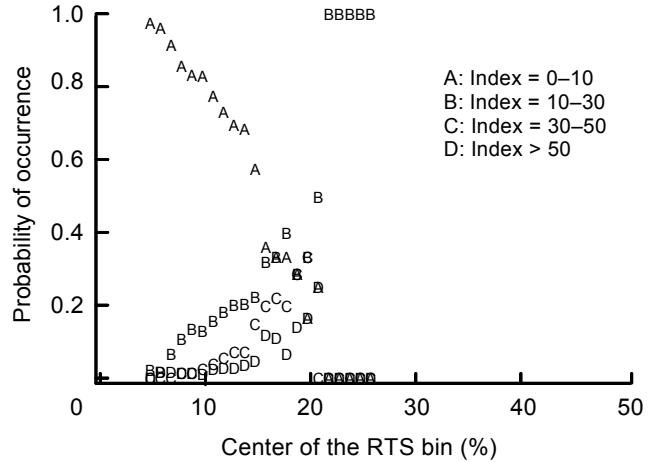
Figure 20. Edge welt index as a function of residual thickness swell (RTS), fence 2, commercial classes only, except OSB (class 9).

As on fence 1, the non-commercial boards on fence 2 show greater susceptibility to edge welt than do commercial boards at a given RTS level, even in the lower RTS bins (compare Figs. 20 and 21). The frequency of boards with little or no edge welt (category A) declines rapidly between the 14% and 18% RTS bins (11% to 21% RTS).

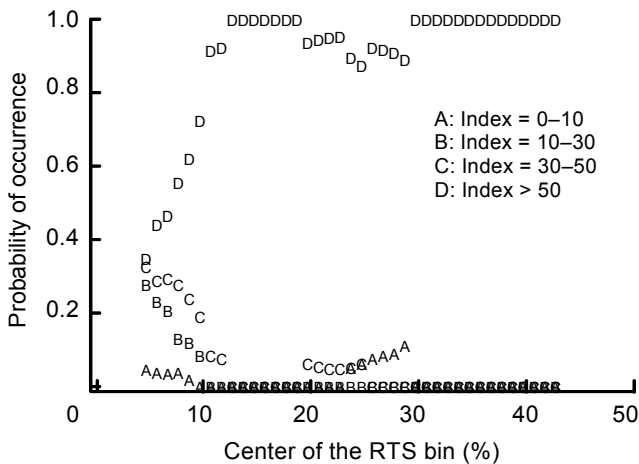
Figure 18—Edge welt index as a function of residual thickness swell (RTS), fence 1, non-commercial classes.

When consideration is confined to commercial board classes on fence 1 (Fig. 17), the data again show a steady increase in more severe wetting (categories C and D) between the 8% and 18% RTS bins (5% to 21% RTS) and a steep increase in the most severe index level (category D) in the 19% and 20% RTS bins (16% to 23% RTS). Above 17% RTS (20% RTS bin) there are no boards with a welt index below 30. A strong relationship between RTS and edge welt also exists for the non-commercial board classes on fence 1 (Fig. 18). With these boards, severe wetting ($I > 50$, category D) steeply increases at much lower RTS ratings, specifically between the 5% and 13% RTS bins (2% to 16% RTS). With a few exceptions, non-commercial boards on fence 1 with RTS ratings over 11% (14% RTS bin and higher) had severe wetting.

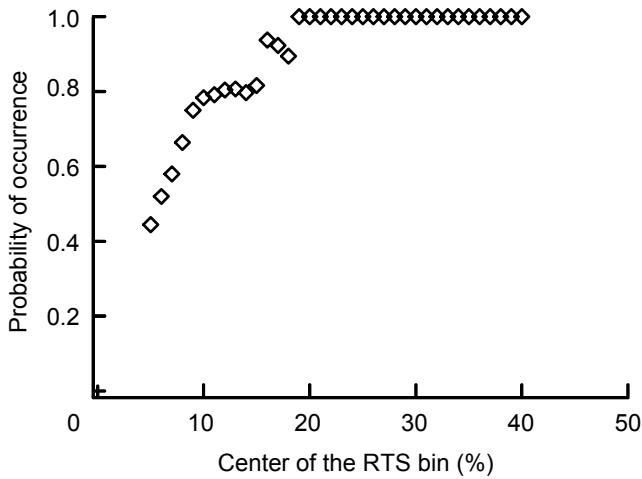
Figure 22—Probability of boards developing edge welt as a function of RTS, fence 2, all classes except OSB (class 9).

Another way of viewing the results is to graph the probability of a board showing any edge welt as a function of its RTS rating. Figures 22 and 23 show the results of this analysis for fence 2, with and without non-commercial classes, respectively. Figure 22 shows an increase with RTS in the occurrence of welted boards in RTS bins below 19%, with the steepest increase between the 5% and 9% RTS bins and a more gradual increase between the 10% to 18% bins. Above RTS = 16% (19% RTS bin) all boards have edge welts. The data for commercial boards (Fig. 23) show similar trends.

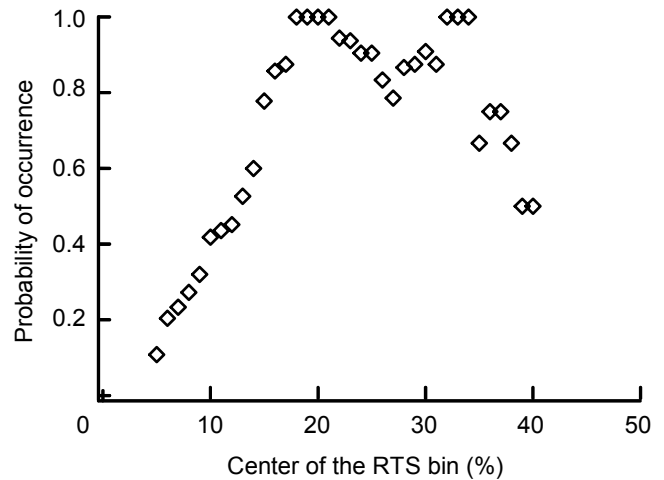
Figure 29—Probability of boards developing mold or mildew as a function of RTS, fence 2, non-commercial classes only.

14% RTS bin (11% to 17% RTS). However, the correlation fails at RTS values of 24% and higher (21% RTS and higher bins) because the sample size is reduced to four specimens or fewer, and the specimen with the highest RTS value had no mildew. Mildew on the non-commercial boards on fence 2 increases rapidly with RTS between 2% RTS and 21% RTS (5% RTS and 18% RTS bins). Mildew occurrence remains high at RTS values over 21% until it seems to drop off after the 34% RTS bin. However, only four or fewer specimens are in these higher bins, and the results are skewed by one specimen without mildew having an extremely high RTS rating.

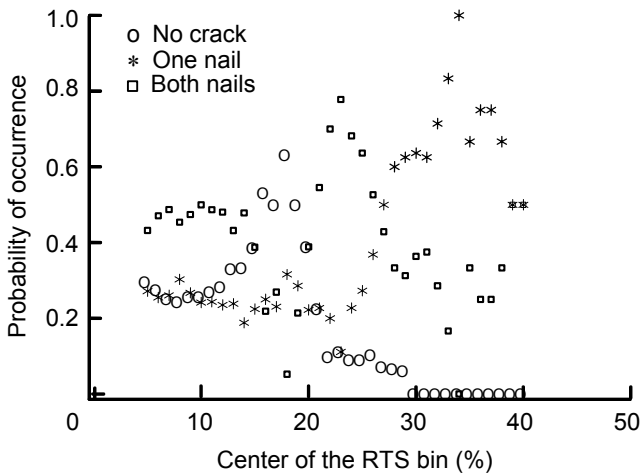
Figure 31—Occurrence of cracks at nail heads as a function of residual thickness swell, fence 2, all classes except OSB (class 9).

Figure 31, which depicts corresponding data for fence 2, also shows little correlation between the occurrence of cracks

around nail heads and RTS. On fence 2, the frequency of boards without cracks declines for RTS bins beyond 21% (RTS > 18%). Above RTS of 27% (30% RTS bin and higher), all boards from fence 2 showed paint cracks.

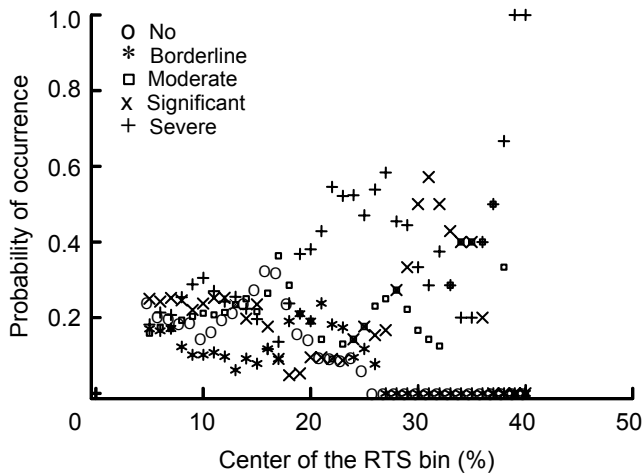
Figure 32 shows the correlation of occurrence of nail heads penetrating the paint surface with RTS for all classes on fence 1. This was also referred to previously in this report as “severity” of paint cracks around the nail head. “Borderline” indicates that one nail head was rated borderline (0.5). “Moderate” penetration means that one nail had fully pulled through (rated at 1) or that two nail heads were rated borderline. “Significant” indicates one complete pull through and one borderline, and “severe” means that both nail heads had completely pulled through the surface. No clear correlation appears to exist below 20% RTS, but above that level the number of boards without penetration begins to drop off. The RTS bins of 26% and higher contain no boards without penetration, which means that all boards with a RTS of over 23% showed nail head surface penetration.

Figure 32—Occurrence of nail heads penetrating the paint surface as a function of residual thickness swell, fence 1, all classes except OSB (class 9).

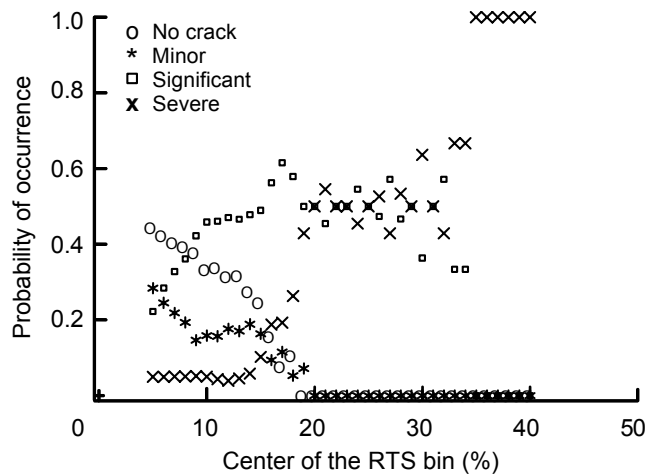
Figure 34 shows the correlation of probability of occurrence of various drip edge crack ratings with RTS. The data show a strong inverse correlation between frequency of boards without drip edge cracks and RTS. The frequency of such

Figure 34—Occurrence of cracks on the drip edge as a function of residual thickness swell, fence 2, all classes except OSB (class 9).

boards steadily declines with increasing RTS until, at 16% RTS and above (19% RTS bin and higher), no board specimens are without drip edge cracks. At 32% RTS and above (35% RTS bin and higher), all cracking is severe, but the number of specimens in those bins is very small (four or fewer).
