# Mold and Decay in TriState Homes

*Anton Ten Wolde*

## **Abstract**

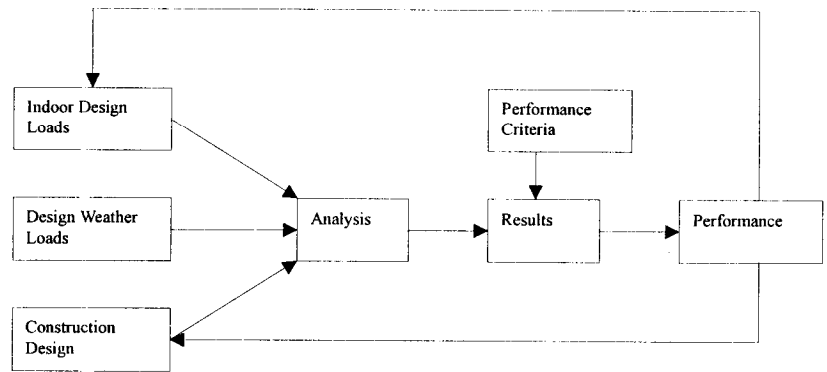
**Figure 1.**—Schematic of moisture engineering design analysis process.

Moisture engineering is an effort to put moisture design on a more rational basis. Moisture engineering involves using interior and exterior design moisture loads as input conditions and established performance evaluation criteria for the analysis and evaluation of the performance of the building envelope. Figure 1 shows a schematic of this process. Current recommendations and rules for moisture control are not based on a set of consistent, performance-based assumptions. This lack of adequate design criteria has often led to pointless discussions about the need for various design features, because the need often depends on what indoor or outdoor
