## DEFENSE NUCLEAR FACILITIES SAFETY BOARD

**SUBJECT:** Report on the Radiation Protection Review at the Rocky Flats Plant

1. **Purpose:** This memorandum documents the Defense Nuclear Facilities Safety Board (DNFSB) technical staff and outside expert trip to the Rocky Flats Plant to review the Radiation Protection Program. The review was based on a visit to Rocky Flats on August 16-20, 1993.
2. **Summary:** The staff reviewed the Radiation Protection Program for consistency with Department of Energy (DOE) Order 5480.11, *Radiation Protection for Occupational Workers*, DOE Notice 5480.6, *Radiological Control*, and DOE Order 5400.5, *Radiation Protection of the Public and the Environment*.

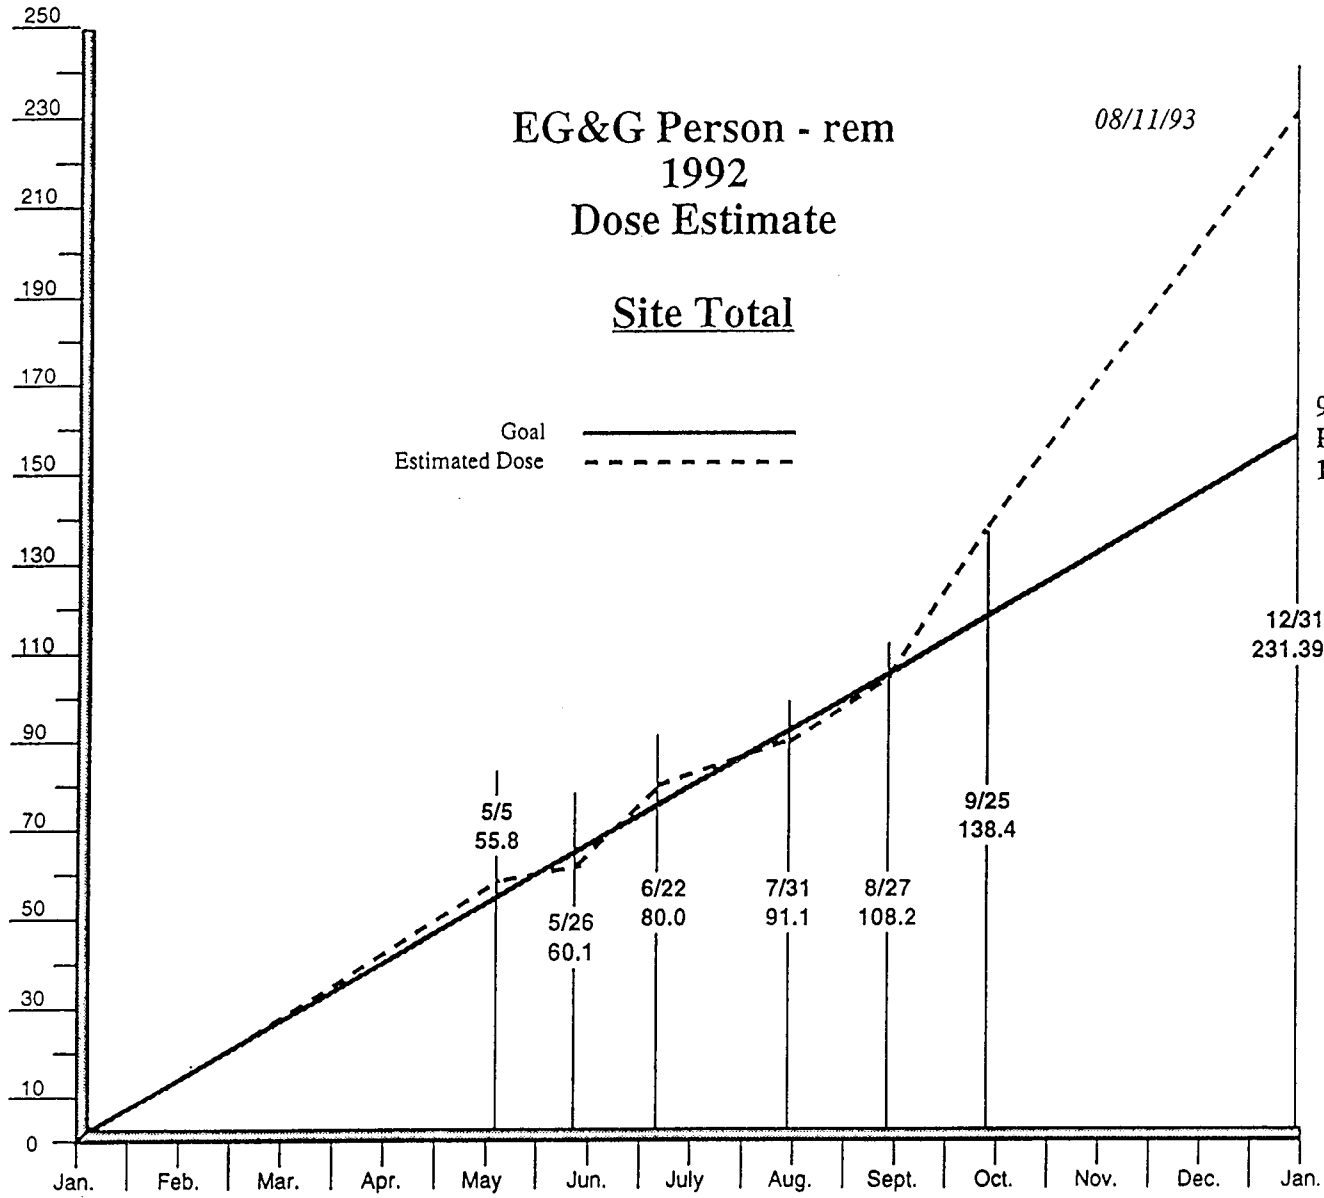
EG&G Person - rem  
1992  
Dose Estimate

92 Goal  
Person - rem  
157.0

5. The method used for development of ALARA external exposure is without a strong foundation. Typically, the estimate of the previous year's external exposure total is simply factored down by 10 %. Allowances are not made for changes in work load or personnel staffing from year to year. Major changes in work assignments can significantly affect a groups external radiation exposure for a year. However, provisions apparently do not exist to adjust a goal during the year to account for these changes. These issues limit the usefulness of the goals as a management tool.
