BIOLOGICAL ASSESSMENT

RIO GRANDE RESTORATION AT SANTA ANA PUEBLO TERRESTRIAL HABITAT ENHANCEMENT PLAN

JULY 1999

U.S. Department of the Interior
Bureau of Reclamation
Albuquerque Area Office
Albuquerque, New Mexico

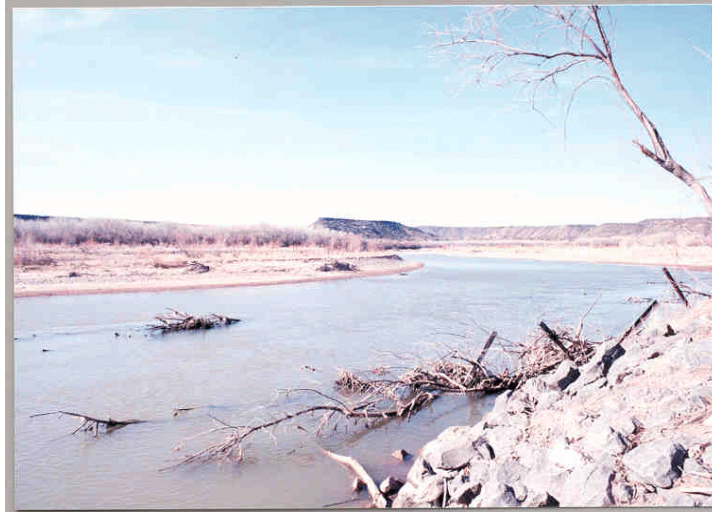
Figure 1. Looking upstream from the project curve. High flows cut into levee eroding the bank. Large gravelbar on opposite bank. Overbank flooding of bar occurs at 13,000 cfs.

Banks along the Rio Grande in the Santa Ana reach were composite banks, made up of noncohesive materials and subject to mass wasting. Inside bends result in large gravel bars two to six feet high with no vegetation (figure 1). The channel is often incised with steep banks, especially on the outside bends become vertical or steeply graded, six to 20 feet high in some places. Where vegetation is prevalent the bank is usually lined with saltcedar and/or Russian olive.

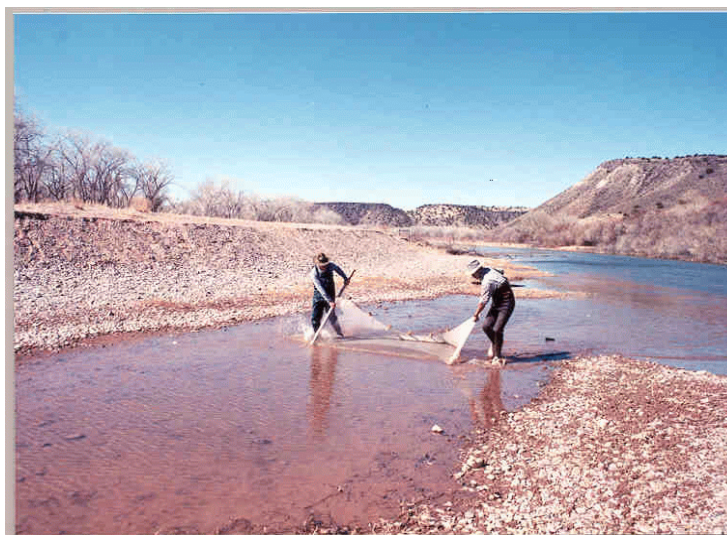
Figure 3. Site A - Reclamation biologists seine for silvery minnows in a backwater located on the Santa Ana Pueblo, directly below Angostura Diversion Dam.

There are two sites where the minnow is sampled for by seine: Site A (about river mile 209.5)(figure 3), directly below Angostura Diversion Dam, and Site B (about river mile 208.7), immediately above the mouth of the Jemez River. Both sites are above the project curve, located one-half mile downstream from the Jemez River. Site A is a main channel run over gravel/cobble. Depending on the discharge at the time of sampling, there are several riffle areas within this section of river. In the middle of the channel at the top of the run there is a woody debris aggregate.
