Appendix C

Early Project Correspondence

Towne Seuk Upper Reservoir Leakage

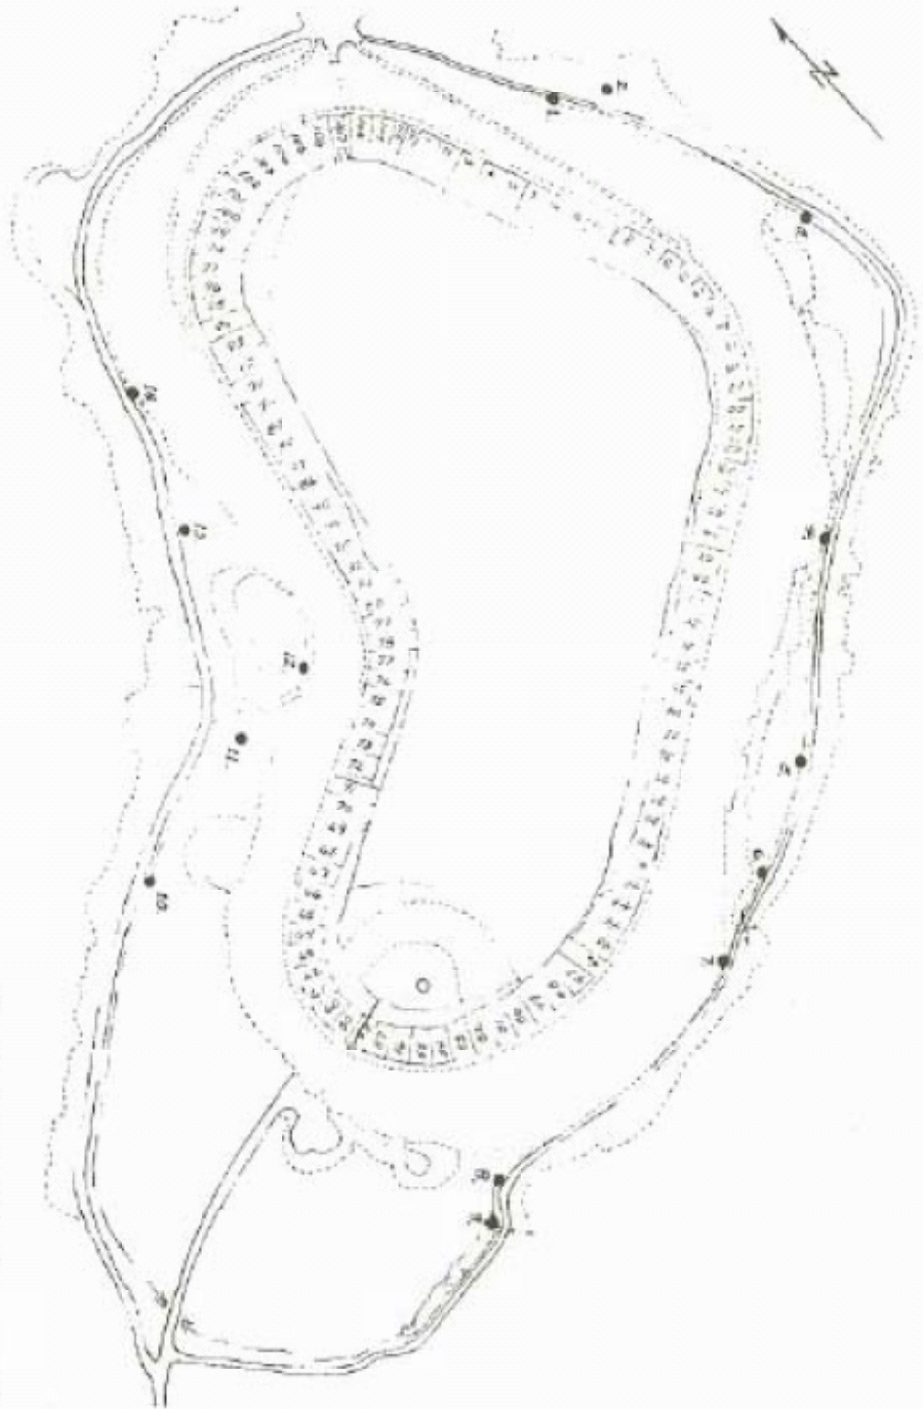
*TAMM SHARK UPPER DESANDING
Location of Looking Flow Gages*

Gage No.	Gage Height*	Condition of Gage	Comments
1	12"	OK	
2	9"	OK	
3	13 1/4"	OK	
4	7"	OK	
5	28 1/4"	OK	
6	19 1/2"	OK	Little rattle noise
7	16 3/4"	OK	
8	16 1/2"	OK	
9	-2 3/8"	OK	
10	21 3/4"	OK	
11	16"	OK	
12	8 1/4"	OK	
13	-6 3/8"		installed at gage 26 1/2" equivalent men removing slide near slide channel discharge
14			
15	30"		
16			
17

General Comments: Leakage was generally down except for area between panels 28 & 102 where it has increased. Drainage channel below panel 30 should be opened to allow water passage to relieve head on sink hole.

The gage readings are generally down while the computed leakage is up. The "fish pond" area, - say between panels 90 & 102, is up in leakage. The increase in leakage in the fish pond area represents from 2 to 3 cfs.
